Phases 2a and 2b west wing

## Appendix 11

Yeomanry House

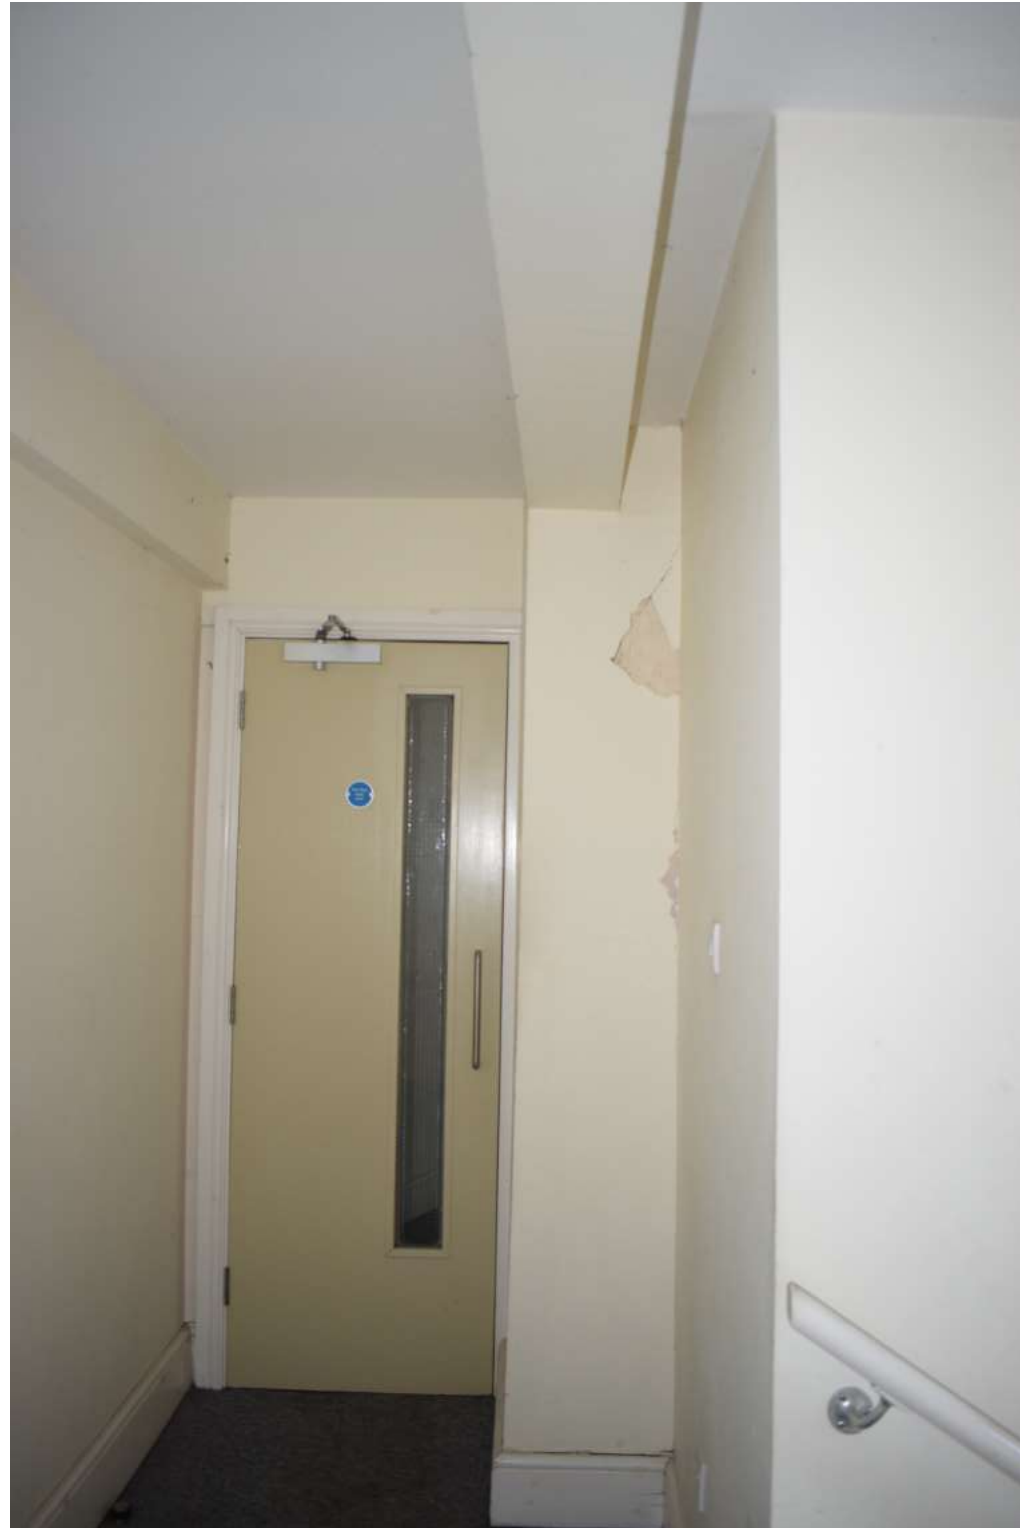
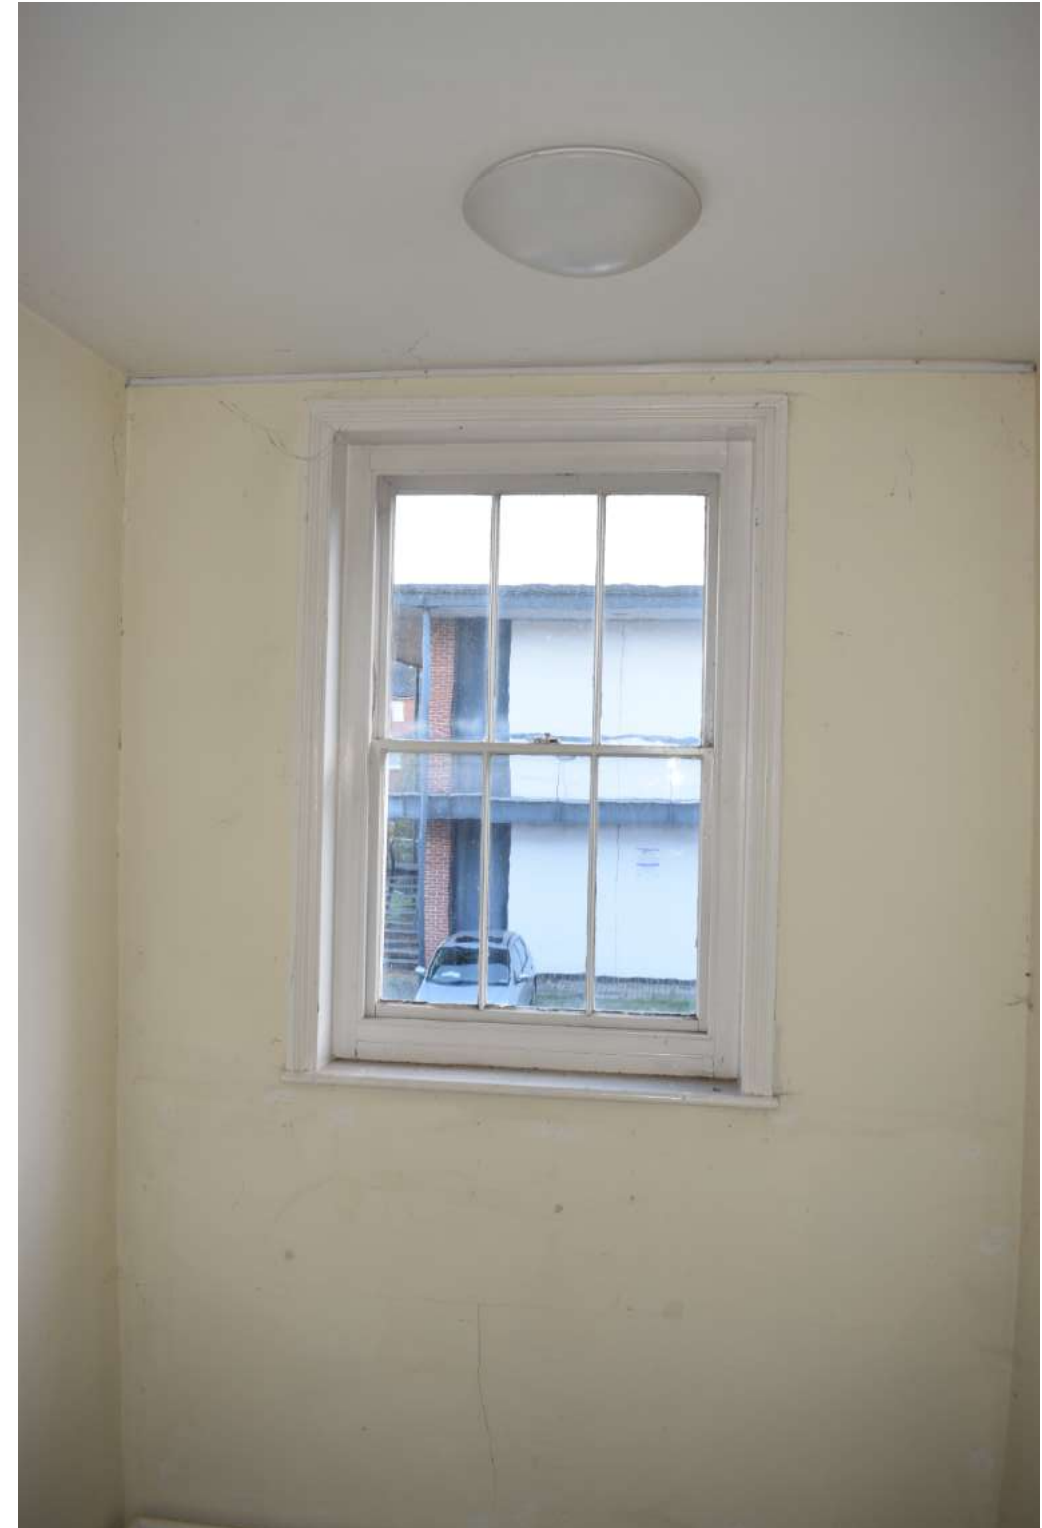
Plate 69

Reconfigured spaces: This image illustrates the downstand supporting the corridor, which is the location of a former wall that once supported a wall.

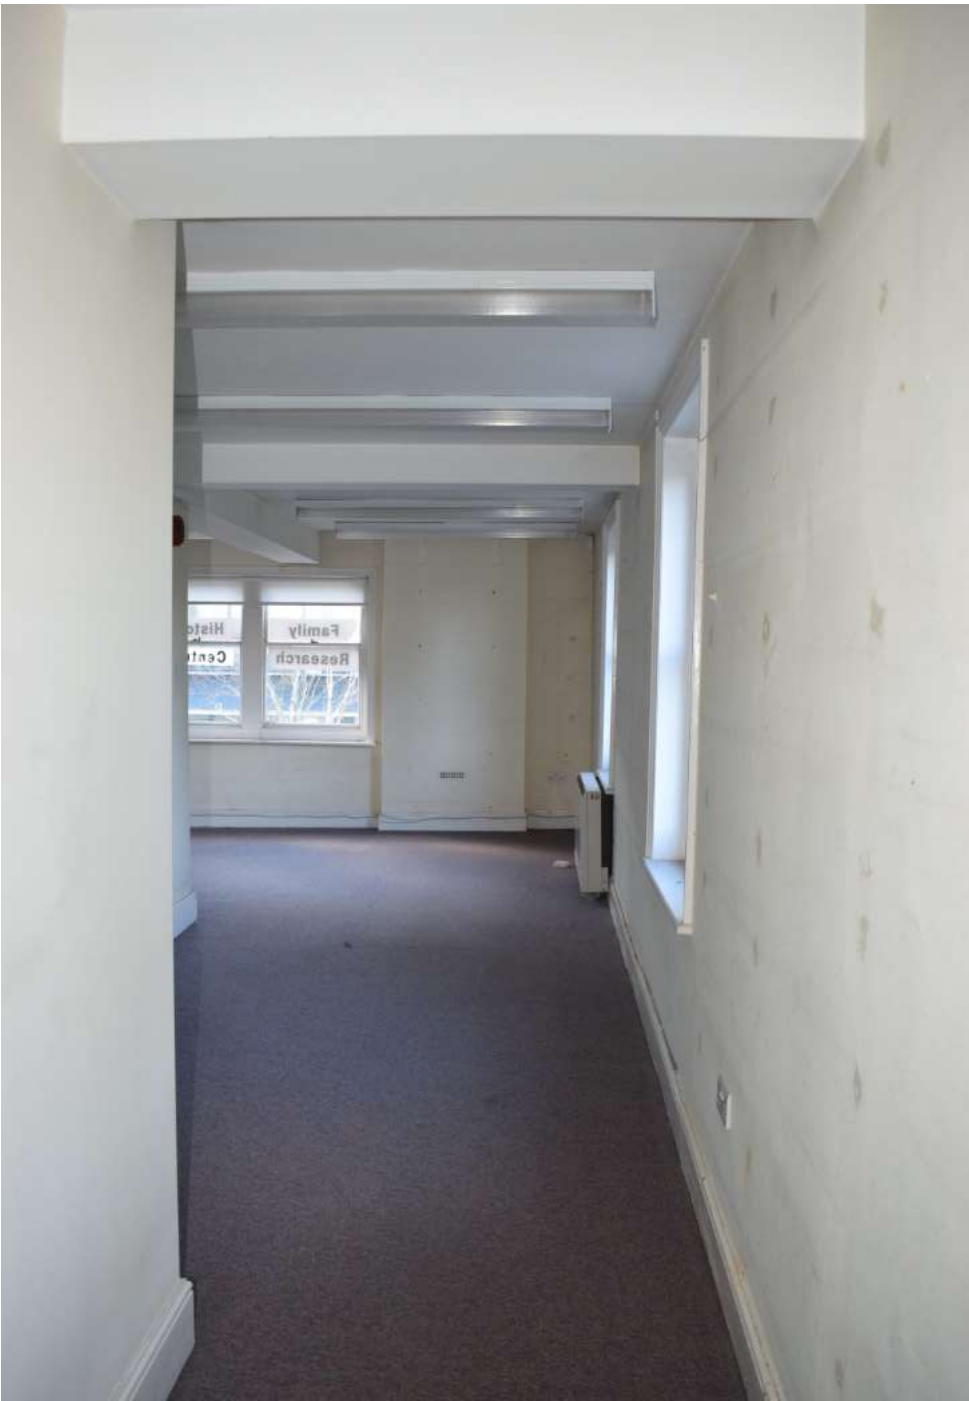
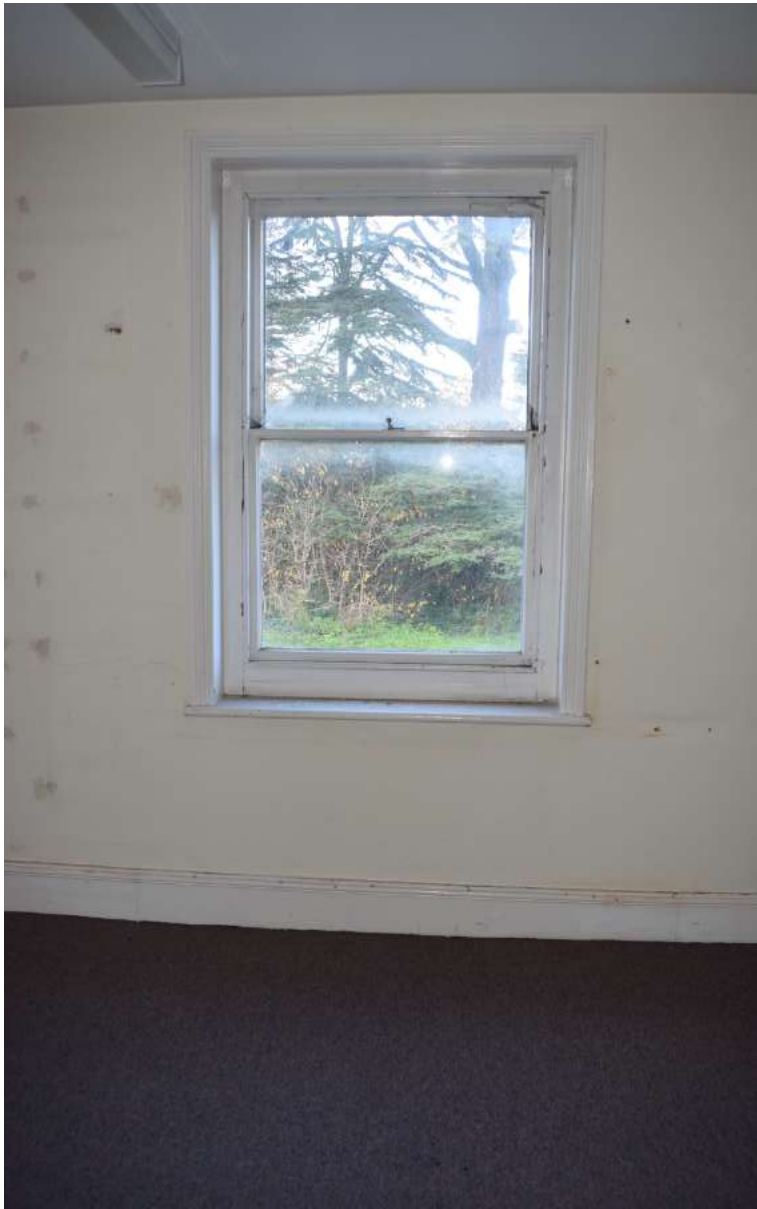
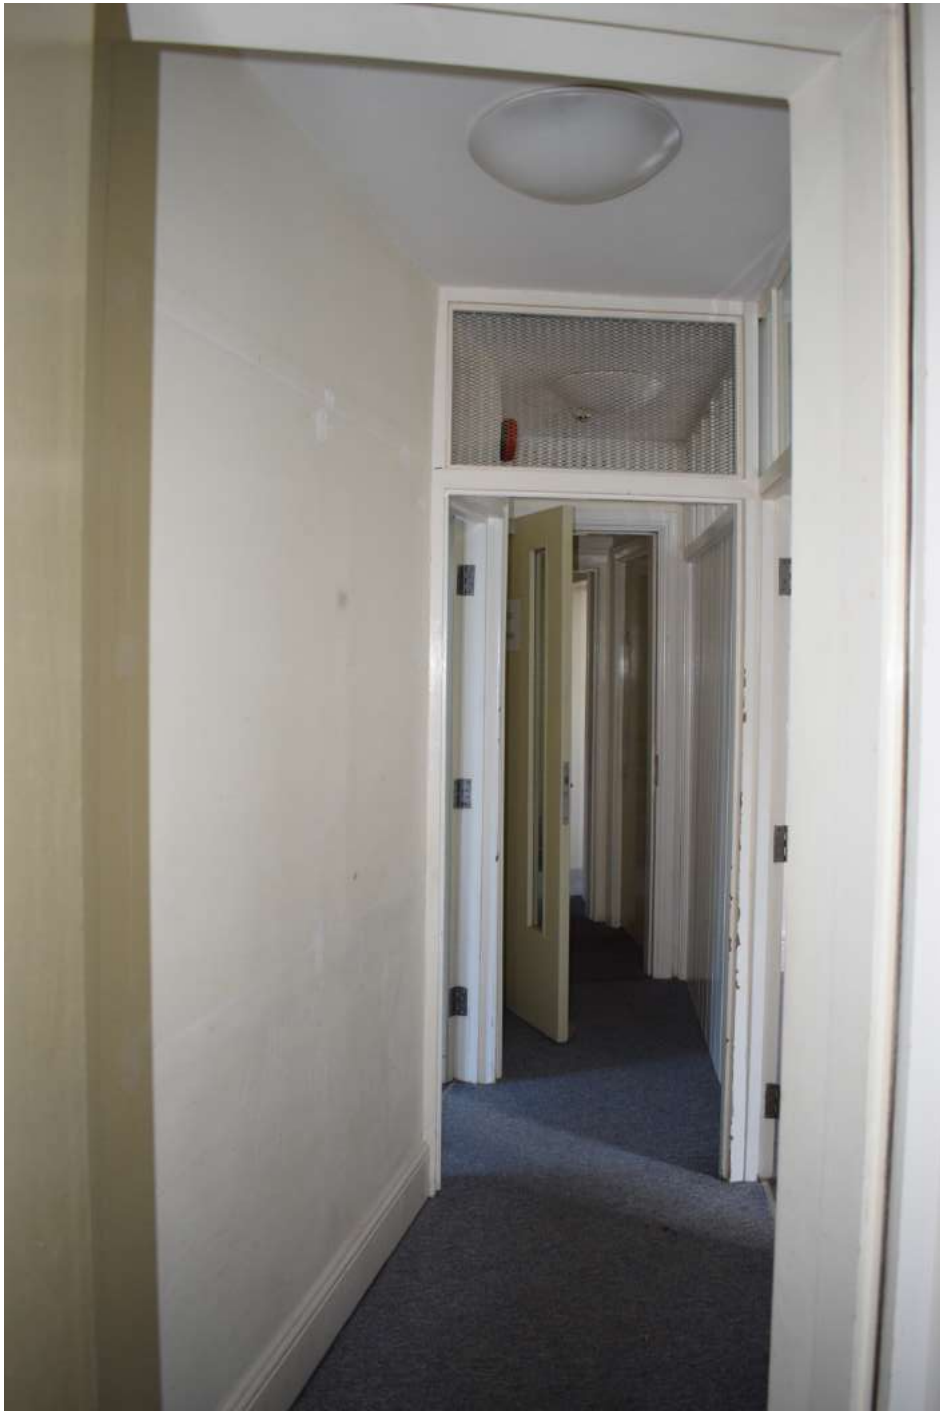
Plate 70  
Reconfigured spaces: This image displays the reconfigured first-floor Exhibition Room, showing a series of downstands spanning the space created for the enlarged room.

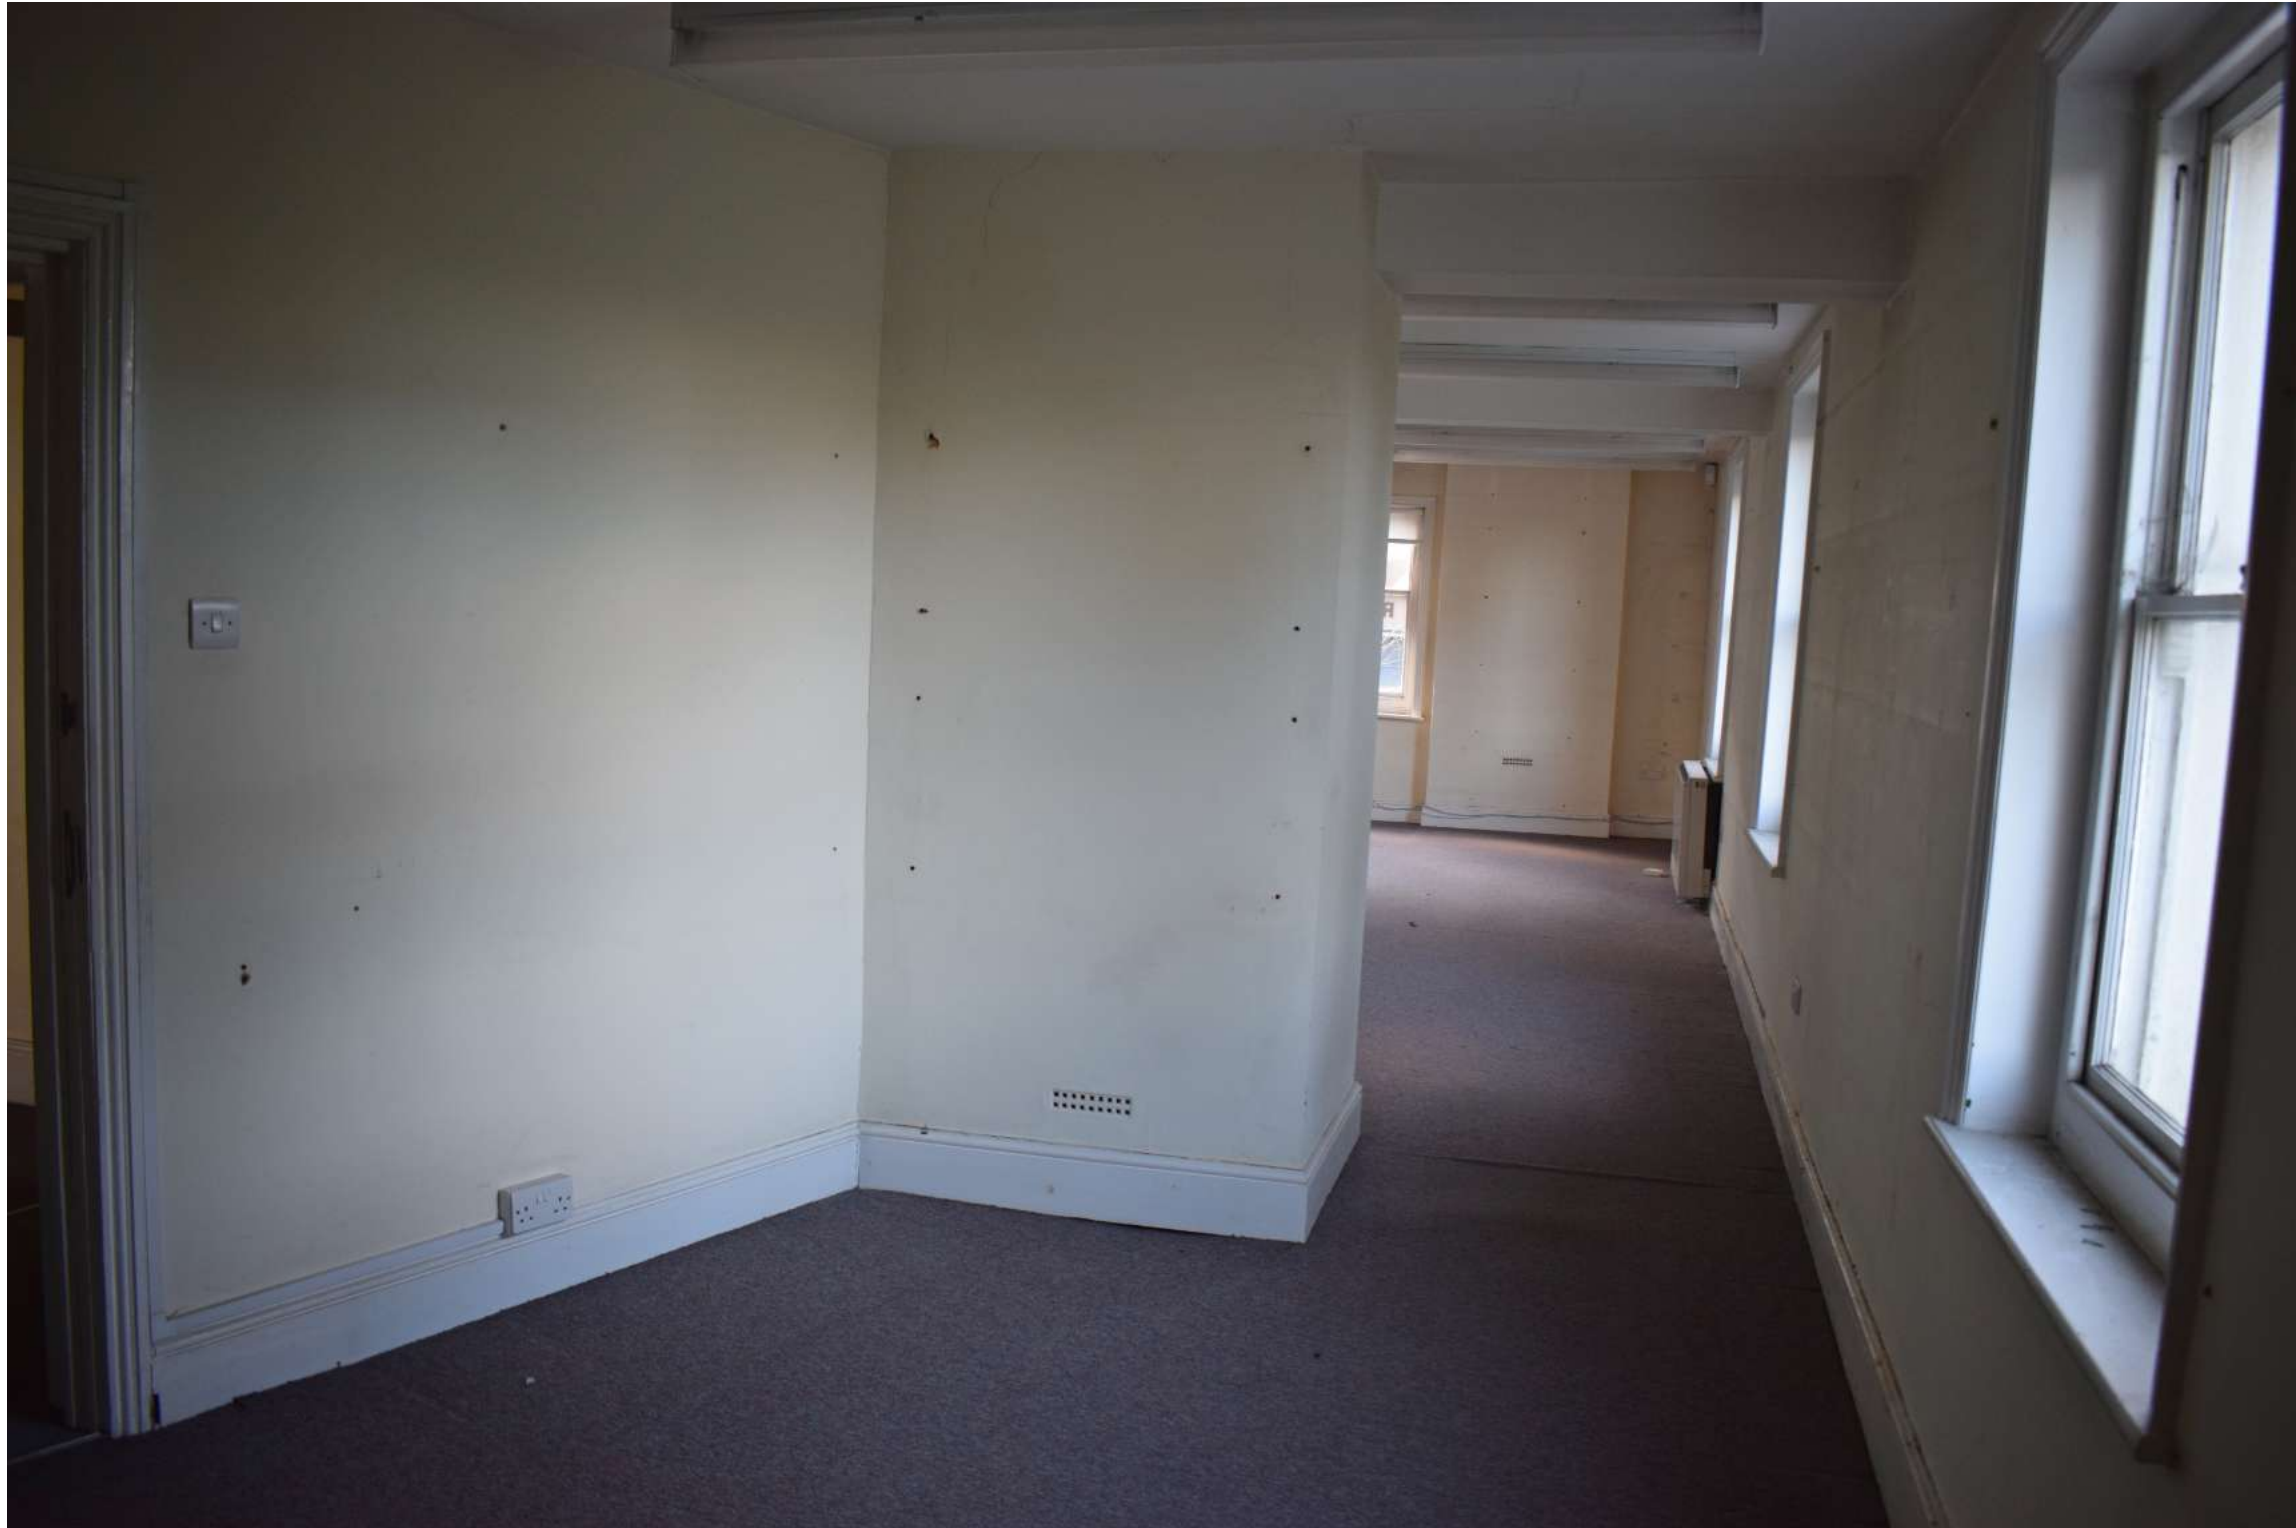
Plate 71m

Reconfigured spaces: Located at the first-floor entrance to the Exhibition Room, this image illustrates reconfigured spaces with awkward angles, which indicate changes in the historic layout.

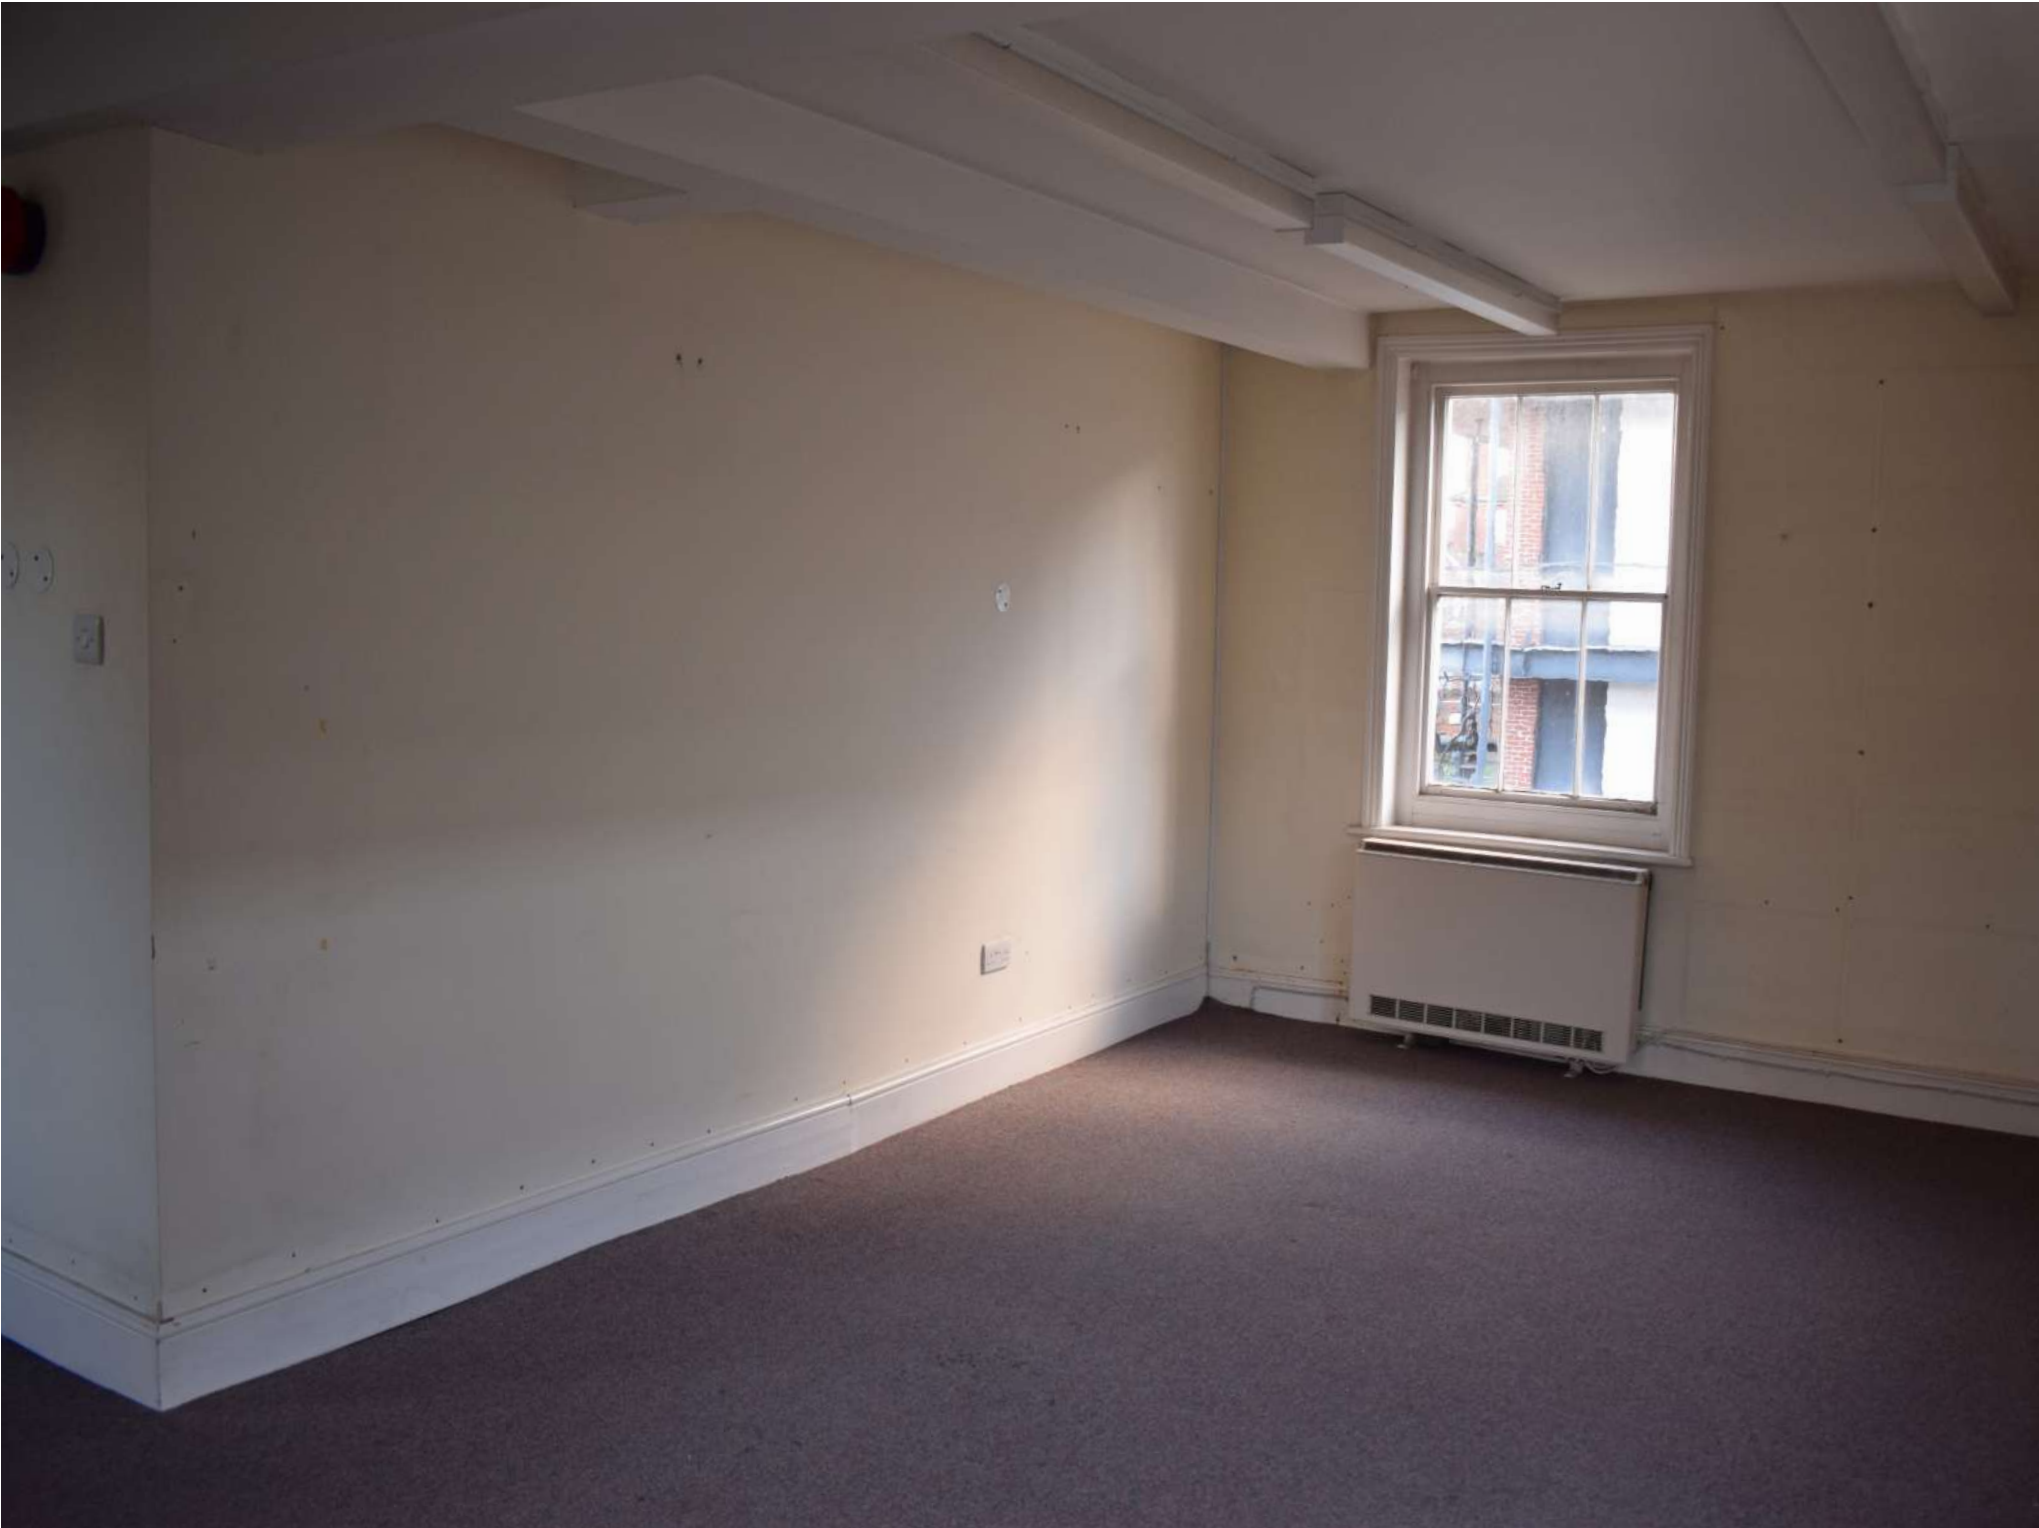
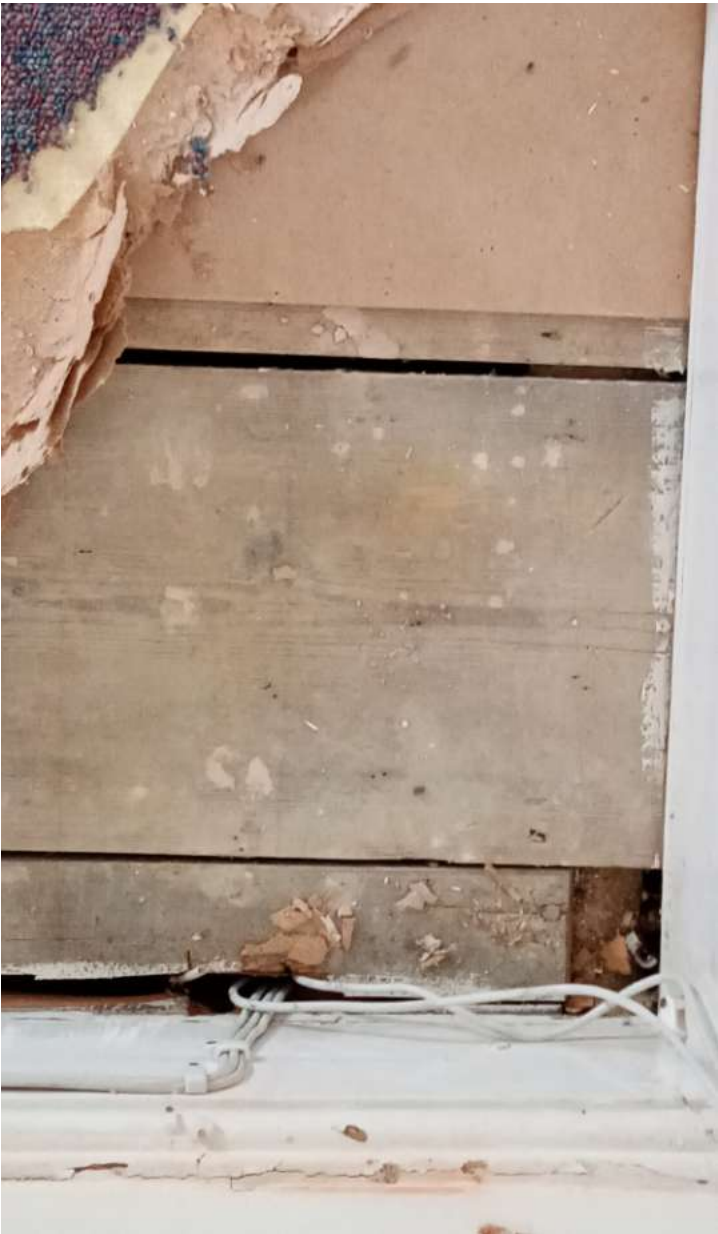
Plate 72

Reconfigured spaces: Within the first-floor Exhibition Room, this image shows downstands which indicate that smaller rooms were demolished to create the current larger space. Inset: a detail of the timber flooring.

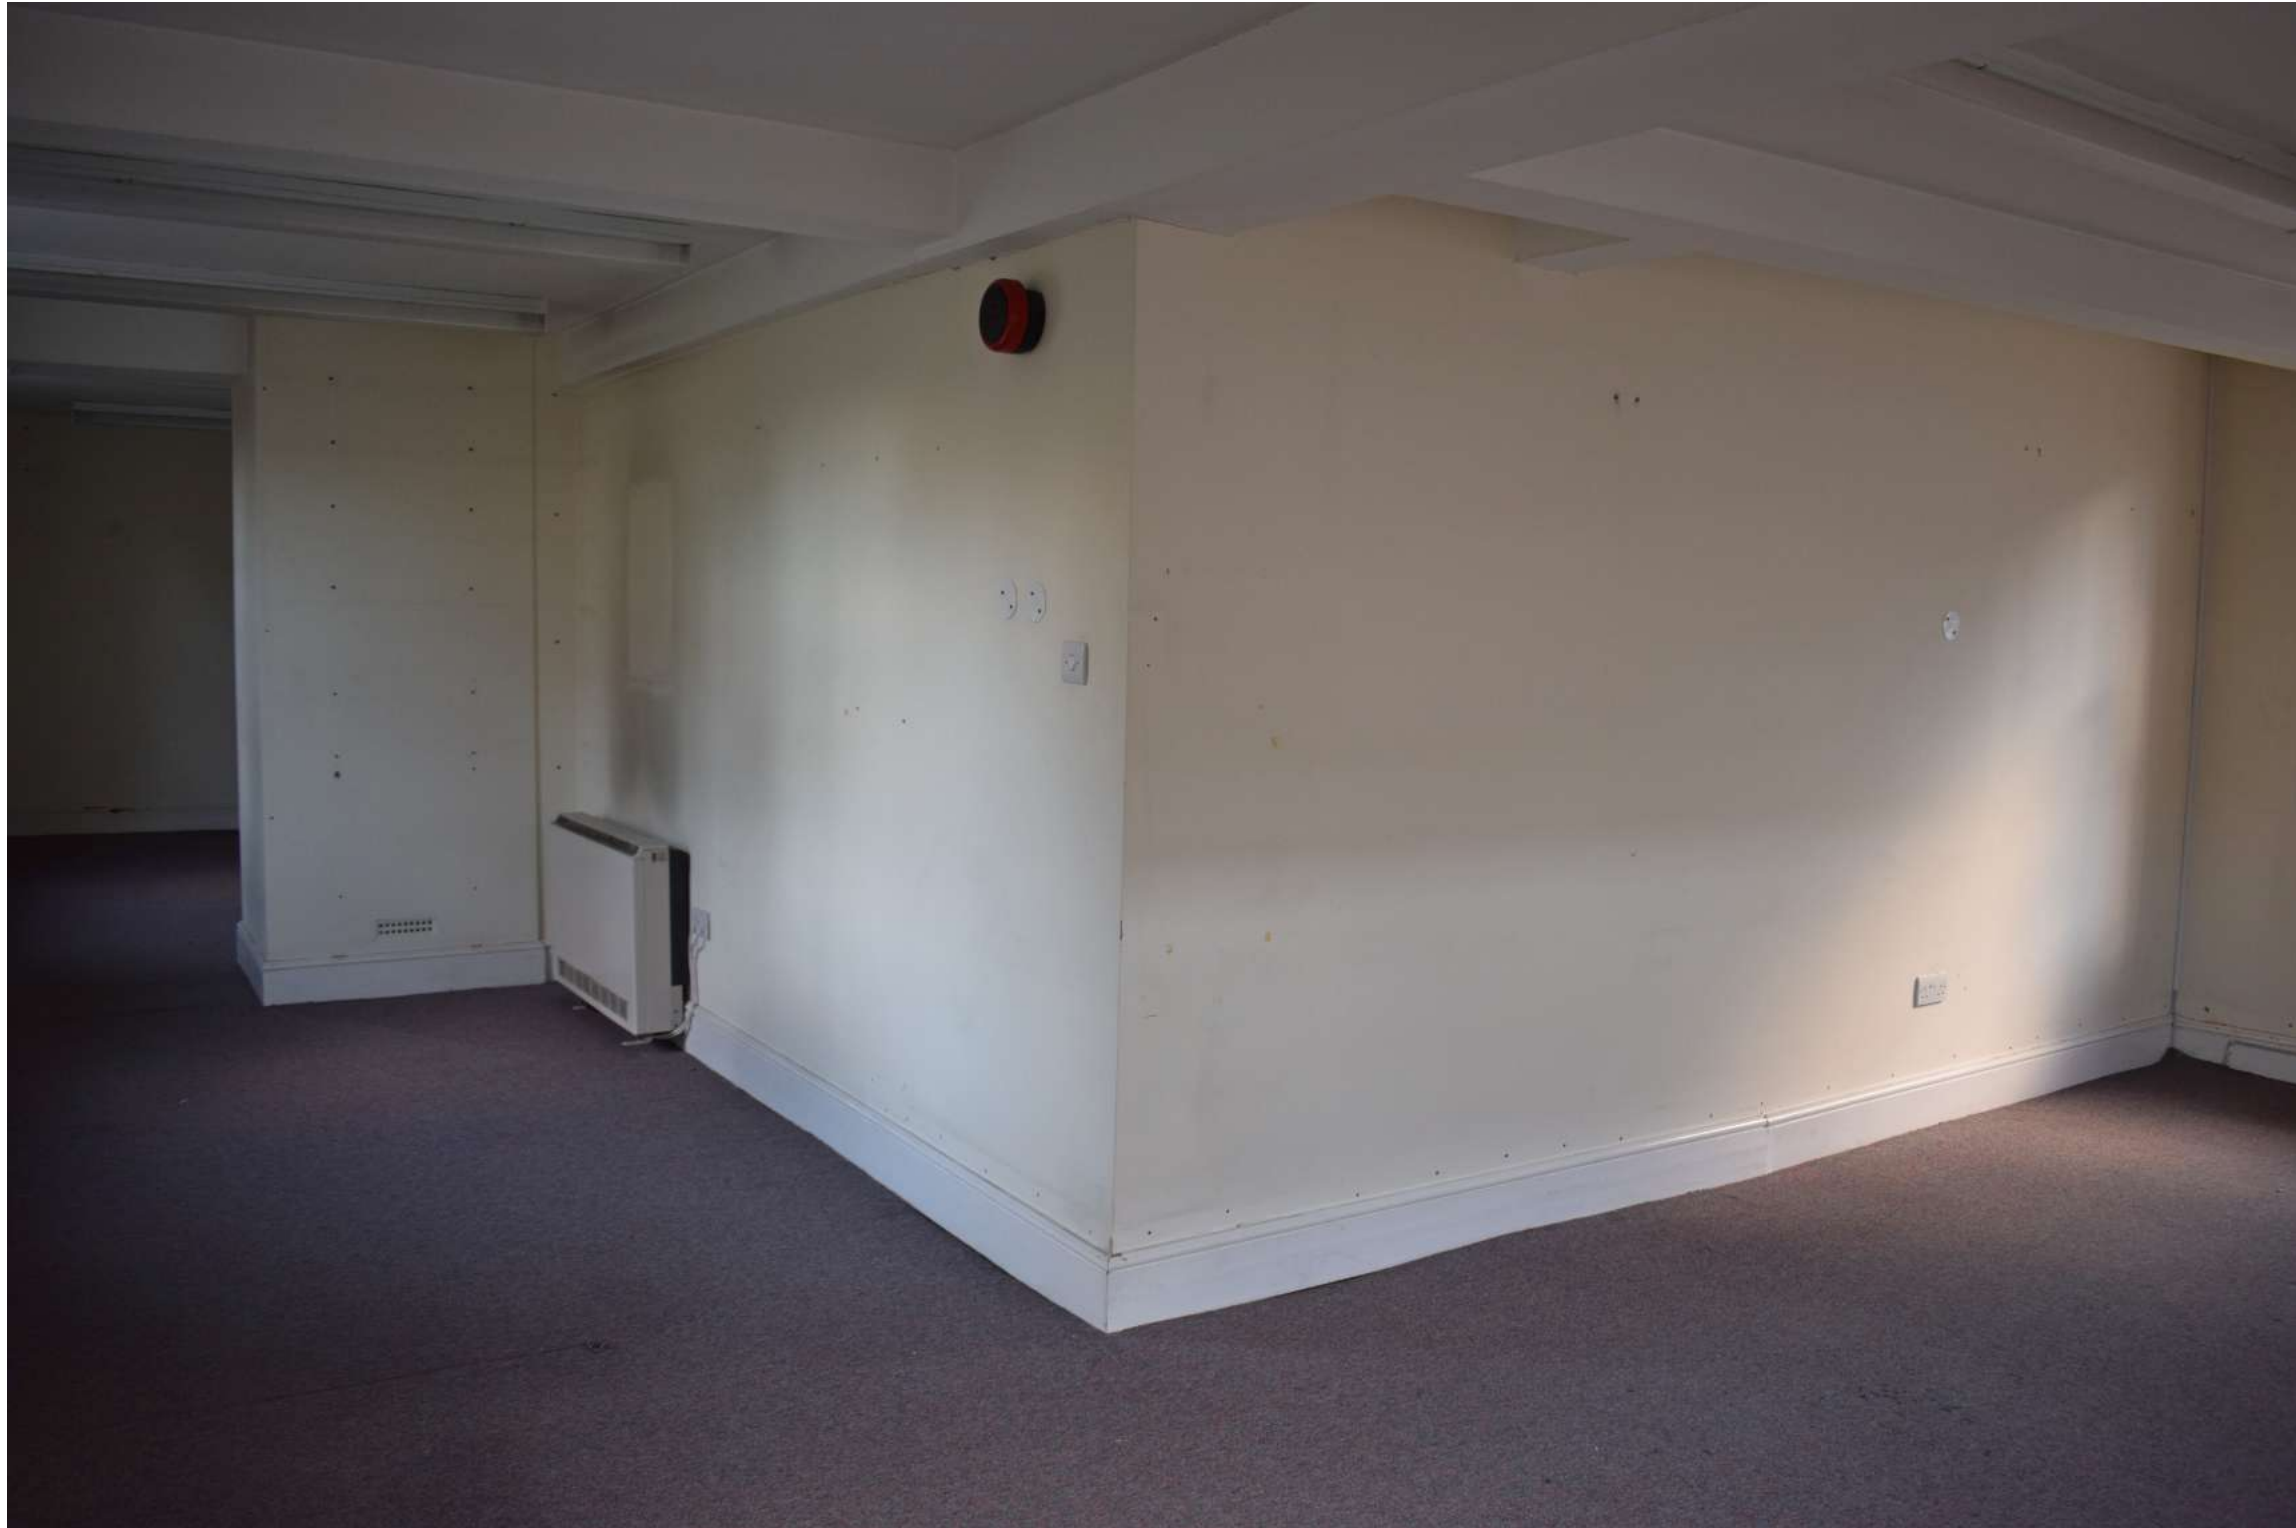
Plate 73

Reconfigured spaces: A general view, located in the first-floor Exhibition Room, shows a view looking towards the space required for the modern stairwell.

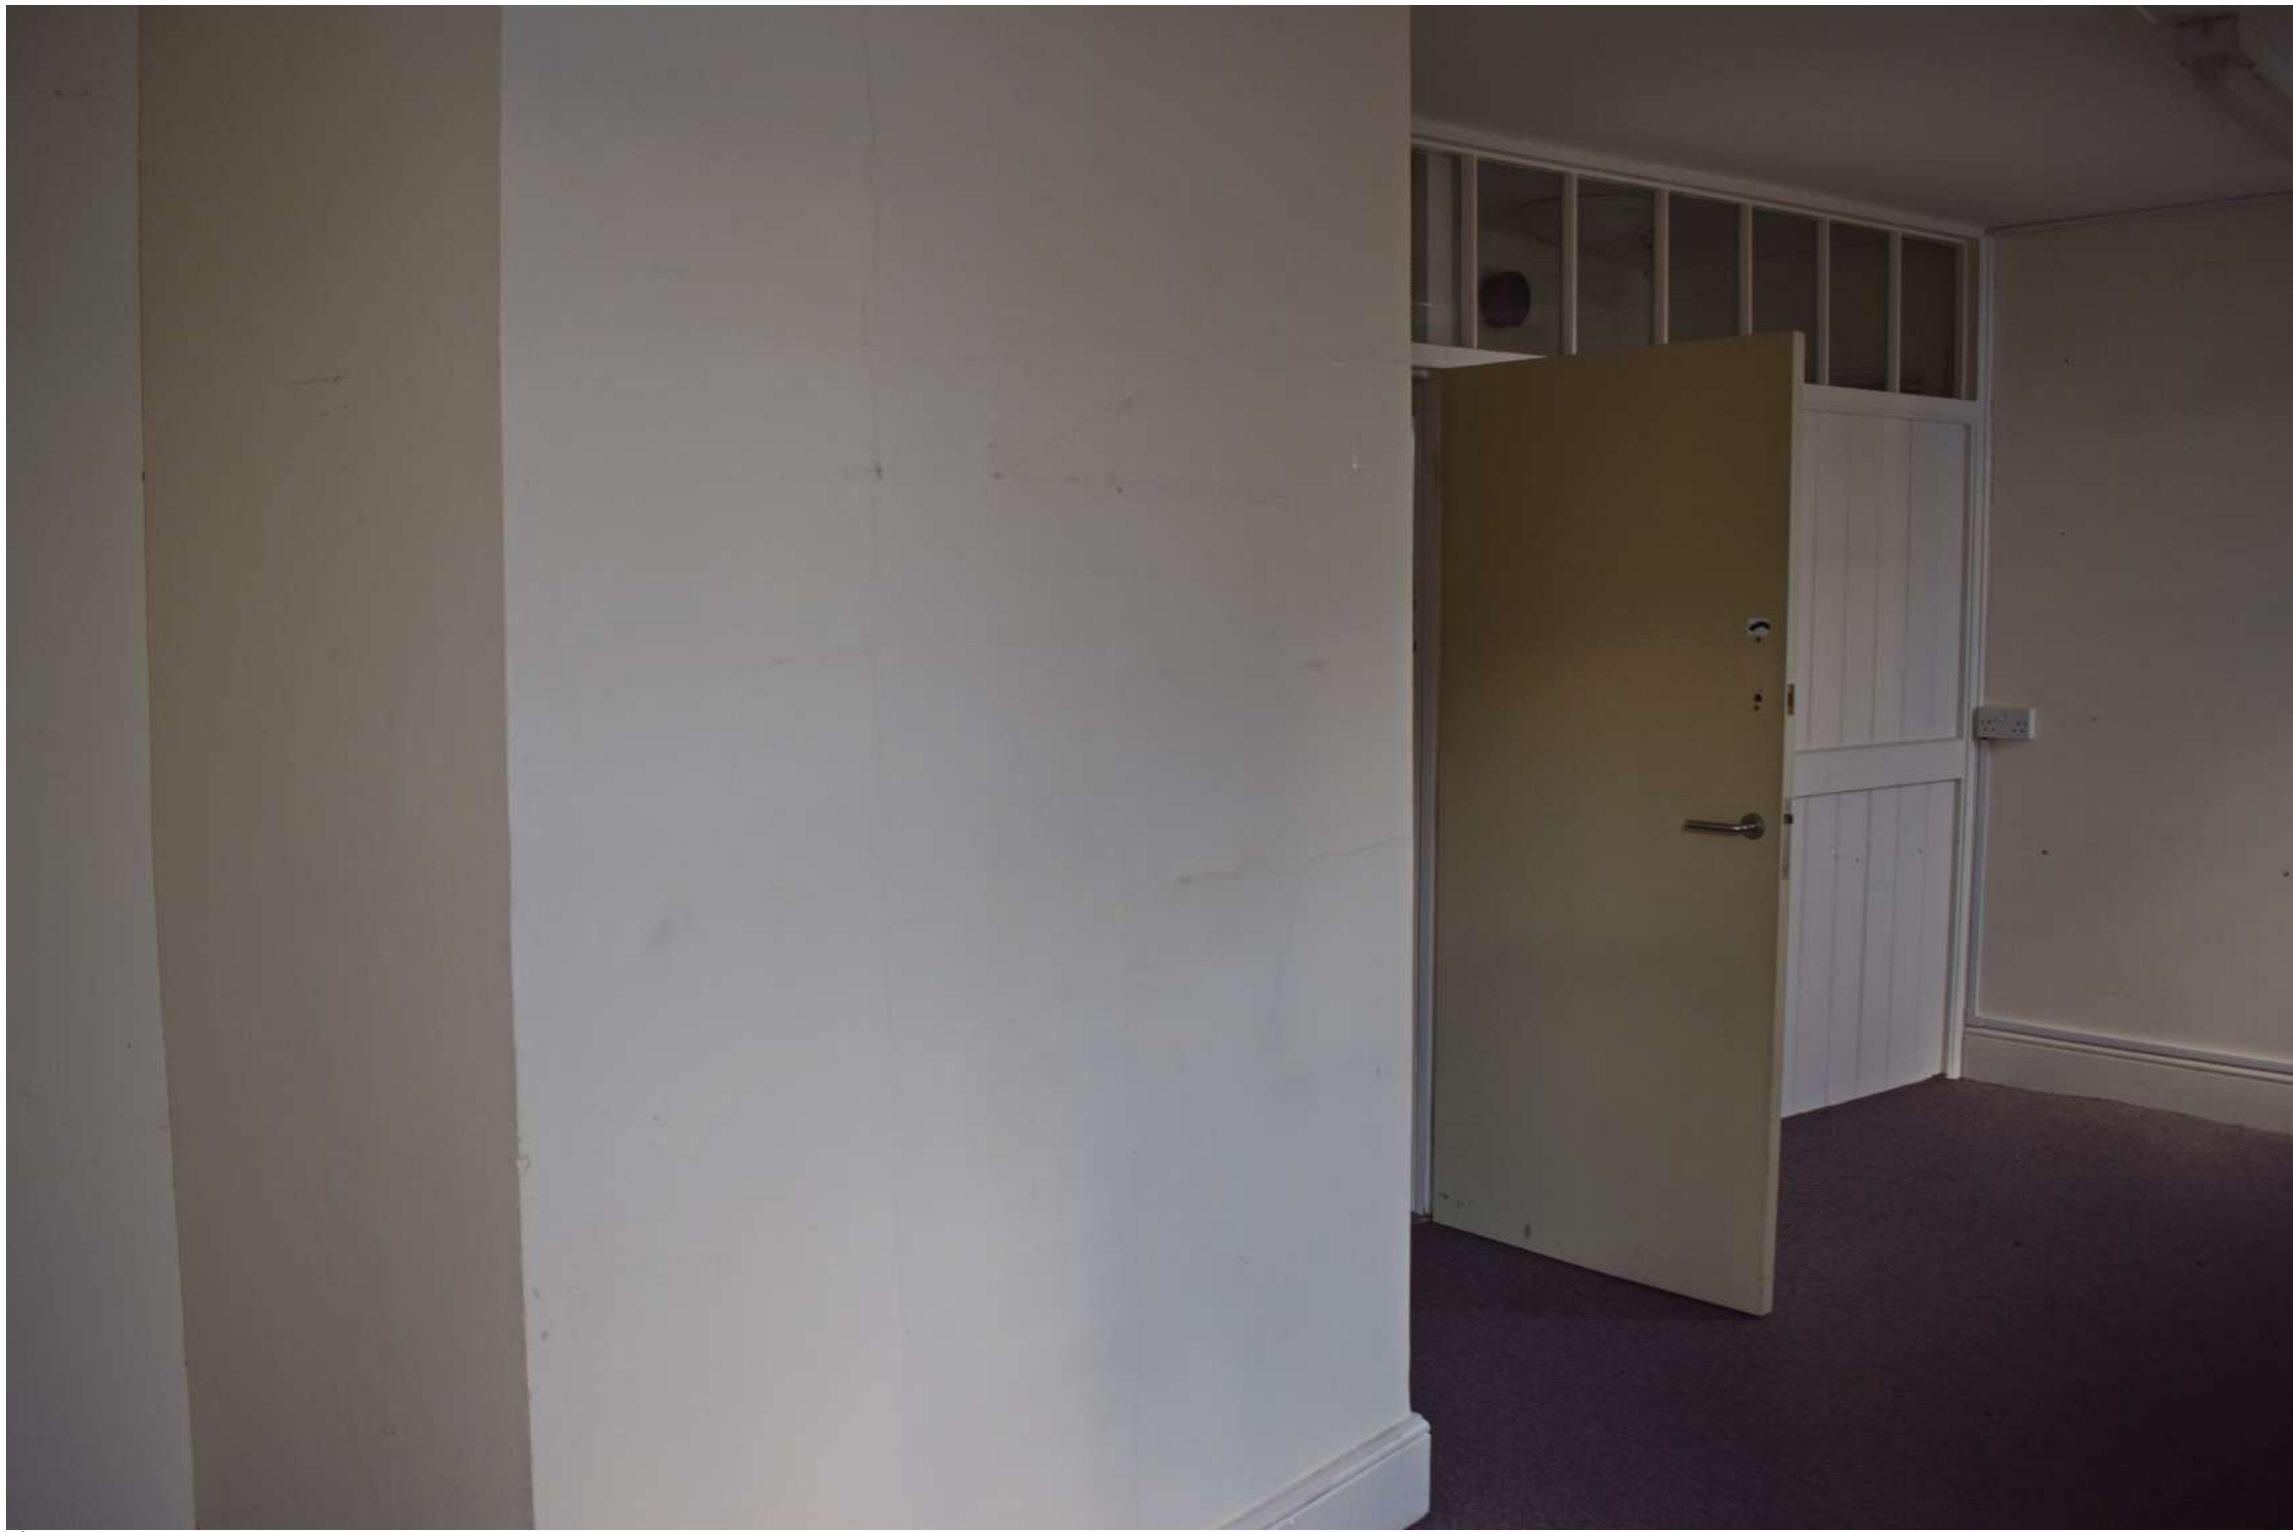
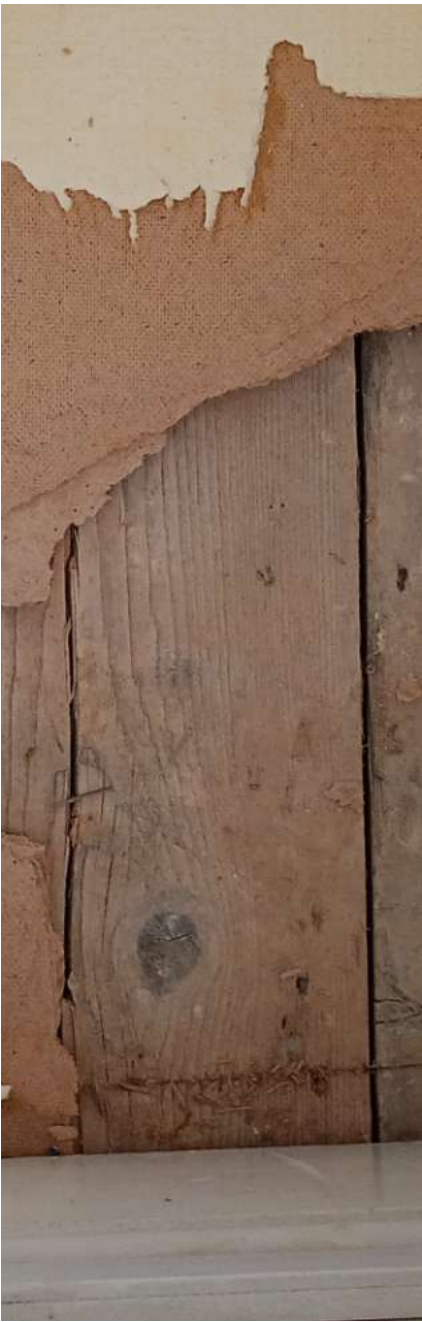
Plate 74

Reconfigured spaces: Located in the first-floor Store Room, this image shows a modern partition installed to create corridors. Inset: a detail of the timber flooring.
