Phases 2a and 2b west wing

## Appendix 11

Yeomanry House

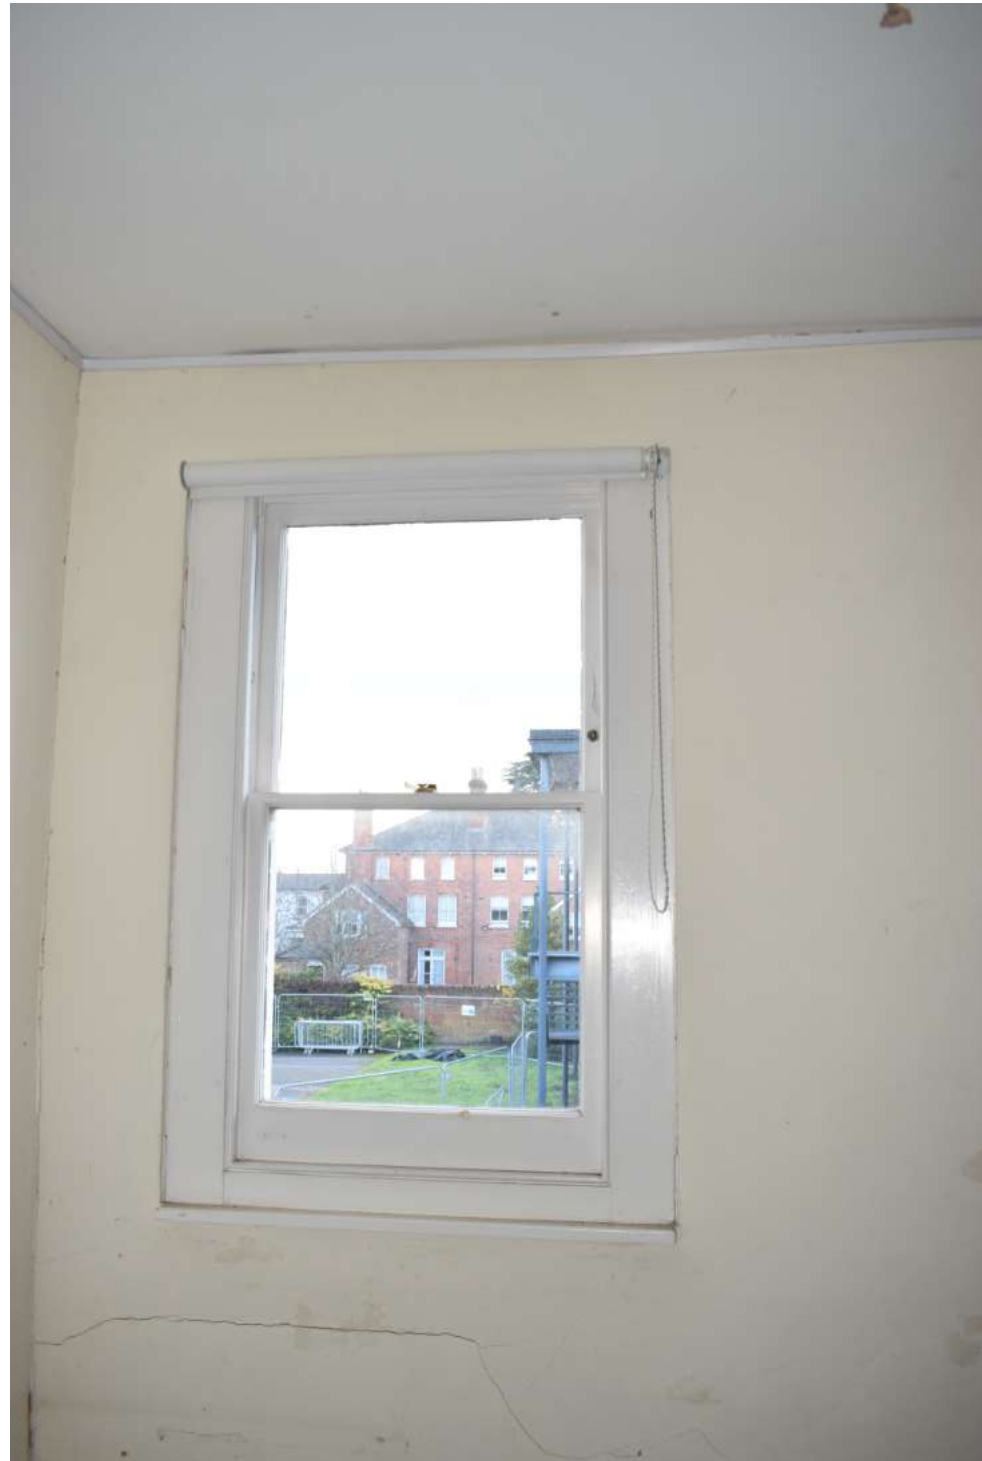
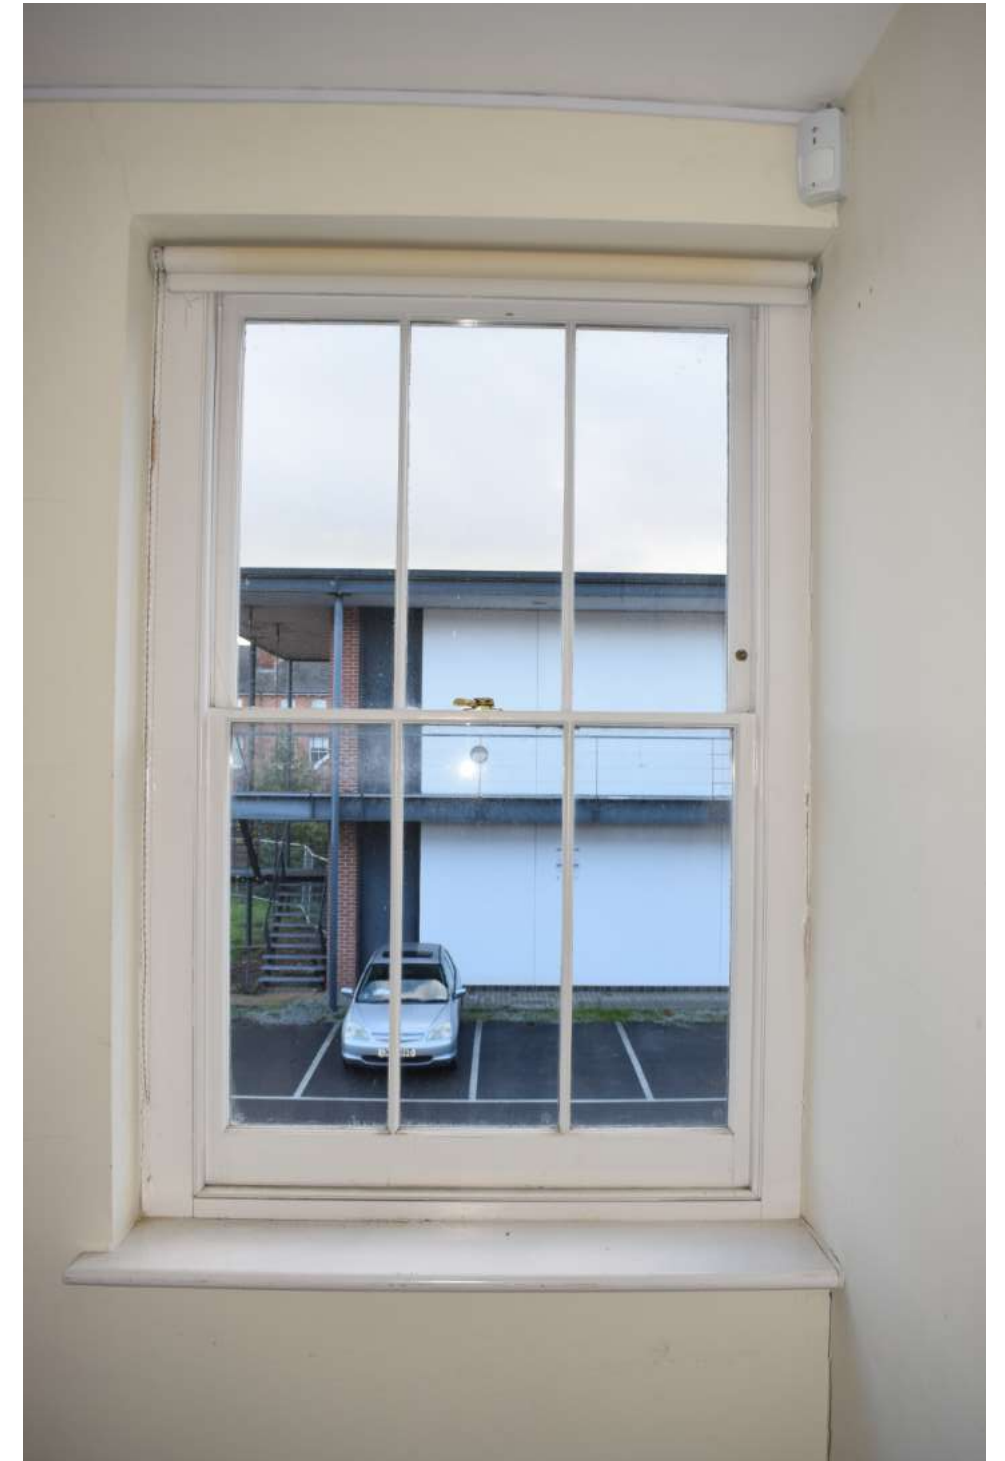
Plate 75

Reconfigured spaces: This image, showing first-floor WC windows, illustrates modernised windows that light the water closets.

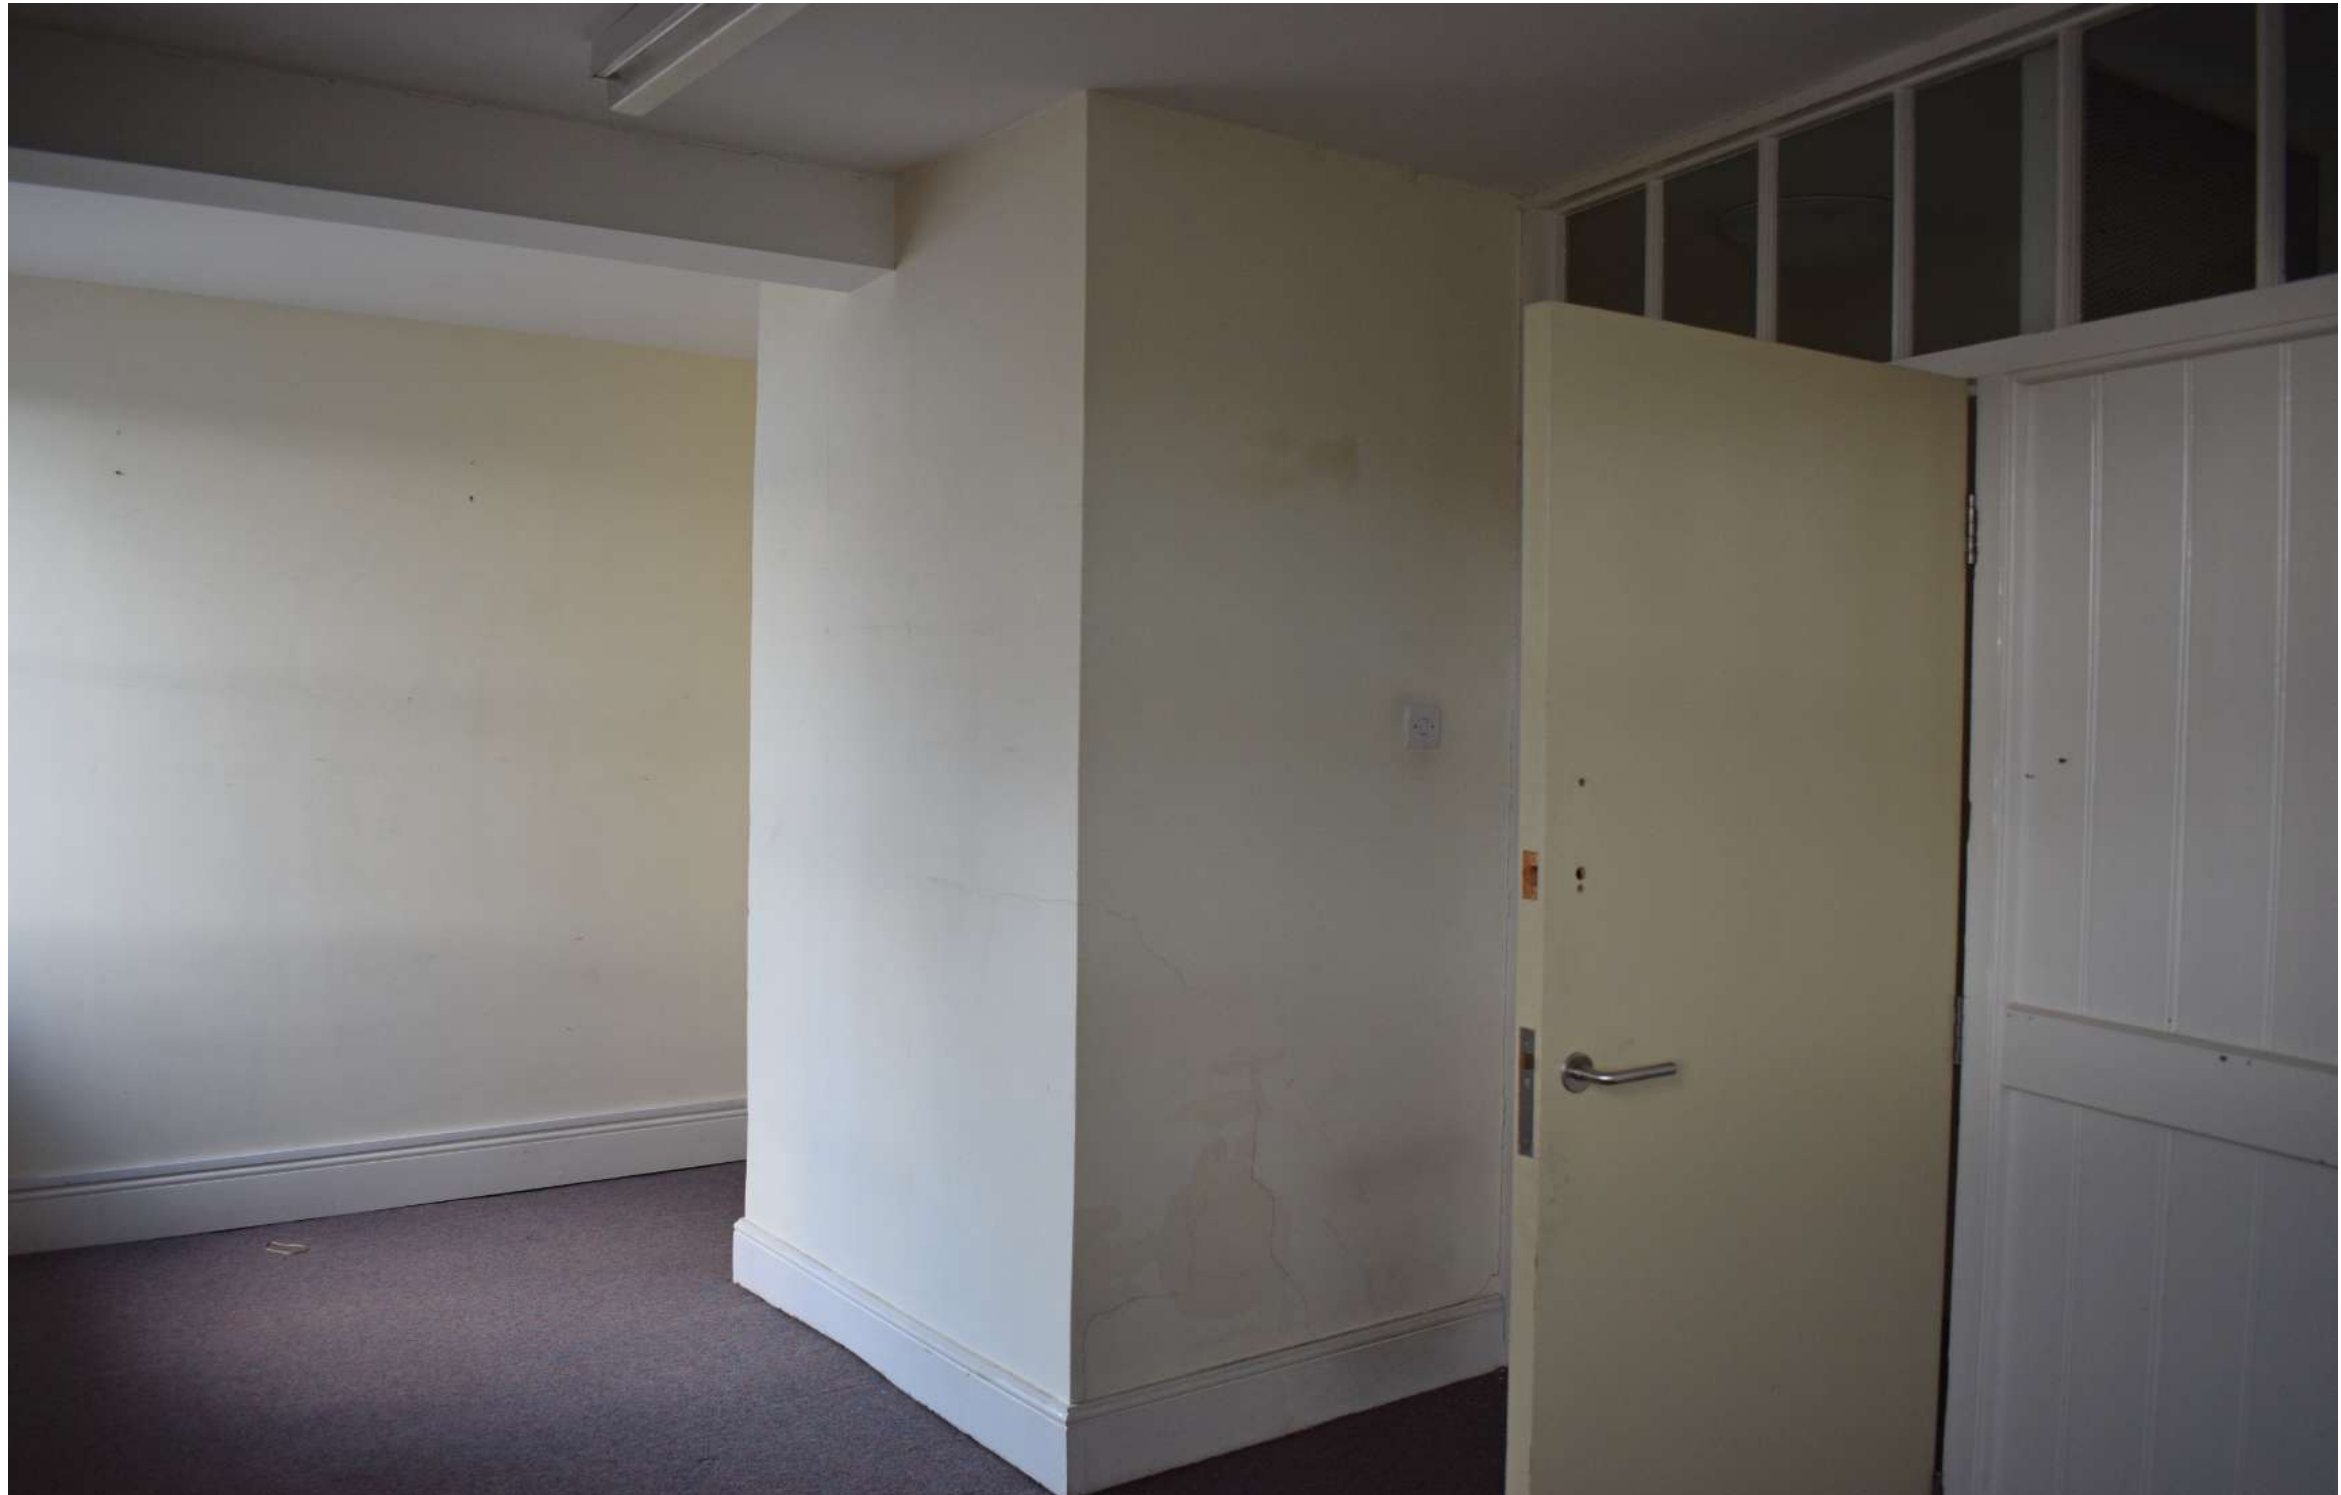
Plate 76

Reconfigured spaces: A view of the first-floor Store Room, this reconfigured space is no longer legible as part of a historic house.

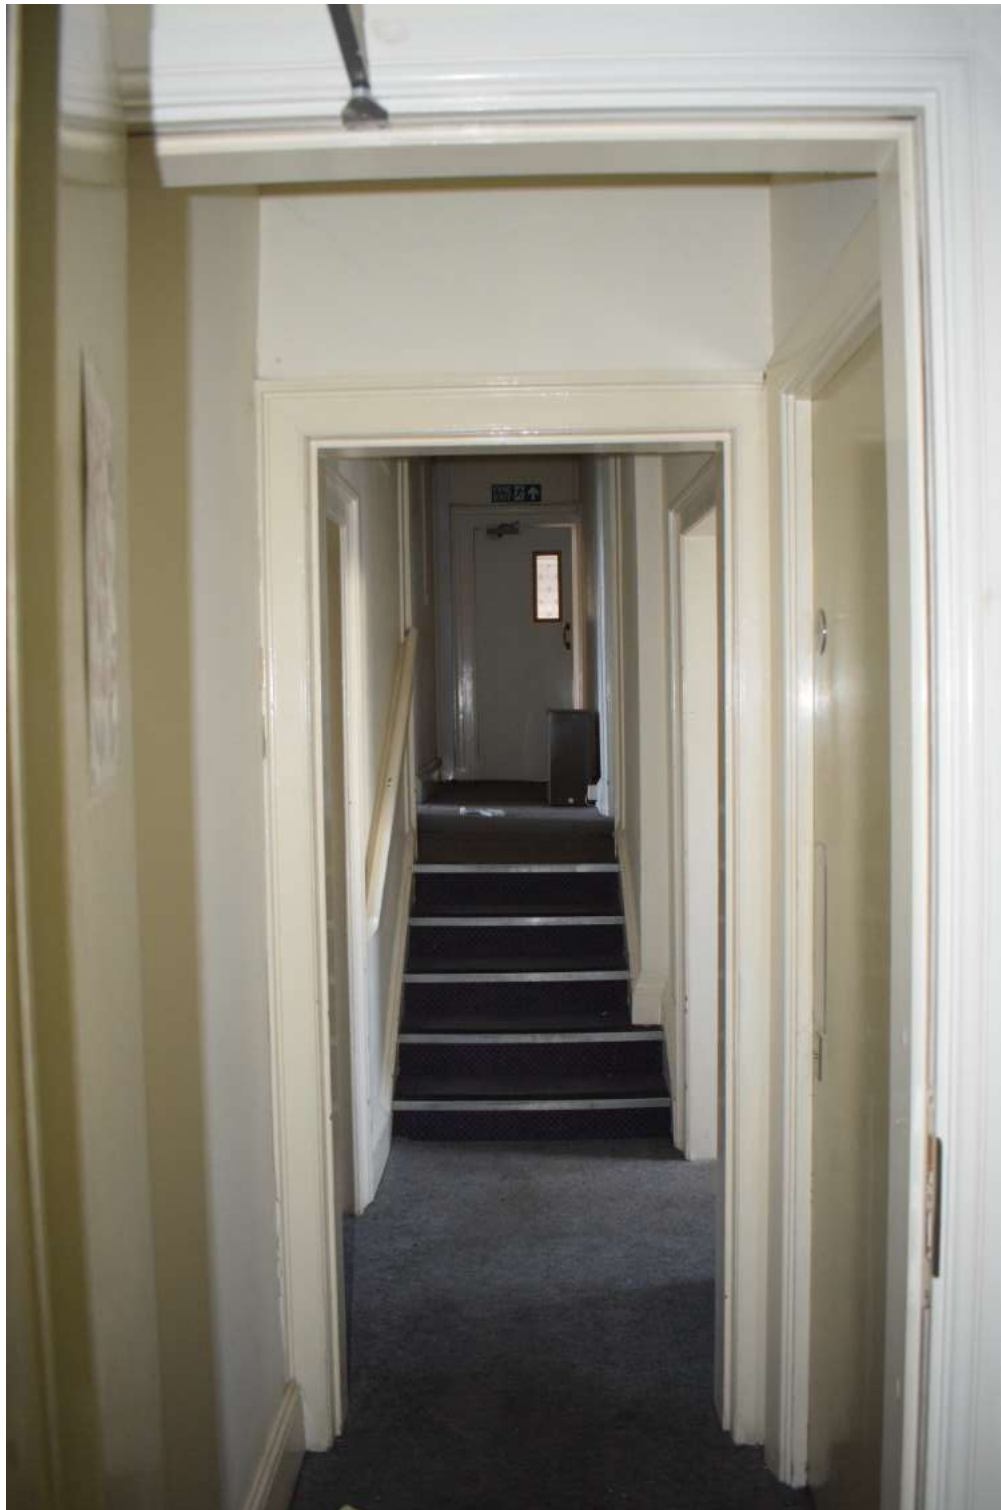
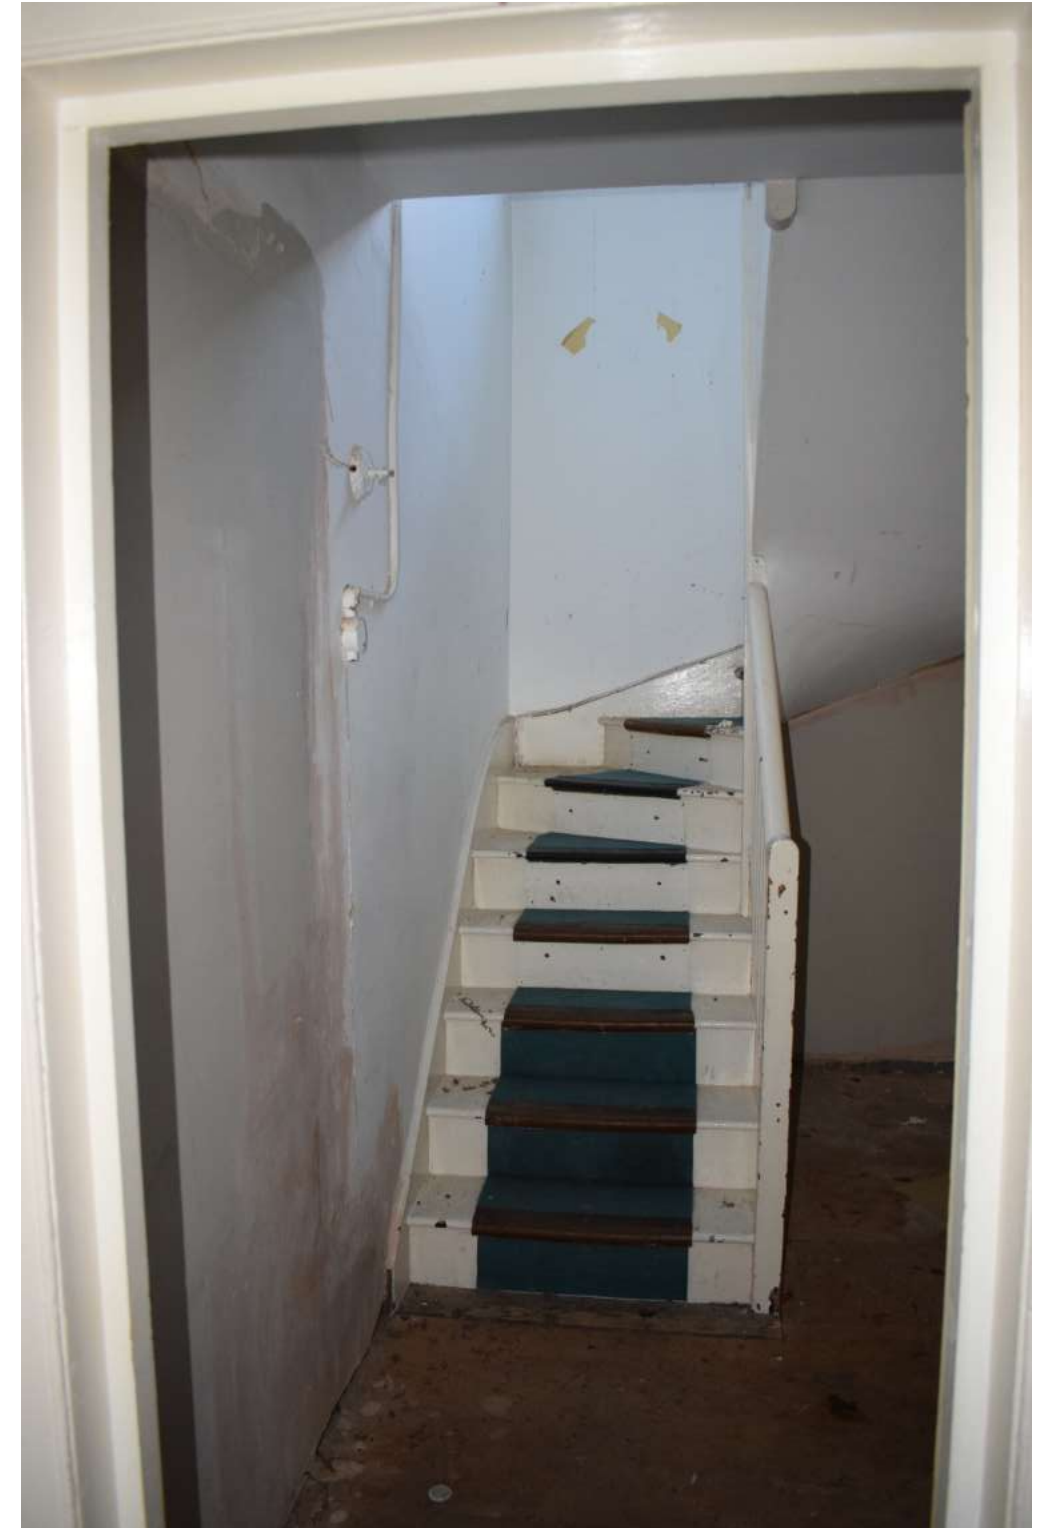
Plate 77

Reconfigured spaces: On the first-floor corridor and doorway to the second-floor stairwell, the ill-legibility of the space is exacerbated by accesses enclosed behind fire doors.

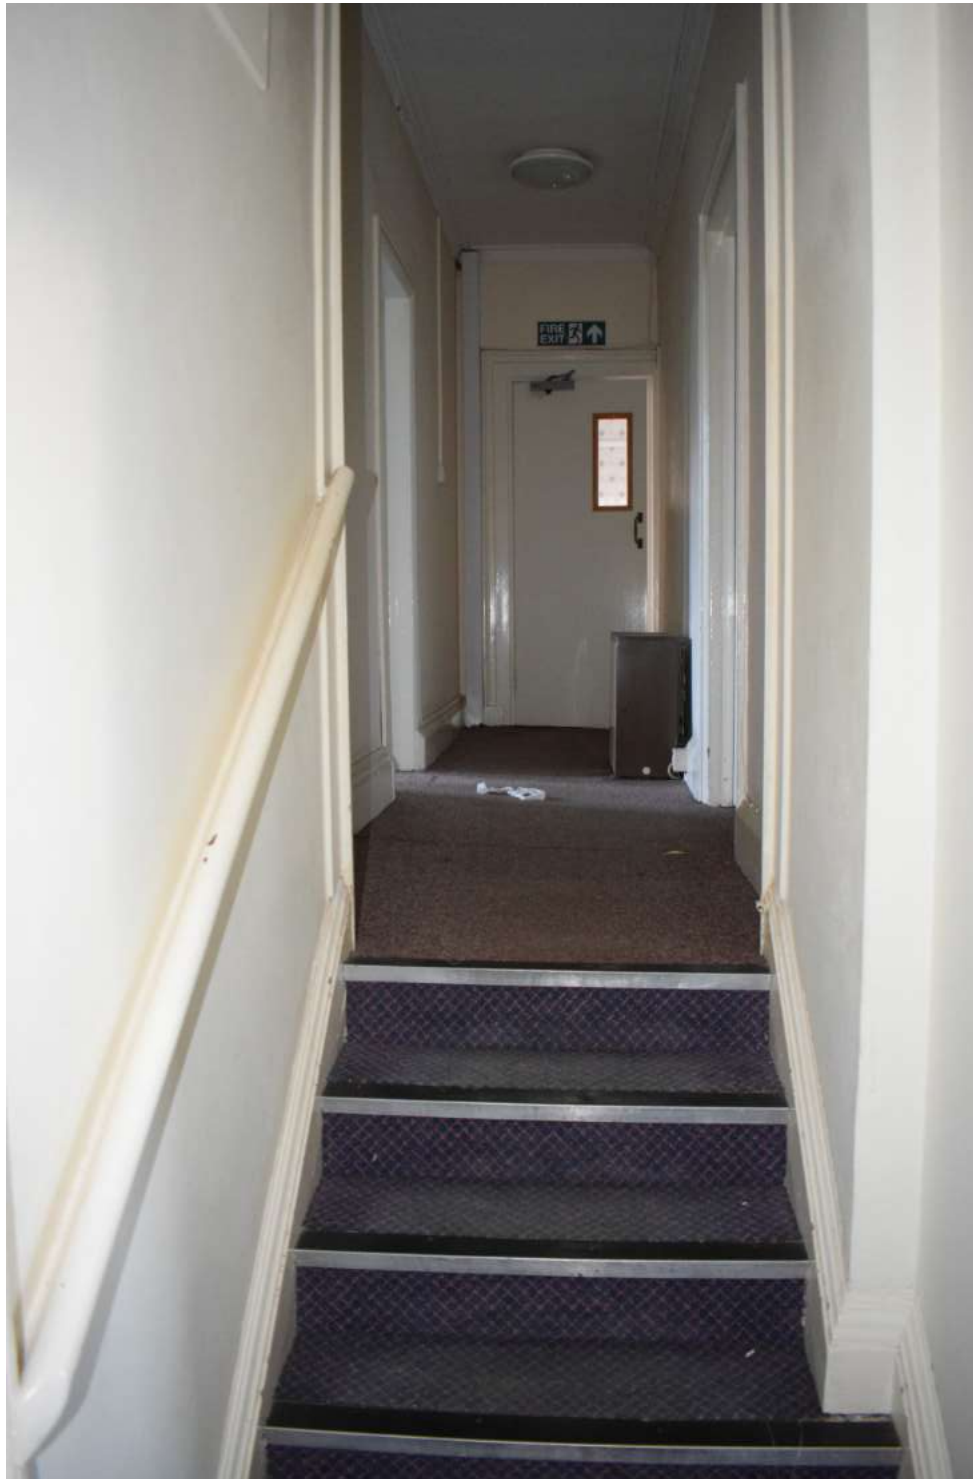
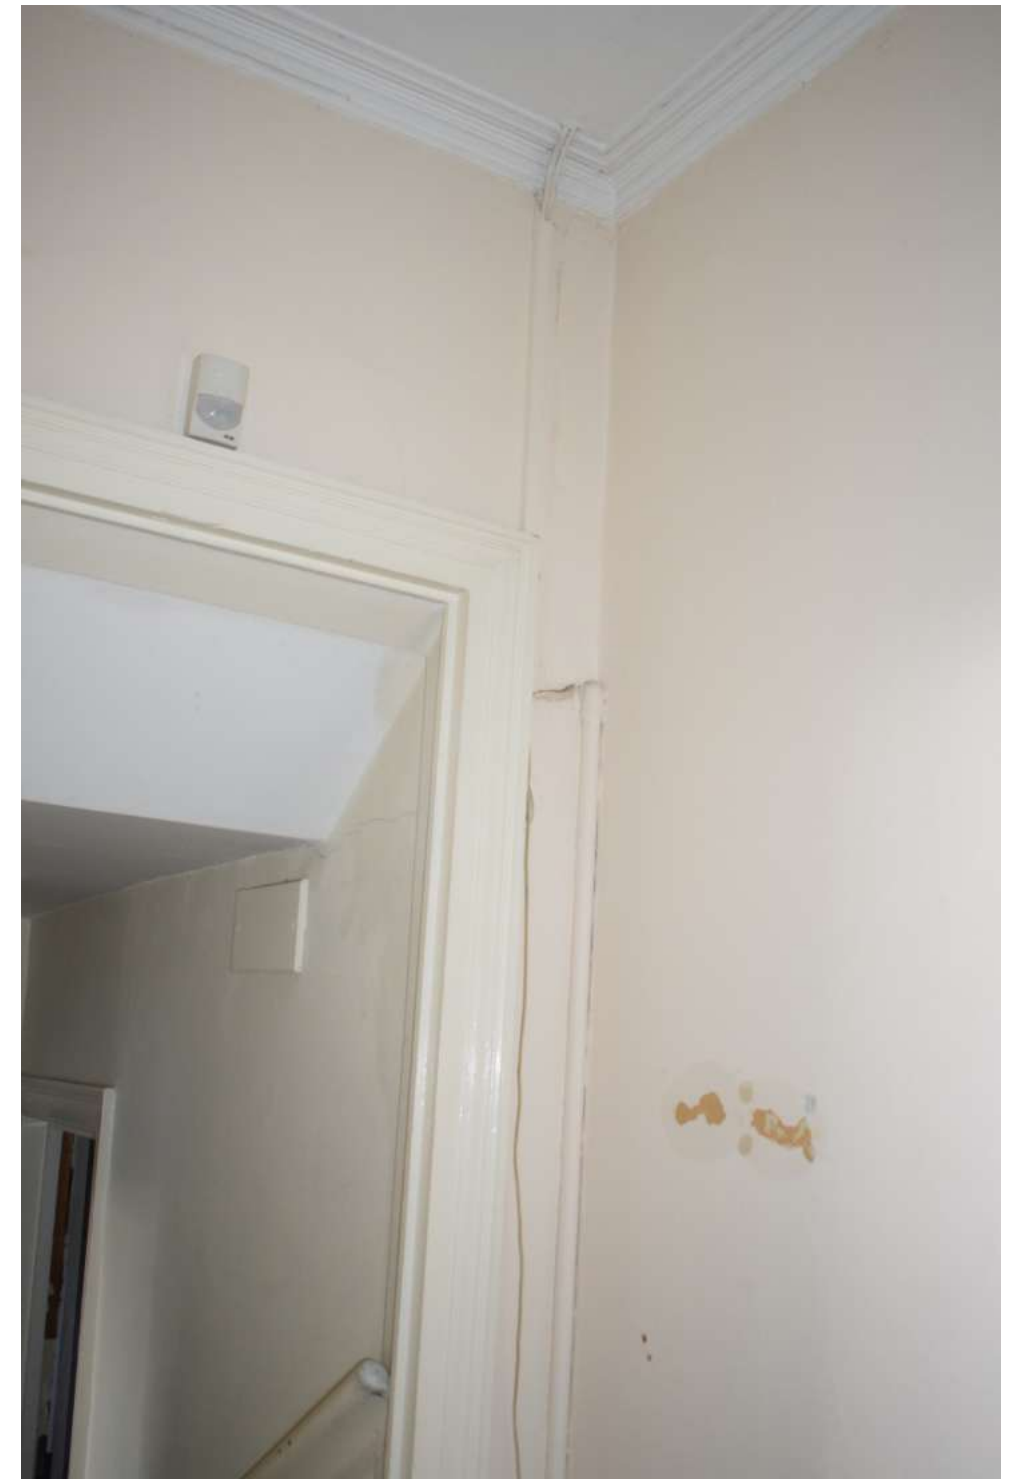
Plate 78

Reconfigured spaces: This image illustrates the reconfigured first-floor corridor associated with changes in floor levels.

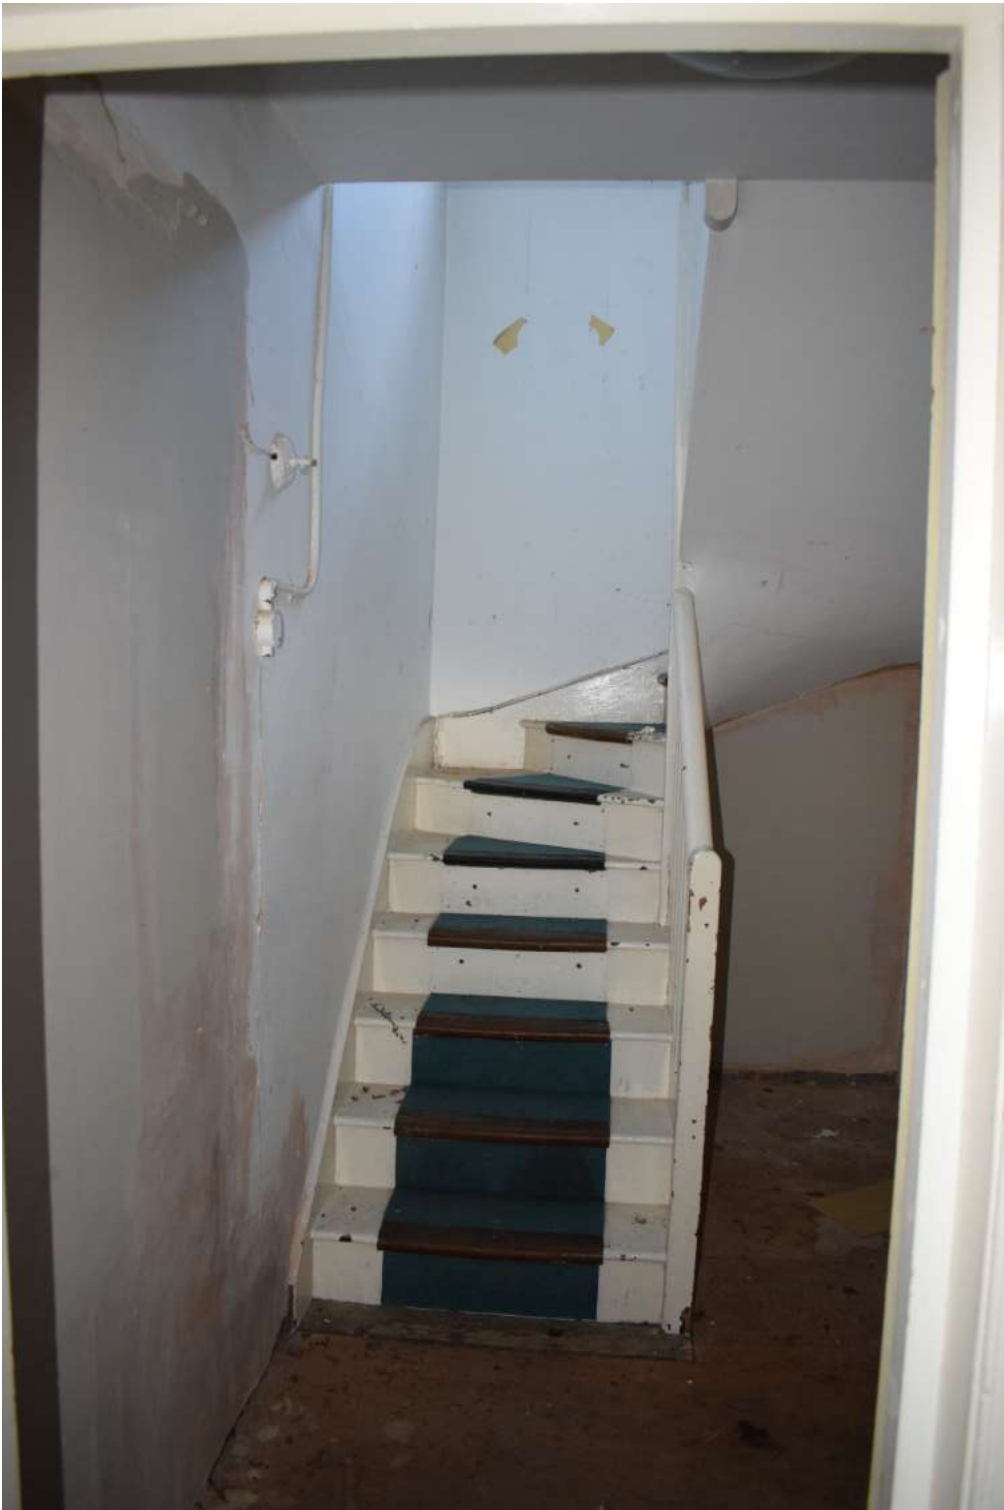
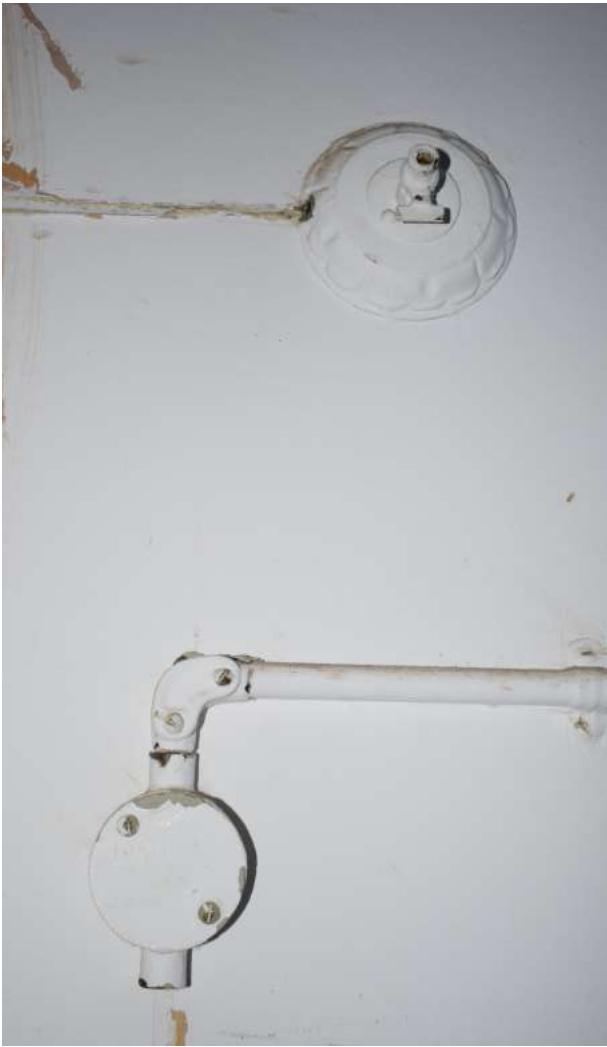
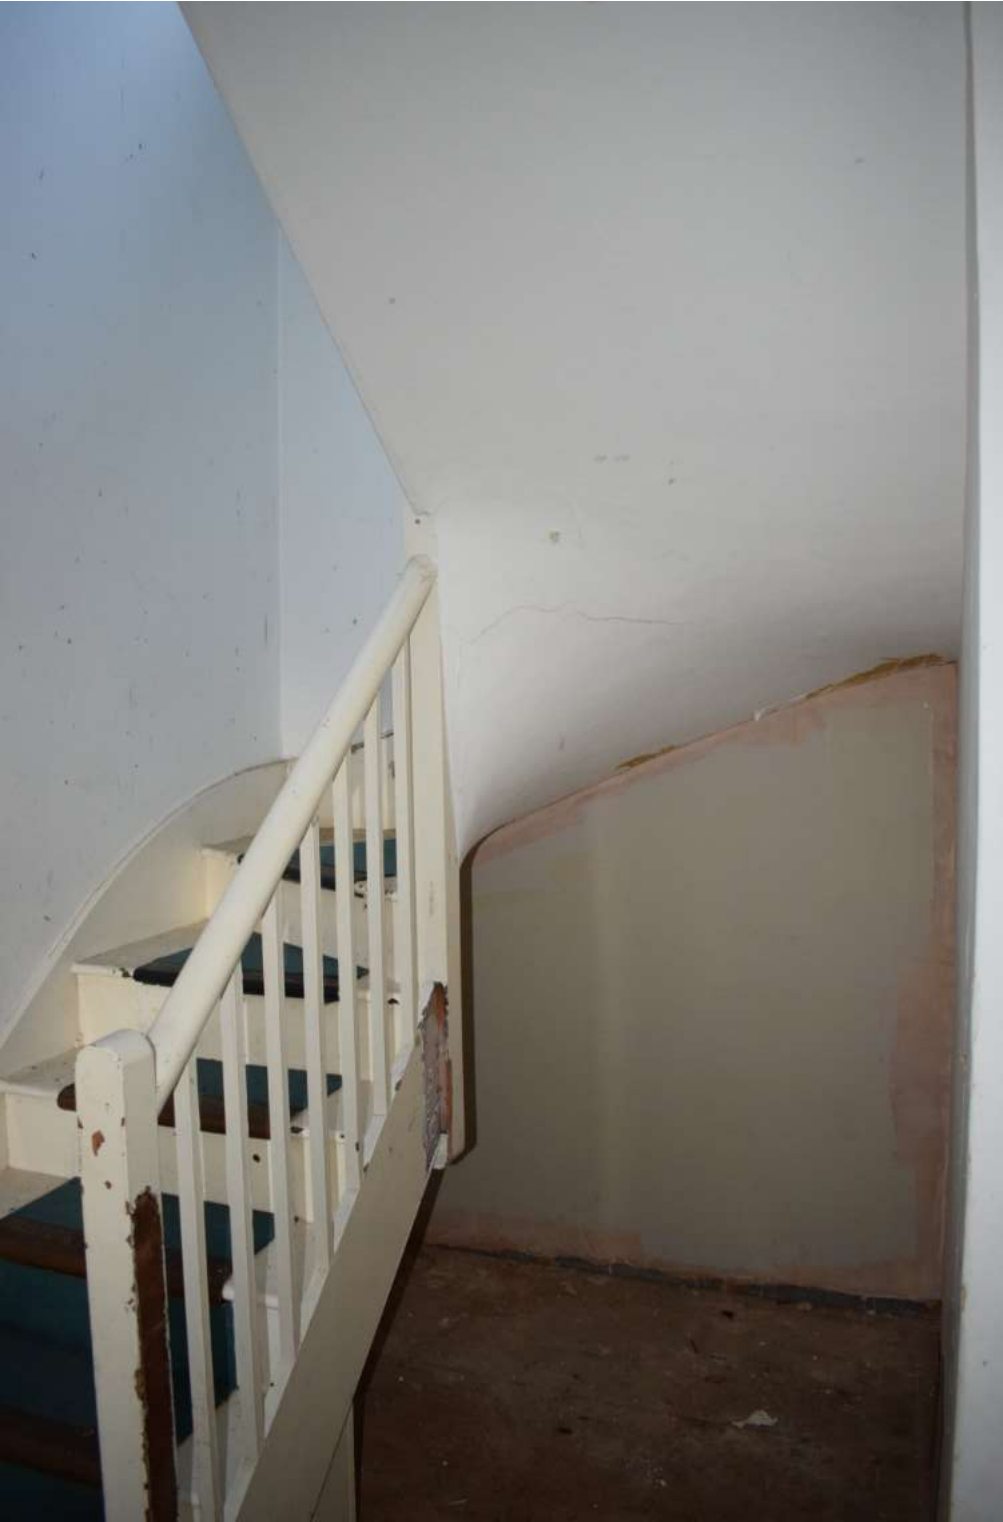
Plate 79

A view of the stairwell to the second floor shows that the space for the former ground-to-first-floor stairwell has been filled in.

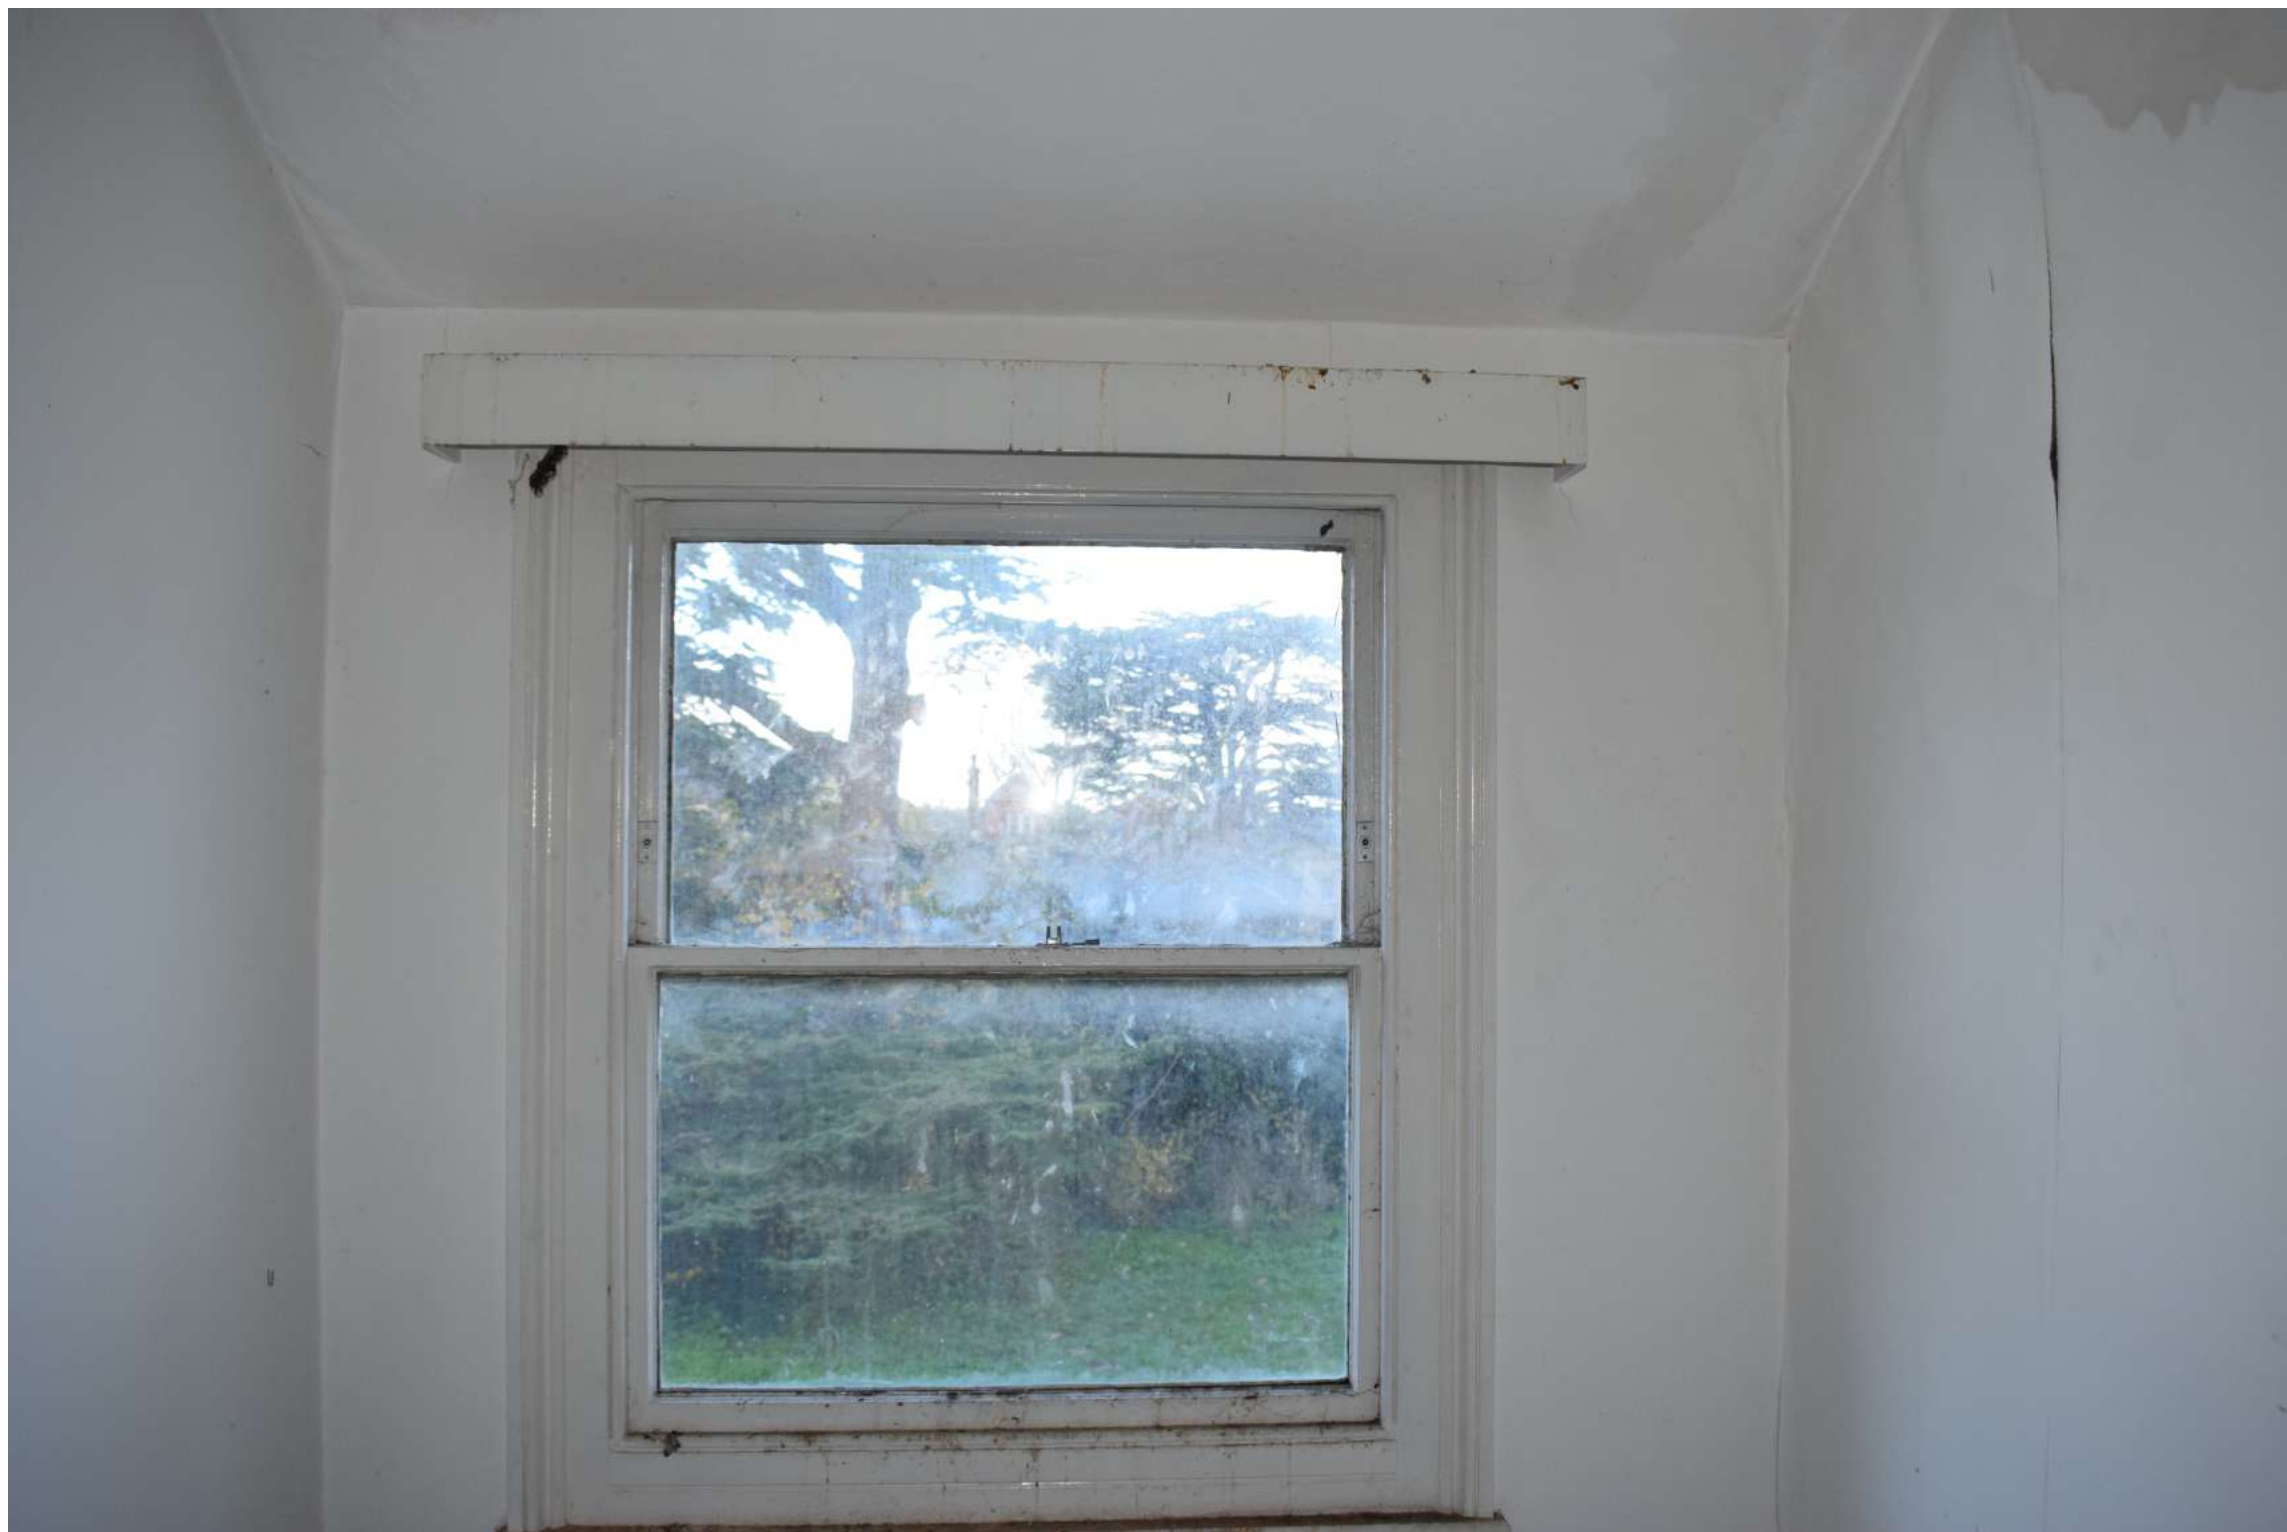
Plate 81

This image, a view from the second-floor landing, shows a modernised window lighting the stairwell.
