Phases 2a and 2b west wing

## Appendix 11

Yeomanry House

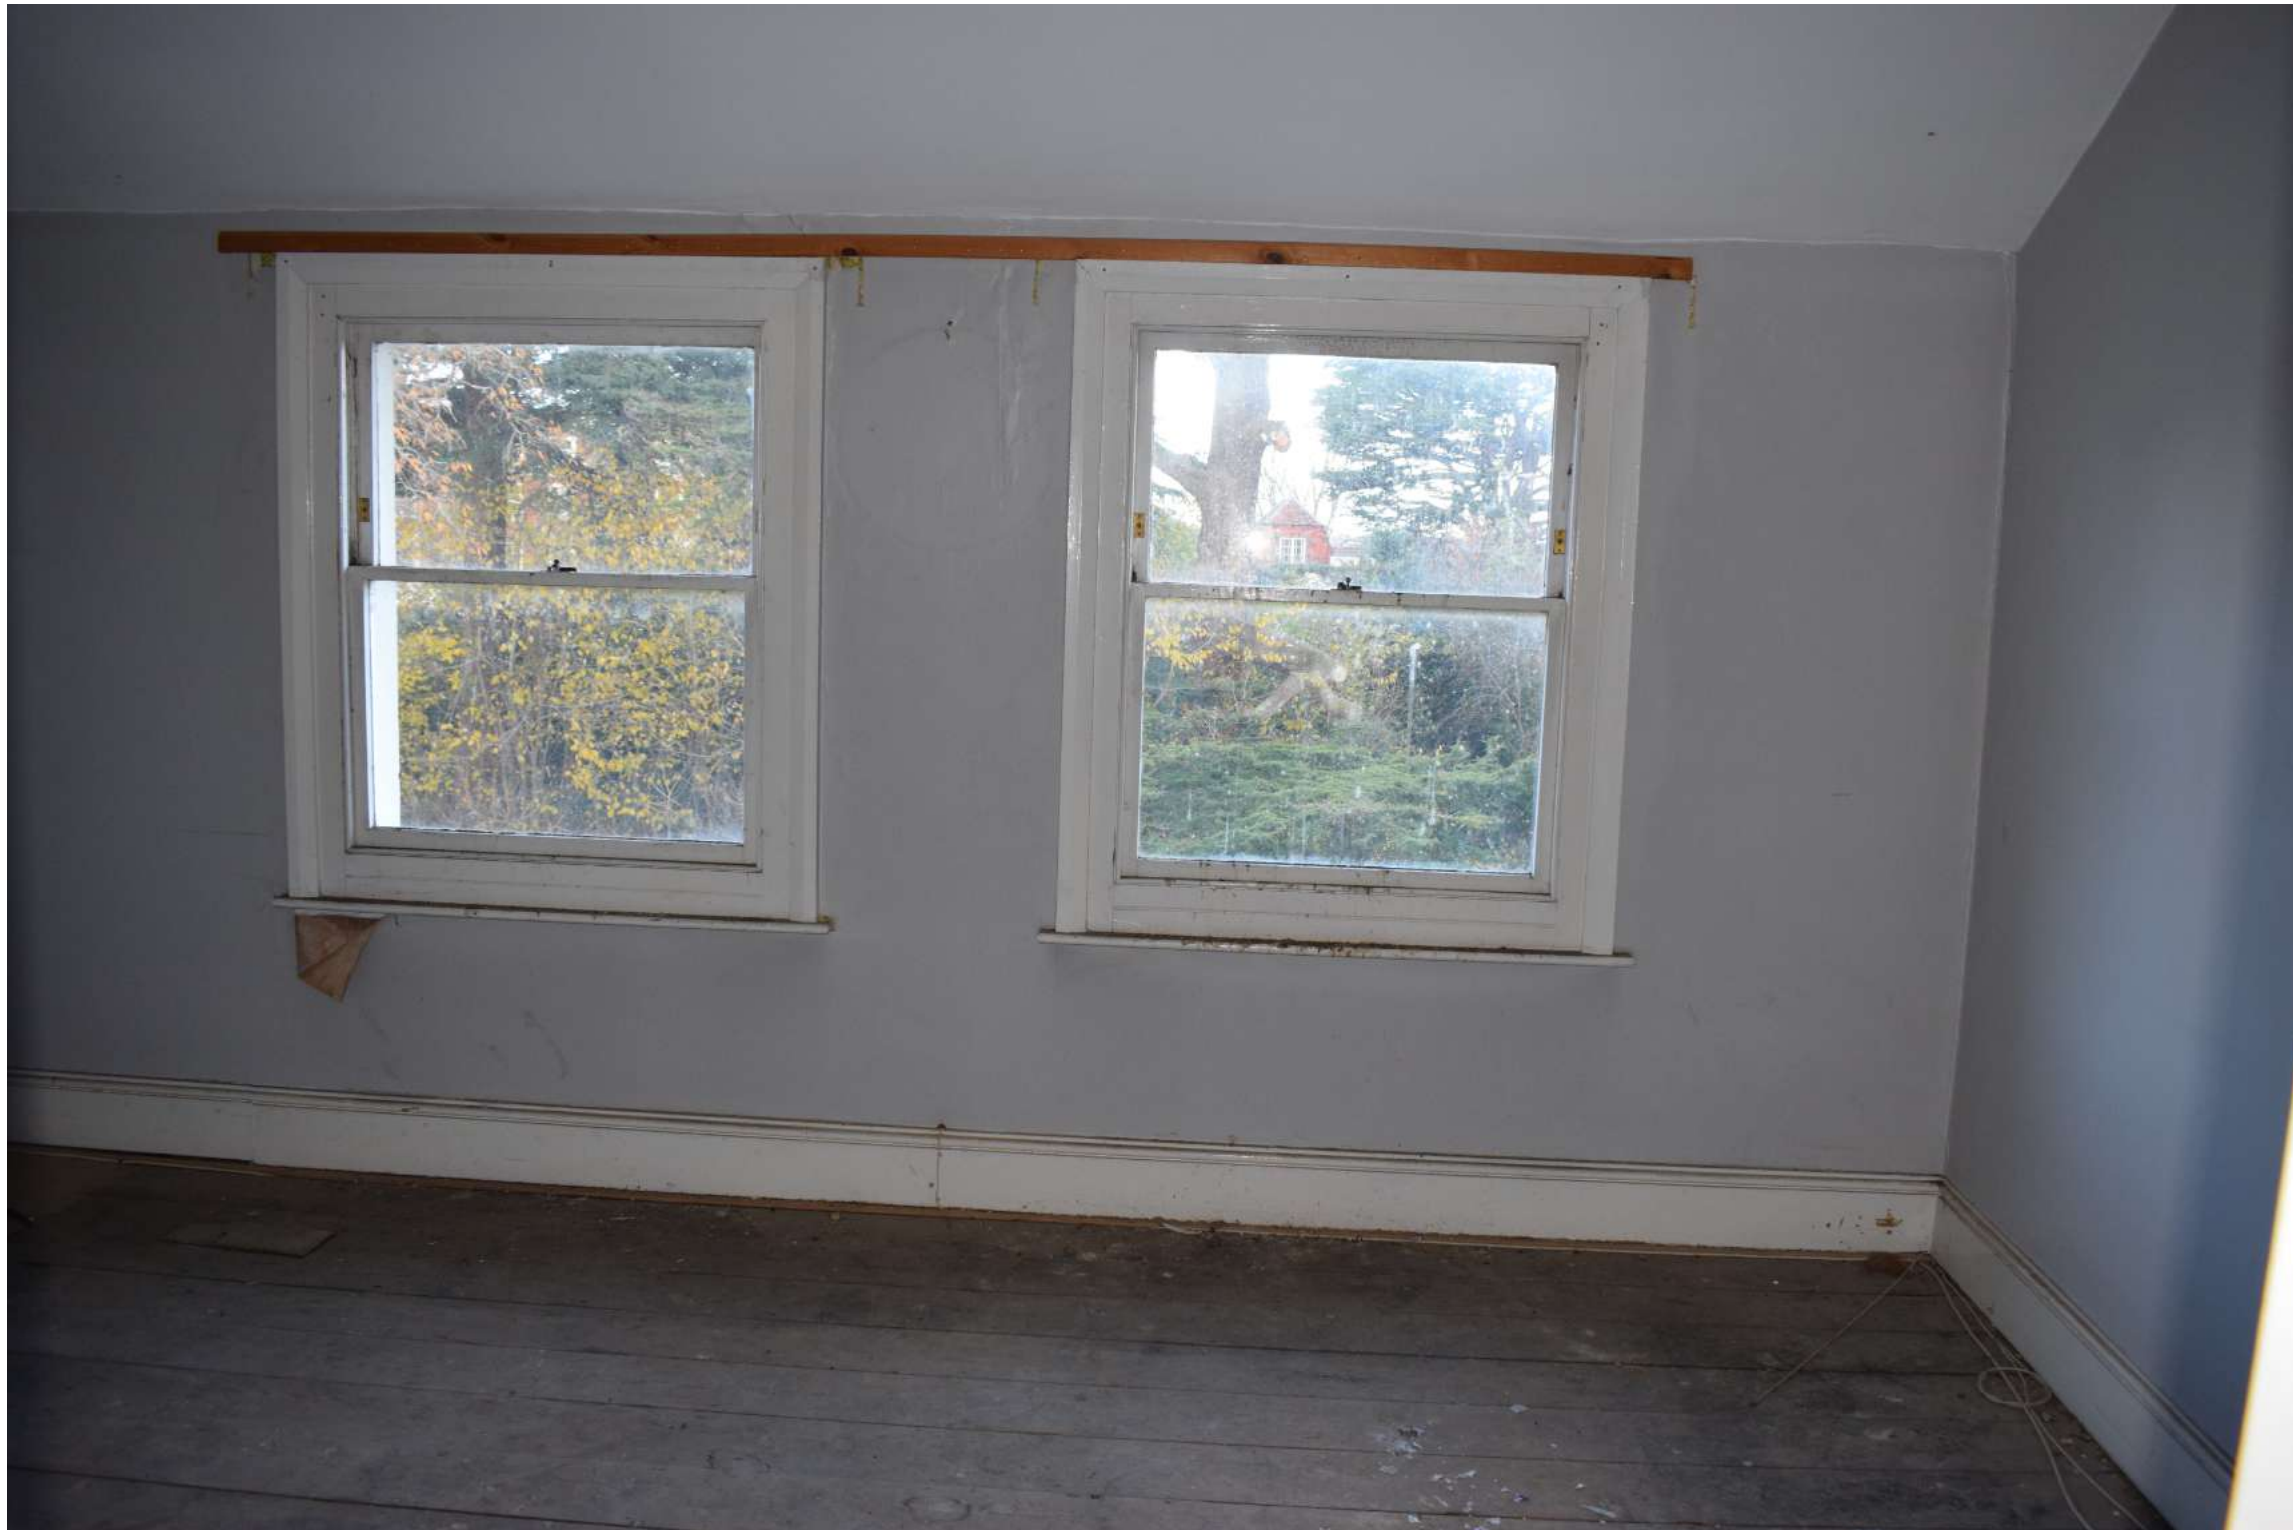
Plate 83

This view shows the detailing the plain architectural finish of the servants' area. Features are consistent with secondary accommodation, evidenced by original basic skirting boards, plain architraves, and the complete absence of decorative coving, picture rails, or dado rails.

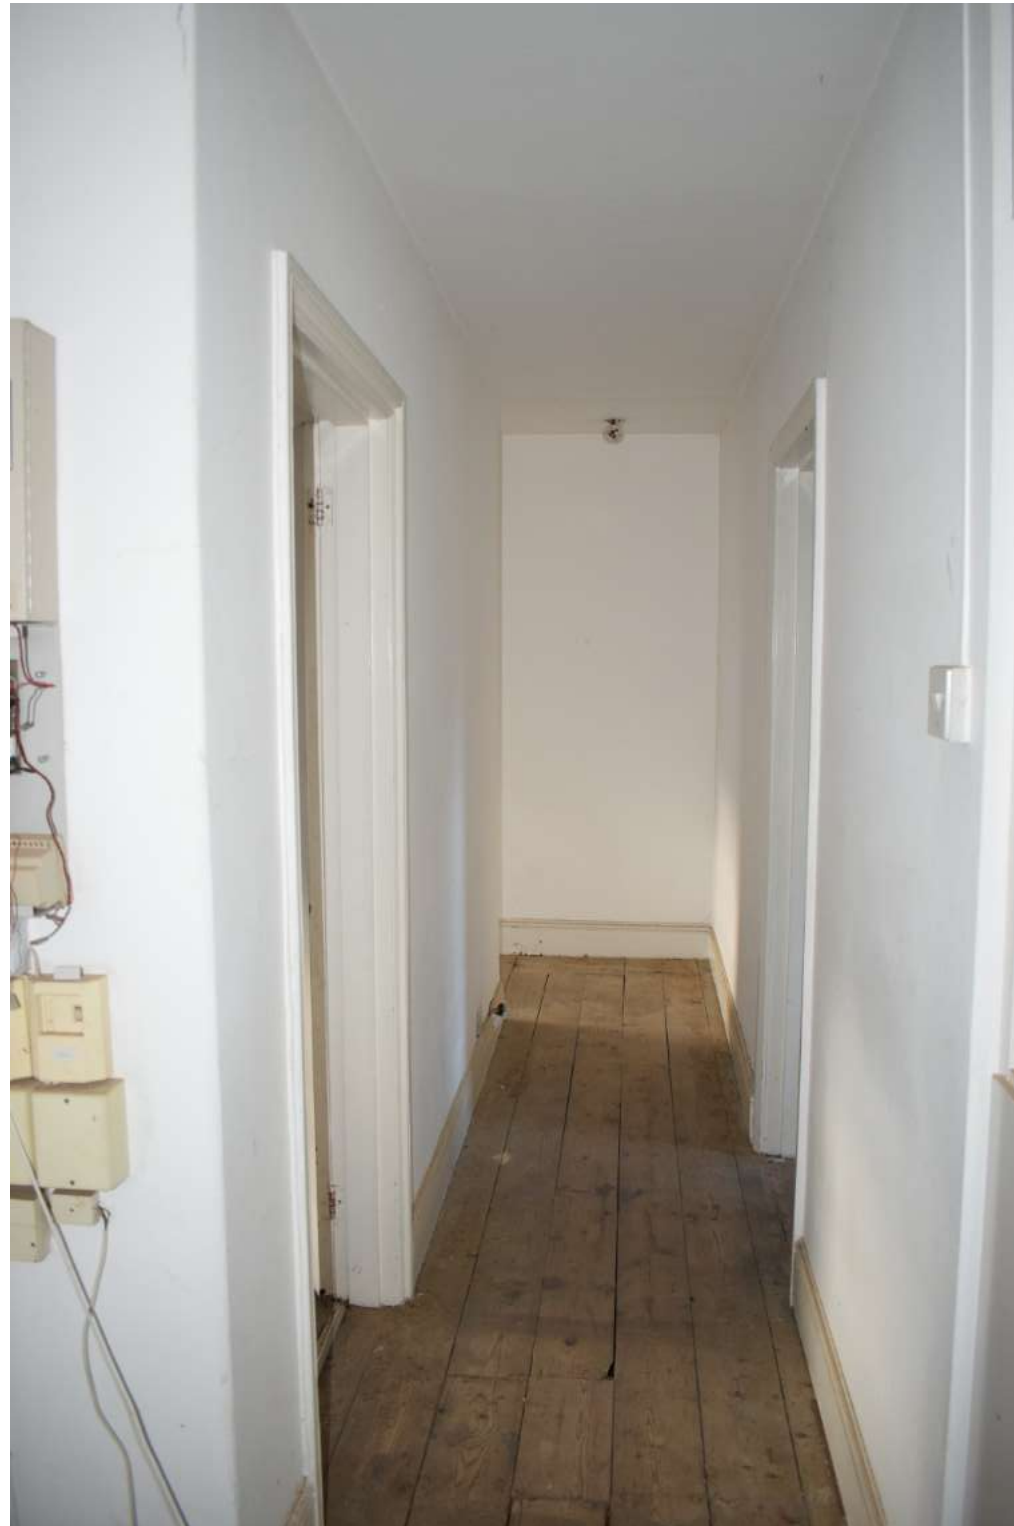
Plate 85

Reconfigured spaces: This image shows the reconfigured spaces where the corridor is off-set to meet the edge of a former fireplace.

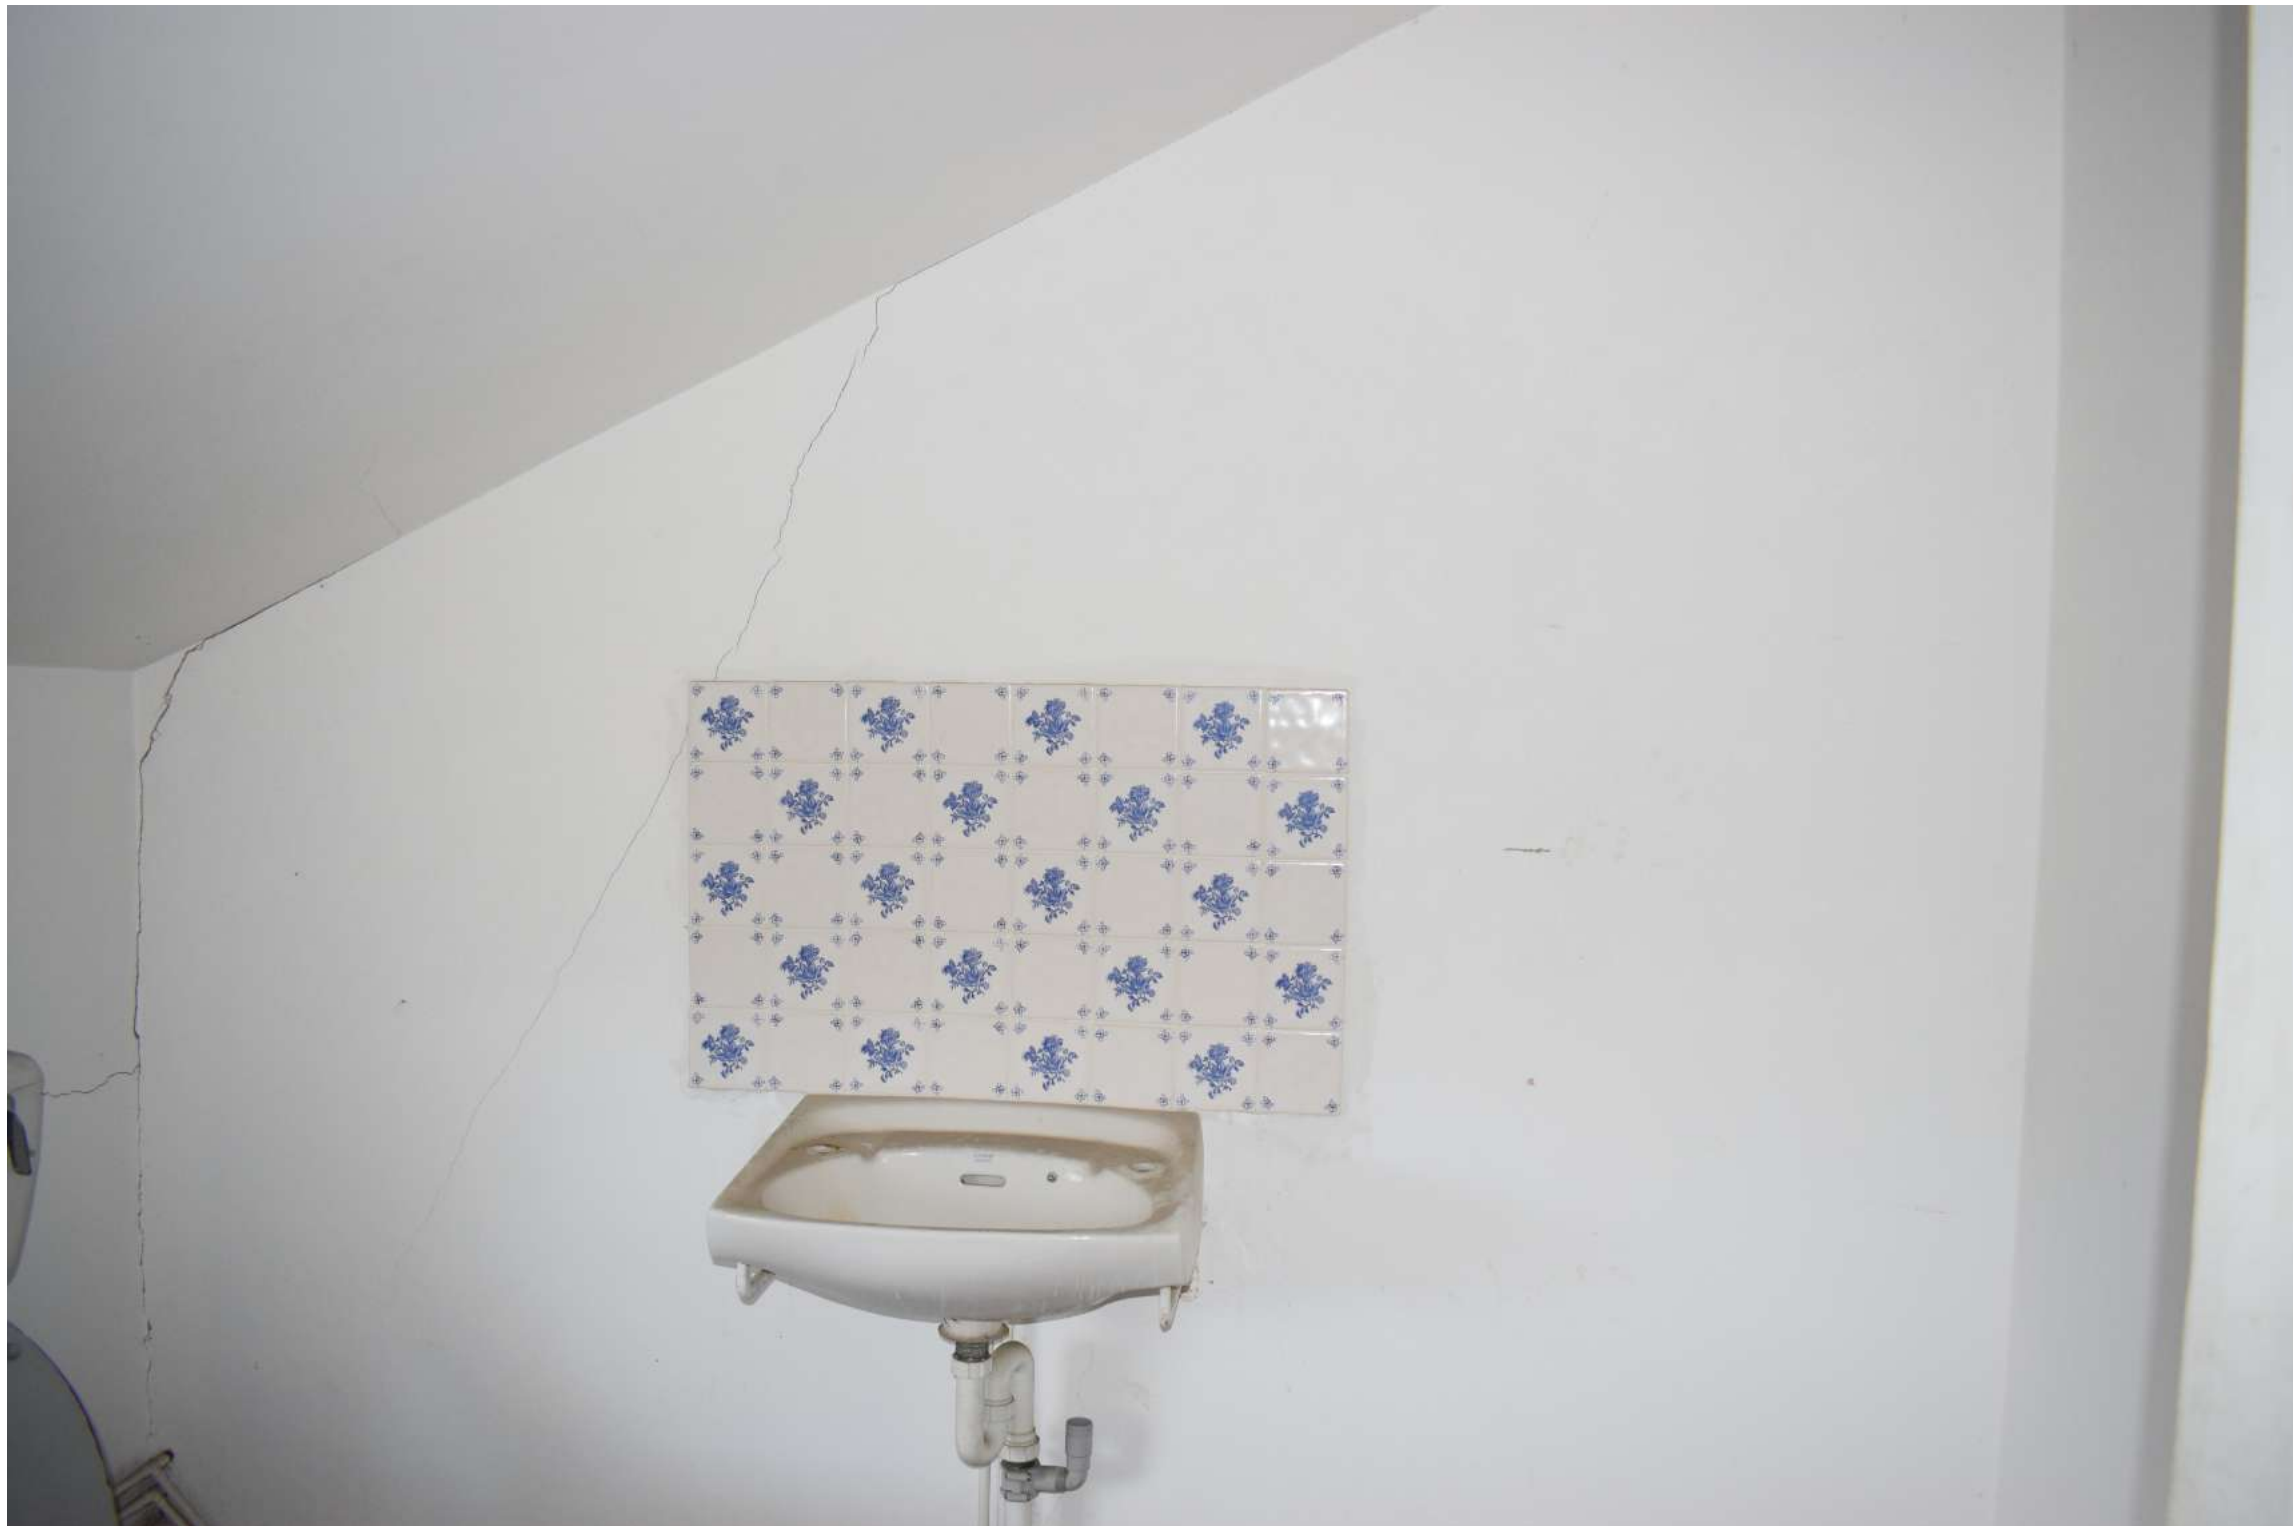
Plate 88

Reconfigured spaces: This image shows the reconfigured space where modern bathroom facilities were installed with limited regard to the value of the historic fabric.

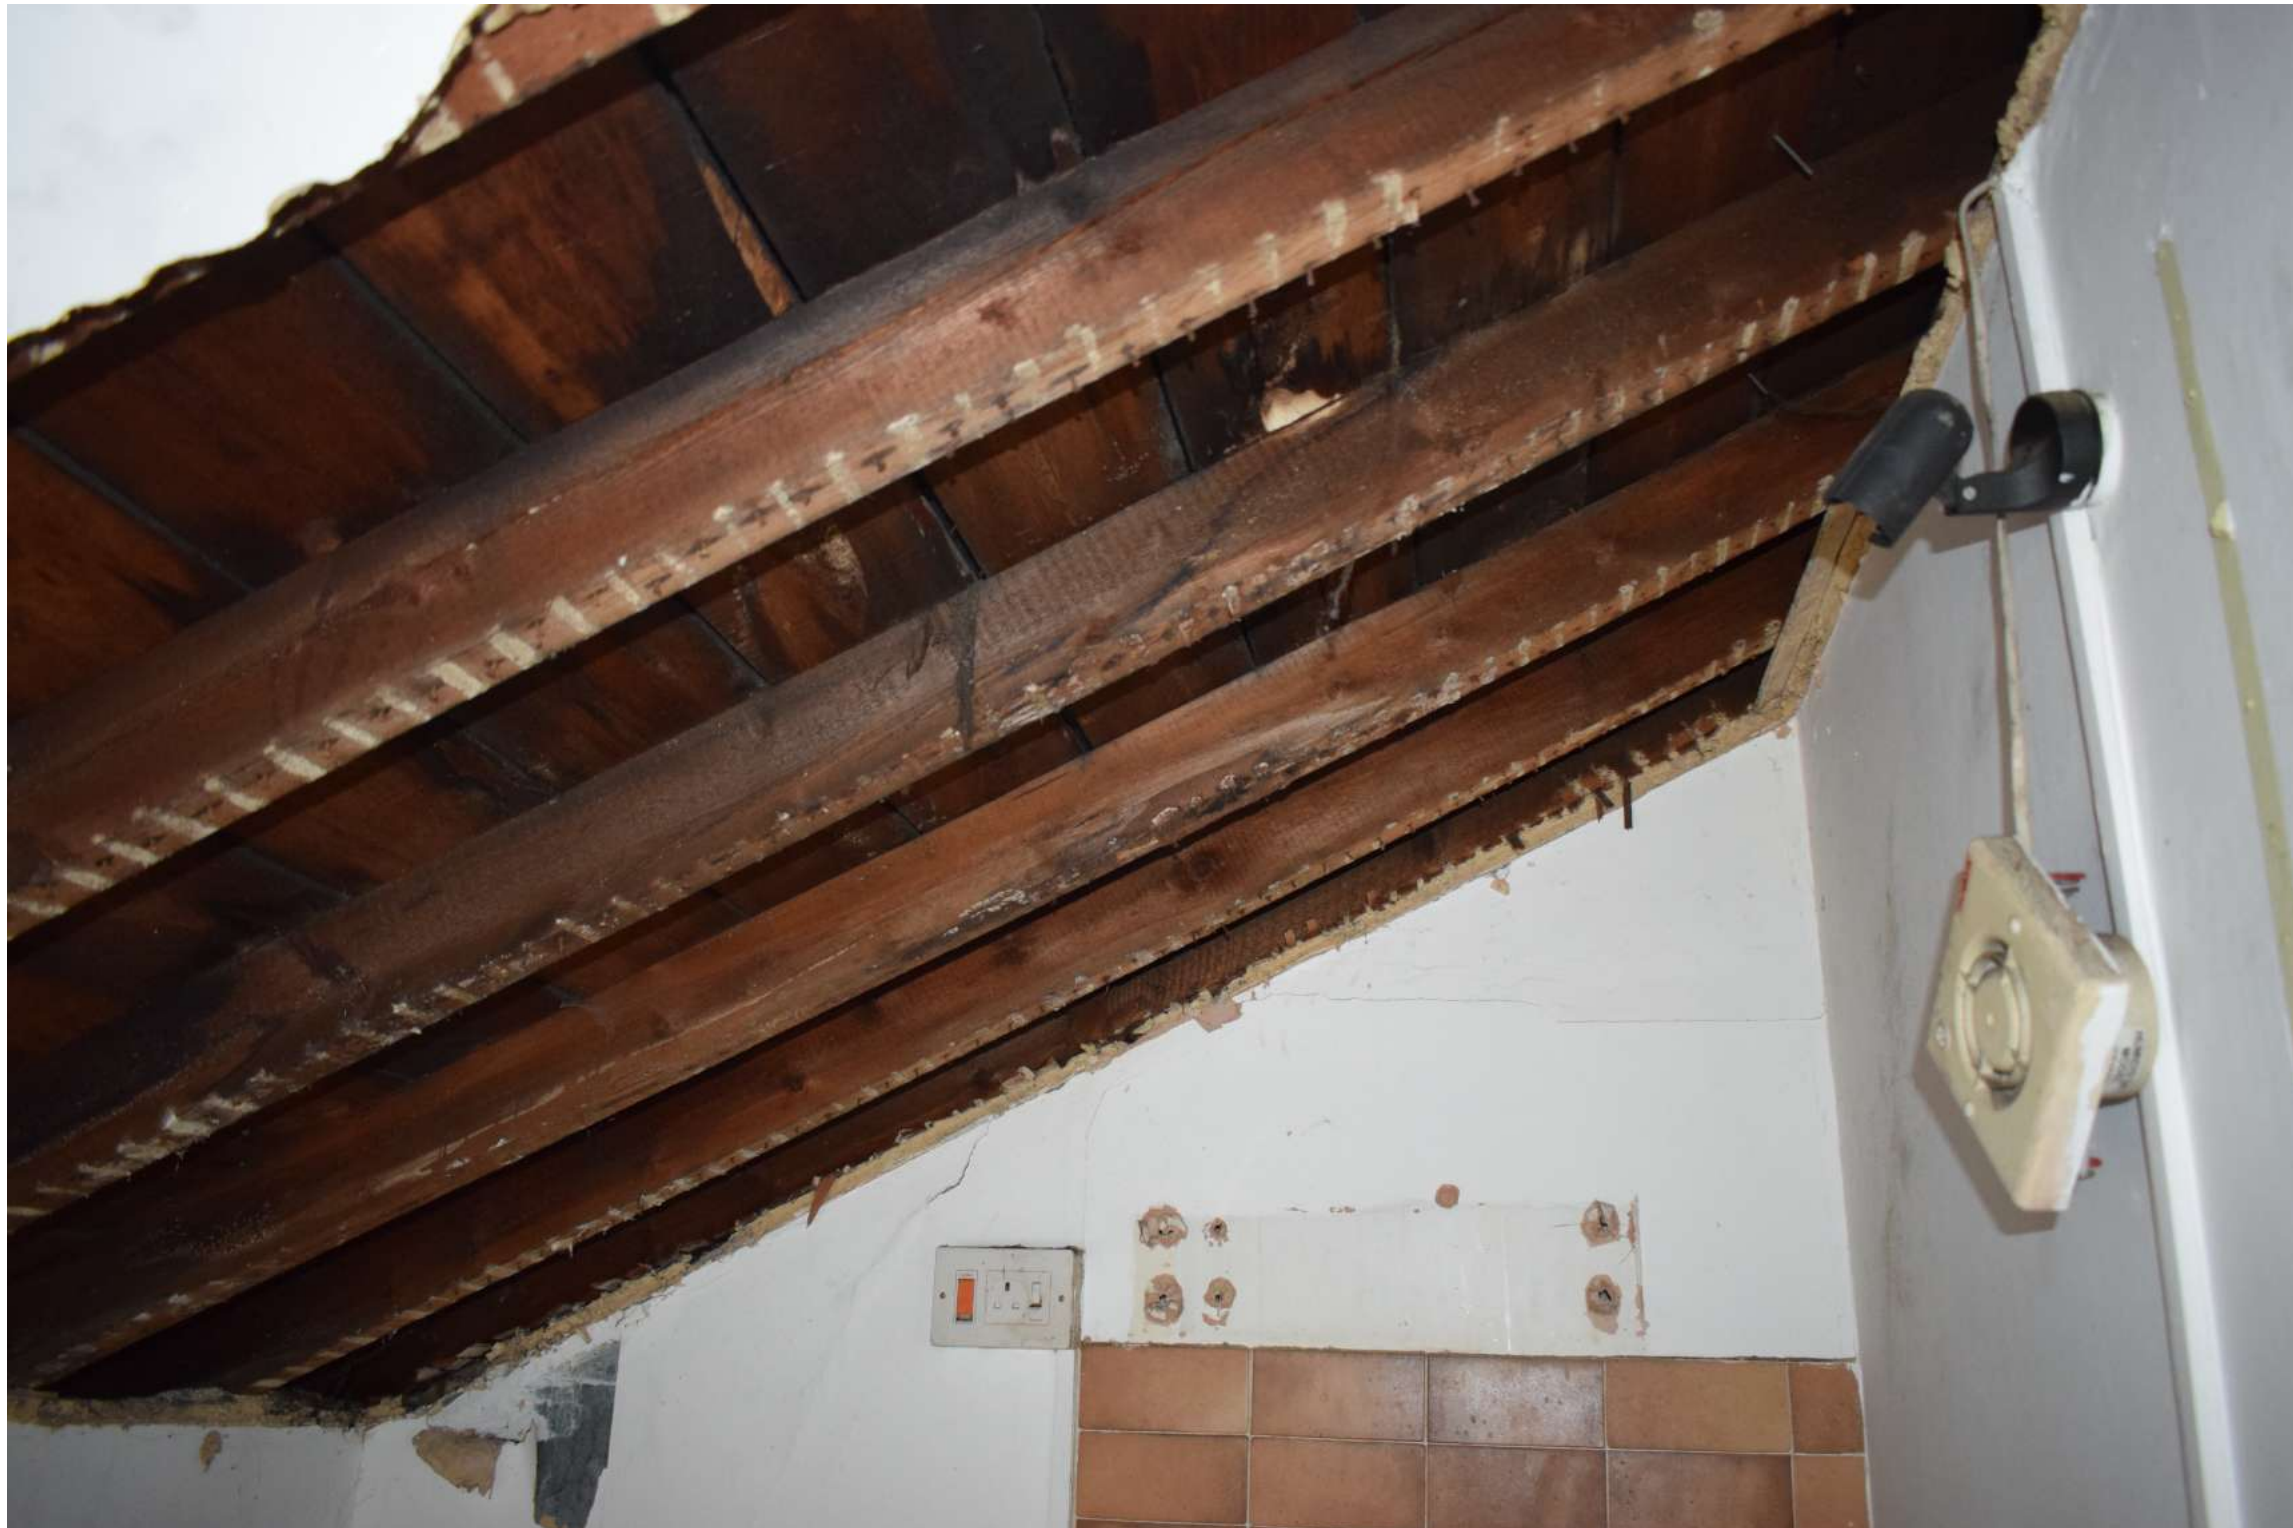
Plate 91

This image shows modern roof timbers to indicate the extent of refurbishment in this part of the property.

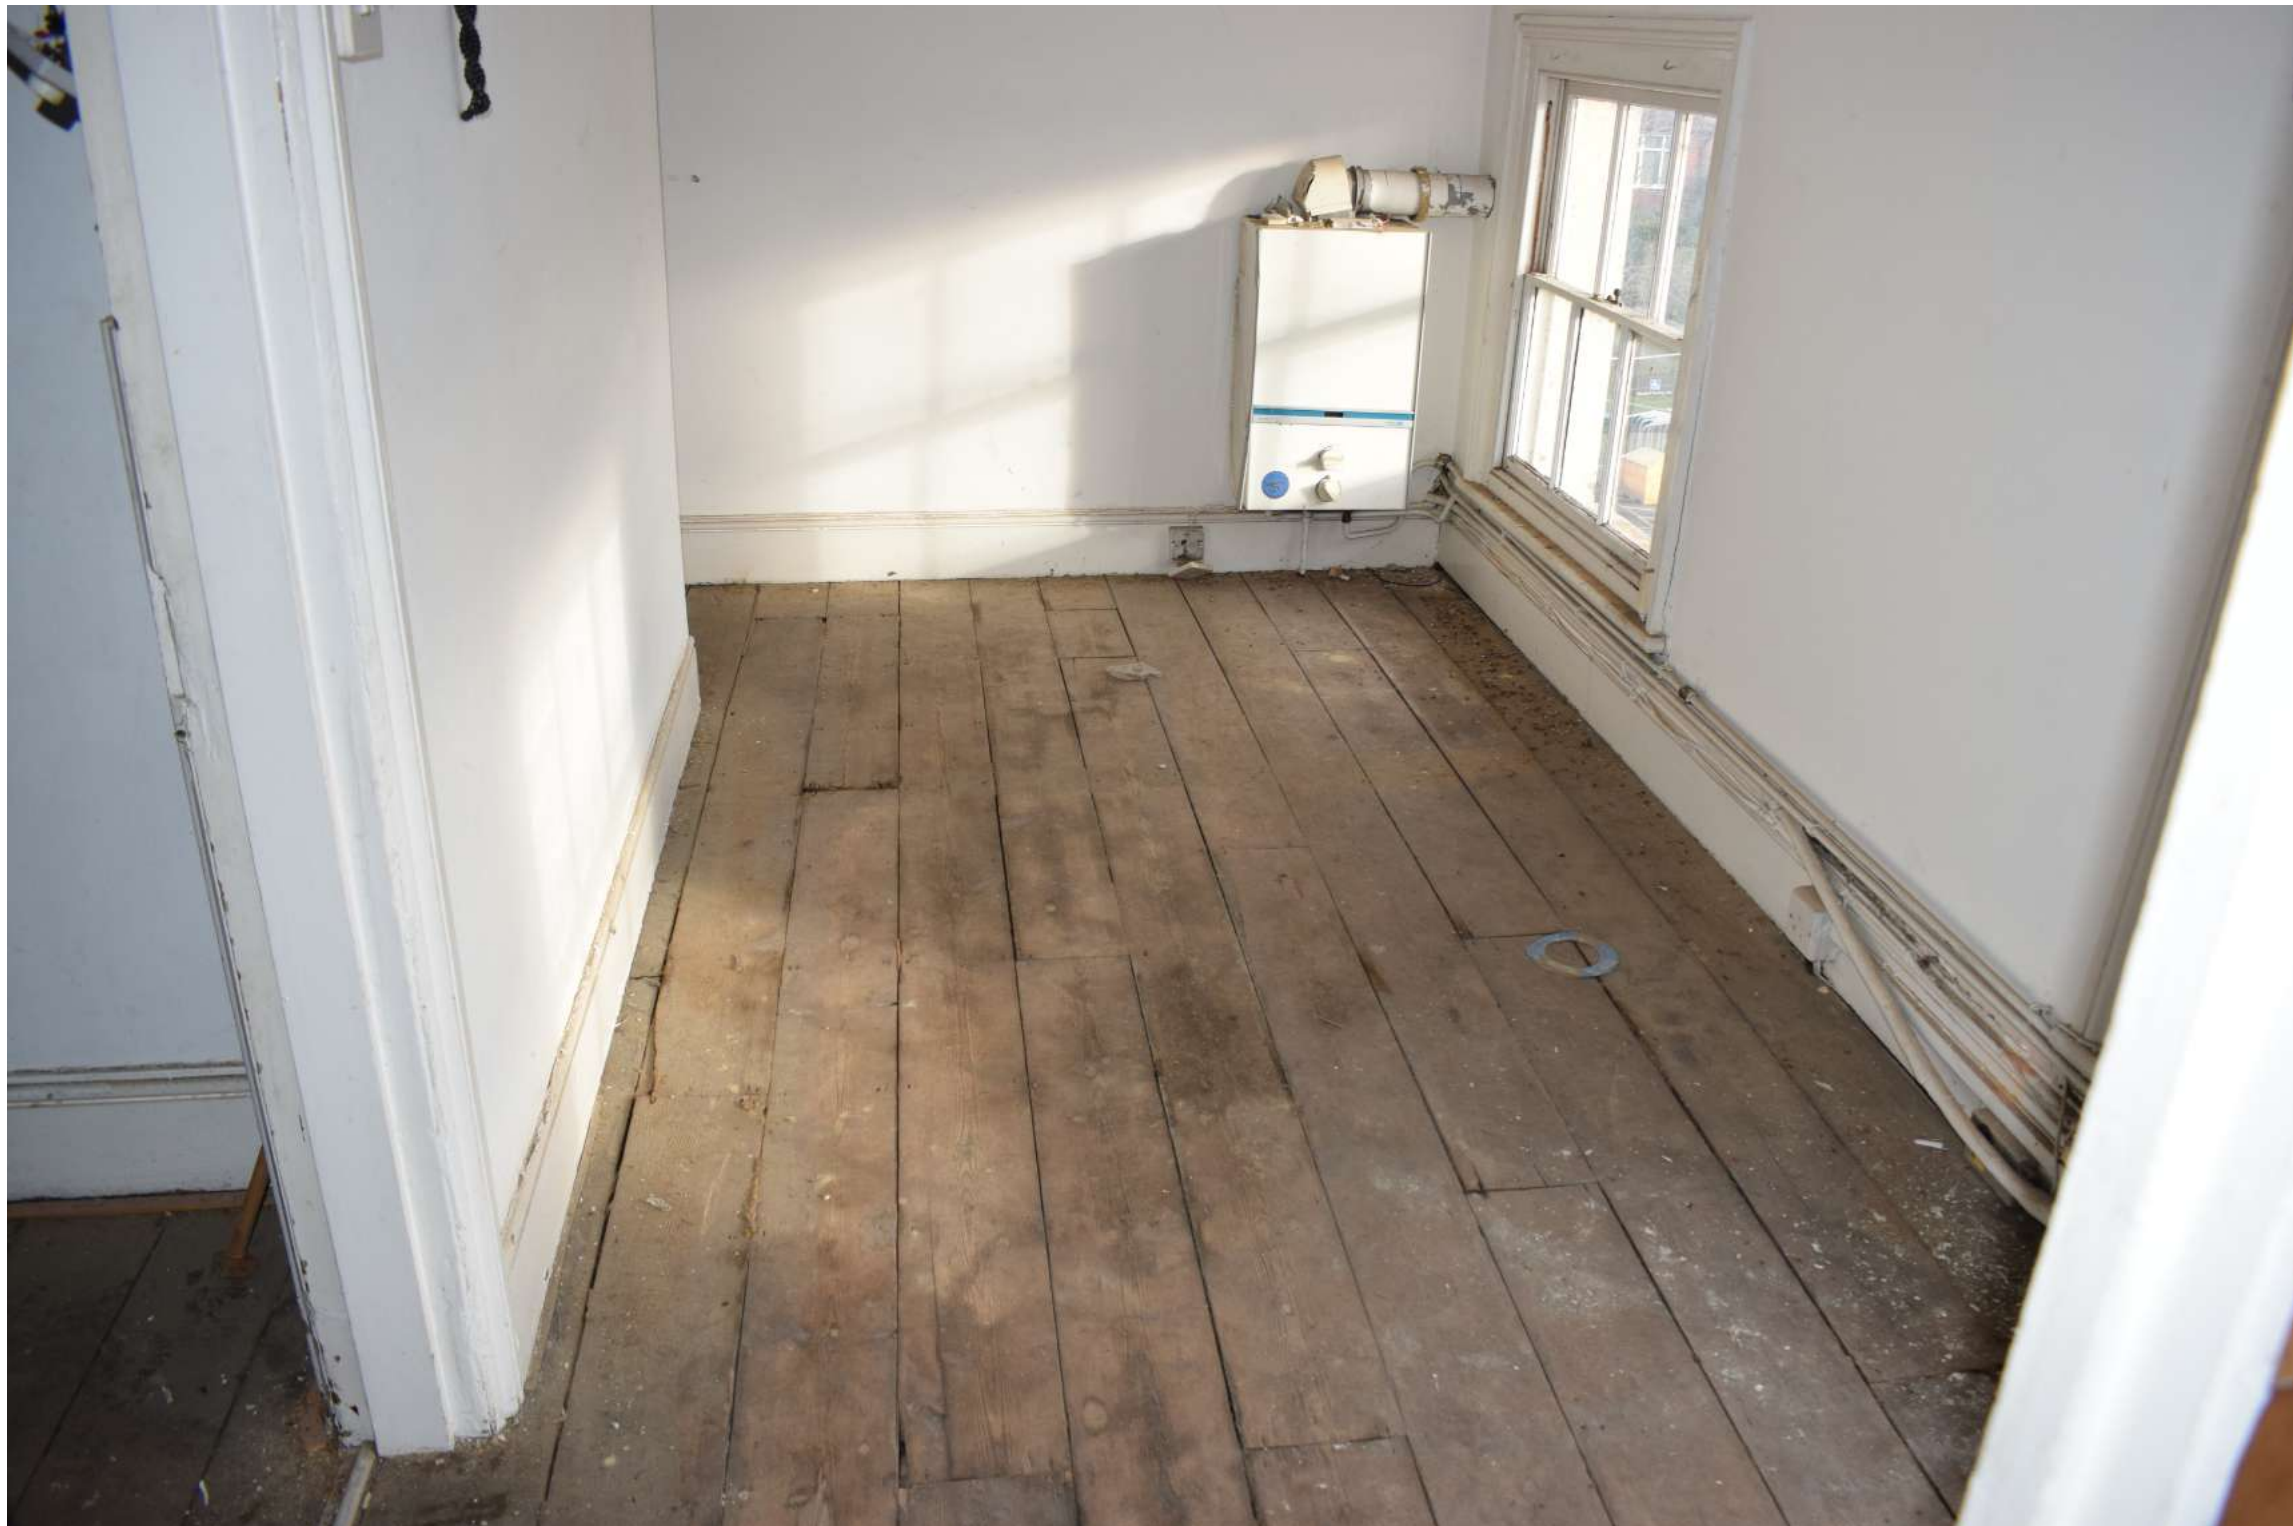
Plate 92

This image provides a view confirming the presence of floorboards in the second-floor Kitchen.

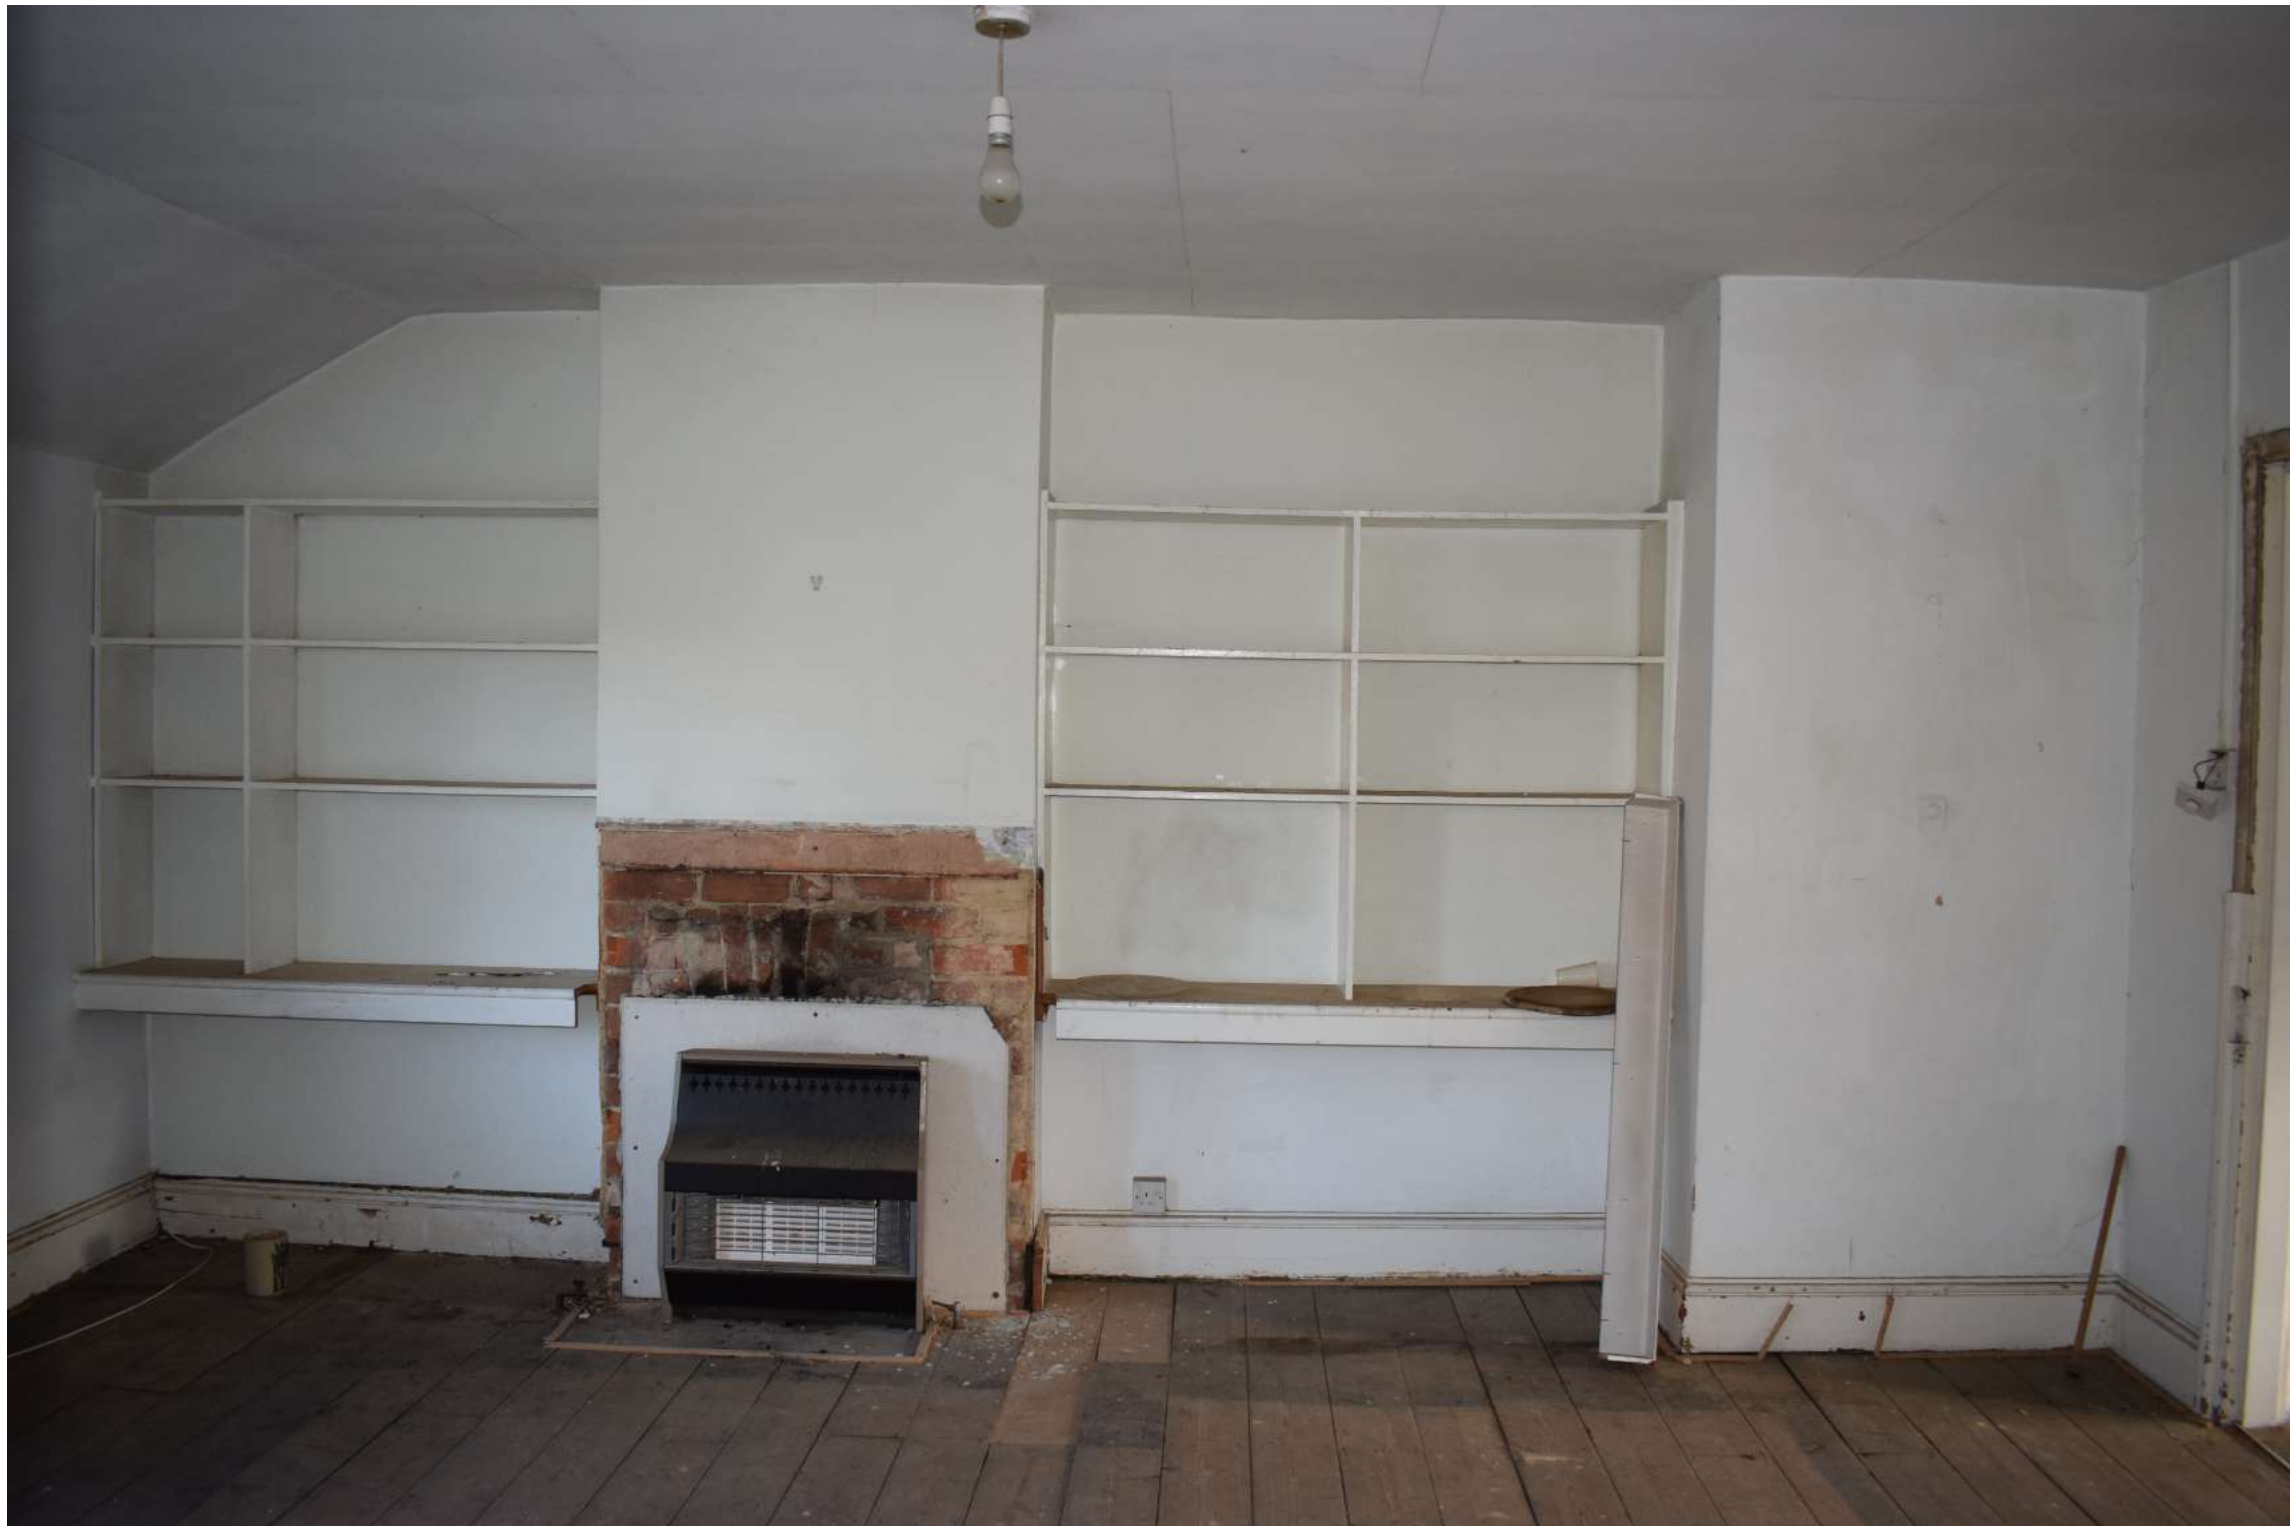
Plate 94

This image shows a view of the fireplace that still offers ventilation.

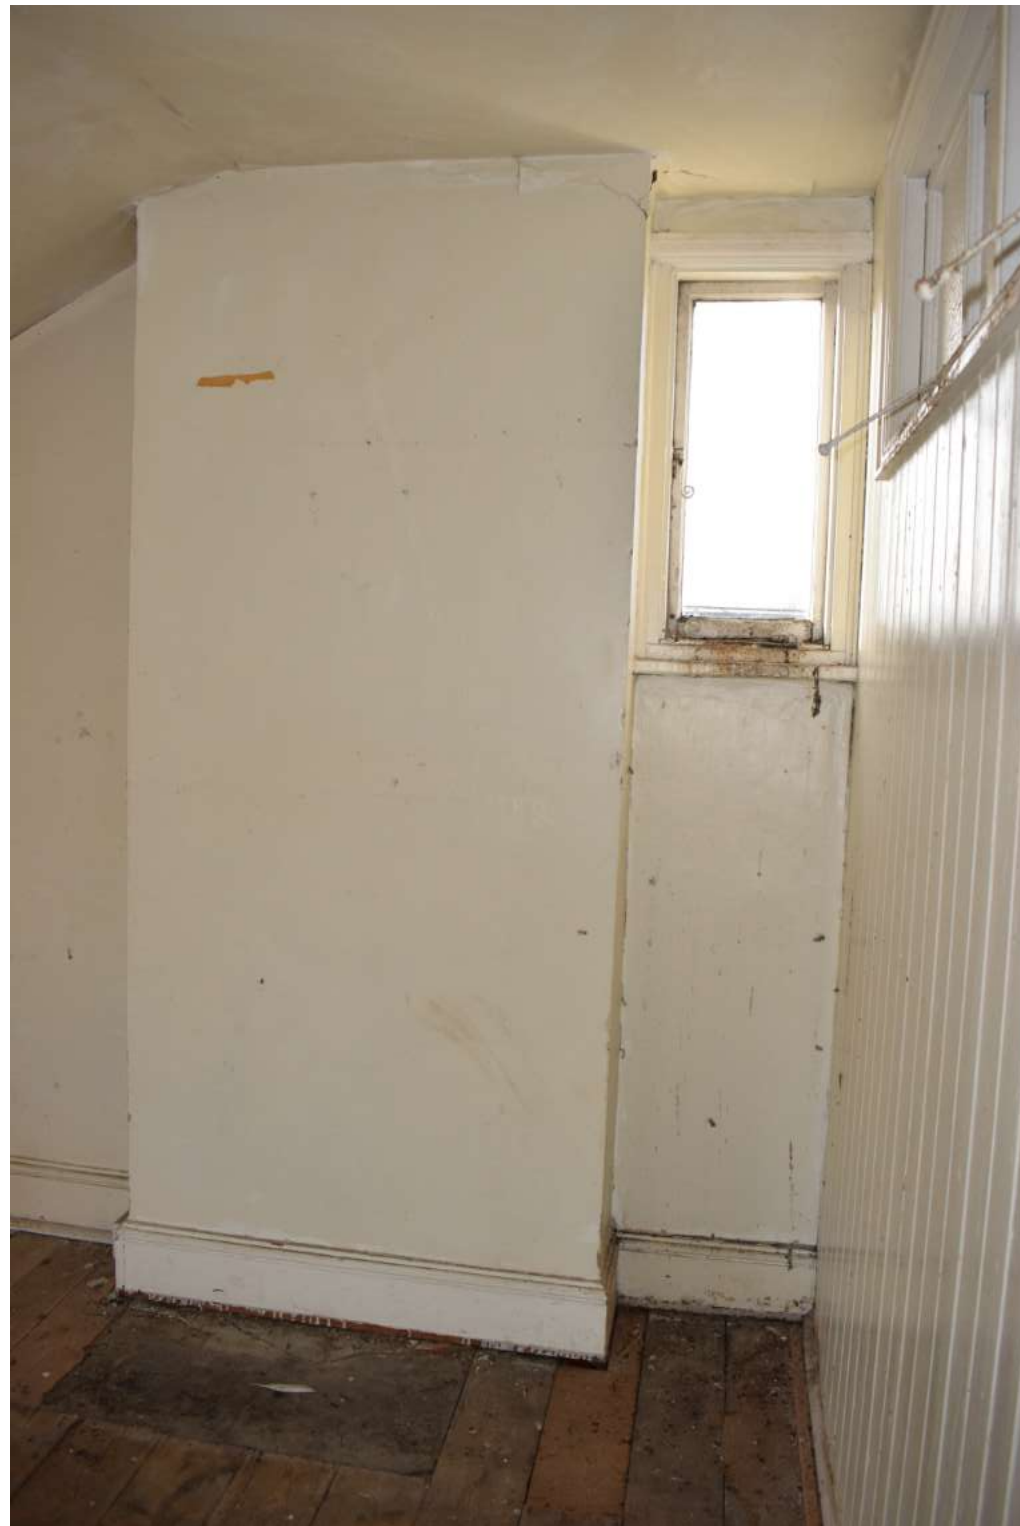
Plate 100

This is a view of the fire place that no longer offers ventilation.
