Phases 2a and 2b west wing

## Appendix 11

Yeomanry House

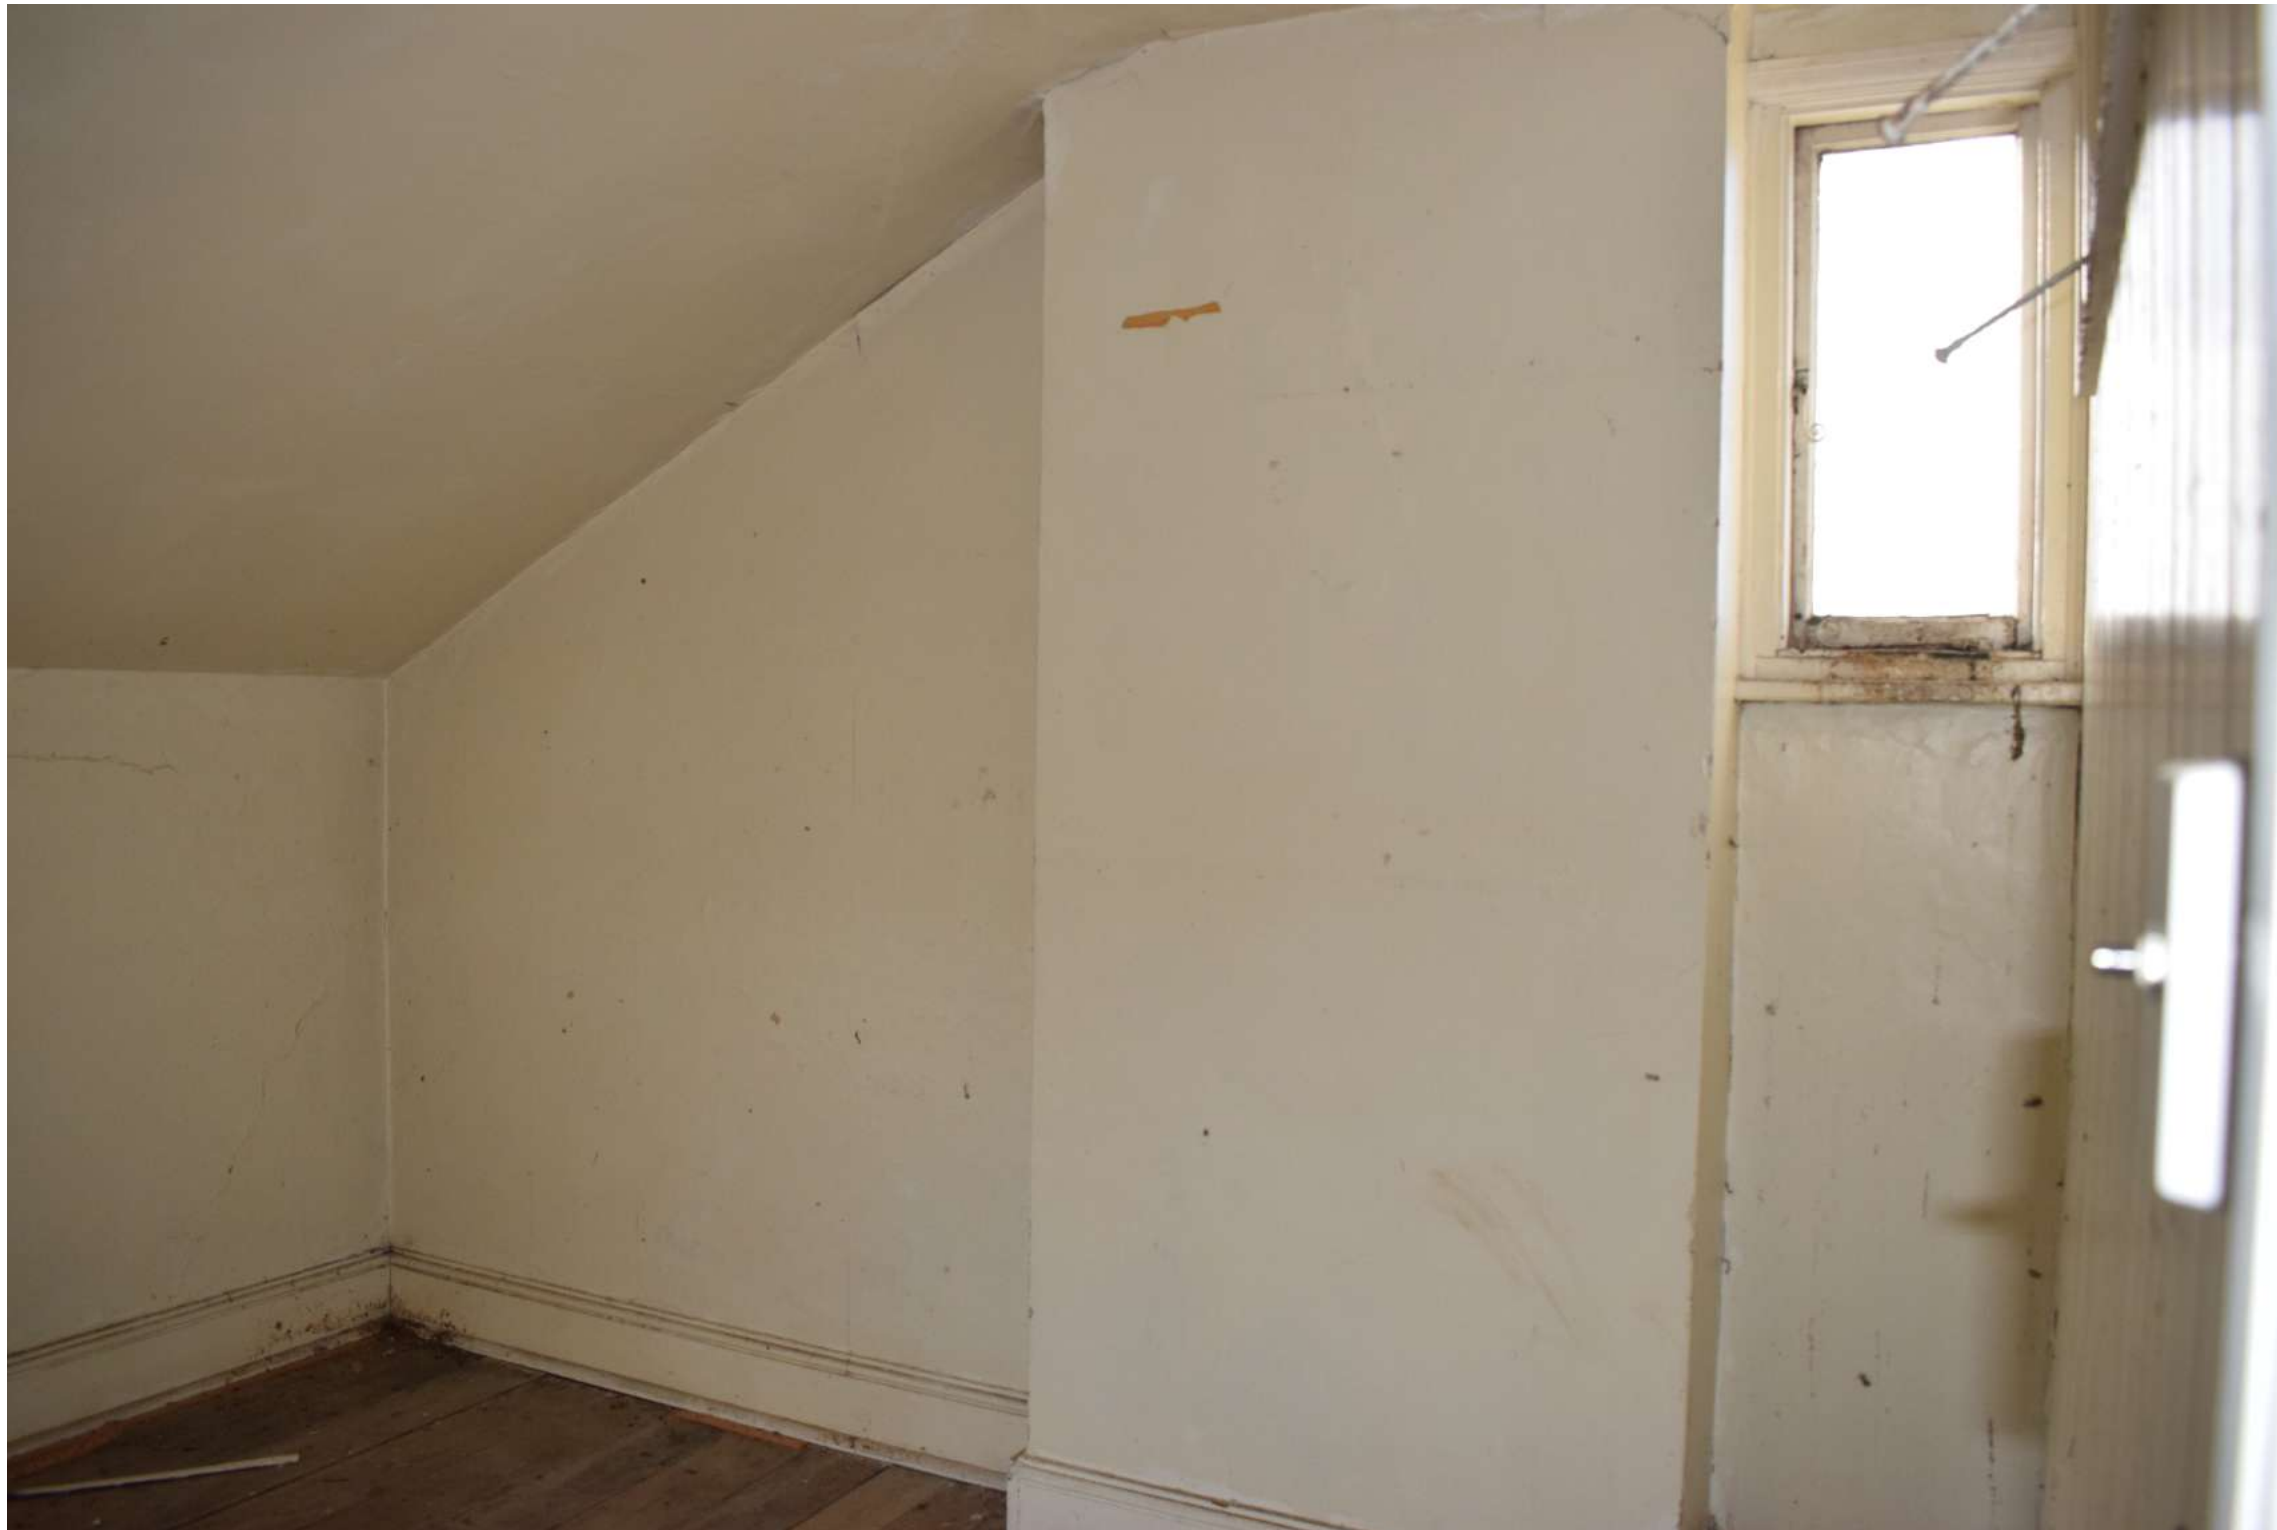
Plate 101

This image shows a modern casement inserted next to the former fire place.

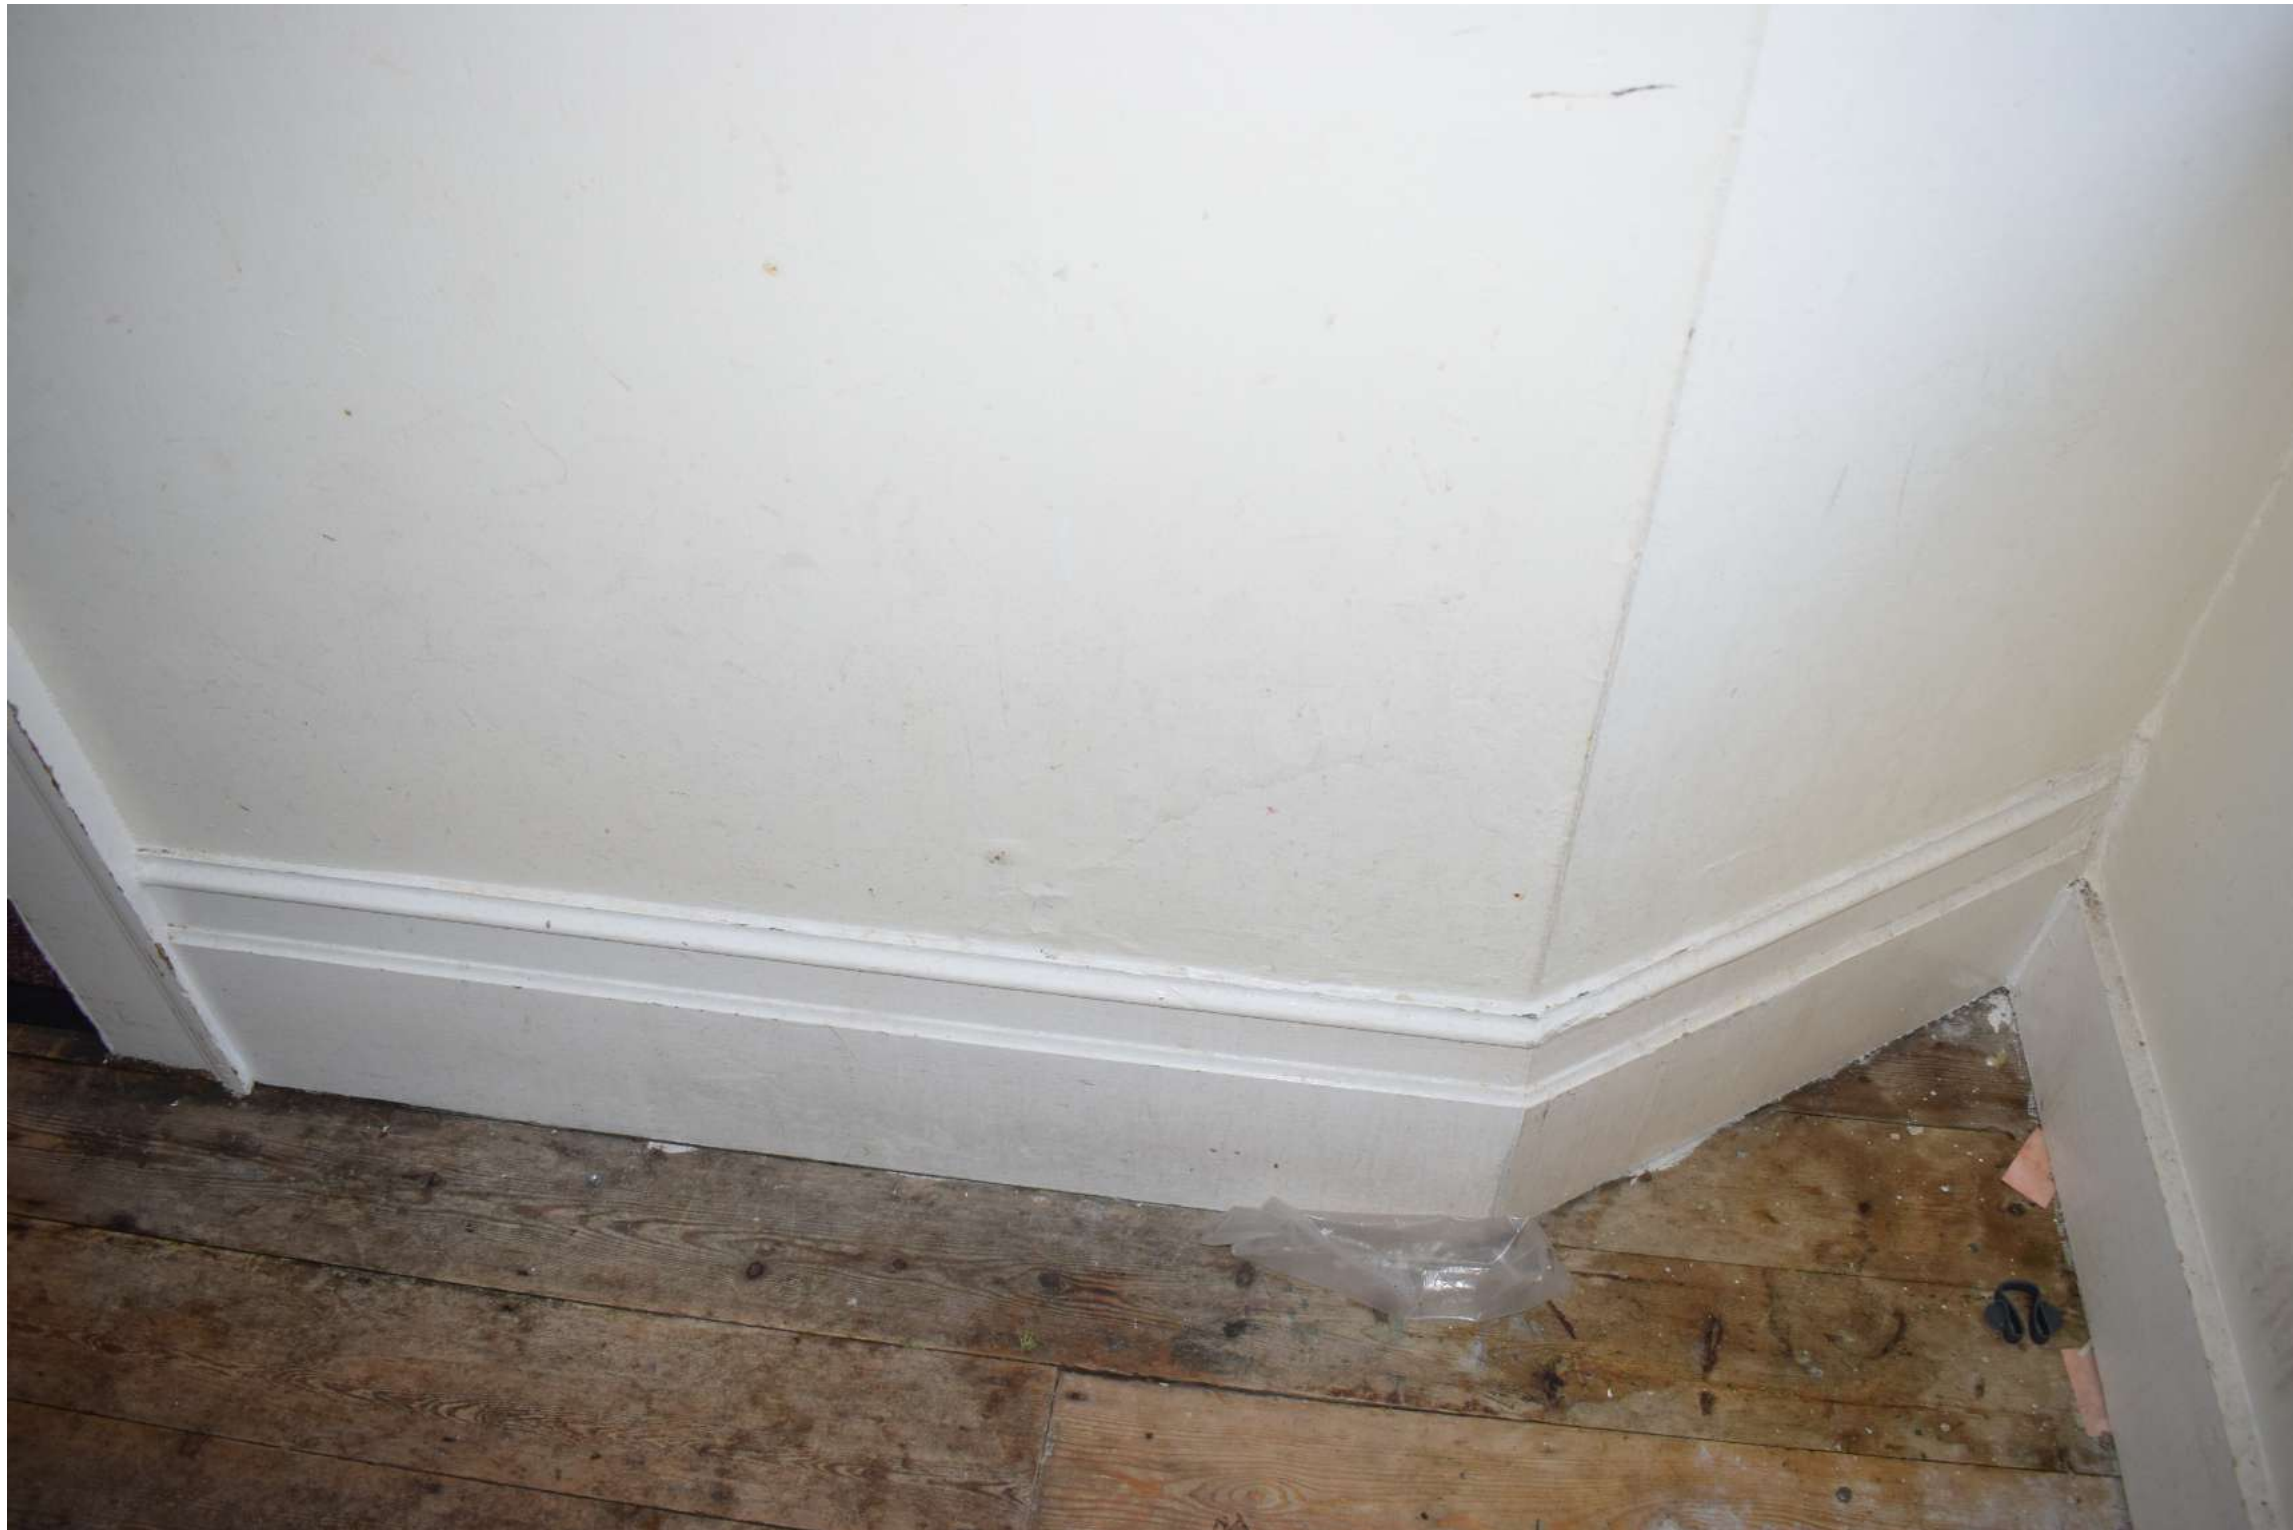
Plate 107

The butler's pantry room has a timber floor and the inserted wall has simpler skirting detailing and lower height than the pantry. The skirting on the exterior wall of the butler's pantry is very makeshift compared to the well-made, inserted-wall skirting.

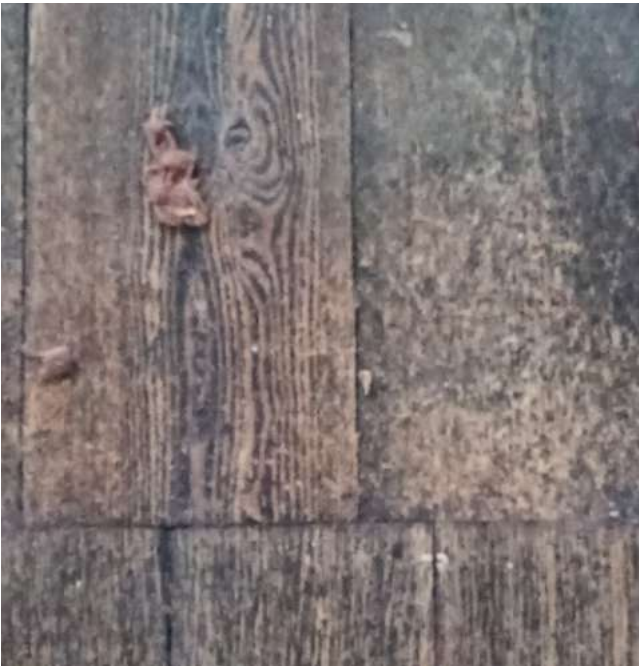
Plate 115

There is damp seen behind very wet wallpaper in the opposite corner. Inset: a detail of the timber flooring.

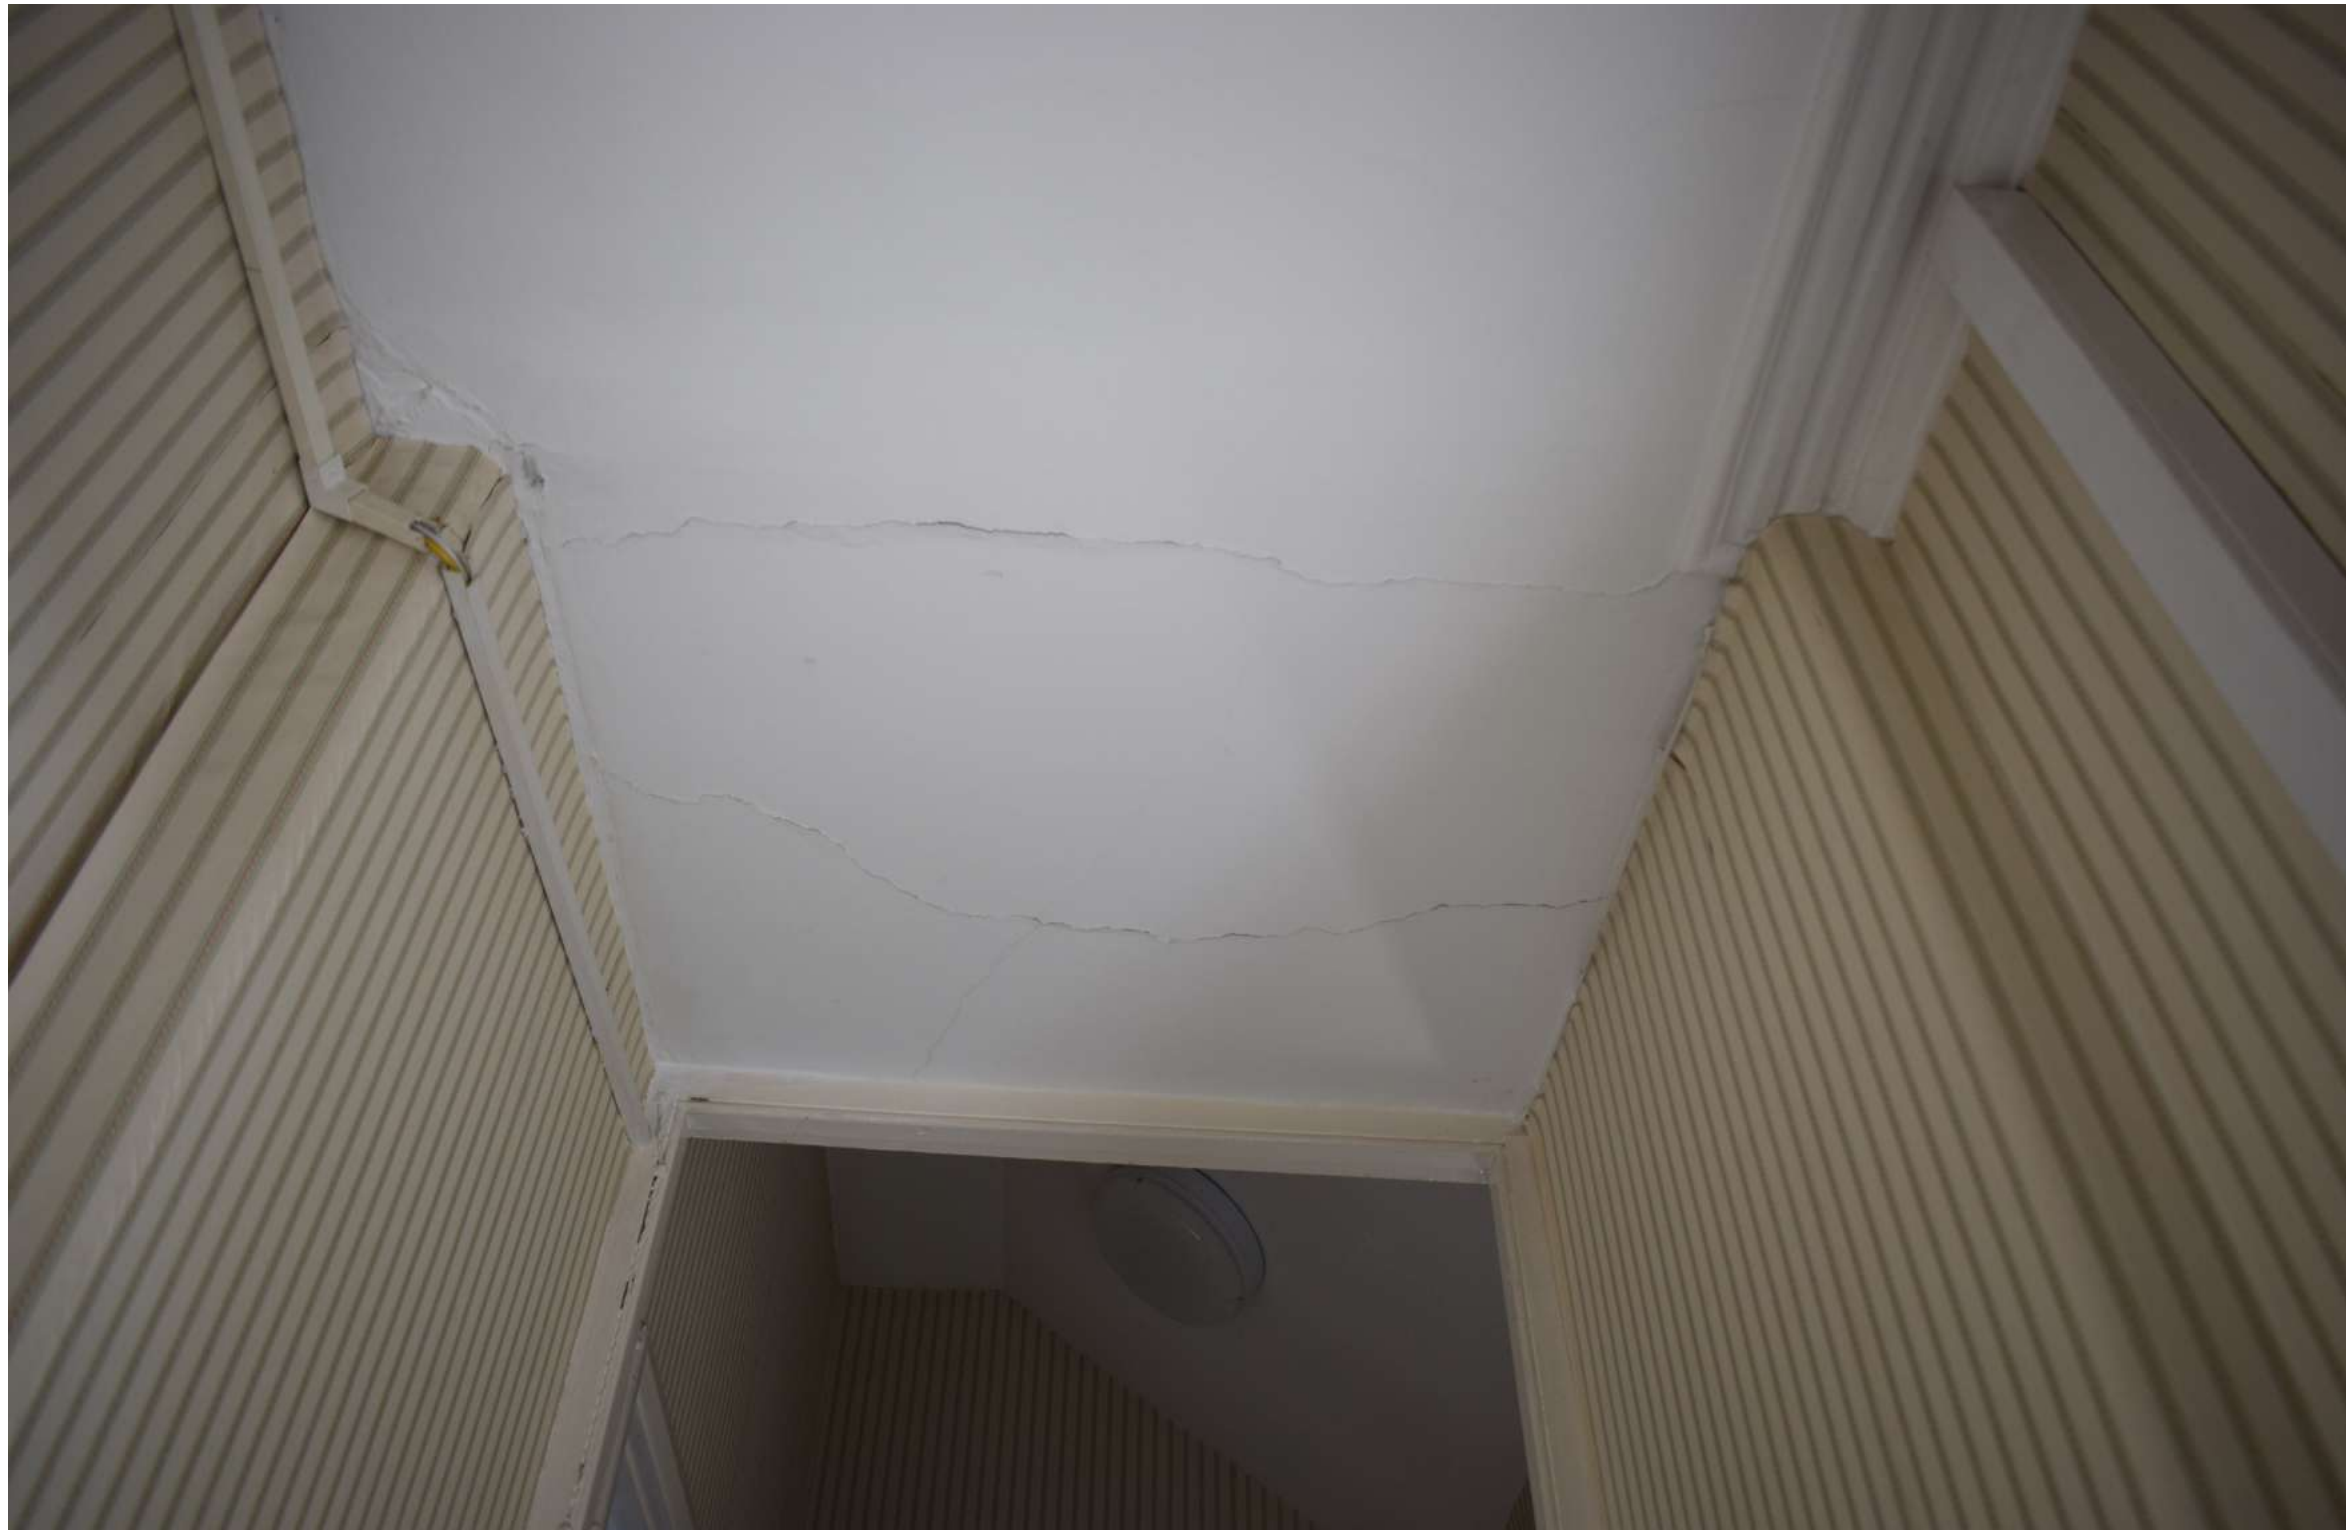
Plate 118

The wall for the corridor interrupts the coving where the steps rise, strongly suggesting this wall was inserted later.

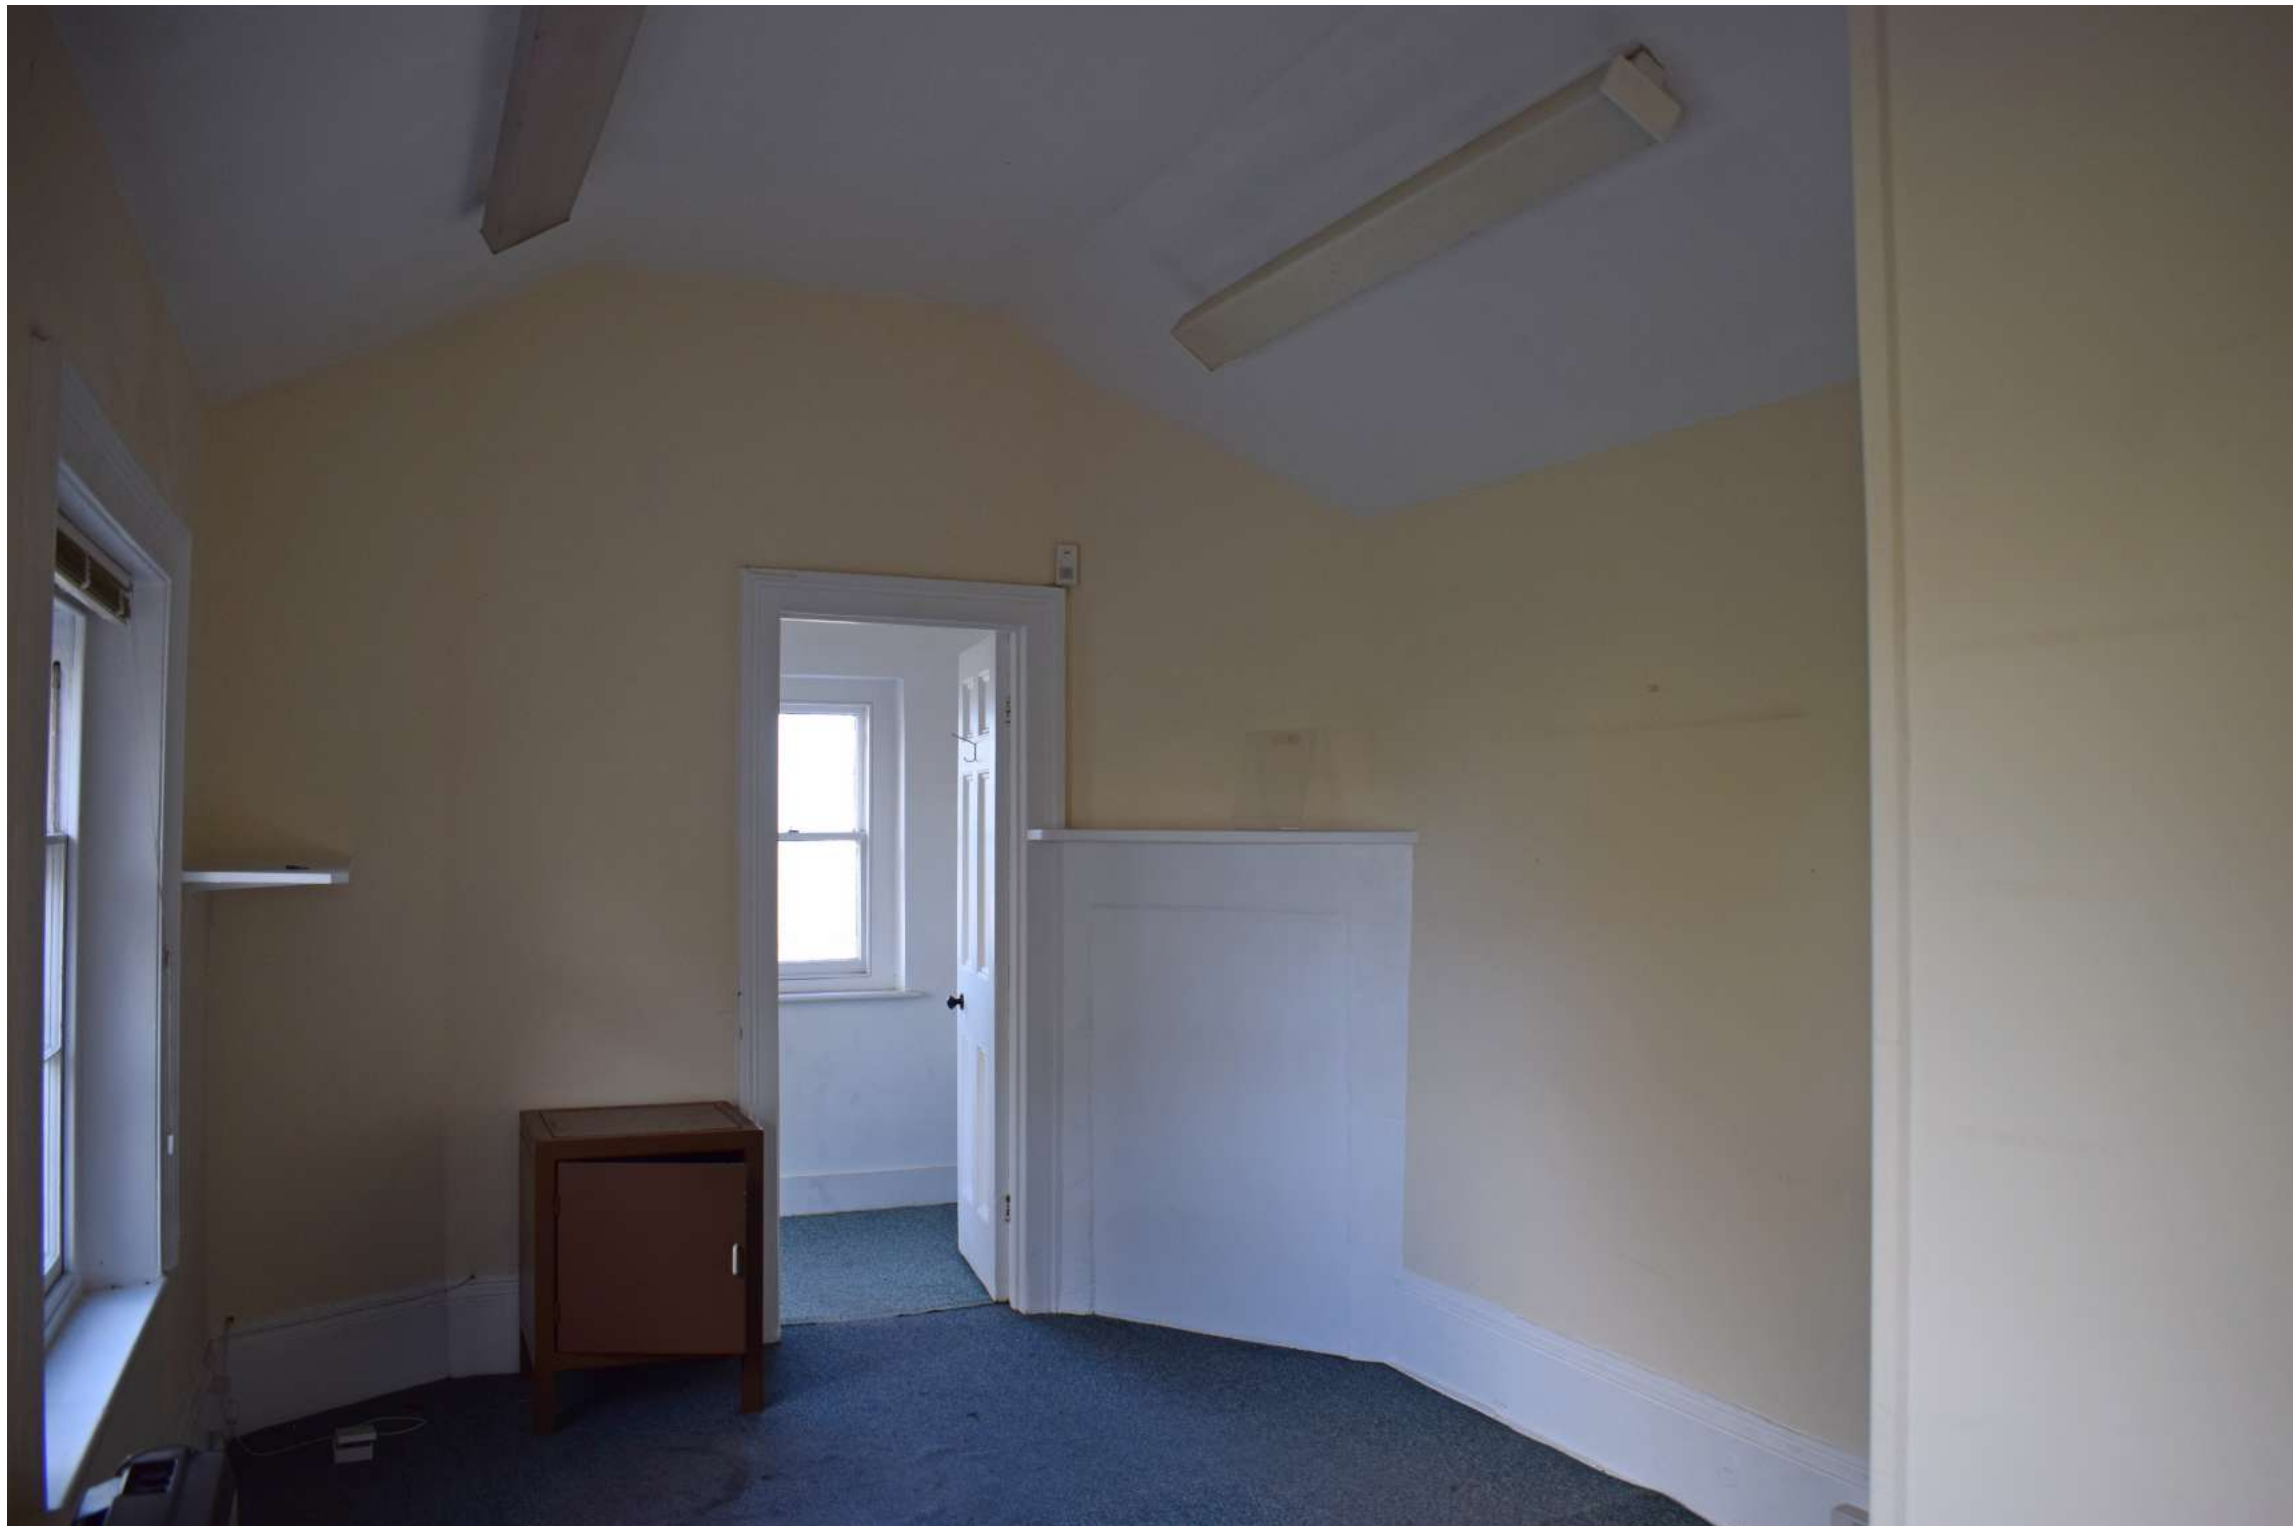
Plate 131

An angled corner former fireplace indicates this addition post-dates the sub-division created by the angled wall.

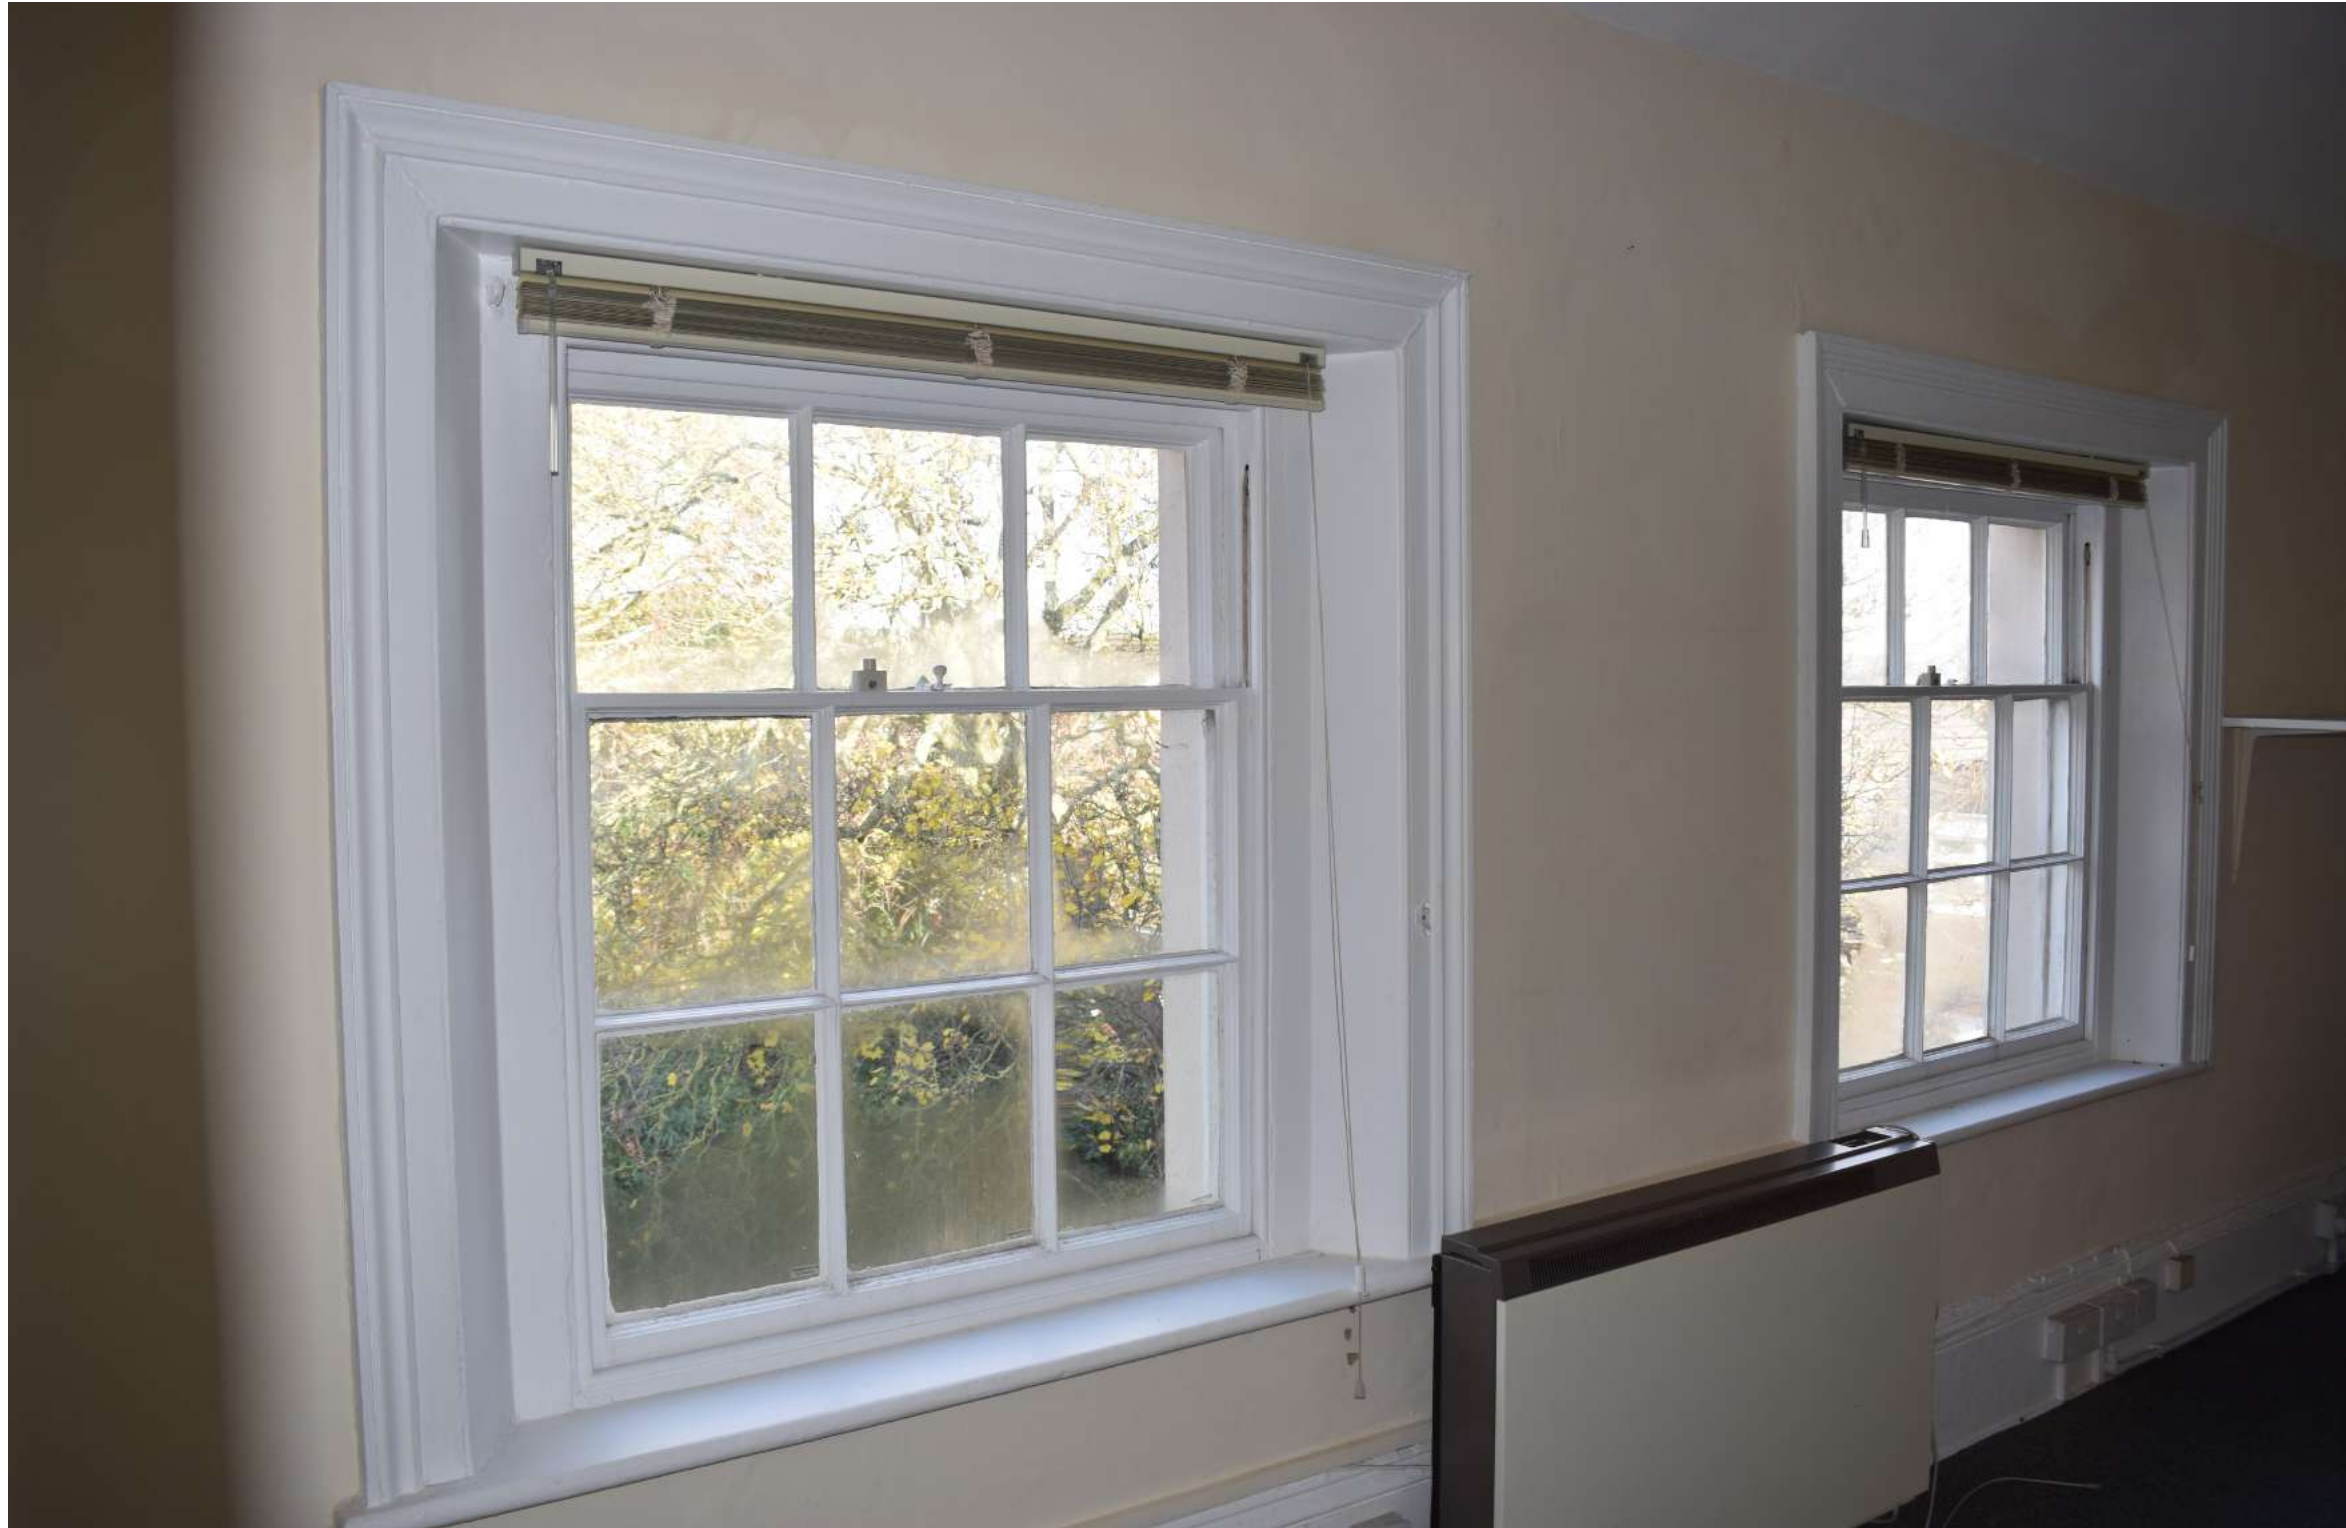
Plate 132

Two windows lit this space, originally three one over two sash windows.

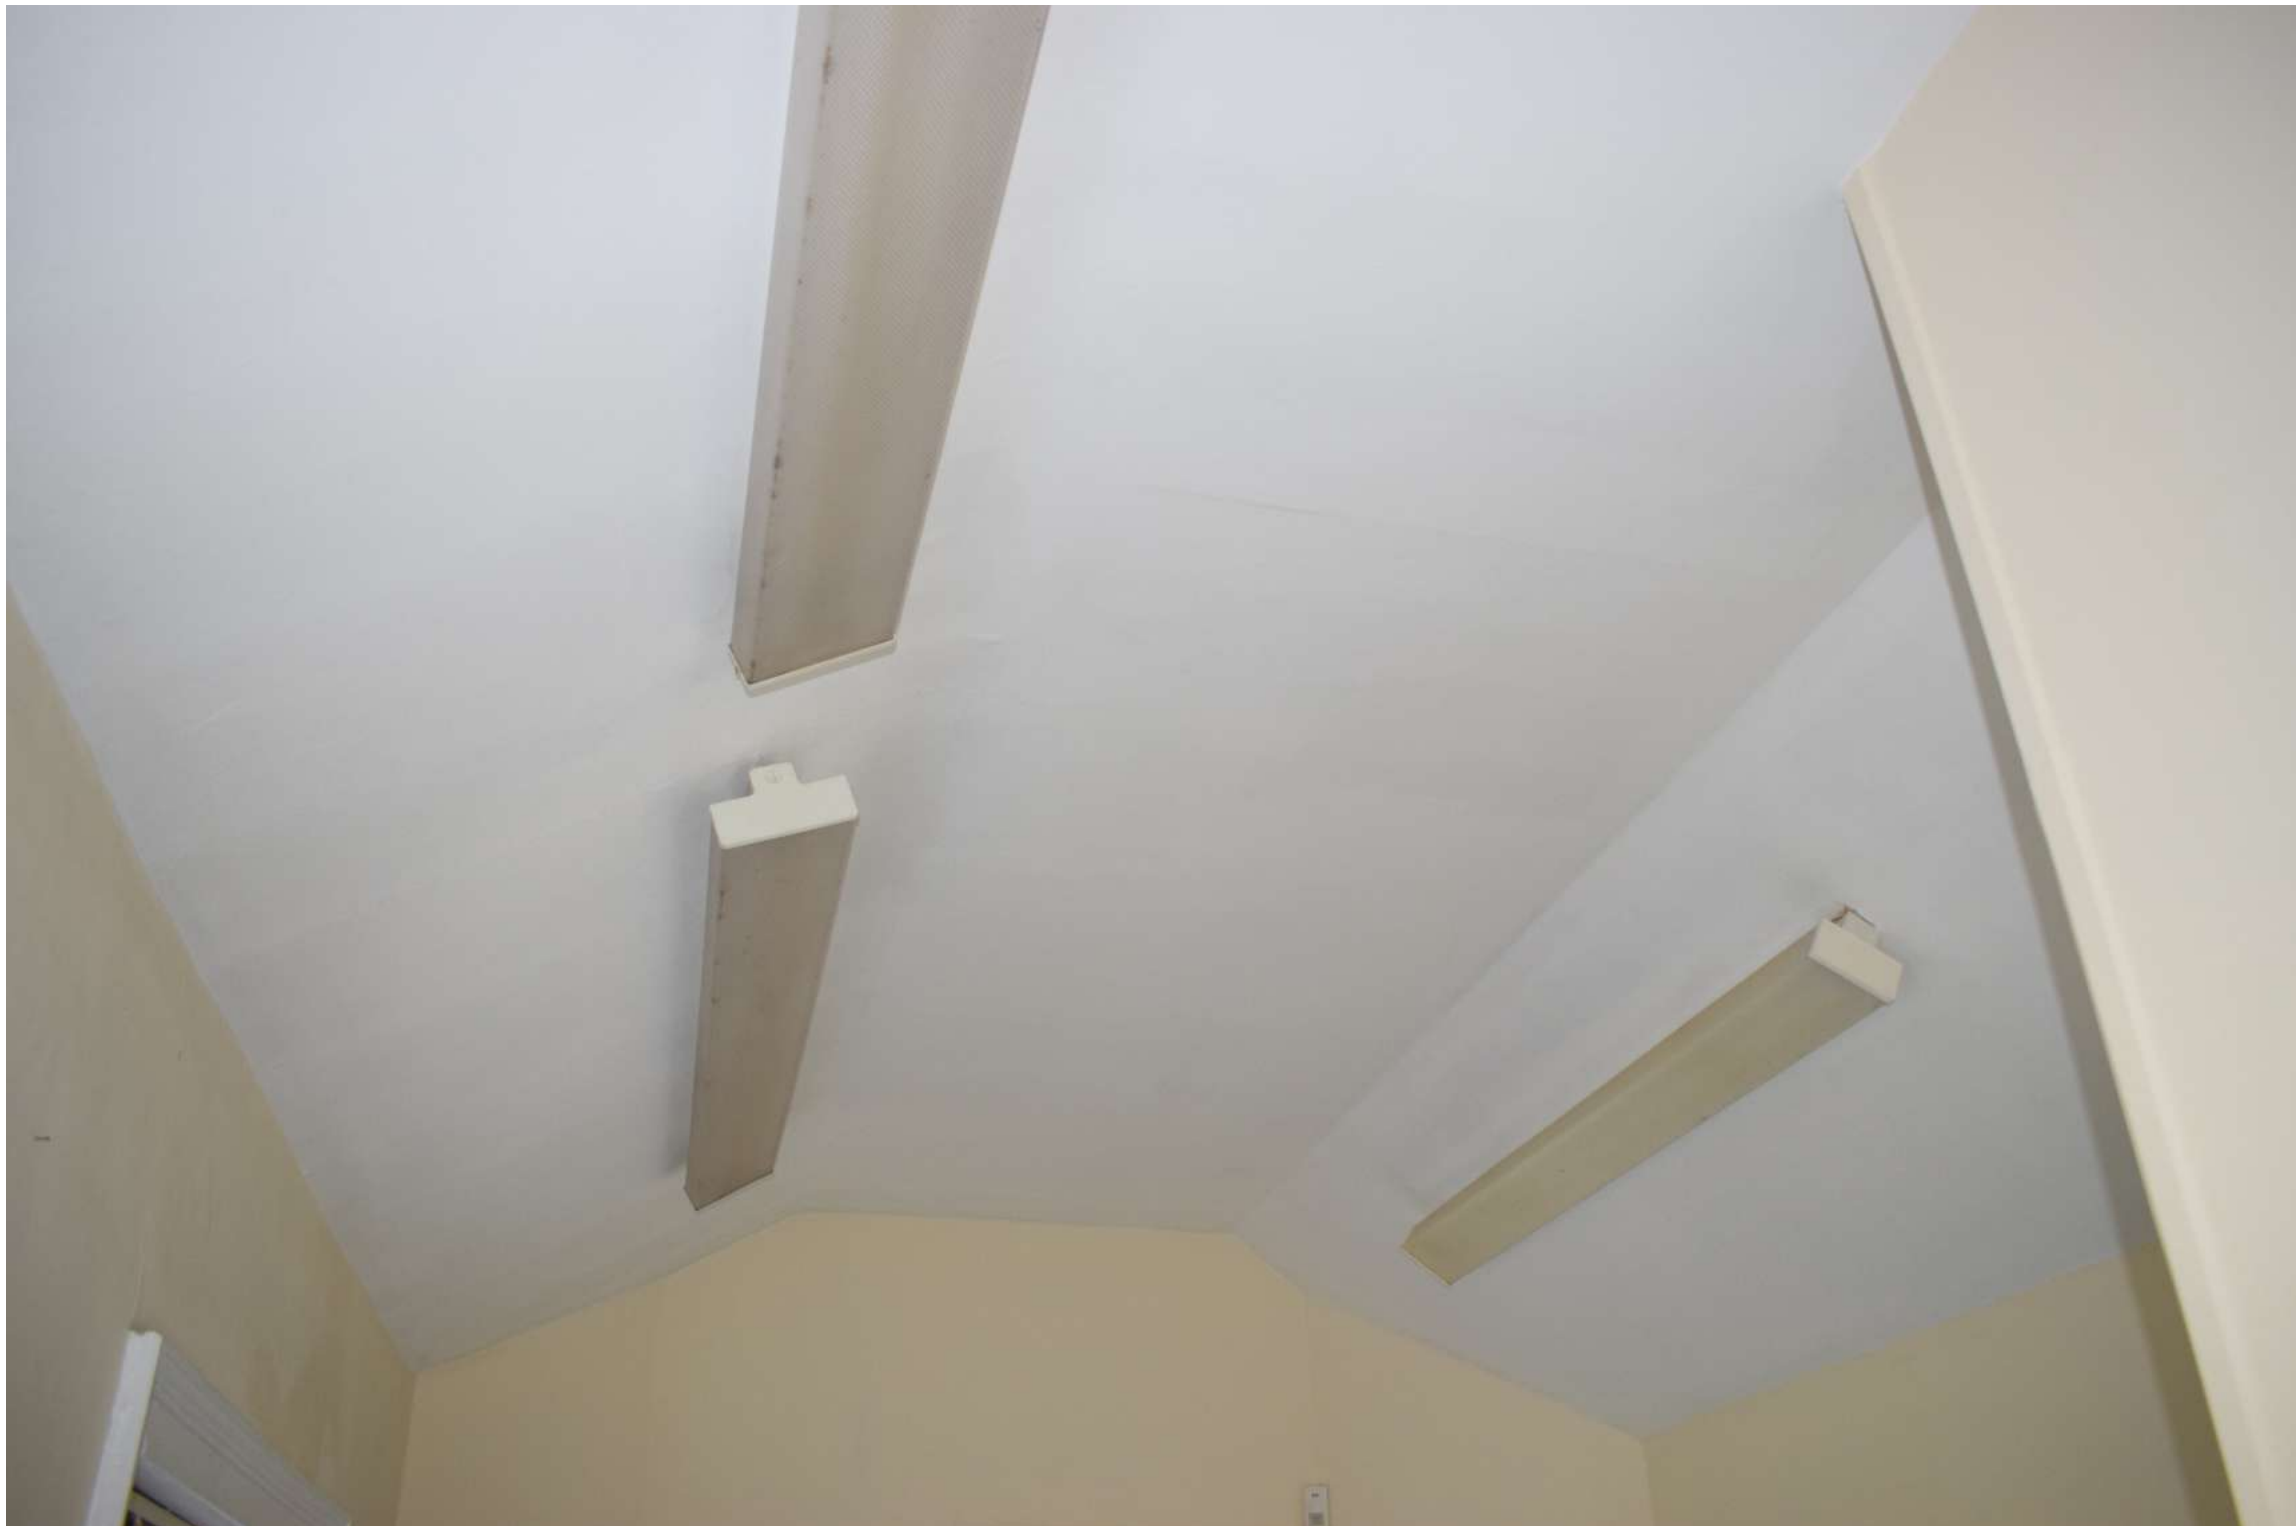
Plate 133

The roofline of Office D has a different slope to the adjacent room because it is narrower than the adjacent bedroom over the original drawing room. Asymmetry in Georgian and Victorian buildings often signals a difference in the room's width or is evidence of later construction or alteration. The geometry of a simple pitched roof dictates that for a consistent ridge height, a narrower room below will result in a steeper ceiling slope (pitch).
