Phases 2a and 2b west wing

## Appendix 11

Yeomanry House

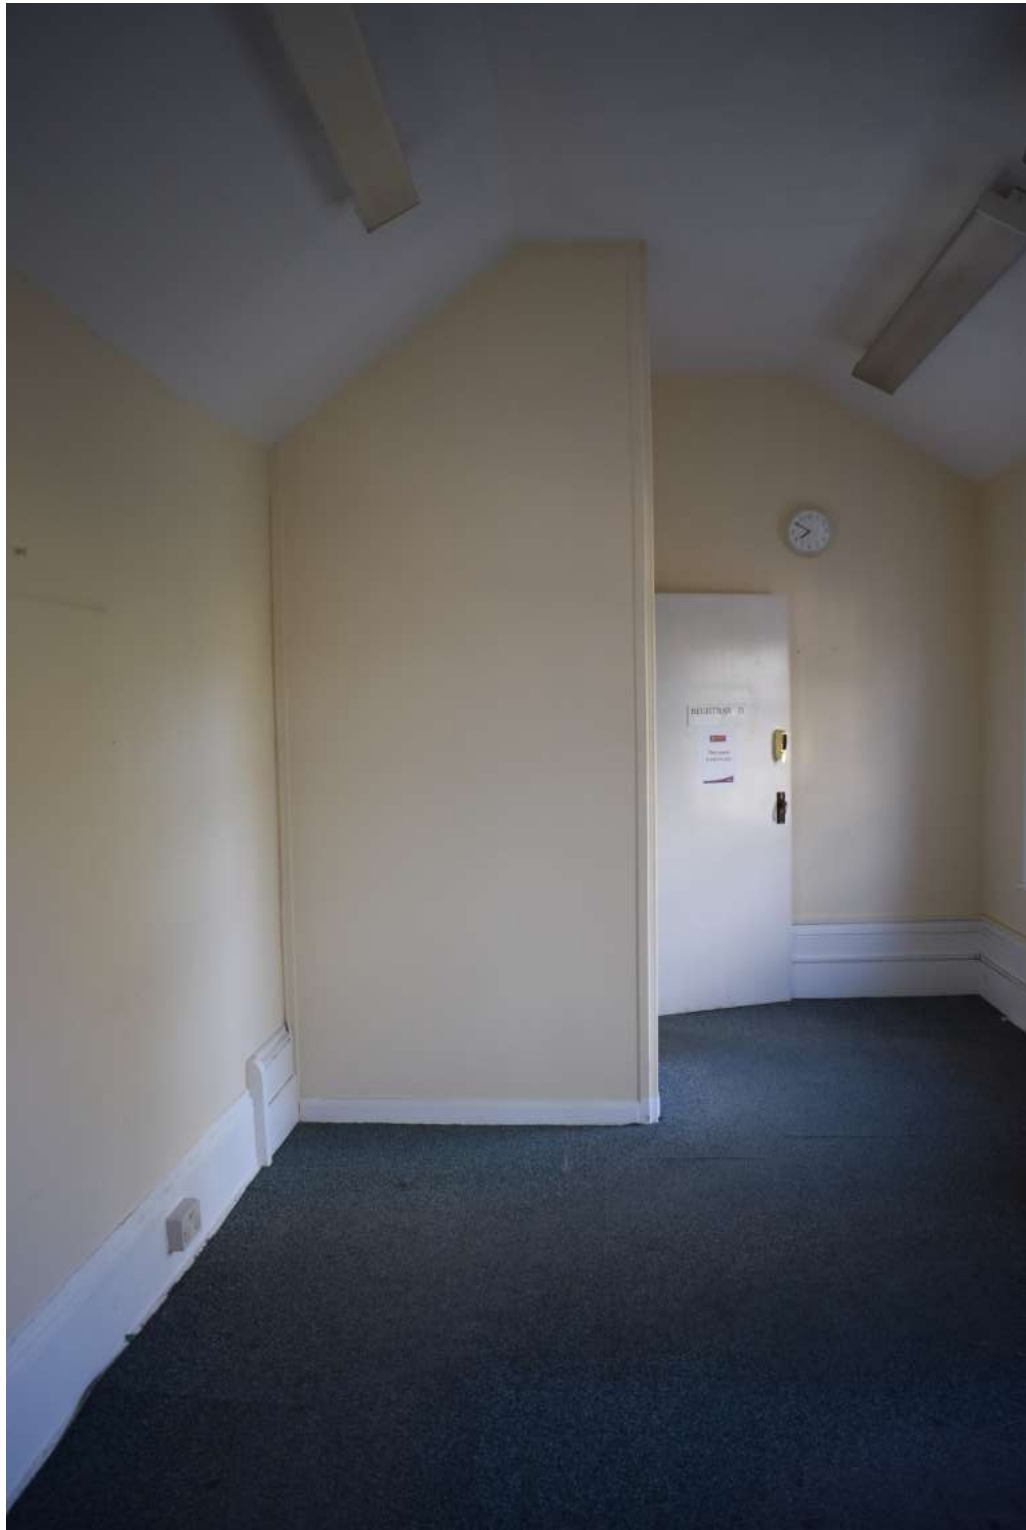
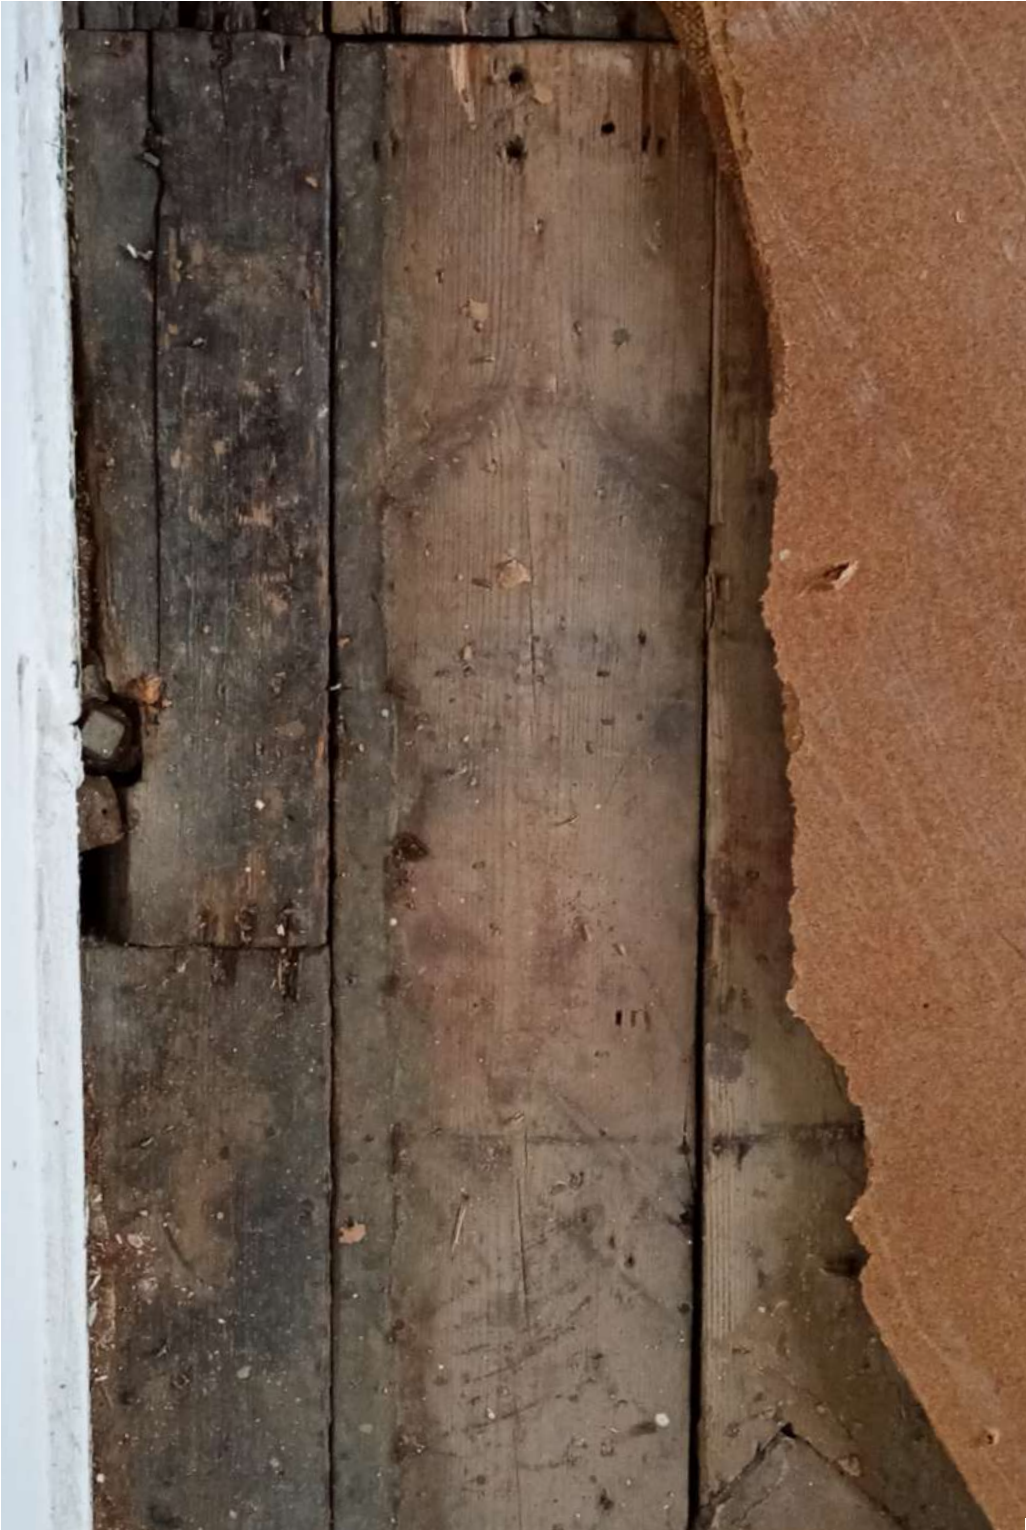
Plate 134

An angled corner feature on the skirting in Office D, seen here in front of the modern partition, indicates a historic change in room plan. Inset: a detail of the timber flooring.

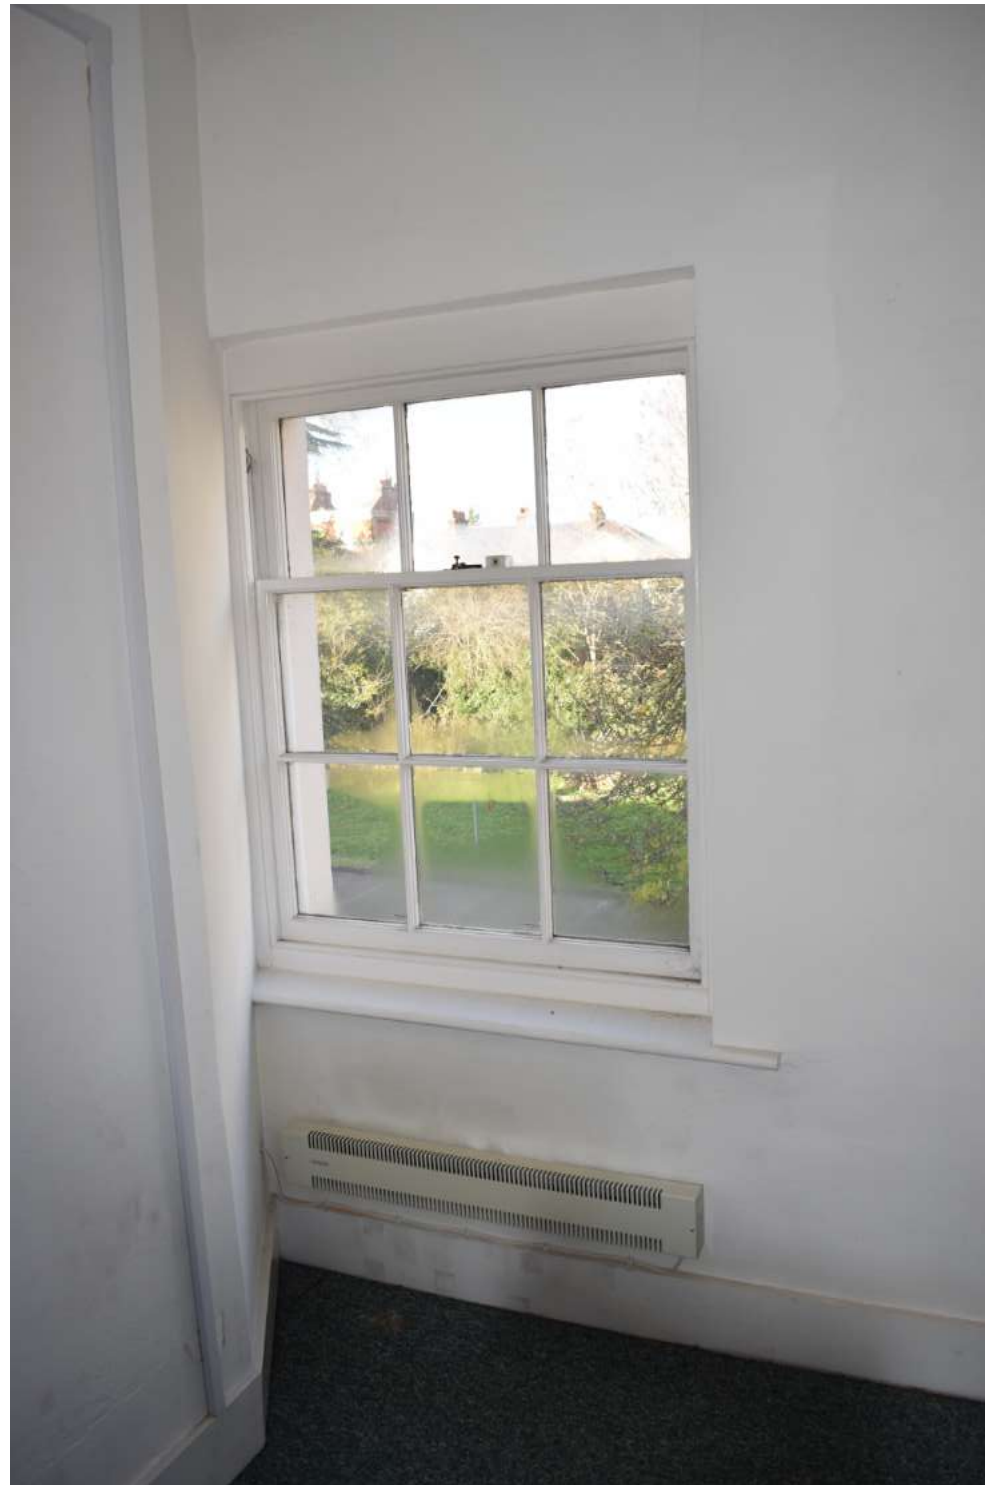
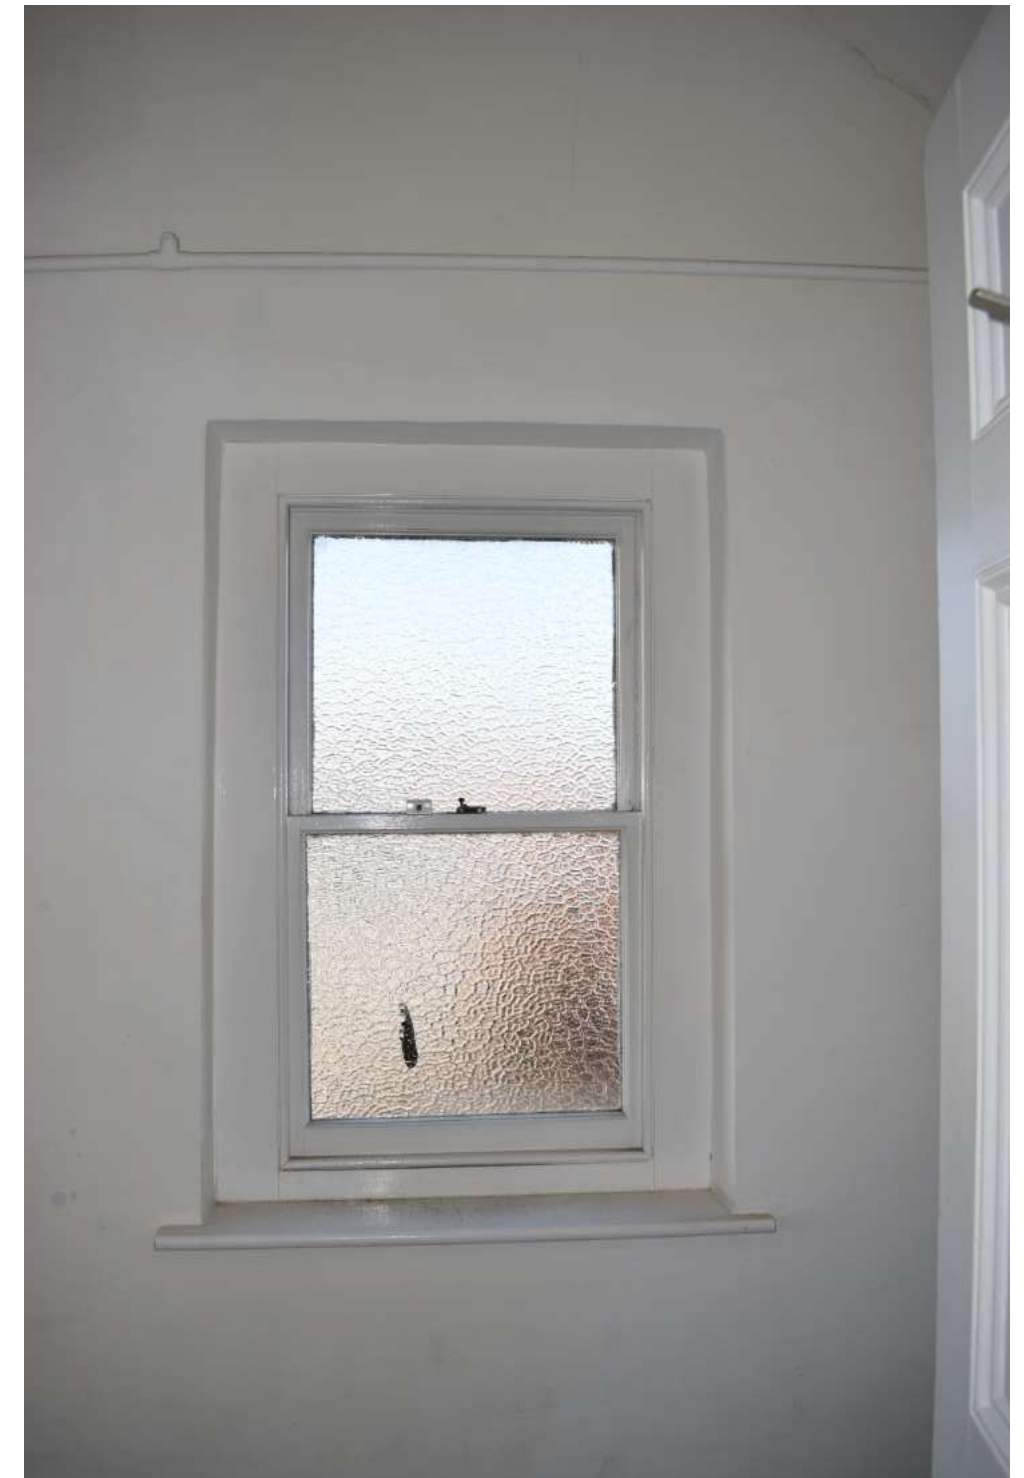
Plate 135

This angled wall that cuts into window architrave. The angled wall cutting into the window architrave is often seen when an original room layout (like a hallway or main reception room) was subdivided later to create a smaller, functional space.

It is lit by an additional casement window.

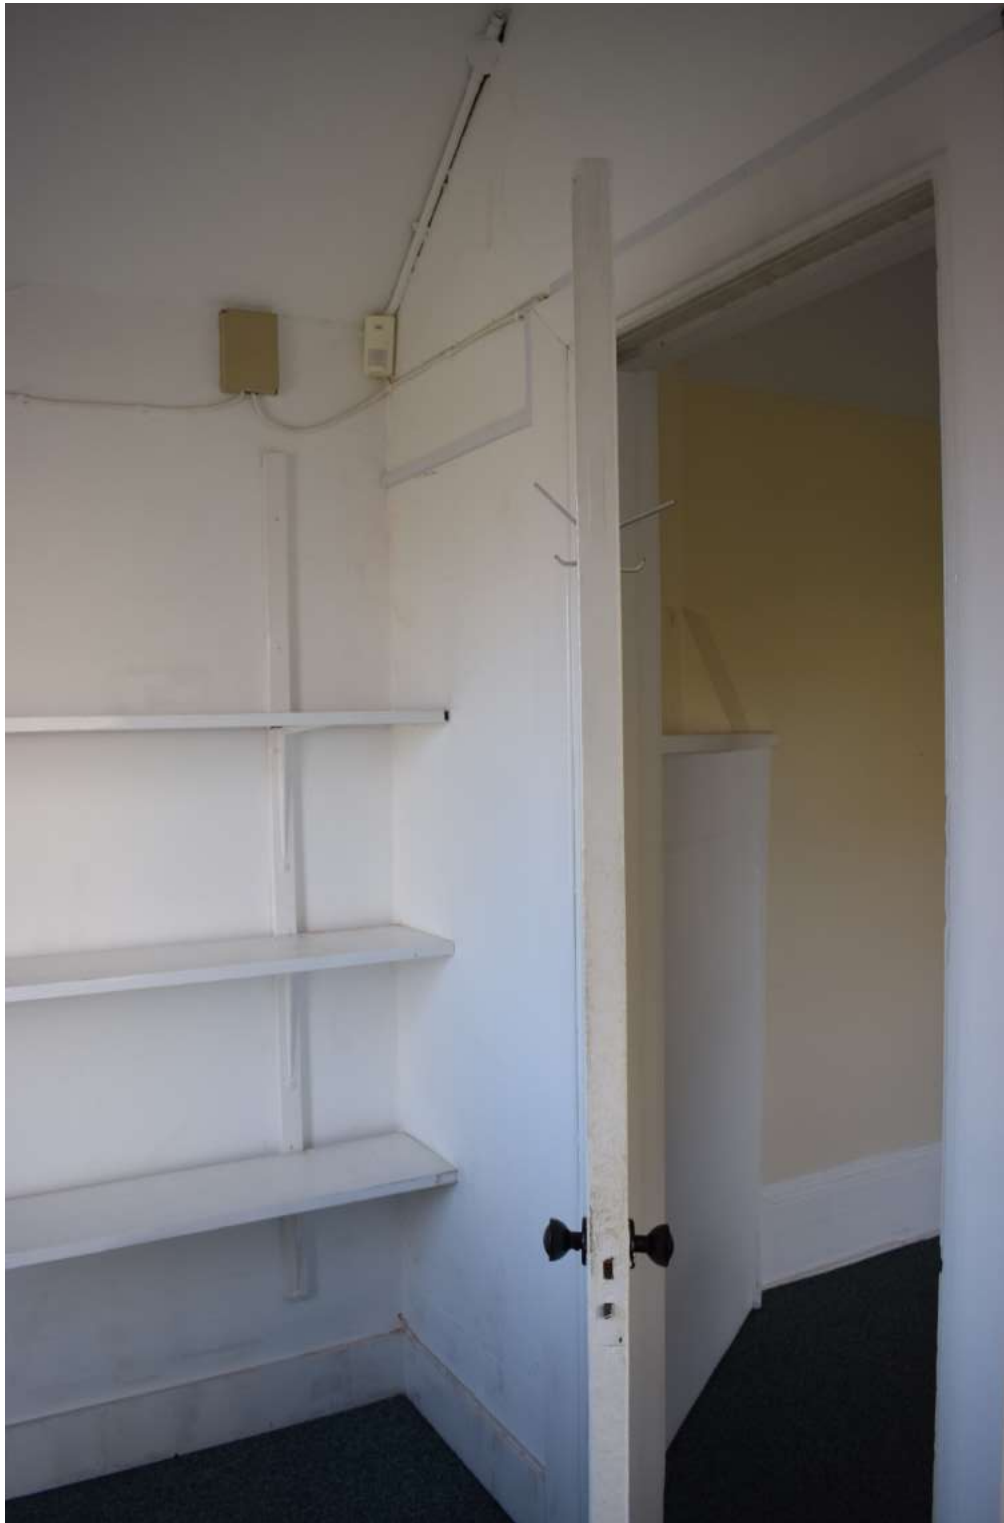
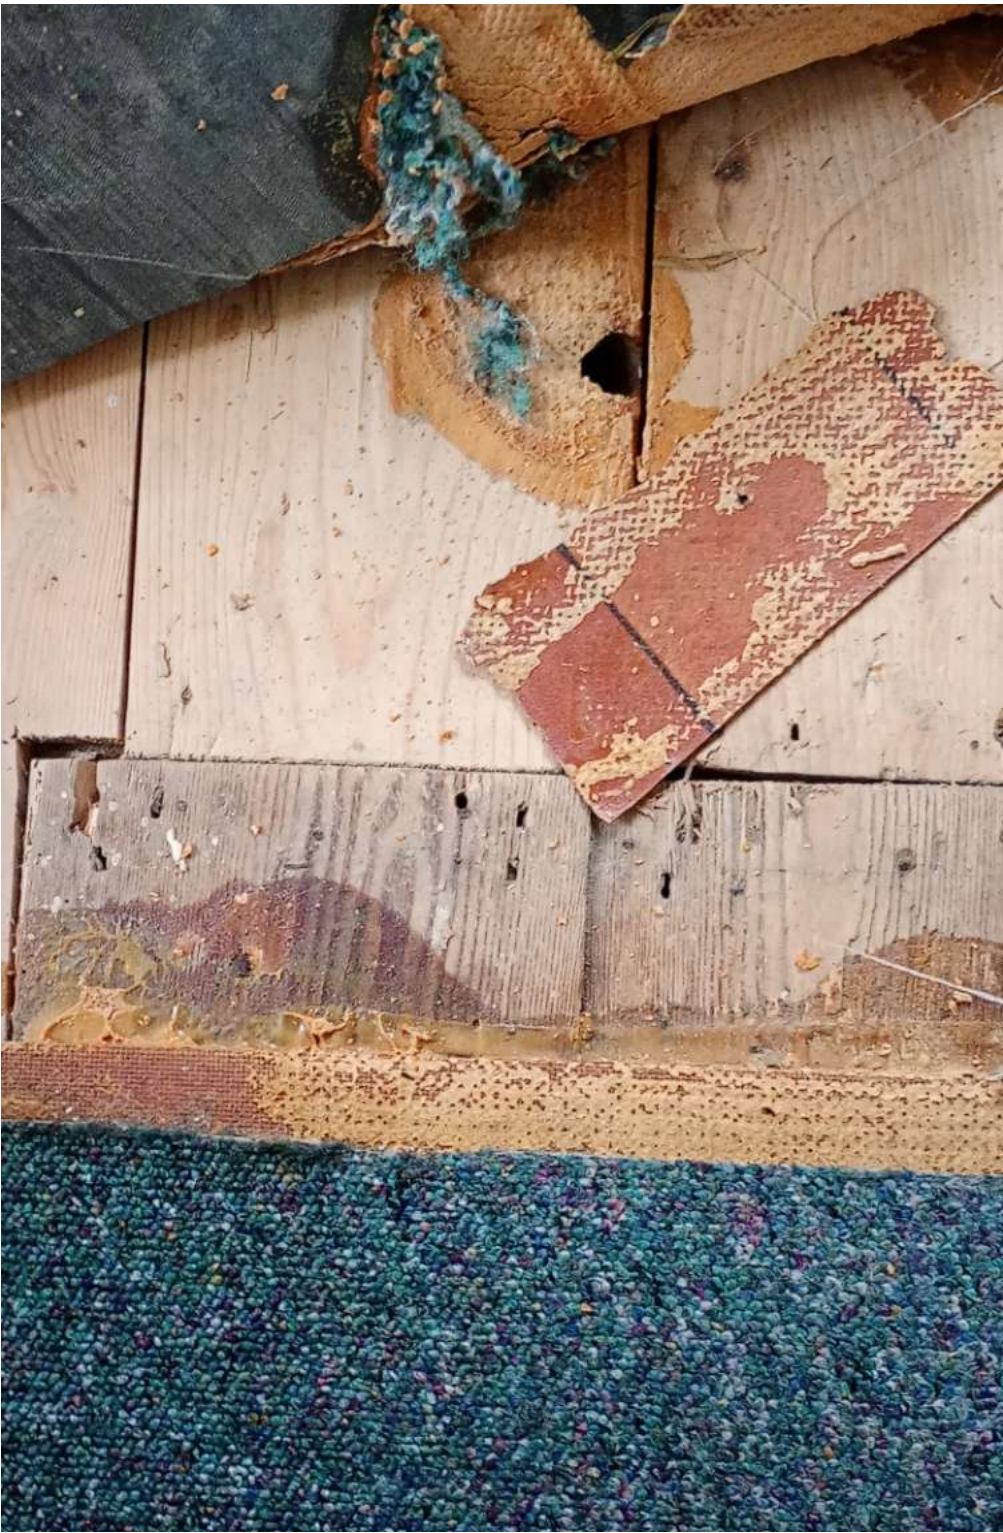
Plate 136

The shelving dates to the adjacent office room. The skirting in Office D are much higher than in the side room, indicating it is a more minor room. Inset: a detail of the timber flooring, showing replacement floorboards.
