## READING SCHOOL EXTERNAL REPAIRS PHASE 2

## 3 - MAIN BUILDING / ENGLISH BLOCK

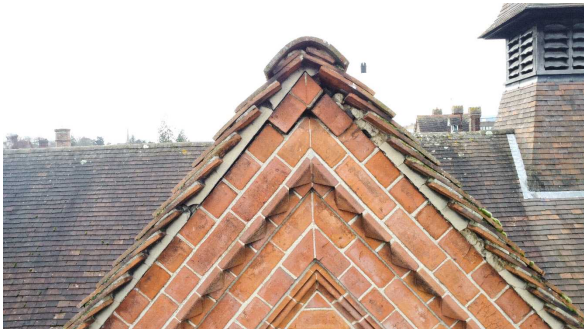
| Ref. | Description | £ |
|---|---|---|
| 3.1.5 | To the apex of the main east elevation facing gable remove 3nr loose / distorted bricks to allow for CA inspection as to potential cause of movement. Allow to reinstate brickwork and bed in fresh NHL 3.5 lime mortar to match existing. | |

| Ref. | Description | £ |
|---|---|---|
| 3.1.6 | In regard to item 3.1.5 above allow a provisional sum of £1,000 for any unforeseen required repairs to structure behind the brickwork. Provisional sum to be expended in whole or part at the discretion of the CA. | 1,000.00 |

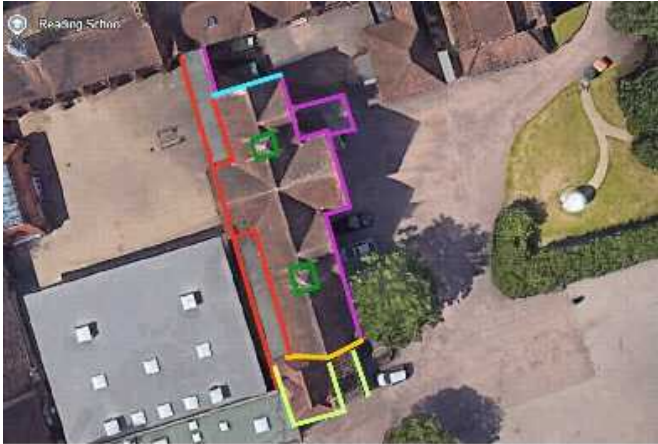
| Ref. | Description | £ |
|---|---|---|
| <i>N.B.</i> | <p>The existing paint to the windows has been analysed and confirmed as having a lead content of 5.5%. It should be assumed that lead paint has been applied to all surfaces and appropriate measures for preparation and redecoration must be undertaken.</p> <p>Works described below are to be carried out to all the elevations as highlighted below (including the covered access corridor by the armoury)</p> <p> <span style="color: red;">—</span> West Elevation<br/> <span style="color: cyan;">—</span> North Elevation<br/> <span style="color: magenta;">—</span> East Elevation<br/> <span style="color: yellow;">—</span> South Elevation<br/> <span style="color: green;">—</span> Armoury Elevations<br/> <span style="color: darkgreen;">—</span> Coupla Louvres </p> | |
