**DESIGN AND ACCESS STATEMENT**

**READING SCHOOL  
MAIN BUILDING (ENGLISH BLOCK)**

30 March 2026 (Rev 2.0)

**READING SCHOOL – MAIN BUILDING / ENGLISH BLOCK  
EXTERNAL REPAIRS  
DESIGN AND ACCESS STATEMENT**

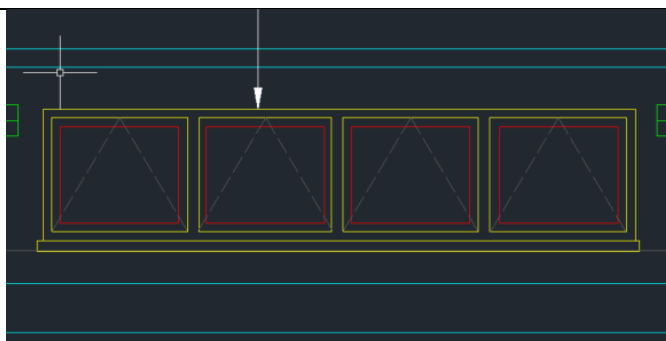
Fig 1.6 – Outline drawing of proposed reduced height window configuration. Extract from drawing 5032376\_RDG\_03\_ZZ\_D\_B\_01003

- 2.3.2. The proposed inclusion of thermal insulation to the flat roof areas will raise the existing flat roof level by circa 100mm. In order for a Guarantee to be provided for the roofing works, a minimum upstand of 150mm is required at abutments / below windows etc. To accommodate the increased roof height and required upstand, the existing windows located above the flat roofs will require replacement with reduced height windows. The existing windows are timber framed with single glazed centrally pivoted casements circa 2700mm wide x 830mm high. The existing windows are currently in a deteriorated condition with large areas of timber decay. The proposed replacement windows would be timber framed with double glazed top hum opening casements circa 2700mm wide x 660mm high. Figures 1.5 and 1.6 below show the existing windows and the proposed replacement. The brickwork wall below the windows will be built up to allow for the new window cill height and weathered with code 4 lead flashings.

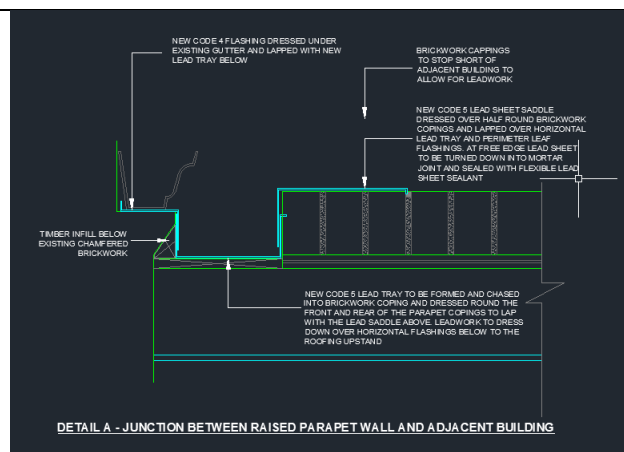
Fig 1.10 – Proposed drawing shown junction between new parapet wall height and adjacent rainwater goods.

- 2.3.3. **Parapet Wall Alterations – Option 1.** As noted in item 2.3.2 above, the inclusion of a new insulation layer will raise the roof level with a further requirement for a 150mm upstand. To accommodate the increased roof height and required upstand, the low-level parapet brickwork walls will require raising by circa 150mm in height. The existing brickwork parapet walls incorporate clay creasing tiles with half round brickwork cappings. The low-level parapet walls requiring raising are shown in Figures 1.7 and 1.8 below. The half round cappings and creasing tiles will be carefully removed and set aside for reinstatement. The brick walls will be raised using bricks to match the existing and bedded in NHL 3.5 lime mortar to match existing. There is a level clash between the new height of the northern parapet wall and the adjacent buildings rainwater goods as shown in fig 1.9. The proposed works include to leave a gap between the brickwork cappings at this junction and form a recessed lead saddle to provide weatherproofing as shown in Figures 1.9 and 1.10.

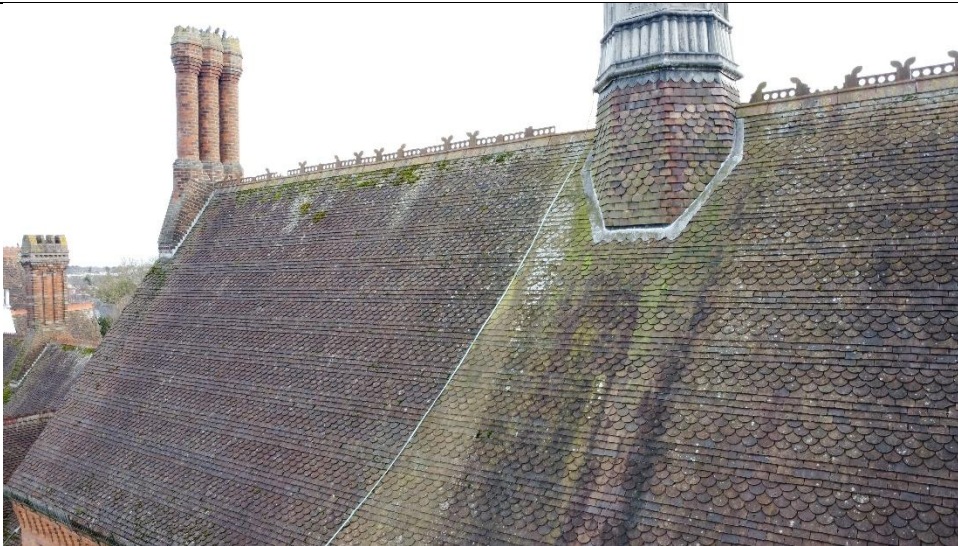
**Photograph 14**

General view of the Main Building (main hall) roof with decorative ridge tile inserts

- 2.2.2. The ridge tiles to the roof of the Main Hall, as shown in Fig 1.2 below, comprise clay ridge tiles with a central groove, allowing for individual decorative mortar bedded clay tile inserts. The decorative inserts are missing in areas and they will be replaced with new bespoke handmade inserts to match the existing profiles / pattern. The existing mortar to the ridge tiles will be carefully ground out to allow for bedding in fresh lime mortar. There are areas where the rolled edge to the ridge tiles have spalled as shown in Fig.1.3, this will be repaired using pins and colour matched mortar to rebuild the rolled profile. The same work and methods used were recently successfully carried out on another building at the school, the Chapel.
