# Arboricultural Impact Assessment (AIA)

**Site:** 122 Kidmore Road, Caversham, Reading, RG4 7NB

| Document Number | J240390-GGC-XX-XX-T-ARB-0600 | | | |

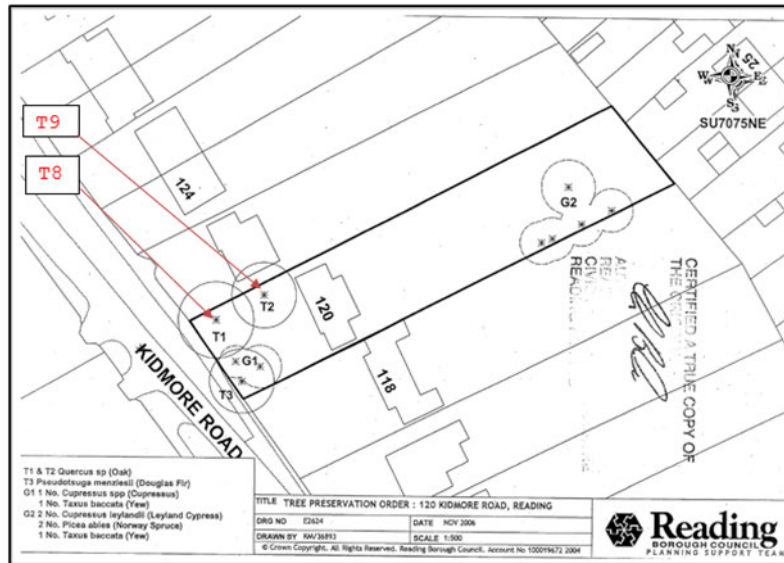
Fig 1 - Council TPO document (annotated to show survey tree numbers (in red) next to RBC TPO numbers).

- 4.7 We have received the TPO document from Reading Borough Council, identifying Tree Preservation Order within the neighbouring property (see Fig 1).

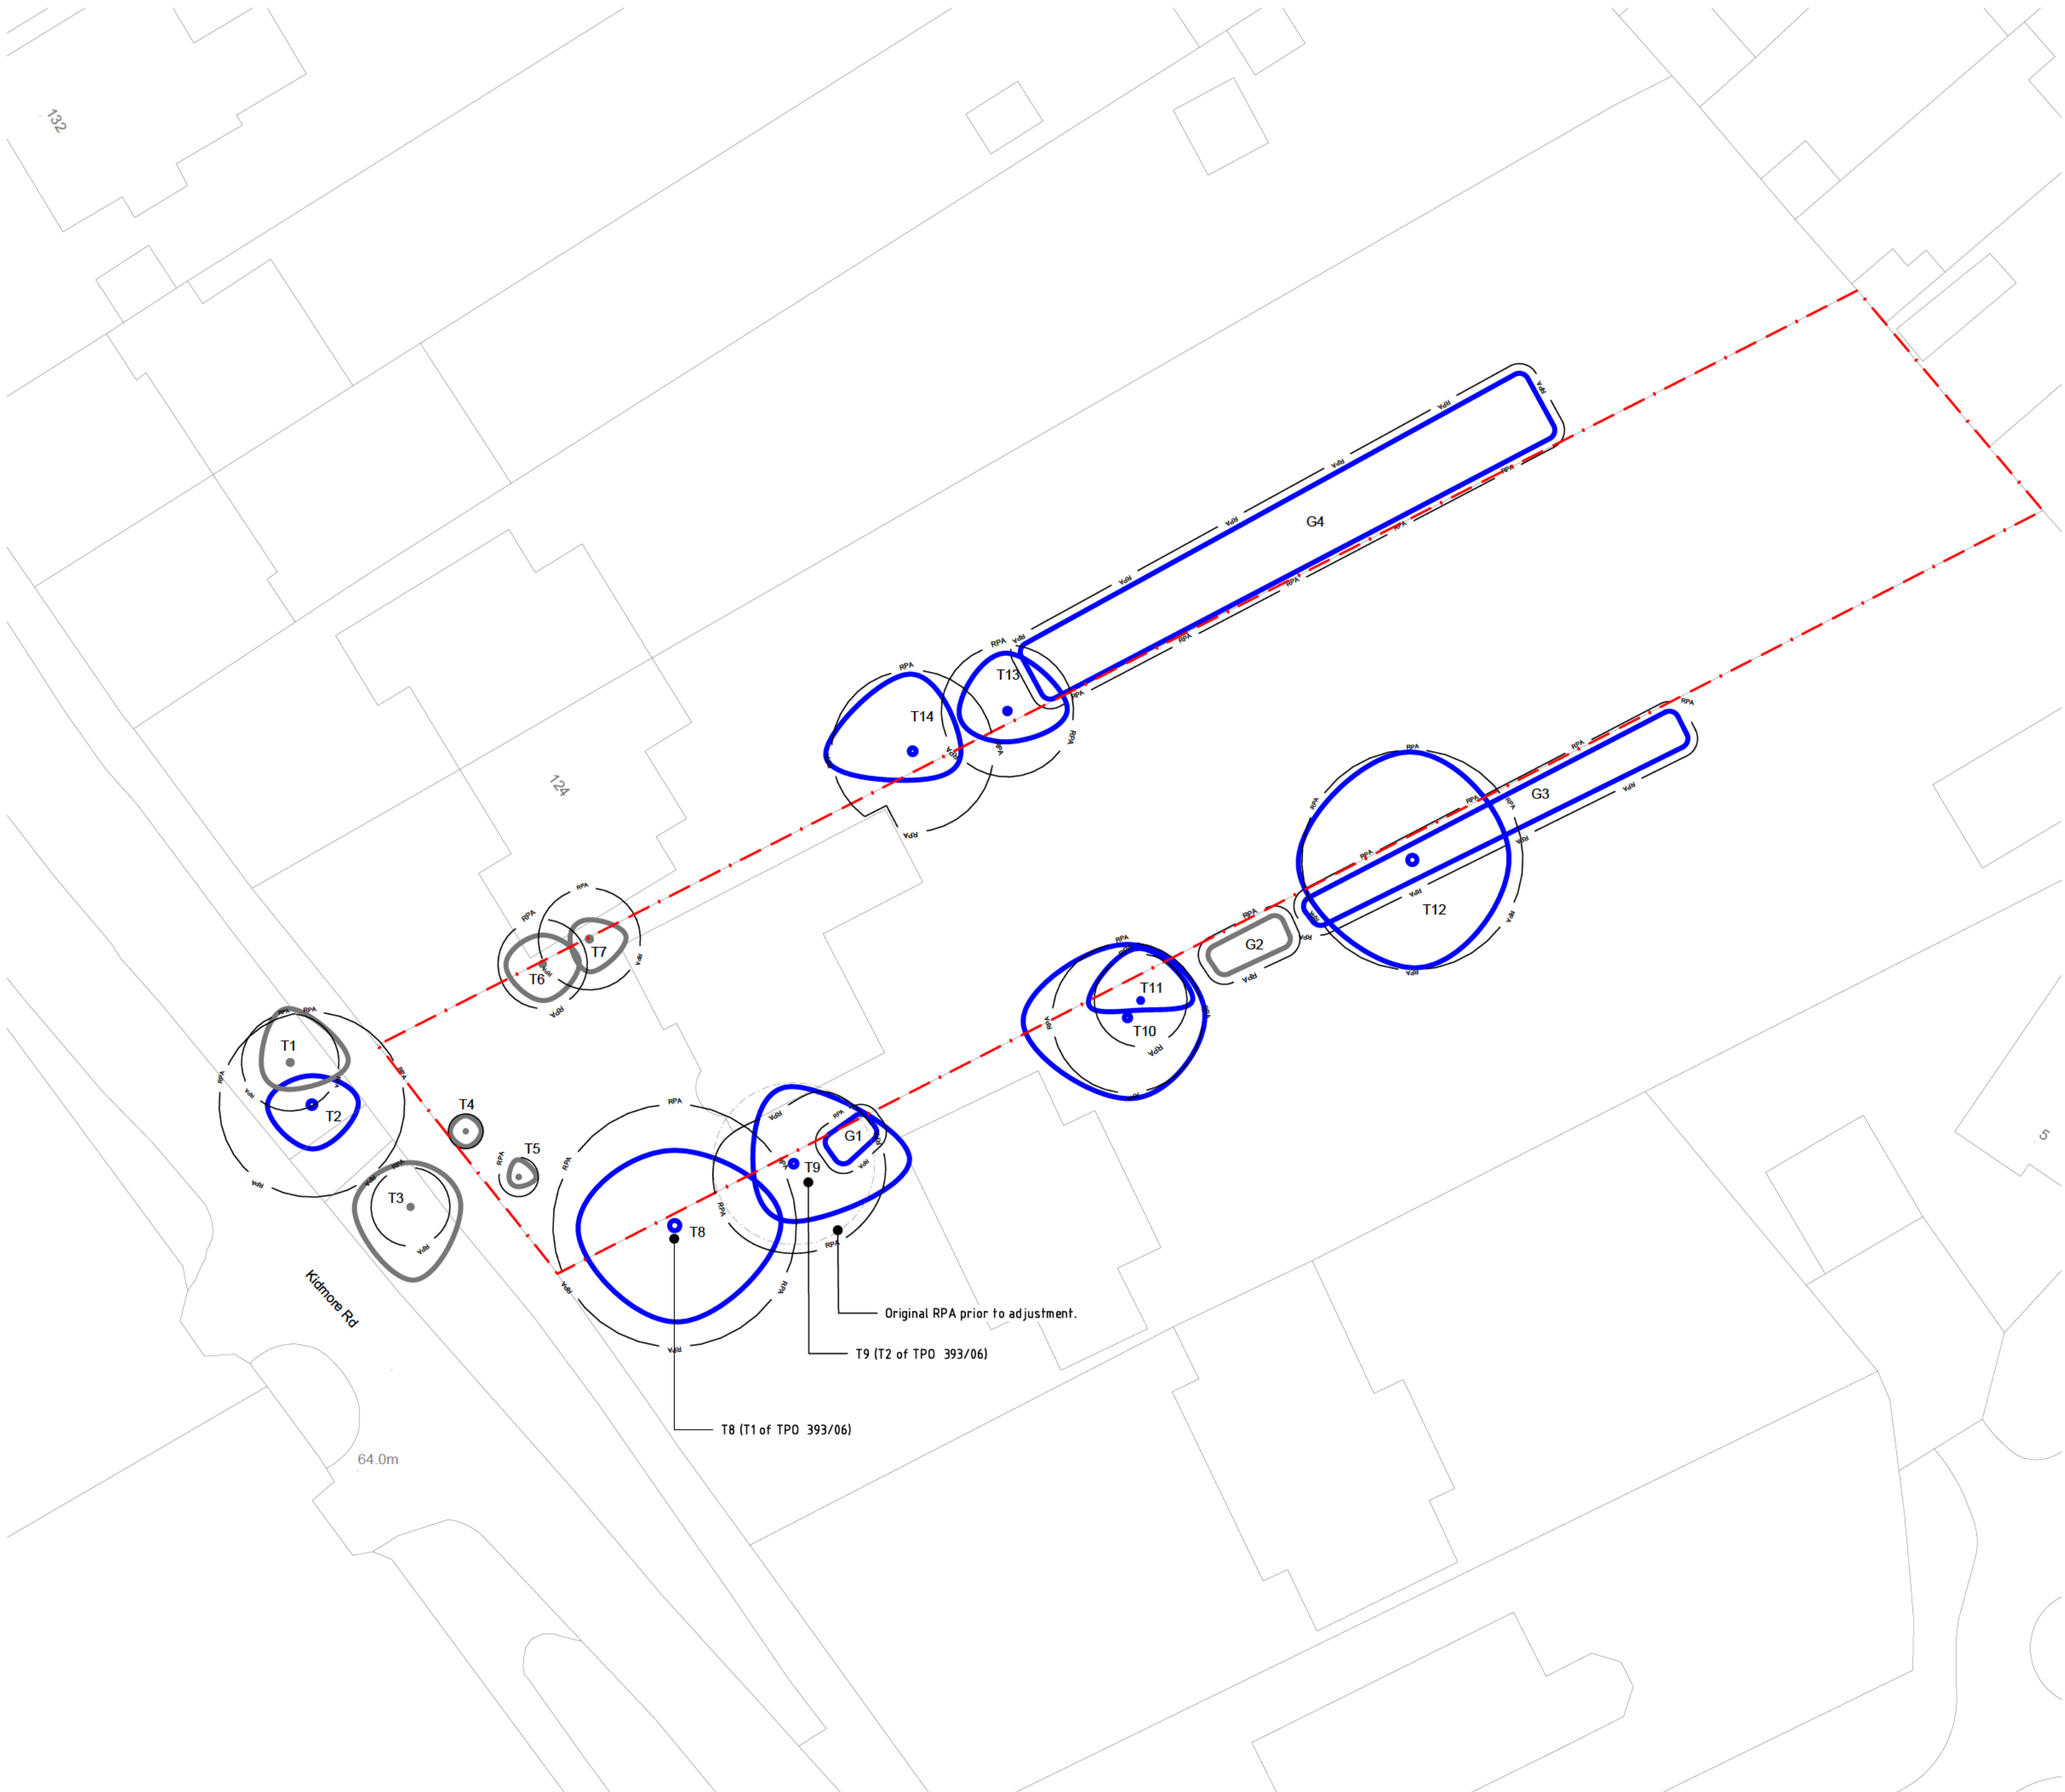
- Tree survey carried out on behalf of HAC Designs LTD for the proposed extension.
- Tree survey was carried out on 14<sup>th</sup> of March 2023 by Mr Morgan Davies Ground Control's Arboricultural Surveyor.
- Tree survey based on HAC DESIGNS LTD existing Location Plan 22048.S.PP-07.
- Tree survey has been carried out in accordance with BS:5837:2012 'Trees in relation to design, demolition and construction - Recommendations' part 4.4. Please refer to these sections for further details.
- Tree canopies outlines as shown on the plan are in accordance with the branch spread details within the tree schedule.
- The location of trees and tree groups are based on visual inspection & estimation of location only due to not being supplied with Topographical drawing.

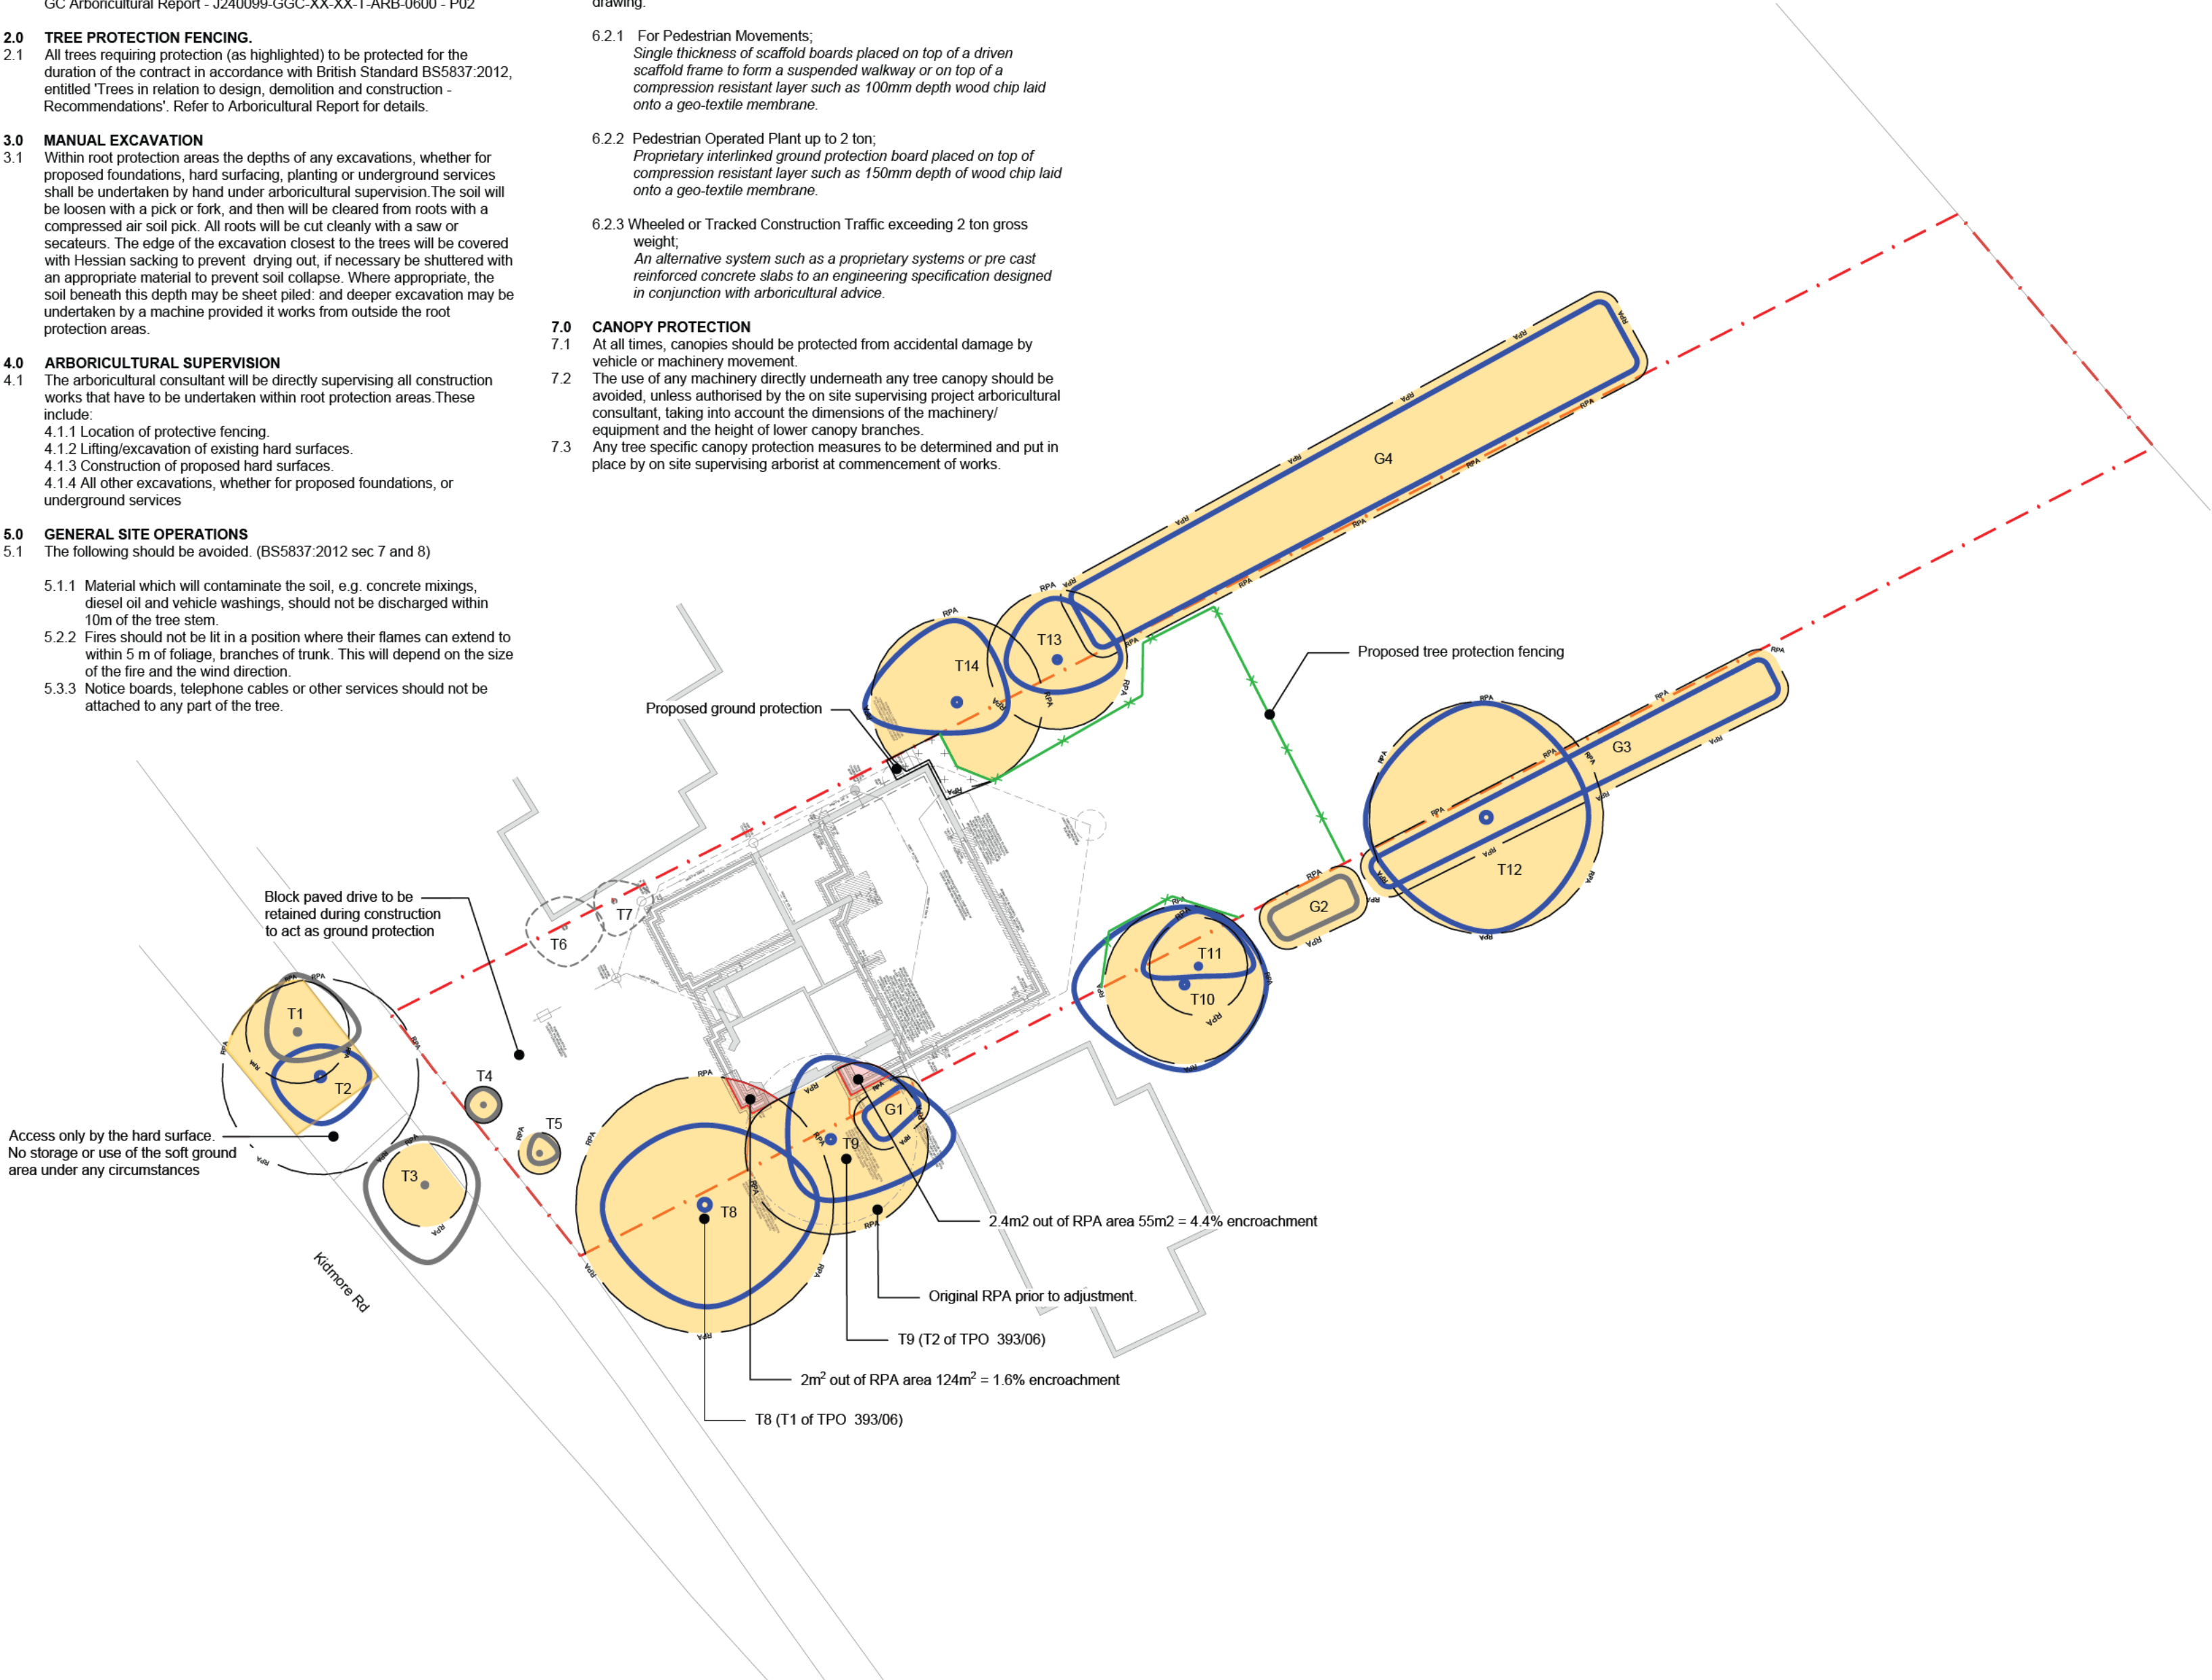
- 5.13 The RPA of T9 and T14 have been adjusted due to pre-existing site conditions. The presence of the previous building foundations would act as a barrier to root growth and deform the RPA with a likely bias of the remaining root distribution favouring the loose aggregate and soft landscaping within 120 Kidmore Road.

- 5.19 Tree protection will therefore consist of robust fencing secured to a solid framework as recommended within BS5837 2012.
- 5.20 When working within the RPA of trees (**as section 5.2 - 5.7**) sections of fencing or ground protection will need to occur and replaced or realigned when completed.

Any tree specific canopy protection measures to be determined and put in place by on site supervising arborist at commencement of works.

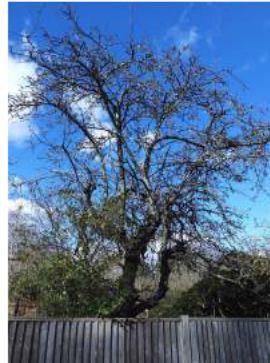
### Apple species Tree ID #14

5.5 In constructing the foundation close to T14, some minor root damage will likely occur. Once the old foundation is removed it is recommended that any exposed roots are pruned in-line with current best practice. The rooting area impacted is at the extremity of the RPA and will likely reveal thinner roots that would be suitable for pruning, which as a species, the apple would tolerate with little impact.

- 5.6 Additionally, amendments made will see a drainage pipe running through the RPA of this tree (T14) to the new soakaway. It is recommended that the area is “hand dug”, preferably air-spade (under arboricultural supervision). **Note: Do not mechanically excavate in the area.** Once rooting area is exposed roots will require protection from the elements e.g. wrapped in hessian and kept wet, when exposed for long periods. The 150mm diameter drainage pipe will need to be feed beneath the roots, where possible and roots (less than 25mm in diameter) to be pruned, in-line with current best practise. Any roots greater than 25mm in diameter that require pruning to be agreed by project Arboriculturalist.
- 5.7 All works undertaken within the RPA of T14 is to be undertaken under arboricultural supervision.
