# Your survey report

122 Kidmore Road, Caversham  
Heights, Reading, Berkshire RG4  
7NB

10th March 2022

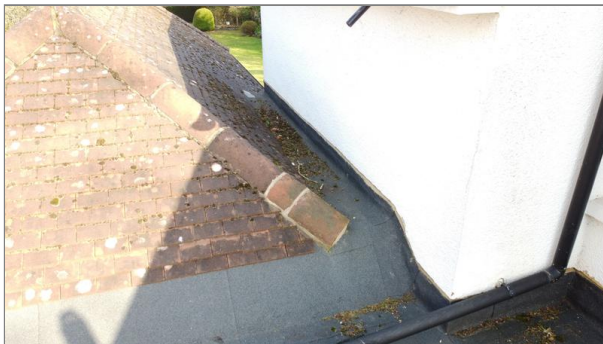
*Photo - 10 Cleaning required*

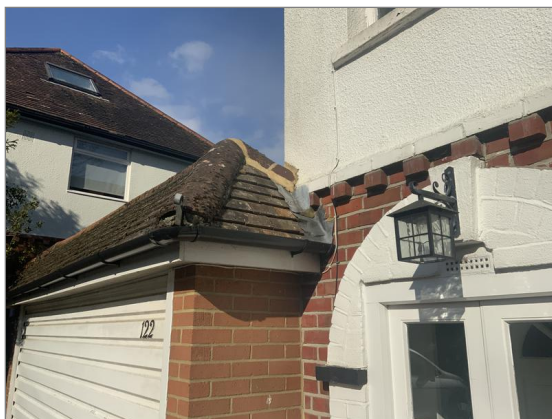
*Photo - 12 Recent repair*

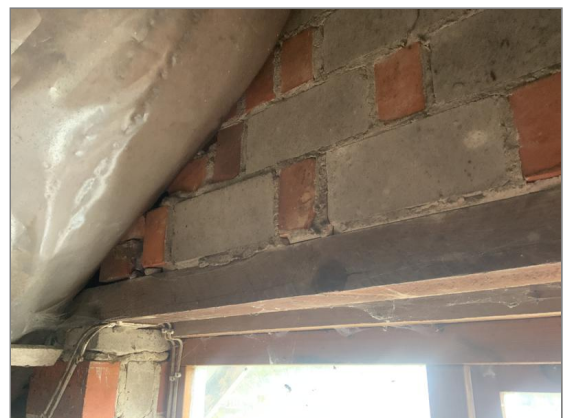
*Photo - 26 Example of support to internal wall*

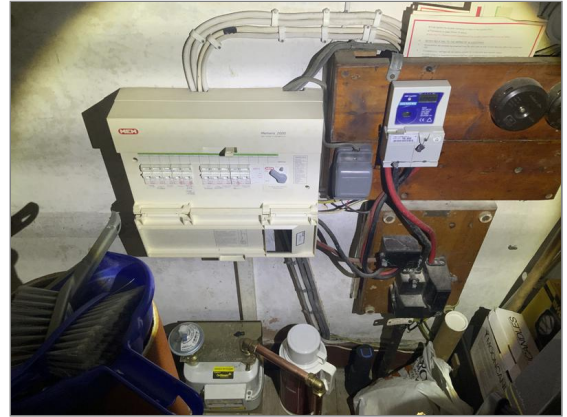
Photo - 67 Electrical fittings

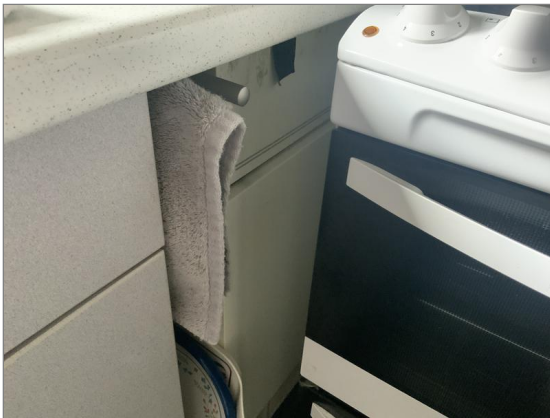
It was very difficult to inspect the boiler, as this is behind the cooker. This is a floor standing gas fired unit, which the vendor informed me they had serviced within the last year. You must obtain a copy of the certificate left by the Gas Safe registered engineer for further review.

*Photo - 70 Boiler serviced end of 2021*

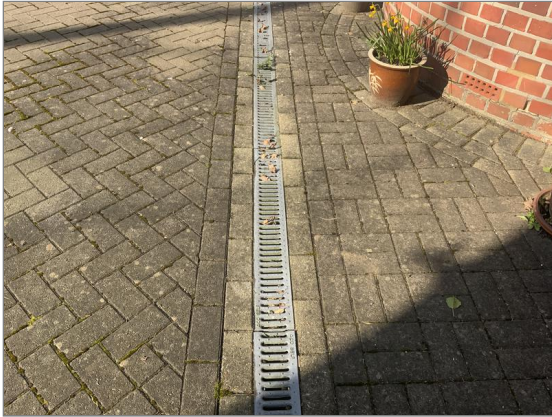
There is a sunken channel to the front drive, which plays an important role because the front drive slopes down towards the house. This collects surface water and sends it into the drains. This is a rainwater drain, as discussed earlier in the report, but they do require cleaning and it would appear that there are blockages within. This should be cleaned out thoroughly now.

*Photo - 71 Cleaning required*

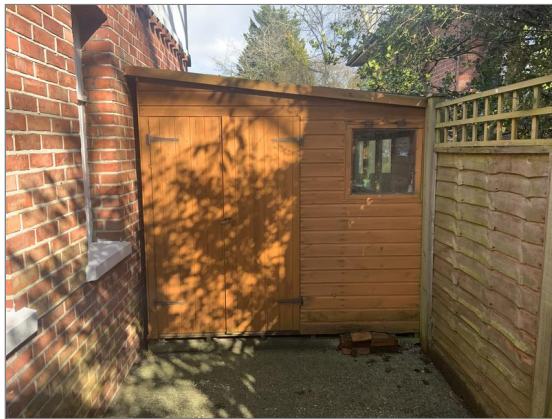
There are two sheds in the side passageway. These are in adequate condition, but will require re-roofing soon.

Photo - 77 Shed to side

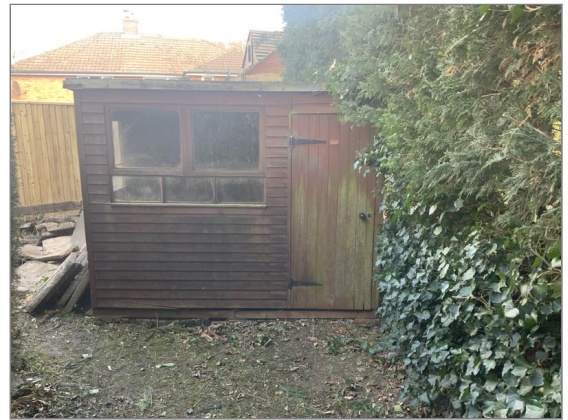
*Photo - 82 Rear shed*

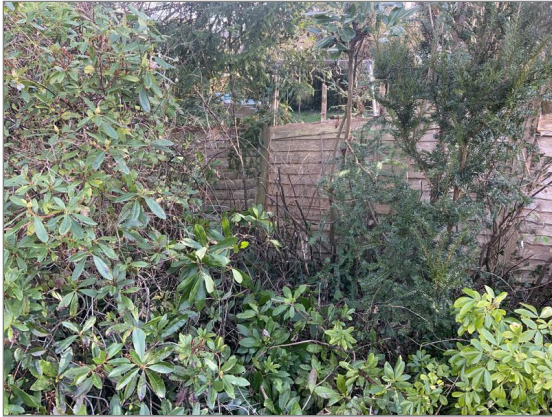
Boundary fencing requires replacement in many areas. Some of the fencing to the rear is propped up, or has fallen over entirely.

*Photo - 91 Fallen over*
