project  
**Reading Town Hall,  
Alterations & Improvements**

title  
**Photosheet Of Existing  
Roof RF17**

| job no.<br><b>997</b> | dwg no.<br><b>117</b> | status/revision<br><b>PL00</b> |

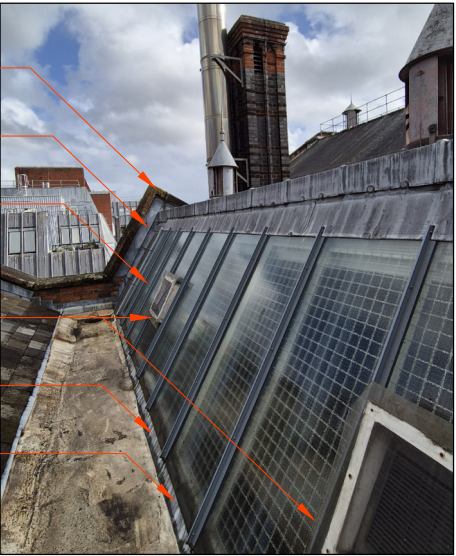
**01 SOUTH SLOPE RF17A AND EAST GABLE END**  
NTS - Date Taken: 09/10/24

- Discolouration/weathering to vents
- Cracked/damaged slates and isolated slipped/displaced slates previously refixed with tingles
- Damaged/defective bricks to chimney
- Dirt present on mortar flaunching to chimney
- Mortar flaunching to chimney has become loose and detached
- Stainless steel gas boiler flue partially obscuring existing windows on floors below
- Vegetation growth along external face of parapet wall
- Open/defective mortar joints to chimney

- Moss, lichen, and dirt present on surface of coping stones
- Loose and lifting lead flashings and upstands
- Single glazed Georgian wired glass patent glazing
- Existing vent function unknown
- Previous water ingress from vents in patent glazing
- Lead cover flashing cracked and fragments missing, staining and algae growth
- Minimal upstand and cover flashing between valley gutter and patent glazing
- Damaged/defective bricks to chimney

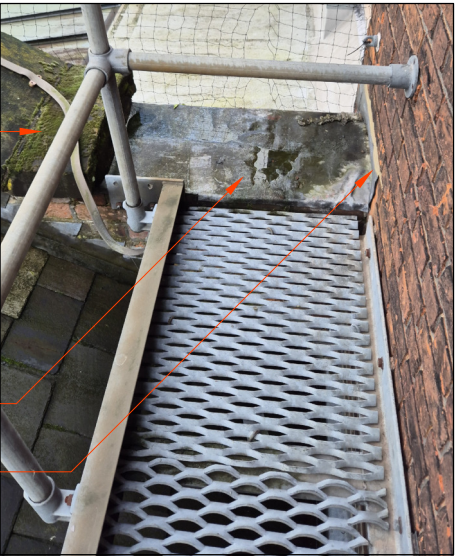
**04 SOUTH SLOPE RF17A AND WEST GABLE END**  
NTS - Date Taken: 09/10/24

- Moss, lichen, and dirt present on surface of coping stones
- Open / defective mortar joints between coping stones along coped gable
- Discolouration/weathering to vents
- Staining/discolouration to bricks
- Isolated defective/open mortar joints in brickwork and damaged/defective bricks
- Algae and lichen present on the bottom courses of slates
- Algae and lichen on coping stones on coped gable and parapet wall
- Efflorescence present on brickwork along coped gable
- Cracked / damaged slates across RF17A

- Vegetation growth along coped gable
- Algae and lichen on lead coping on parapet wall and coped gable
- Lead cover flashings damaged and lifting, gaps in flashings to coped gable
- Isolated slipped/displaced slates, previously refixed with tingles
- Defective lead coping surface to parapet wall showing signs of slumping, standing water has been trapped due to uneven surface in coping material
- Loose lead flashing due to previously failed and repaired mortar joint
- Dirt and staining present on surface of slates on RF17A

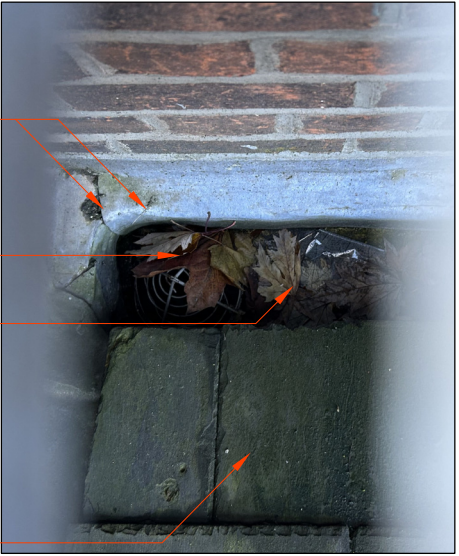
**08 OUTLET RF17-OUT.01**  
NTS - Date Taken: 25/11/24

- Algae along lead flashings to roof slope RF17A
- Signs of possible moisture ingress where lead cover flashings overlap/is damaged
- Lead cover flashings are displaced and lifting
- Guard for outlet RF17-OUT.01 surrounded and blocked by debris
- Debris present along valley gutter RF17-VGUT.01
- Algae and lichen present on the bottom courses of slates
- Possible slumping and splitting asphalt upstands along valley gutters to roof slope RF17A
- Algae and lichen present on the bottom courses of slates
