project  
**Reading Town Hall,  
Alterations & Improvements**

title  
**Photosheet Of Existing  
Roof RF23**

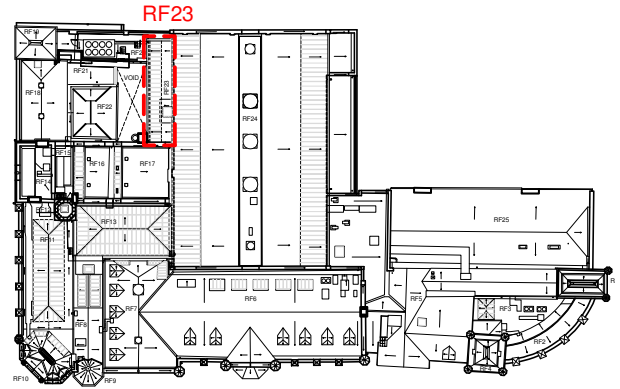
## 07 SMOKE VENT RF23-VENT.01

- Space between lean-to canopy and existing window for water to penetrate
- Lean-to canopy constructed over smoke vent to prevent water ingress
- Staining to sheet material, no permanent waterproof covering
- Strength of existing fall arrest system bolt eyes is unknown
- No sign of water ingress on the underside of the flat roof timber decking
- Split in timber wall plate that continues along the length of the timber
- Smoke vent unit is open and insufficiently waterproofed
