# ASBESTOS REFURBISHMENT SURVEY REPORT

J330513

FOR: Reading Borough Council (Corporate)  
AT: Reading Town Hall, Blagrove Street, Reading

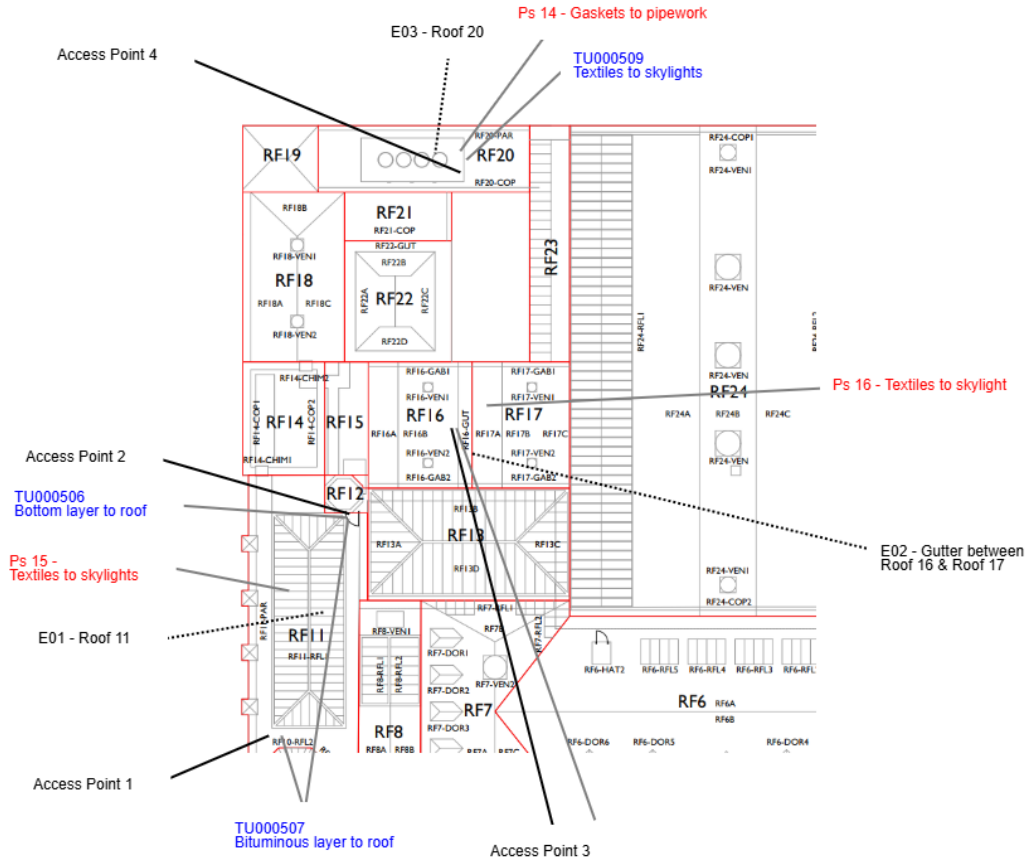
| Sample number | Location | Item | Product type | Extent of damage | Surface treatment | Asbestos type | Accessibility | Sample type | Material assessment score | Approx quantity | Action |
|---|---|---|---|---|---|---|---|---|---|---|---|
| Presumptive Sample 15 | Reading Town Hall E.01 - Roof 11 | Textiles to skylights | Asbestos Textiles/Paper | Good Condition | Unsealed AIB, textiles, encapsulated insulation. | Chrysotile | D | P | 5 | Unknown | Remove prior to demolition or refurbishment |

| Sample number | Location | Item | Product type | Extent of damage | Surface treatment | Asbestos type | Accessibility | Sample type | Material assessment score | Approx quantity | Action |
|---|---|---|---|---|---|---|---|---|---|---|---|
| Presumptive Sample 16 | Reading Town Hall E.02 - Gutter between Roof 16 & Roof 17 | Textiles to skylight | Asbestos Textiles/Paper | Good Condition | Unsealed AIB, textiles, encapsulated insulation. | Chrysotile | D | P | 5 | Unknown | Remove prior to demolition or refurbishment |
| Presumptive Sample 14 | Reading Town Hall E.03 - Roof 20 | Gaskets to pipework | Asbestos Textiles/Paper | Good Condition | Surface Sealed | Chrysotile | D | P | 4 | 2no. | Remove prior to demolition or refurbishment |
