**CAVERSHAM COURT GARDENS, GAZEBO**

**STRUCTURAL REPORT**

| SFK Document No: | | 25143/R02 | | |

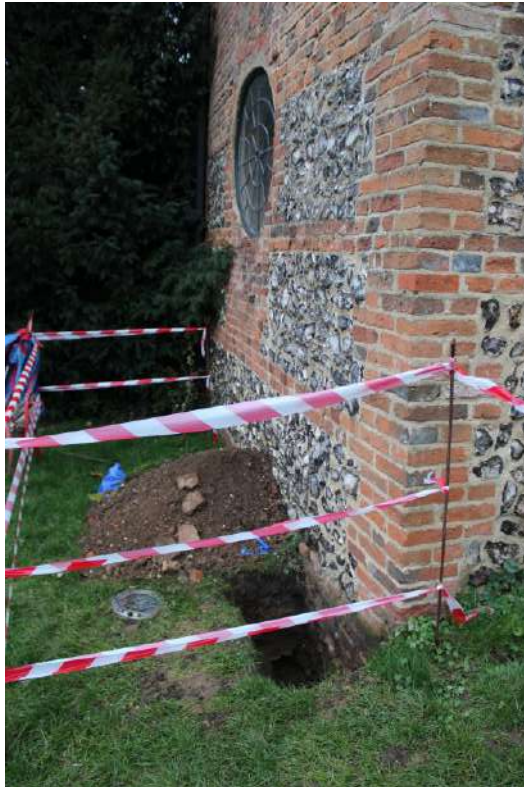
*Fig. 4.19 Trial pit position*

To investigate the wall foundation and ground conditions to the southeast corner, a trial pit was dug by Reading Borough Council, Fig. 4.19. This was in accordance with SFK sketch SK100 in Appendix A.

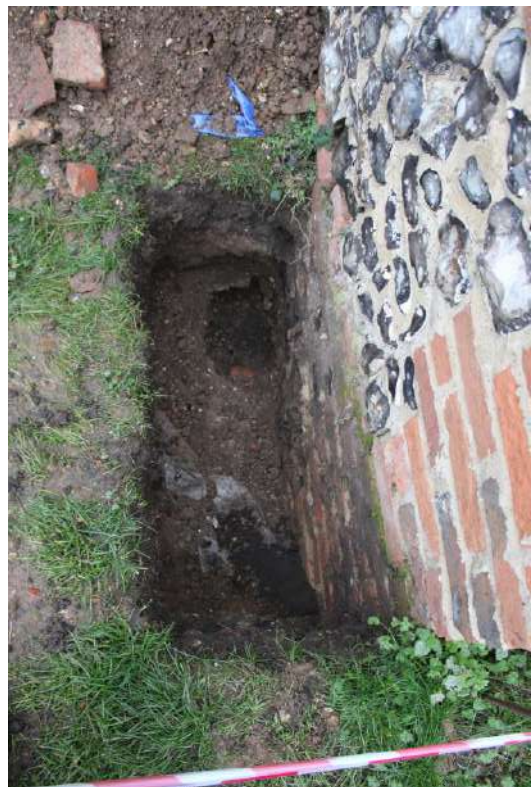
*Fig. 4.20 Trial pit plan view*

The findings are recorded below and on SFK sketch SK101 in Appendix A. The flint and brick wall continued below ground level at the same width and did not corbel out on the outside face, Fig. 4.20. The main pit was dug to a depth of 550mm below ground level and a smaller area at the west end was dug approximately 150-200mm deeper. By probing in the deeper hole, it was established that the bottom of the wall was founded approximately 800mm below the south elevation ground level. The cracking to the wall at the corner did not extend below ground level. The ground at the founding level was soft brown clay. See Fig.4.21.

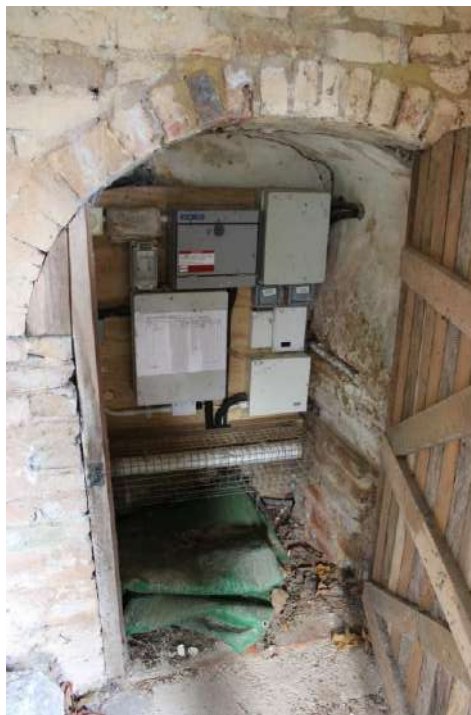
The north elevation is shown in Fig. 4.27. The brick wall has a small cupboard to the east side. This houses an electrical switchboard, Fig. 4.28.

*Fig. 4.28  
Ground floor –  
electrical switchboard  
cupboard*

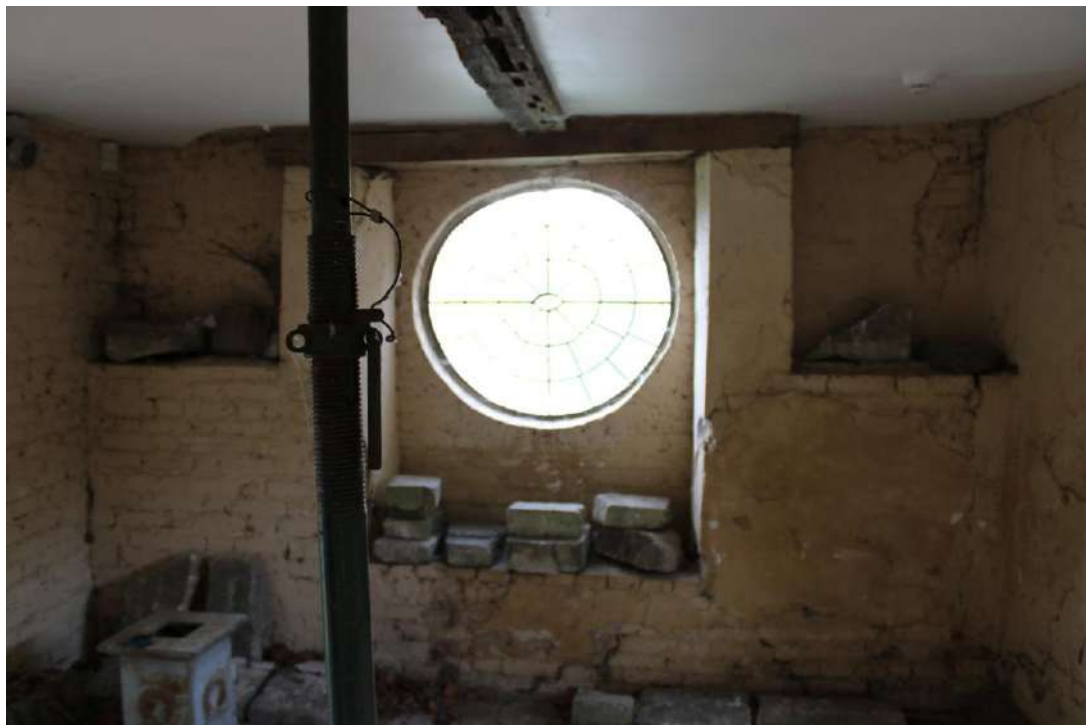
*Fig. 4.34 Ground floor – south elevation*

There is some diagonal cracking to the brickwork below the window seat, but this appears historic. The two timber lintels above the window are modern replacements and measured approximately 170mm wide x 120mm deep. The main beam appeared to bear onto both lintels. At the window (1300mm clear), the wall thickness was measured as  $220+360 = 580\text{mm}$  overall approximately. To the east end of the lintels a small area of plaster ceiling has failed, Fig. 4.35.

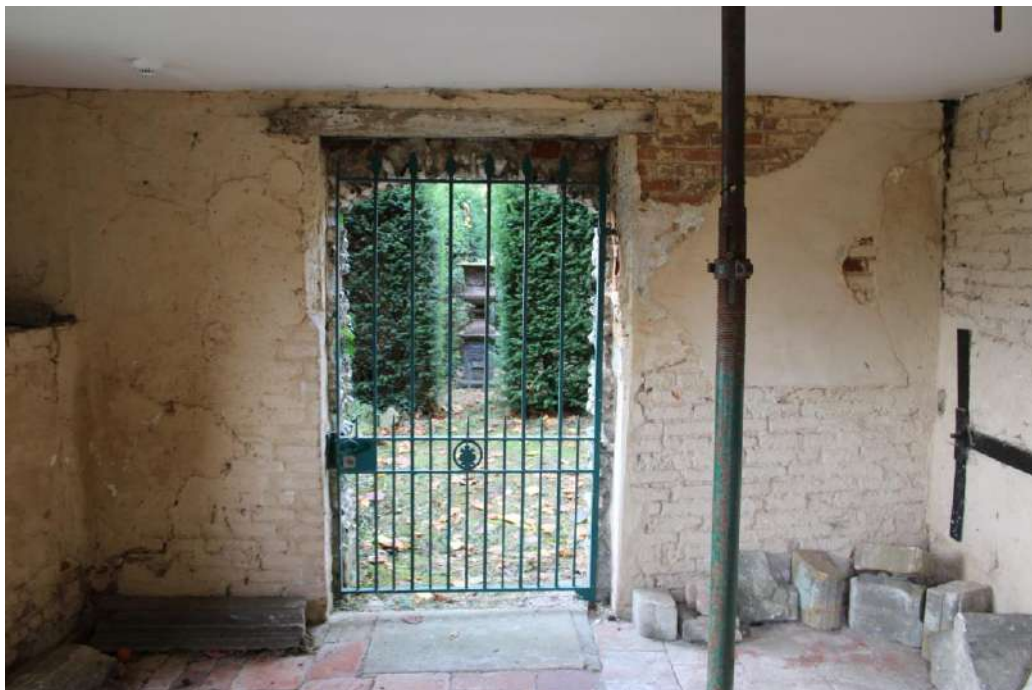
*Fig. 4.36 Ground floor – west elevation*

There is some diagonal cracking to the lower brickwork south of the gate, but this appears historic. At the gate, the wall comprises an outer leaf of 300mm flint and an inner leaf of 240mm brick work. At the north side there is some separation cracking between the materials, Fig.4.37. This measured 2mm wide at 1660mm height.

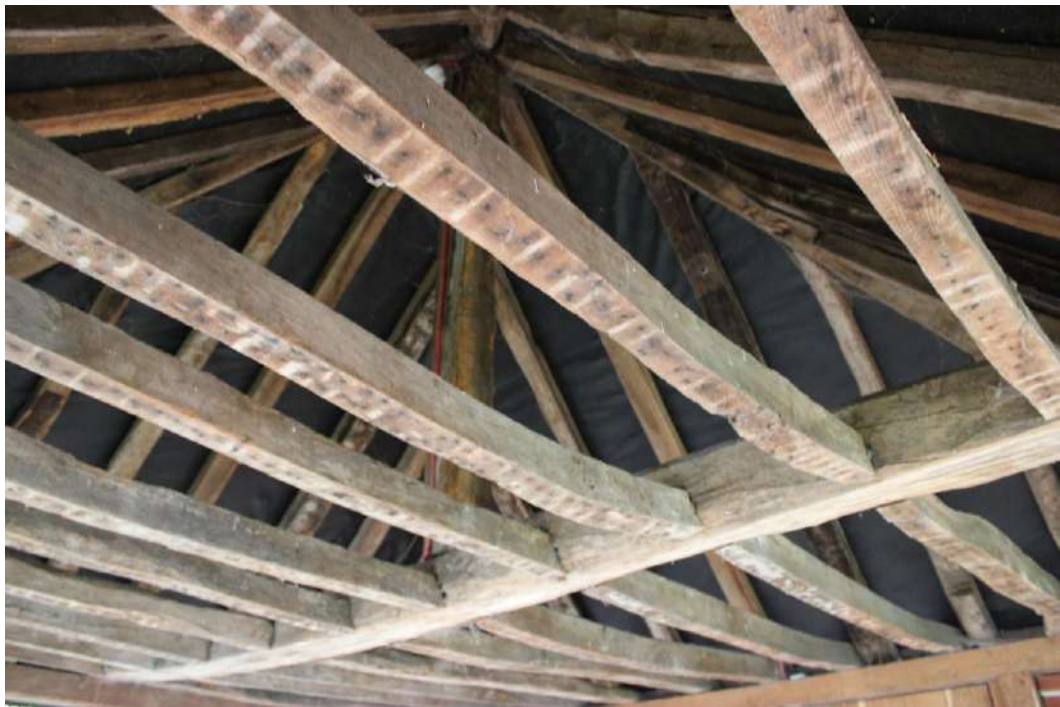
The roof over has a main beam running east-west and ceiling joists running north-south. The main beam supports a central post to the pyramid roof. Hip rafters span from the wall plates to the post and jack rafters span from the wall plates to the hip rafters. See Fig. 4.38. There is no ceiling, but the ceiling joists have nail marks indicating a previous lath and plaster ceiling. The roof has a modern sarking membrane and appeared dry at the time of inspection with no evidence of leaks. Some of the historic rafters appear to have had historic wood worm attack. Some rafters have been replaced.

*Fig. 4.38 General view of pyramid timber roof*

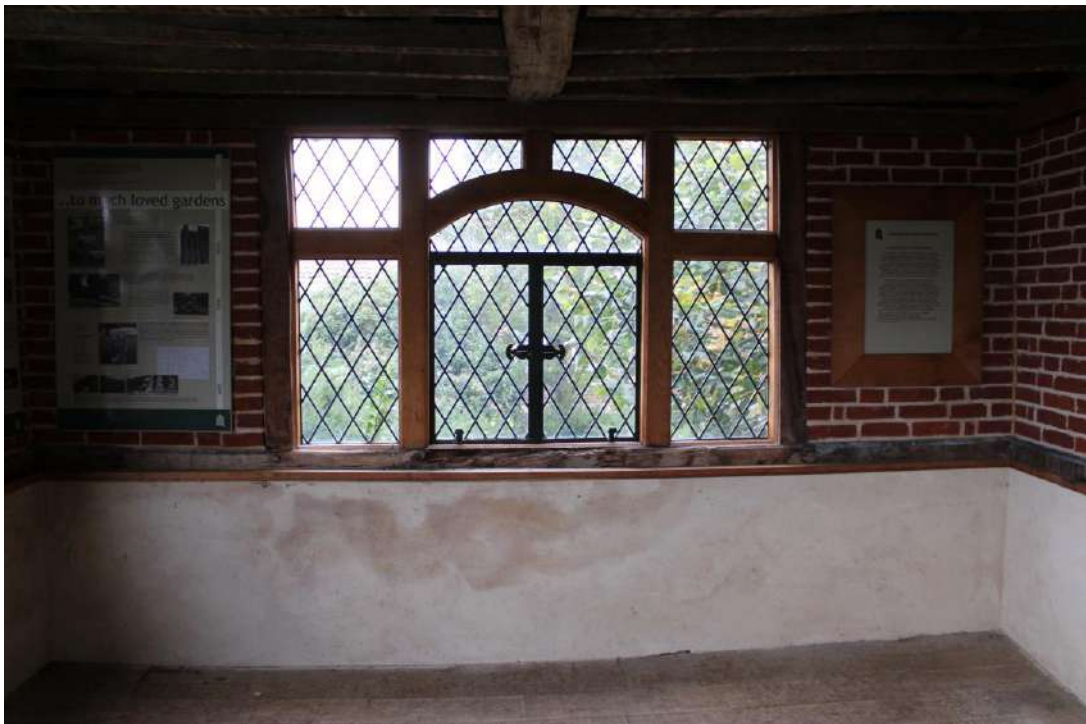
The west elevation is shown in Fig. 4.47. The main defect is extensive decay to the central part of the wall plate under the window, Fig. 4.48.

*Fig. 4.47 First floor – west elevation*

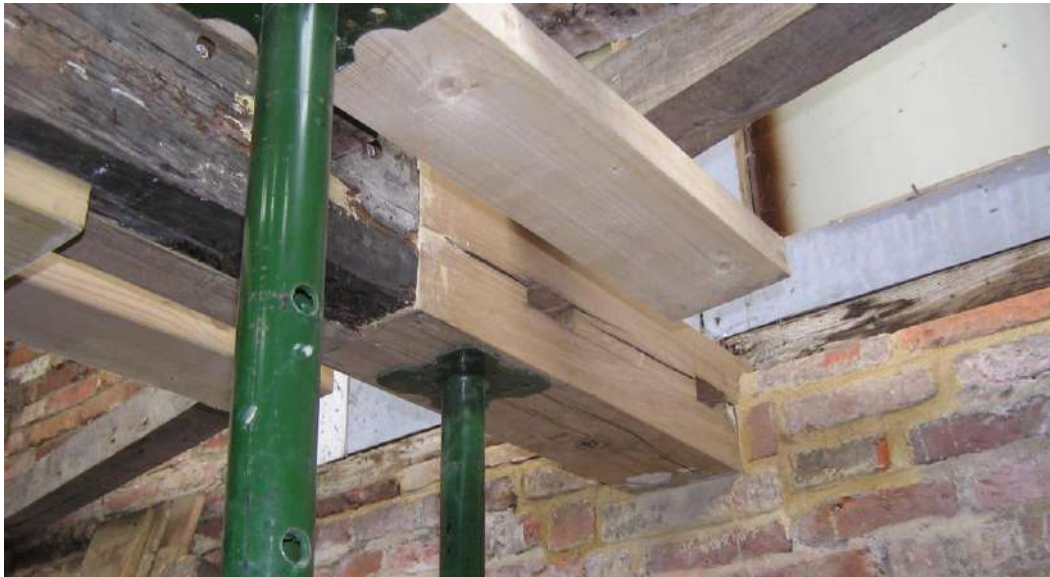
Drawing E1280-21 C1 Proposed repair to oak beam Gazebo, from 2008 shows a central steel flitch plate bolted through the main beam at the north end over a length of 850mm. However, photographs of the repair work, Fig. 5.1 and 5.2, do not show a flitch plate repair. Instead, the end of the timber beam has been replaced and jointed to the existing with a vertical half joint. The joint has two small bolts the top and is likely to have been glued with an epoxy adhesive.

*Fig. 5.1 First floor – repair work to north end of main beam in 2008*

Drawing E1280-21 C1 suggests that the main beam is 195mm deep by 180mm wide. Based on this, preliminary calculations using a nominal imposed load of 2.0 kN/m<sup>2</sup> indicates that the bending stress is at its limit, but that deflection would exceed suggested current design code limits by over a factor of 2. It was also noted that the beam has been reused and has significant mortice holes to the soffit along its length. Making an appropriate reduction for this to the beam width leads to a failure in bending stress and deflection exceeding limits by a factor of 3. It is not known why temporary propping has been introduced but based on the preliminary calculations, it is suspected the beam is likely to deflect excessively under imposed load which may cause alarm to users.

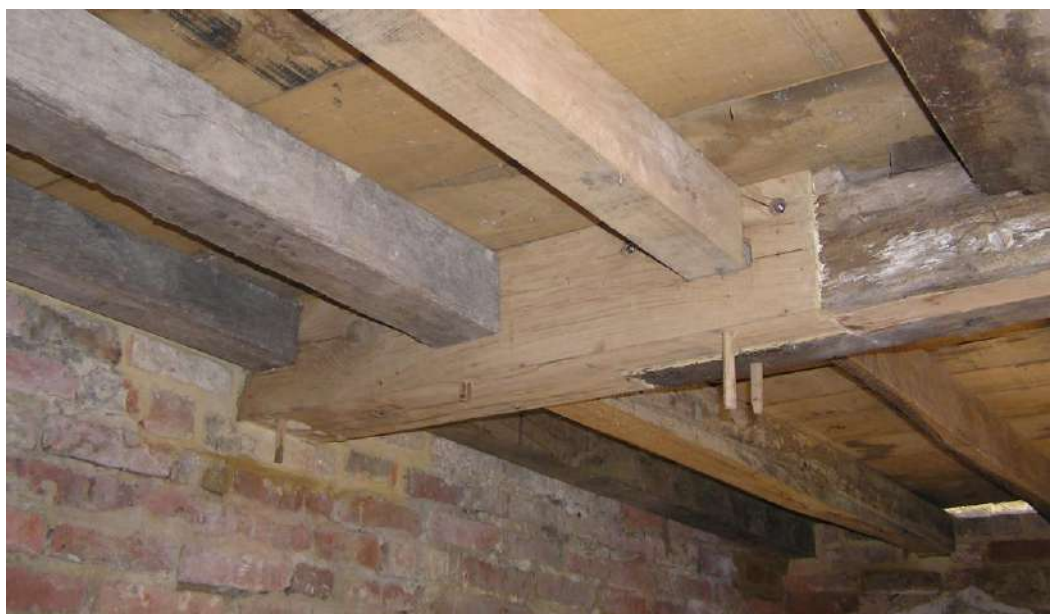
*Fig. 5.2 First floor – repair work to north end of main beam in 2008*

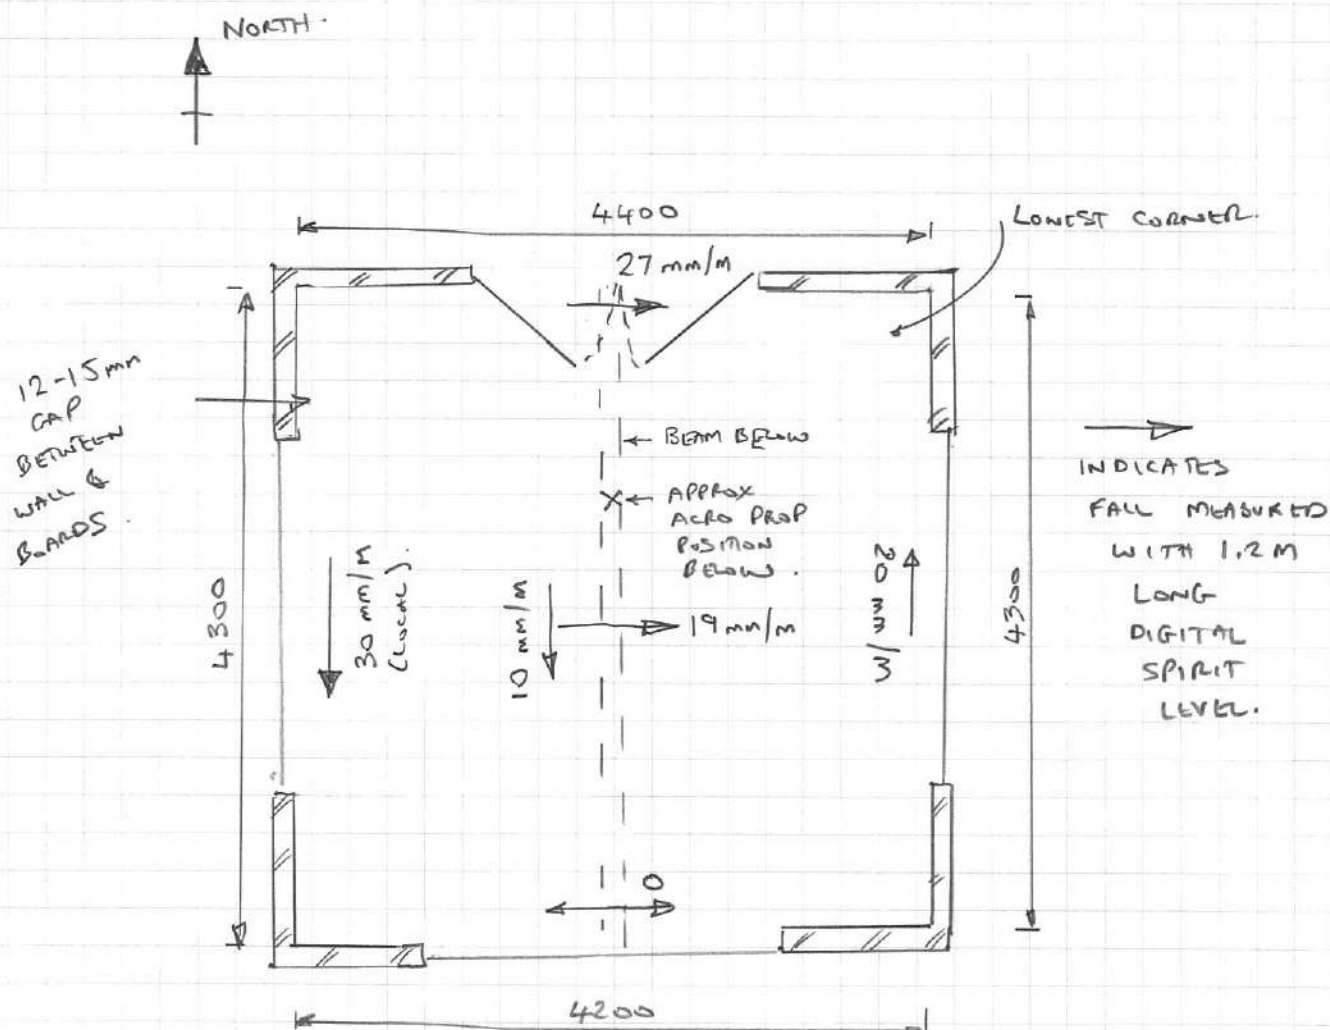
1st Floor PLAN (SHOWING MEASURED FALLS).

The first floor was noted to be uneven in level. There was a distinct fall to a lower level in the northeast corner, Fig. 4.49. The floor along the west elevation was also bowed, Fig. 4.46. To gauge and record the falls to the floor, measurements were taken with a 1.2m long digital spirit level, and these are recorded on sketch SK102 in Appendix A.
