## CAVERSHAM COURT GARDENS, CAUSEWAY

### STRUCTURAL REPORT

| SFK Document No: | | 25143/R03 | | |

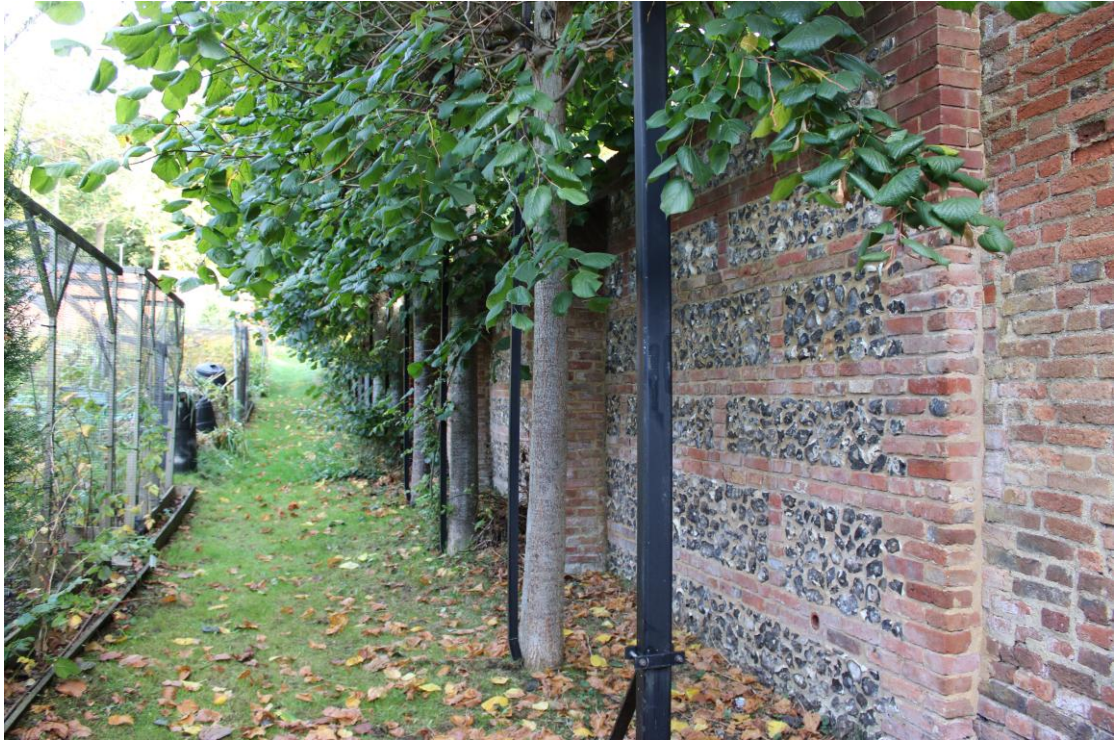
*Fig. 3.4 Causeway, west wall elevation looking north*

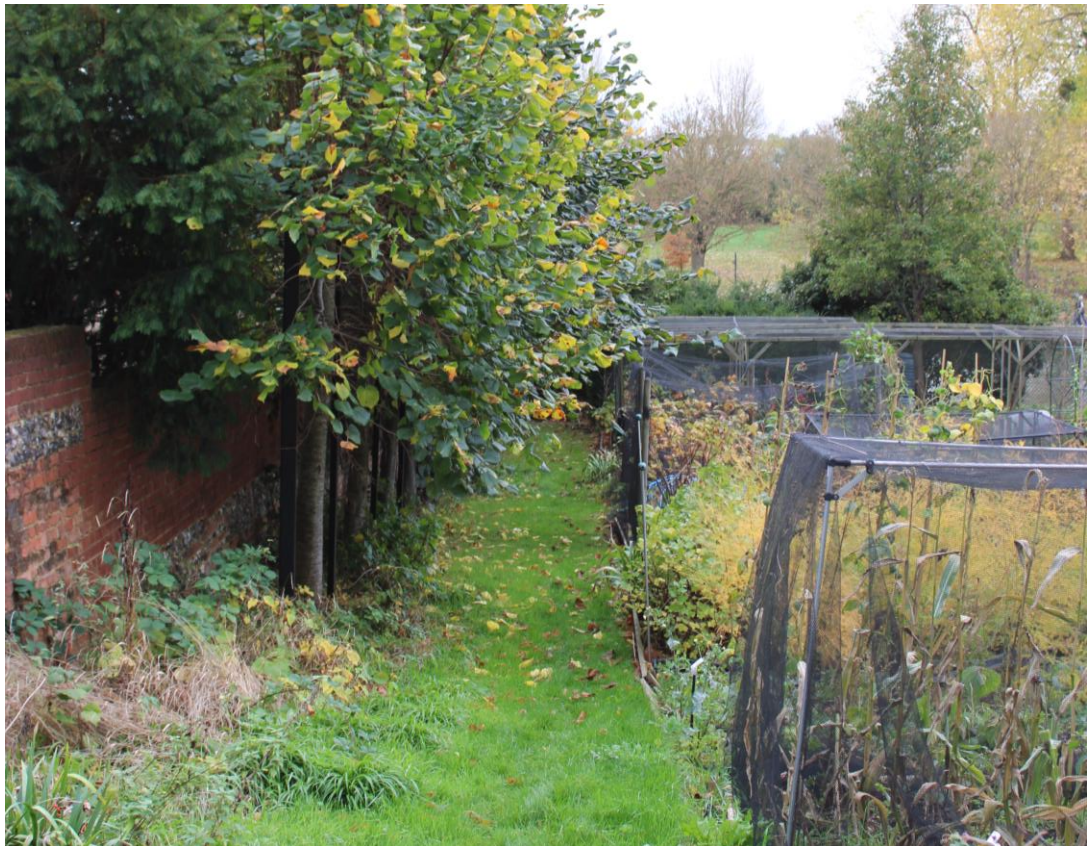
*Fig. 3.5 Causeway, west wall elevation looking south*

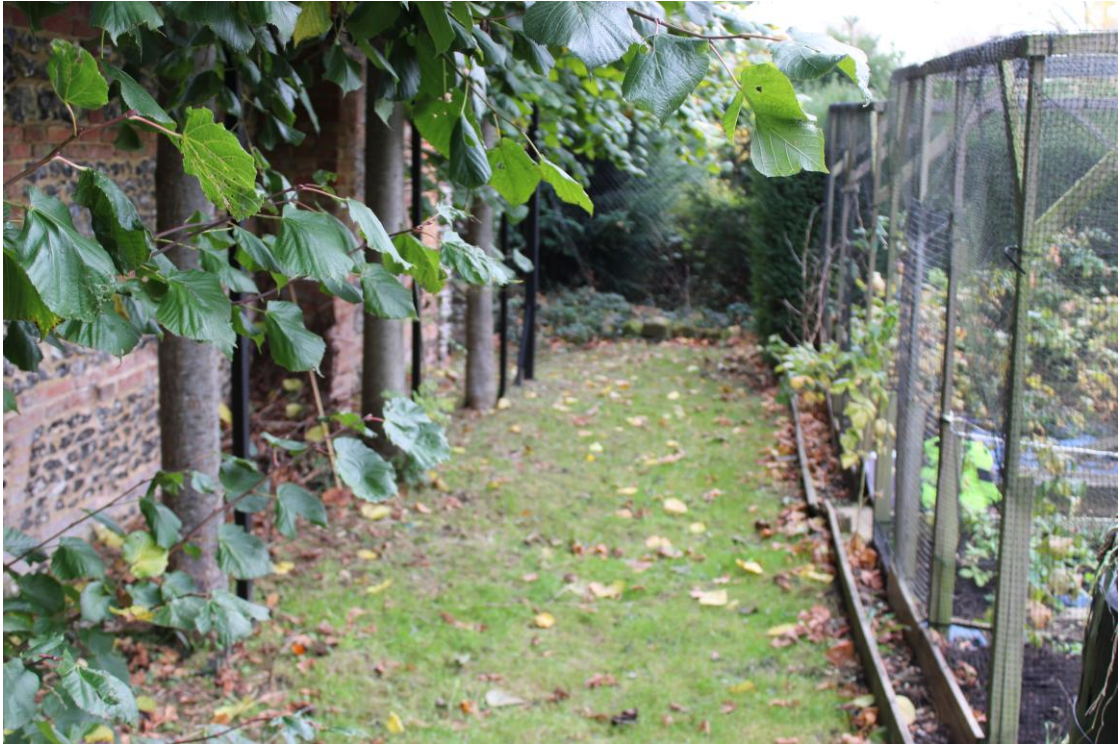
*Fig. 3.6 Causeway, west wall elevation looking south at south end*

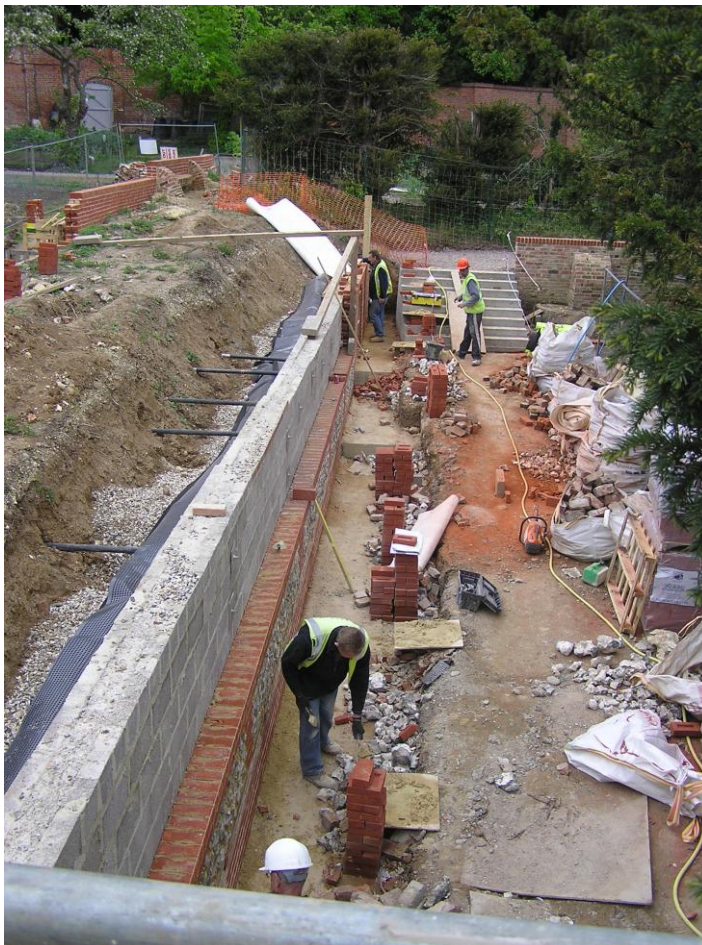
The east wall was largely rebuilt with a new stepped concrete foundation. The wall comprised a blockwork cavity wall infilled with concrete and assumed reinforced. This wall was faced with brickwork and flint, Fig. 3.8. The wall also had metal tie rods taken through to the west side of the wall.

*Fig. 3.8 Causeway, east wall during restoration works in 2008*

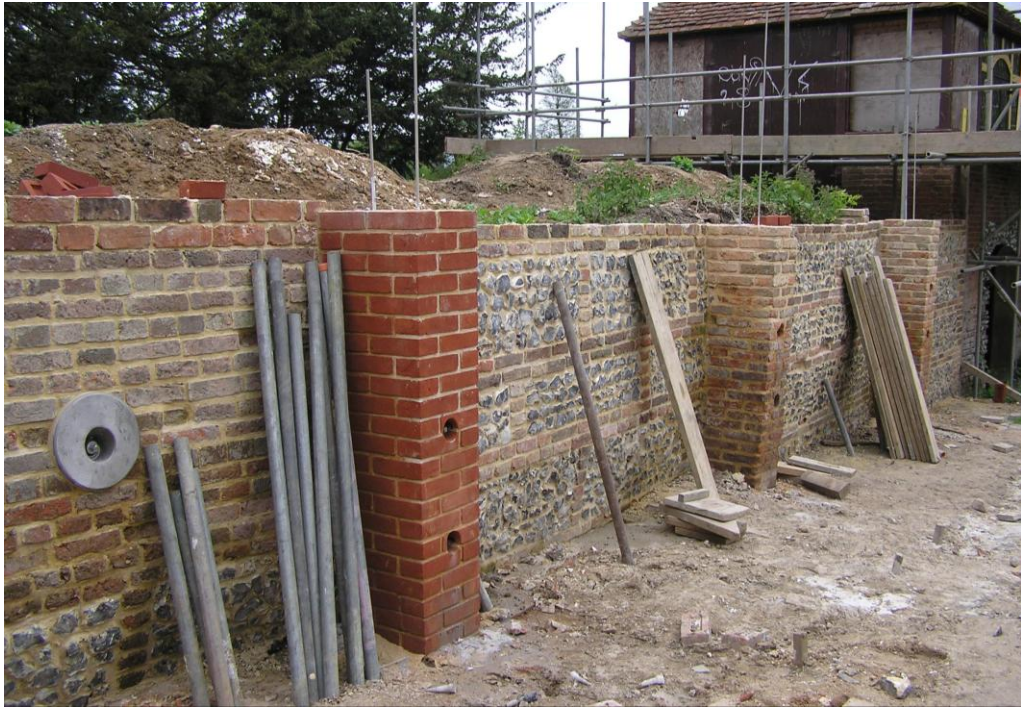
For the west wall much of the brick and flint wall was rebuilt matching the existing. At the southern end panels were repaired. This included repair and strengthening of brick piers, an additional pier, ties rods through to the east side and ground anchors, see Fig. 3.9. Drawings also indicate horizontal Helifix Helibars in the brick bands, but the photos available do not confirm if this was installed.

*Fig. 3.9 Causeway, west wall at south end during restoration work in 2008*

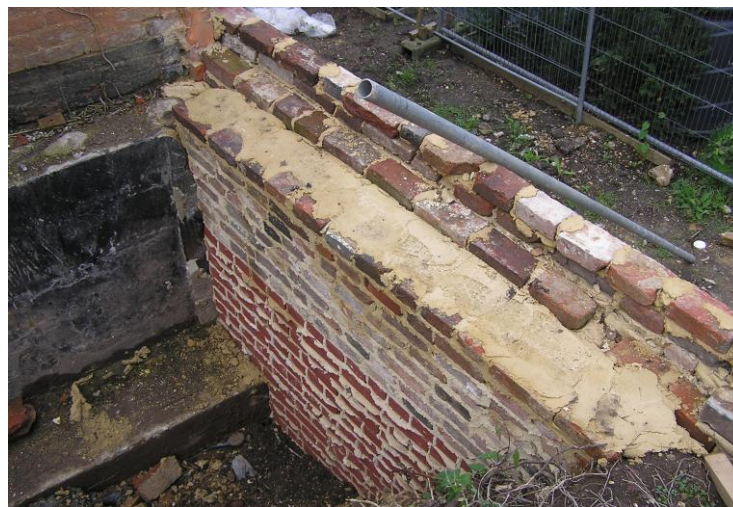
For the first bay, Bay 1, adjacent to the Gazebo on the west side the rear of the wall appears to have been largely rebuilt, Fig. 3.10.

*Fig. 3.10 Causeway, rear of west wall at south end, first bay adjacent to Gazebo during restoration work in 2008*

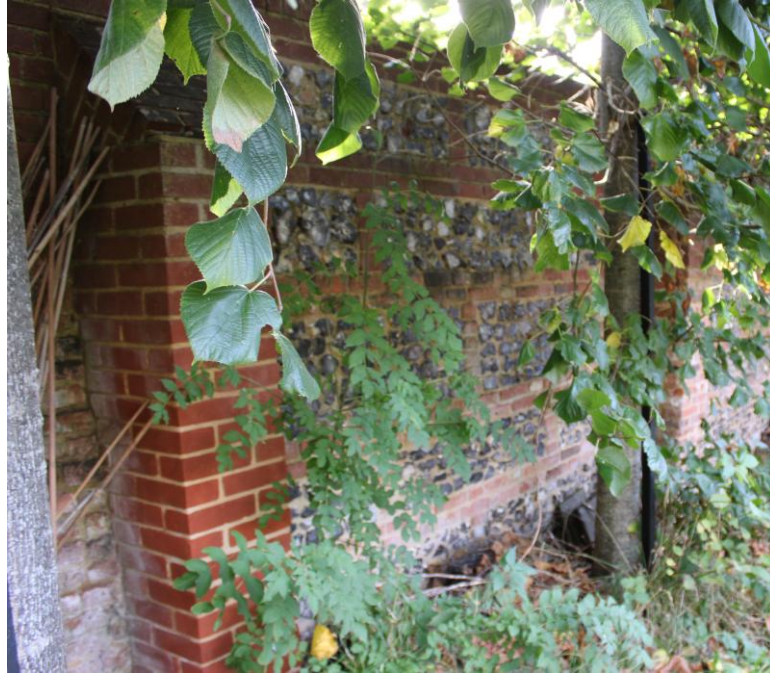
Bay 3 sits between two brick piers and comprises horizontal and vertical brick bands with flint infill panels, Fig. 4.7.

*Fig. 4.7 West wall Bay 3*

The panel has a small area of bulging in the bottom right-hand corner. There is no cracking to the mortar and no loose material. The projection of the bulge is approximately 50mm, Fig. 4.8. Other than this defect the panel is in generally good condition.

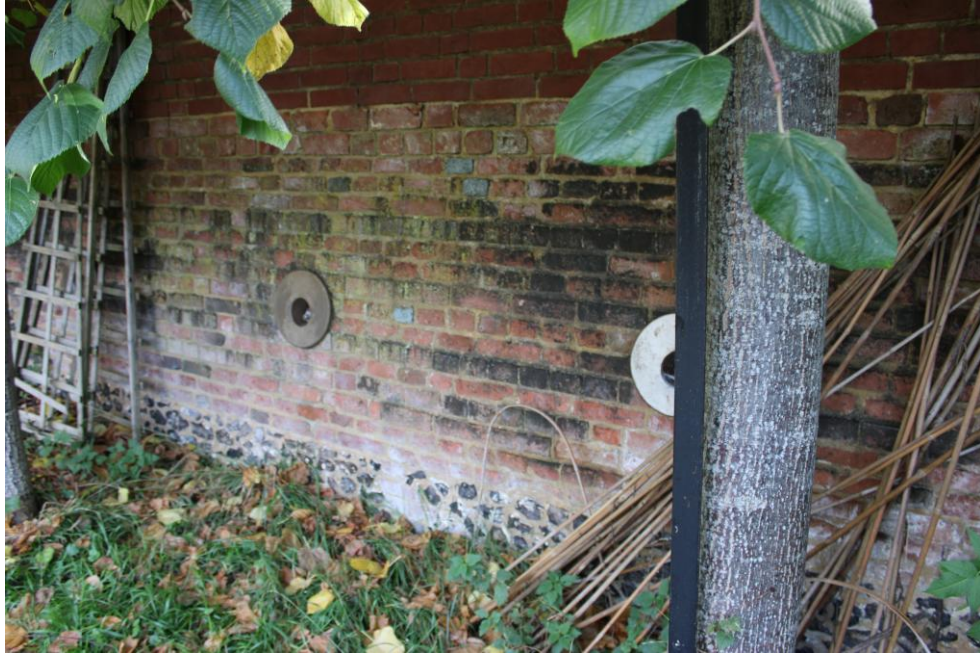
The wall north of Bay 3 was generally in good condition. Just north of pier 3 to Bay 3 is a series of four ground anchors through the wall which is mainly brick with flint banding at the bottom, Fig. 4.9. Adjacent to the first anchor there was a very small area of local bulge projecting approximately 50mm, Fig. 4.10.

*Fig. 4.9 West wall just north of Bay 3*
