## Heritage Statement for 8&10 Church St roof essential repairs

8&10 Church St are two Grade II listed interjoined properties under one single ownership title.

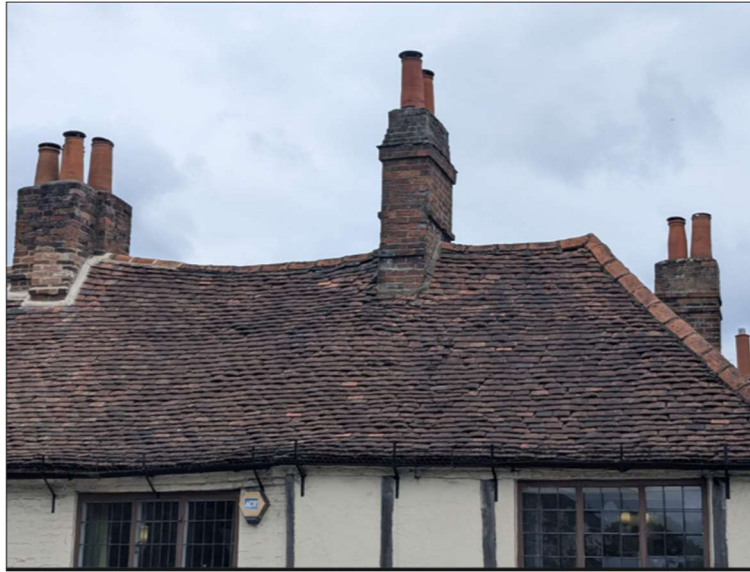
The following photographs were taken during a site visit on Tuesday 5<sup>th</sup> May 2026. This first photograph shows the front elevation of 8&10 Church Street from Church street.
