## ARBORICULTURAL REPORT

TREE CONDITION SURVEY

ENGLISH MARTYRS CATHOLIC CHURCH  
64 LIEBENROOD ROAD  
READING  
BERKSHIRE  
RG30 2EB

Ref: 07023 / 2026

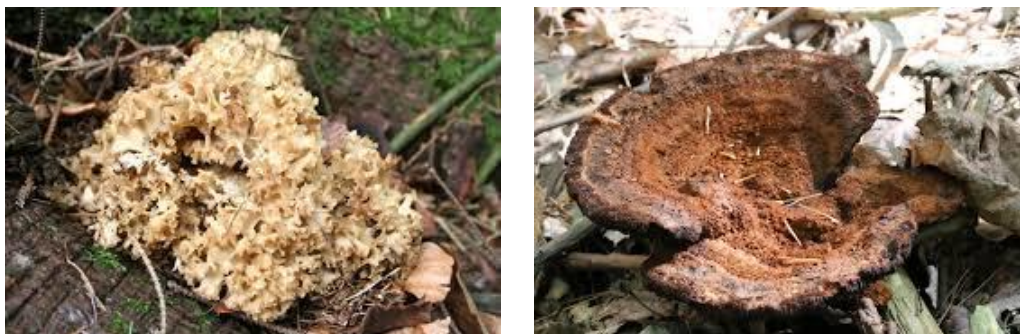
The two most common seasonal decay fungi on Douglas Fir are *Phaeolus schweinitzii* and *Sparassis crispa*. Church members are advised to monitor the ground at the base of T1 (Douglas Fir) throughout the year. Any unusual fungal growths should be photographed and forwarded to a professional arborist for identification. The fungus growth should be left in situ to mature (for identification purposes).

Figure 1. Sample photos of fungal fruiting bodies of *Sparassis crispa* (left) and *Phaeolus schweinitzii* (right)
