# External Wall Investigation

## Addendum Photographic Report

### 19-21 Castle Street

### Reading

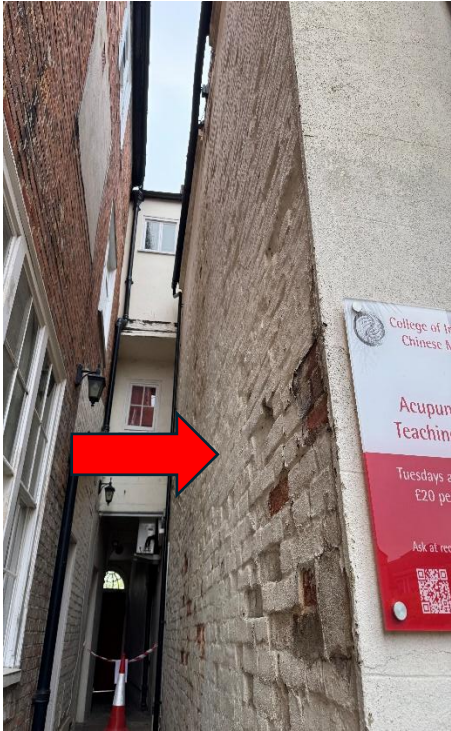
| <p>1. North Elevation looking up from alley way.</p> | <p>2. West Elevation looking up from alley way.</p> |

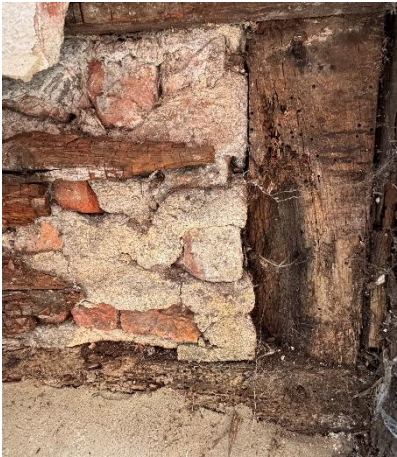
| Element | Material(s) | Comment |
|---|---|---|
| Timber backing board / battens | Timber | Evidence of rot to timber in situ.<br>Extent of rot to timber unknown. |
| Other comments | | Rot to timber at vertical and horizontal joints.<br><br>Previous concrete repair undertaken adjacent to horizontal timber joint. |

| W02-03 | Close up view of opening formed by removing clay tiles | W02-04 | Close up view behind clay tiles. |

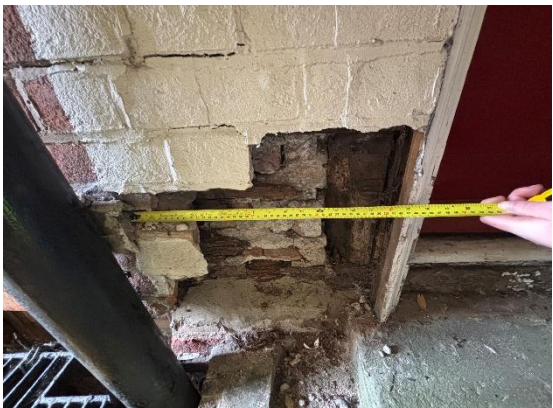
| W02-05 | View within structure, no timber batten evident. | W02-06 | Check measurement of |

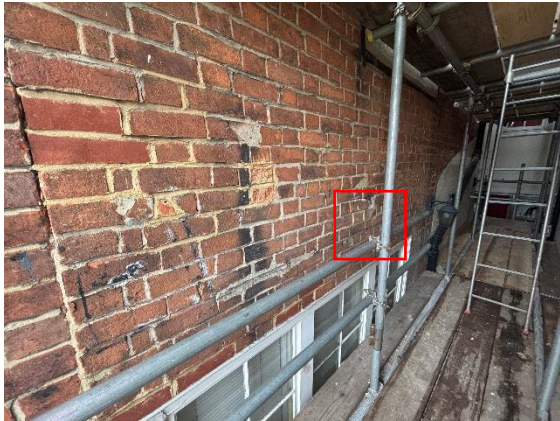
| W03-01 | Survey location on elevation photo | W03-02 | Close up view of existing opening. |

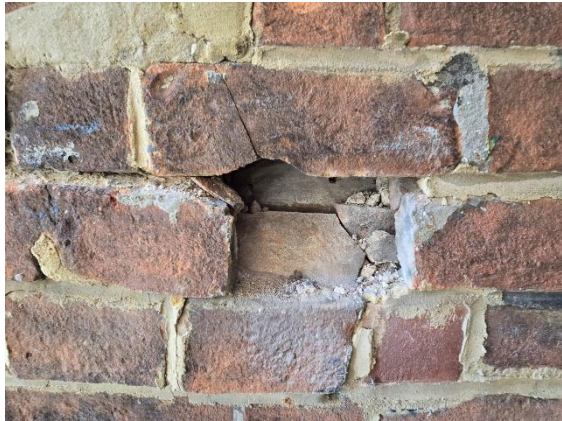
| Element | Material(s) | Comment |
|---|---|---|
| Outer Leaf finish | Clay tile | Tile came off easily during investigation works |
| Nails | Assumed iron. | Evidence of corrosion to nails |

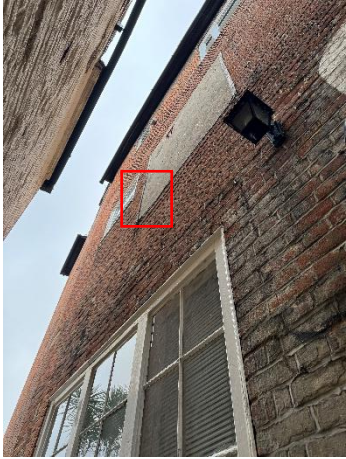
| <p>W04-01</p> <p>Survey location on elevation photo</p> | <p>W04-02</p> <p>Close up view of location.</p> |

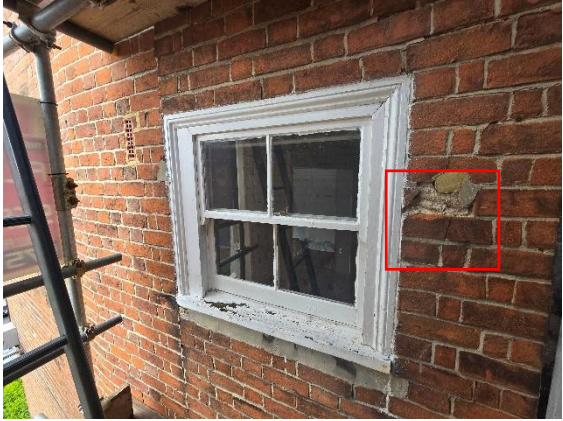
| Element | Material(s) | Comment |
|---|---|---|
| Timber backing board / battens | Timber | Area of timber backing board previously removed (assume from a boiler flu).<br><br>Timber board appeared dry at time of inspection. |

| Element | Material(s) | Comment |
|---|---|---|
| Other comments | | Remove insulation to cavity / backing board. |

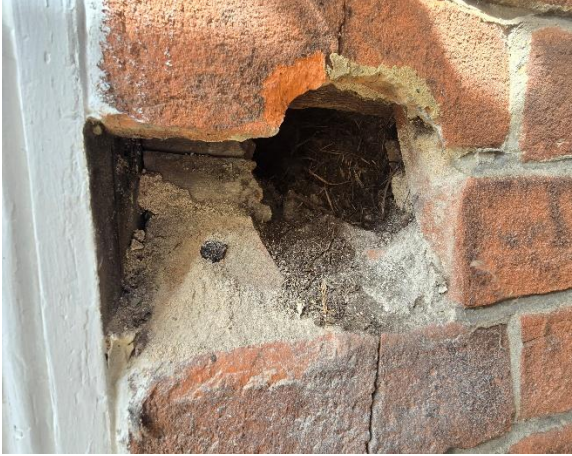
| <p>W04-03</p> <p>Close up view of opening formed by removing concrete mortar.</p> | <p>W04-04</p> <p>Close up view behind concrete mortar.</p> |

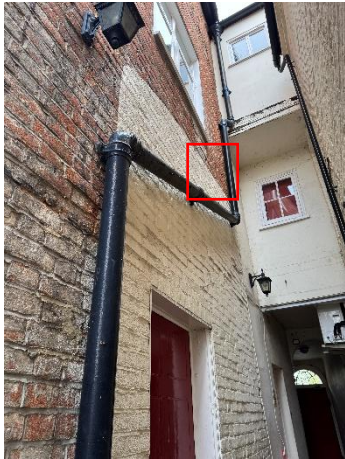
| Element | Material(s) | Comment |
|---|---|---|
| Other comments | | Mortar joints to the newer addition clay tile are showing early signs of cracking and deterioration. |

| W05-01 | Survey location on elevation photo | W05-02 | Close up view of location. |

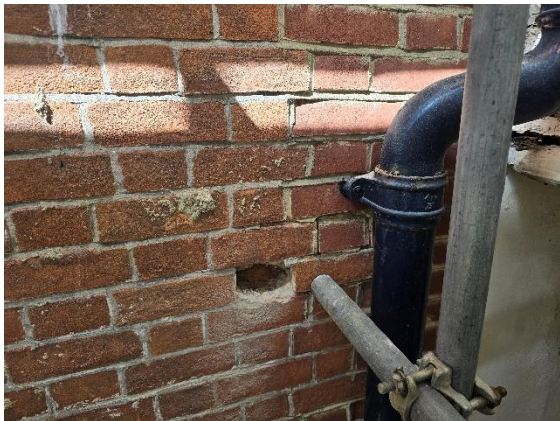
| Element | Material(s) | Comment |
|---|---|---|
| Outer Leaf finish | Clay tile | Tile came off easily during investigation works |

| W05-03 | Close up view of opening formed by removing clay tile. | W05-04 | Close up view behind clay tile. |

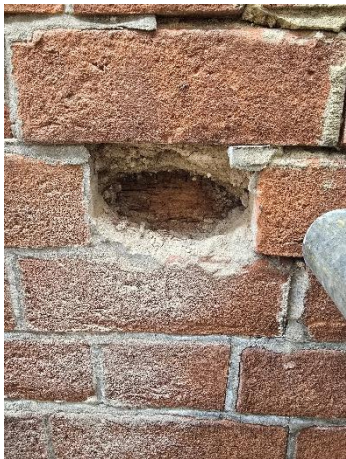
| Element | Material(s) | Comment |
|---|---|---|
| Timber backing board / battens | Timber | Backing board appeared dry at time of inspection, evidence of rot to timber. |

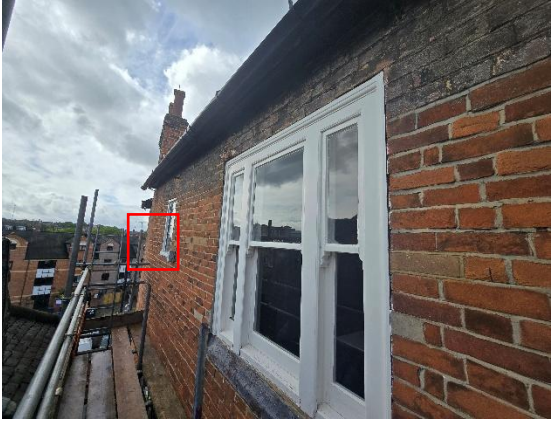
| Element | Material(s) | Comment |
|---|---|---|
| Other comments | | Mortar joints surrounding clay tile showing signs of cracking. |

| W06-01 | Survey location on elevation photo | W06-02 | Close up view of location. |

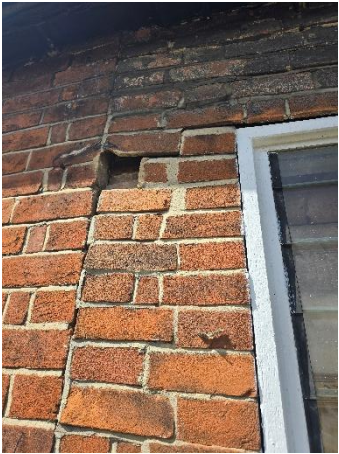
| Element | Material(s) | Comment |
|---|---|---|
| Outer Leaf finish | Clay tile | Tile came off easily during investigation works |

| W06-03 | Close up view of opening formed by removing clay tile. | W06-04 | Close up view behind clay tile. |

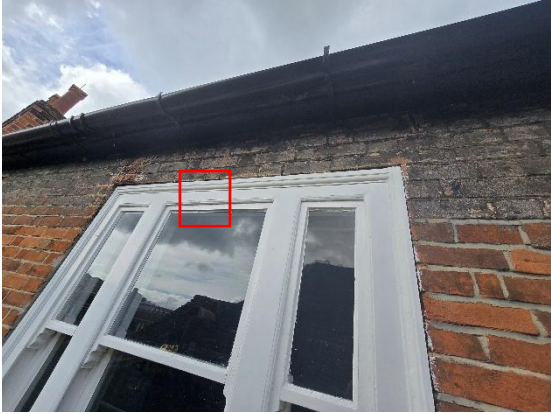
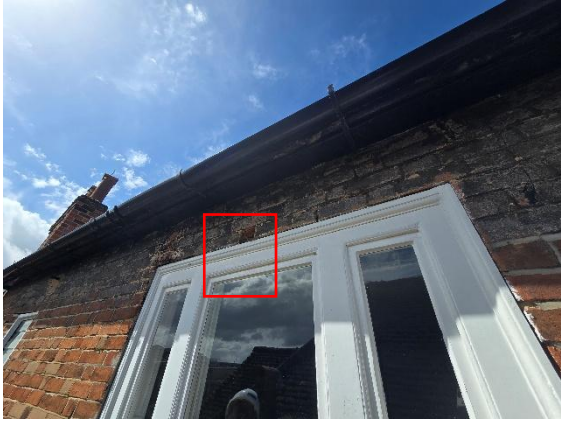
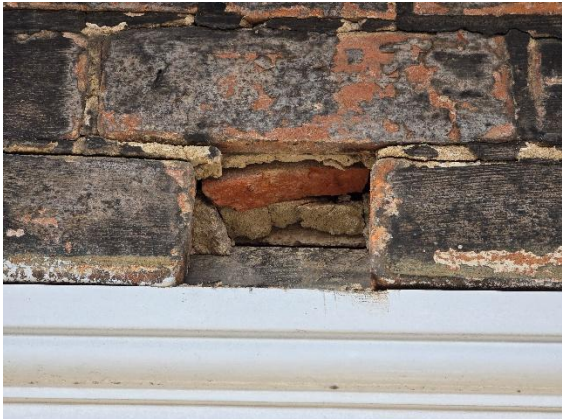
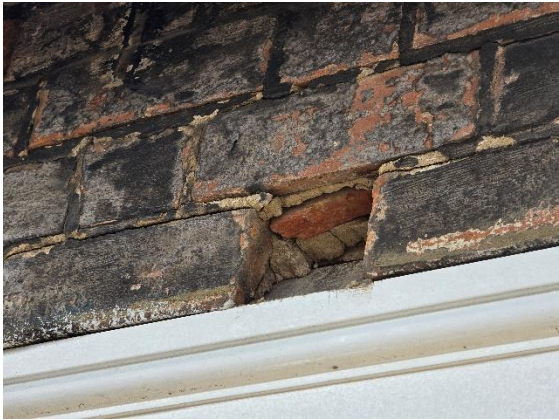
| Element | Material(s) | Comment |
|---|---|---|
| Outer Leaf finish | Clay tile | Tile came off easily during investigation works |

| <p>Survey location on elevation photo</p> | <p>Close up view of opening up</p> <p>Close up view of opening formed by removing clay tile</p> <p>Close up looking towards the left of the opening up</p> |

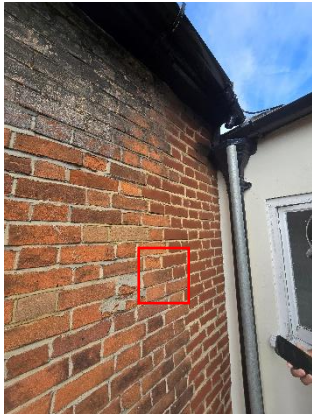
| W08-01 | Survey location on elevation photo | W08-02 | Close up view of opening up |

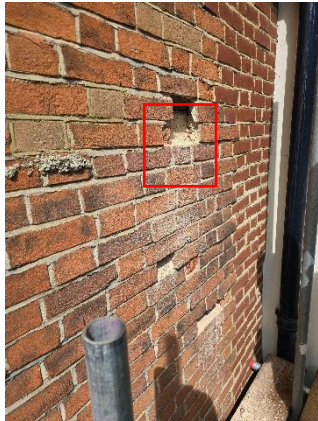
| Element | Material(s) | Comment |
|---|---|---|
| Outer Leaf finish | Clay tile | Tile came off easily during investigation works |

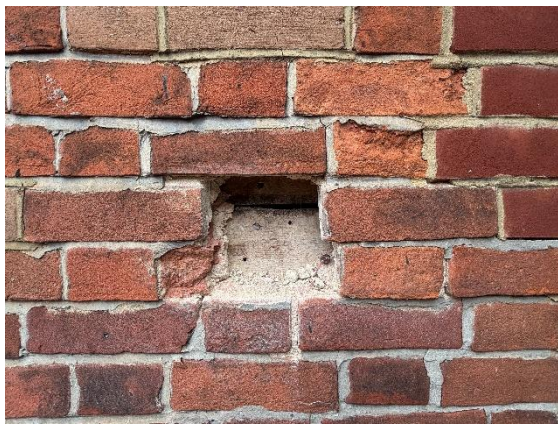
| W08-03 | Close up view of opening formed by removing clay tile | W08-04 | Close up looking towards the left of the opening up |

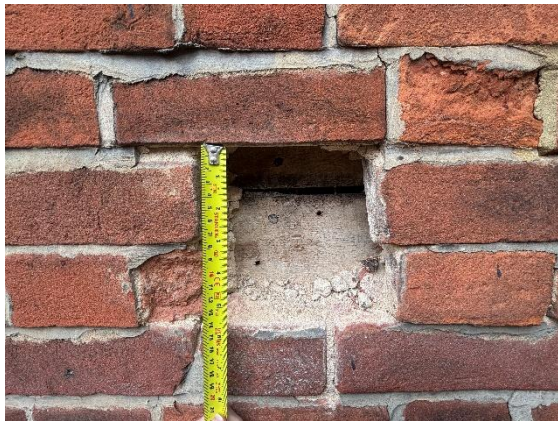
| W08-03 | Measurement of clay tile length | W08-04 | Measurement of clay tile width |

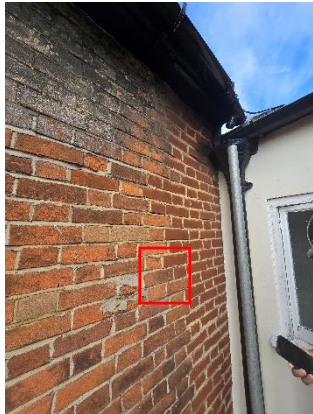
| W09-01 | Survey location on elevation photo | W09-02 | Close up view of opening up |

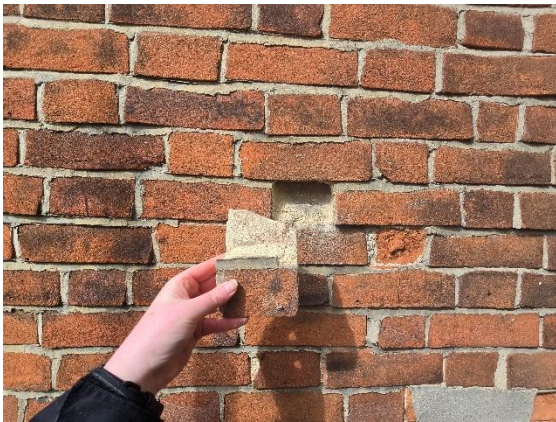
| W09-03 | Close up view of opening formed by removing clay tile | W09-04 | Close up looking towards the left of the opening up |

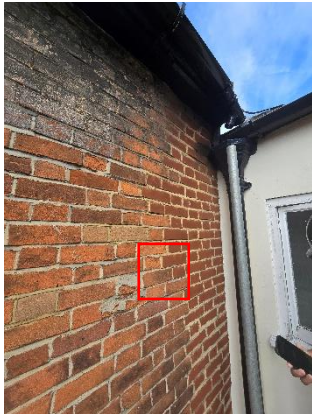
| W10-01 | Survey location on elevation photo | W10-02 | Close up view of opening up |

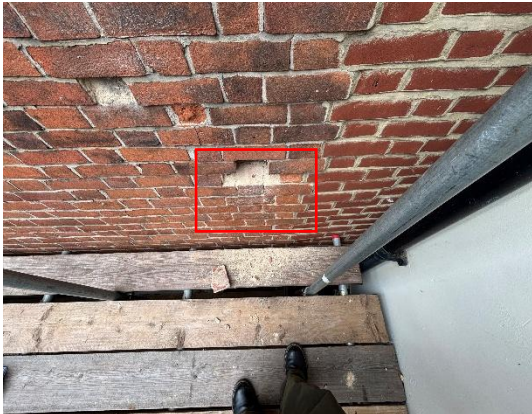
| Element | Material(s) | Comment |
|---|---|---|
| Timber backing board / battens | Timber | Backing board appeared dry at time of inspection. Evidence of rot |
| Nails | Assumed iron. | Evidence of corrosion to nails to backing board |
| Other comments | | Extent of rot to timber unknown |

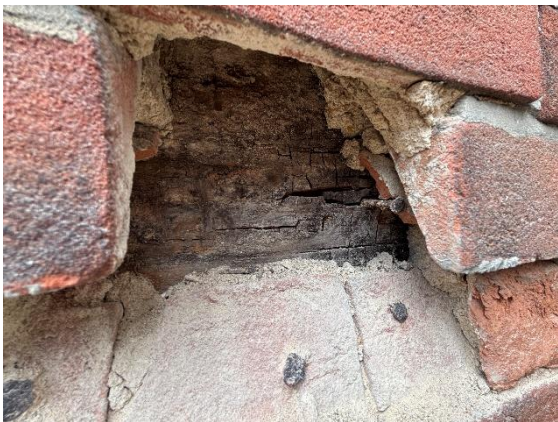
| W10-03 | Close up view of opening formed by removing clay tile | W10-04 | Close up looking towards the left of the opening up |

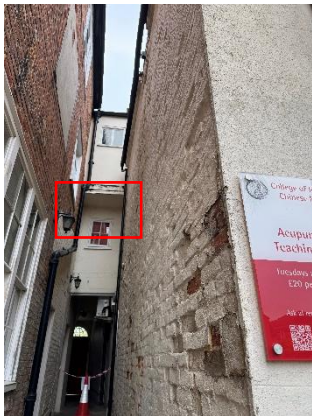
| Element | Material(s) | Comment |
|---|---|---|
| Timber ‘structural’ beam | Timber – Assume Oak | The timber beam shows evidence of rot, which will have implications for its structural integrity |

| W08-01 | Survey location on elevation photo | W08-02 | Close up view of timber beam |

| Element | Material(s) | Comment |
|---|---|---|
| Other comment | | Refer to Timber Specialist Report |
