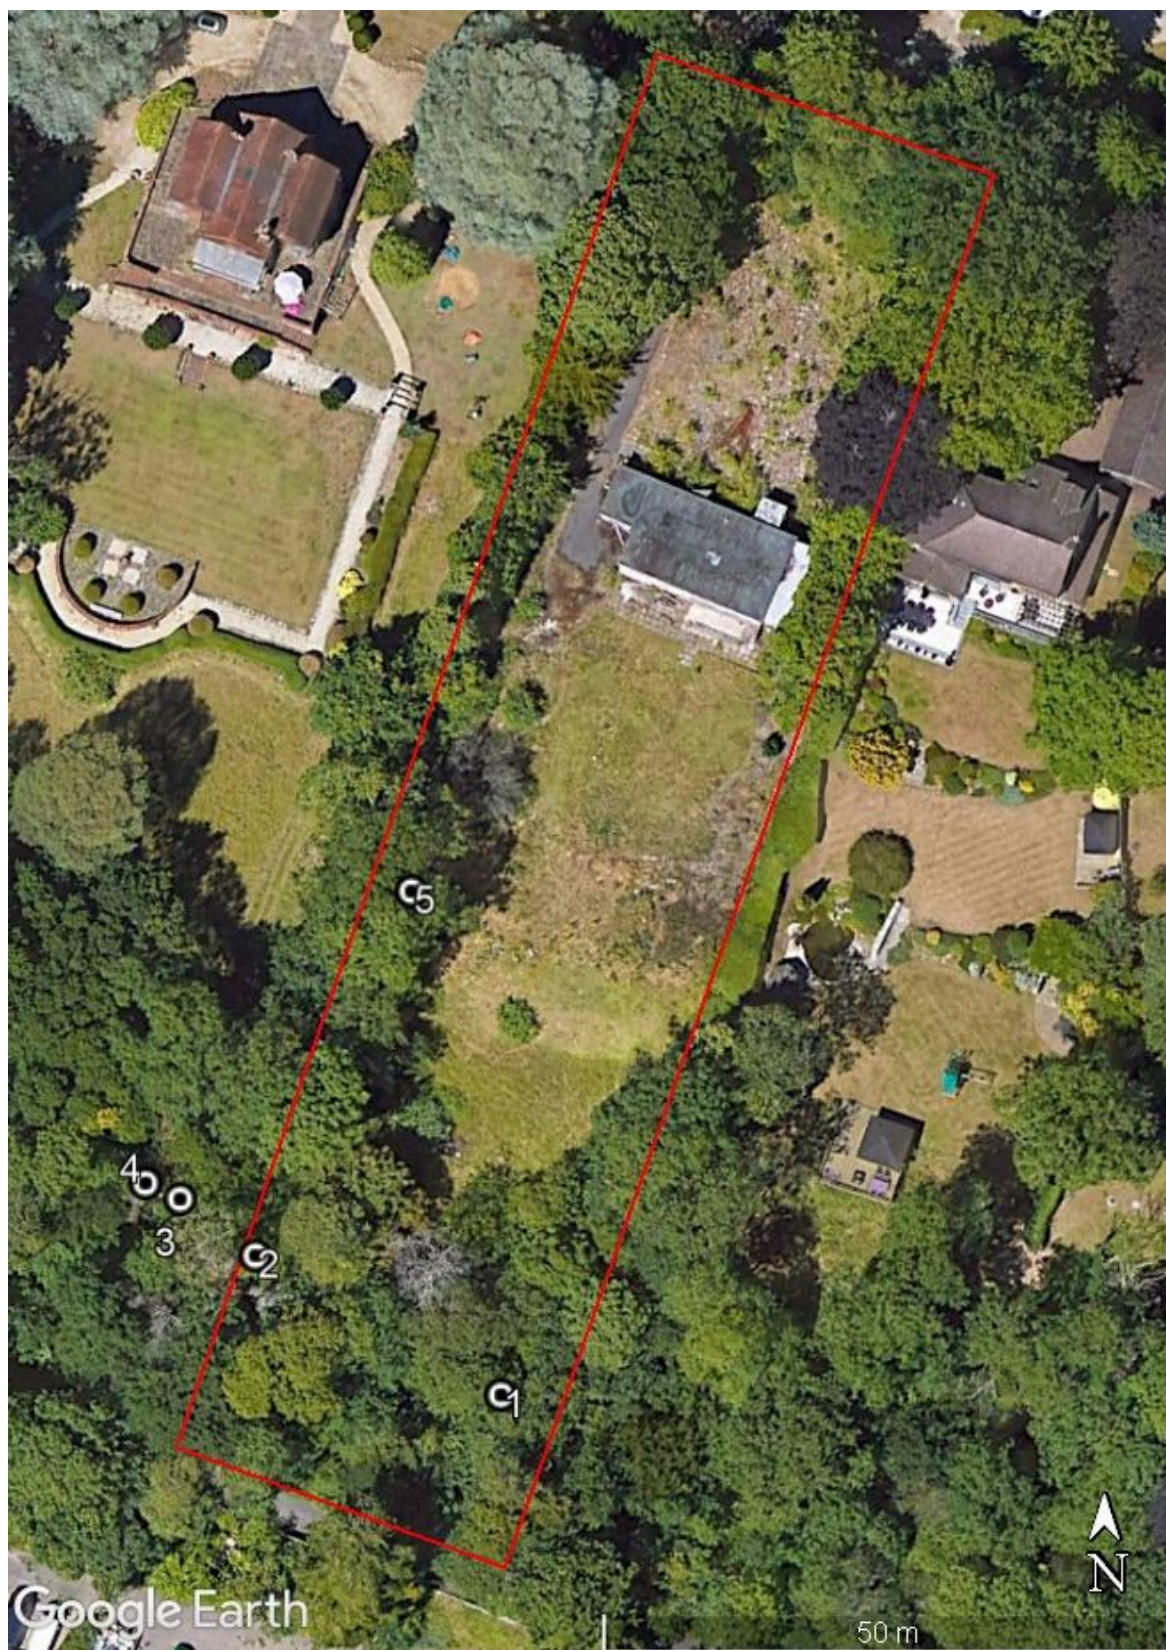
| Sett entrance number | Location | Assessment | Status |
|---|---|---|---|
| 1 | SU 69699 75197 | Clearly disused, with dense accumulation of leaf litter and twigs in hole entrances. Tunnels found to be collapsed and not extending beyond 30-40 cm upon inspection. | Disused |
| 2 | SU 69675 75199 | Clearly disused, partially cobwebbed with extensive leaf litter, twigs and soil accumulating in the entrance. The entrance tunnel turned sharp right then appeared to narrow significantly upon inspection, suggesting most recent use by rabbits. | Disused |
| 3 | SU 69669 75204 | Appeared currently disused with accumulated soil, leaf litter and stinging nettle growth in entrance. | Disused |
| 5 | SU 69689 75231 | The entrance hole was found to be clear of debris with a well worn path leading up to it, however this path appears established by people and the lack of leaf accumulation is likely caused by an overhang above the hole. Upon inspection the hole was found to bend left then right, continuing beyond the reach of inspection towards the centre of the site, narrowing as it went. The sett entrance is situated at the base of an ash tree in obvious poor health (hollow at base, standing dead wood, leaning) that seems about to collapse. | Potentially active |

Figure 1: Site ownership boundary with potential and disused badger sett entrances numbered

There is no definitive evidence that sett entrance 5 is in active use, and while badgers typically avoid high-disturbance environments, the possibility of this burrow being used as an outlier sett by badger cannot be ruled out. Adhesive hair traps were deployed at this entrance on 31st July 2025. If these traps remain in place for a significant time and badger hairs are not found to have adhered to the tape, this would indicate a lack of current use by badger. Camera trapping would provide the most robust conclusion on current badger use.
