## Arboricultural Impact Assessment

SEN School

The Ridgeway Primary School  
Hillbrow  
Reading  
RG2 8JD

Survey Date: 21<sup>st</sup> & 26<sup>th</sup> August 2025  
Report Date: 24<sup>th</sup> September 2026  
Project no: 2485

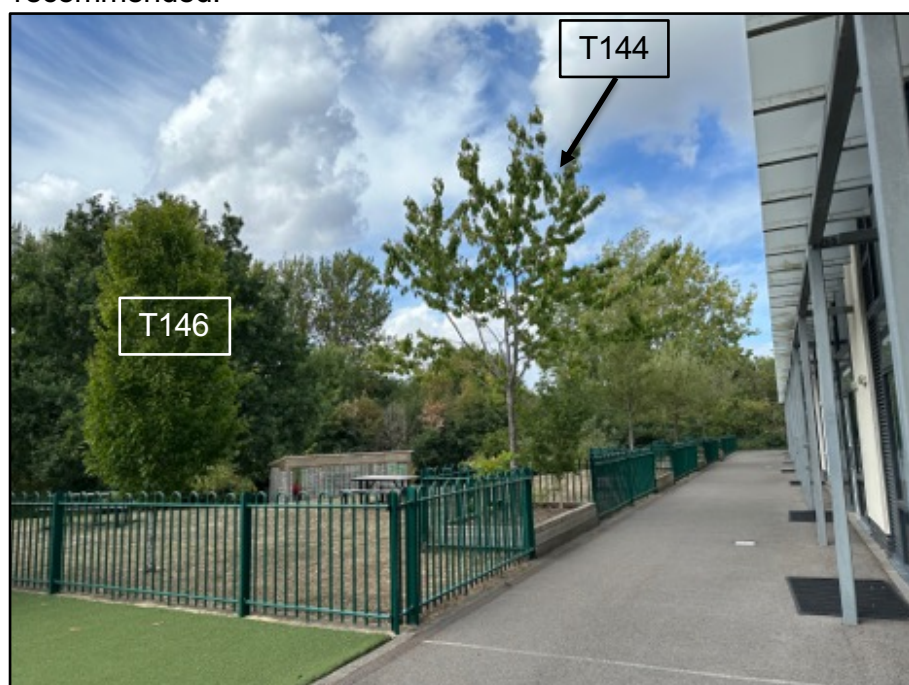
Views along west side of school building where new play area is proposed. Some trees in raised timber beds may be unsustainable in the long term and replacement with more suitable trees is recommended.

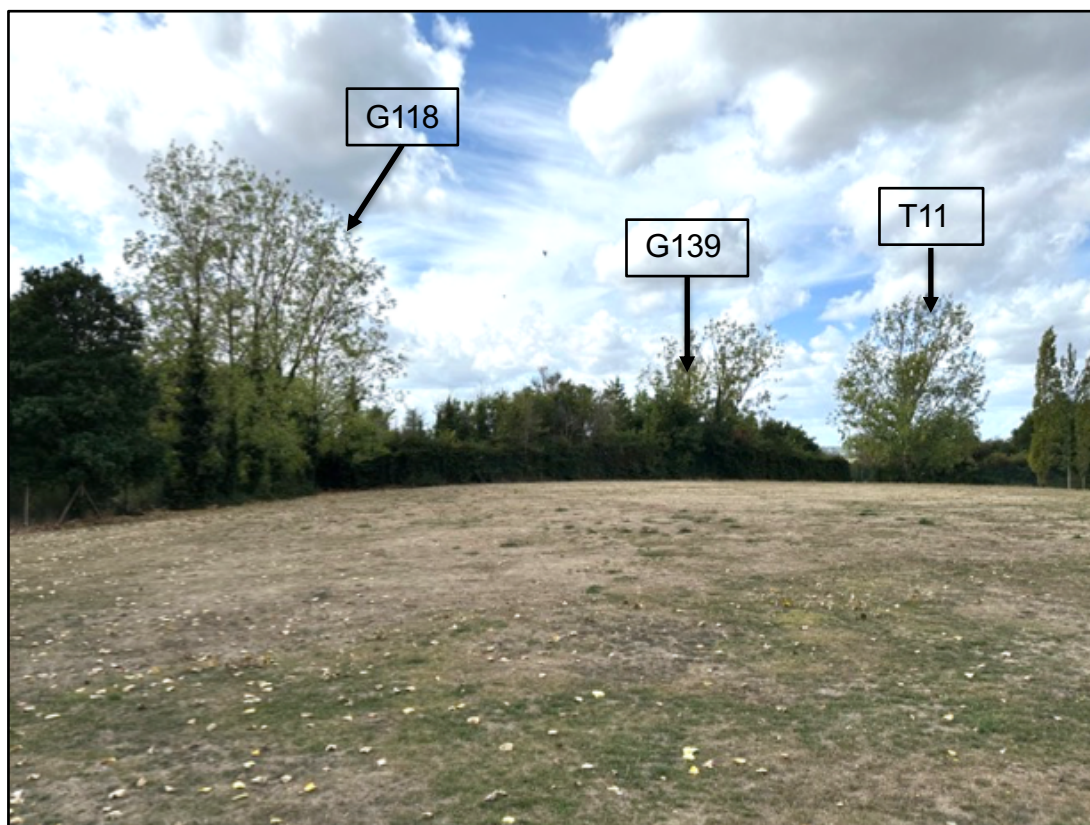
Above: Area where new netball court is proposed.
