## **RIVERMEAD LEASURE COMPLEX**

### **Application Number: 201734**

## **LIST OF DRAWING AND LANDSCAPE MANAGEMENT PLAN CHANGES**

**DRAWING:**  
**EML PEL 1142 01-06 PL10**  
**DOCUMENT EML PEL 1142**

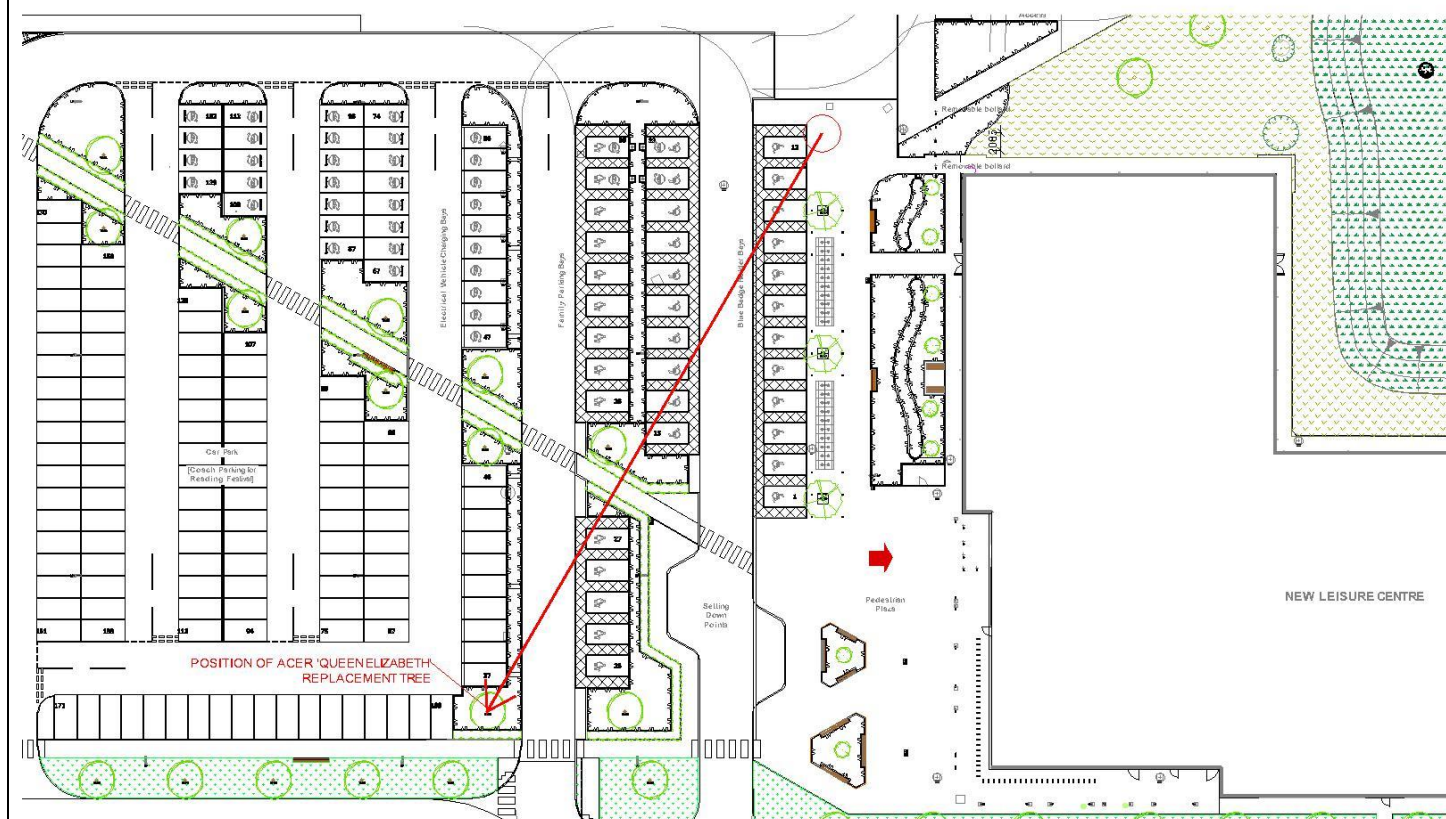
| <p>Tree planting in main car park – these are proposed as Acer campestre Queen Elizabeth, which is a narrow form of Field maple. Whilst I think it is positive and apt to have this named species planted at this time (ref the Jubilee), they do not utilise the canopy space available. Generally, large canopy species should be used to break up large areas of hard surfacing and, in line with EN14, our Tree Strategy and our SDP on Sustainable Design &amp; Construction, large canopy trees should be proposed where feasible for the multiple environmental benefits they provide. This is a regular requirement on development sites and the Council should lead by example on its own sites. I note Acer.campestre Queen Elizabeth are proposed adjacent to the car park, so there would still be some included.</p> | <p>EML</p> <p>The acer along the central car park pathway were changed to Liquidamber styraciflua 'Worplesdon' This species can achieve a broad canopy size of 8m+ and the rooting volumes are appropriate to the constraints of the location.</p> <p>Root barrier 600mm depth was added to each planting bed</p> <p>The acer queen Elizabeth adjacent to the car park have been reduced to 3no. from the original 4no.</p> <p>The stock size of the Acer trees has been increased from 18-20cm girth to 20-25cm girth to increase initial impact and provide mature specimen tree planting.</p> <p>The reason for the reduction in numbers of the tree pits in hard landscaping is due to conflicts with existing and proposed underground services and the Breeam requirement for cycle shelters.</p> <p>The 1no. Acer removed has been replaced within the scheme by an additional Corylus columna (See drawing extract below).</p> |

1. Planting beds have changed to the main car park entrance and as previously advised an additional *Corylus colurna* has been proposed.
2. Planting beds to play area and de-mountable pool have been altered to suit new site layout.
3. TP1 tree pit in hard landscaping has been changed to accommodate cycle shelter foundations above the tree pit. Additional aeration has been added to the tree pits.
4. Landscape management plan has been
5. Staff area location moved to East side rear of building
6. *Cercis chinensis* Avondale changed to Specimen shrub species *viburnum bodnantense* 'Dawn' & *Cornus mas*. Change due to limited availability at sizes previously specified.
