## J1273 CASTLE STREET ALMSHOUSES

### Scope of Work

J1273-BA-RP-A-002\_Scope of Work-P02

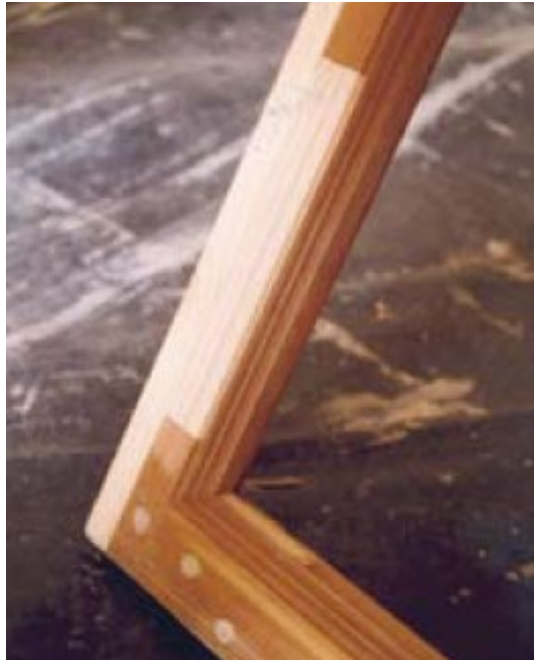
**Figure 1.** Joint of a sash rail and stile repaired with a timber splice, screwed and plugged. (Source: Historic Scotland)

- Timber Splicing: The defective / rotten wood is cut out by the joiner back to an angled edge of sound healthy timber. A new piece of timber in the correctly detailed profile, usually in hardwood or durable softwood for dimensional stability, is added in place of the defective timber. It's fixed by bedding in a resin adhesive and screwed into place. Joints between new and old timber are smoothed with a resin, screw heads are capped, and the surface is sanded flush ready for repainting.

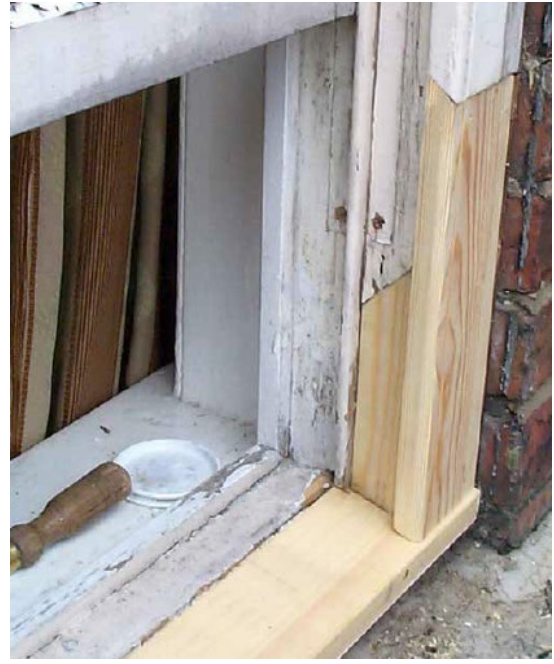
**Figure 2.** Half cill replacement, outer lining replaced, and part of the pulley lining replaced with new timber splices (Source: Historic England)

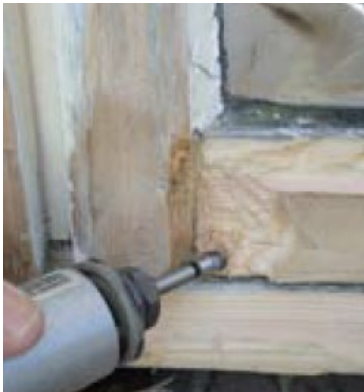
**Figure 3.** Decayed timber can be removed with a small handheld power tool. (Source: Repair Care International)

- Resin repairs: For minor repairs a small area is routed out using a precise handheld routing tool back to sound healthy timber. A two-part resin is mixed then applied to fill the area of removed defective timber and shaped in to match the existing window frame profile exactly. Once dry the surface can be treated like timber, sanded flush and repainted.

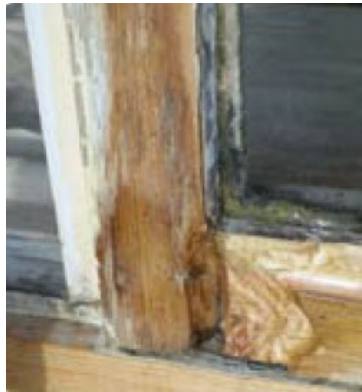
**Figure 4.** Sound timber primed to receive resin repair. (Source: Repair Care International)

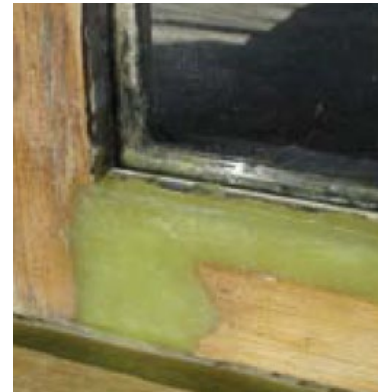
**Figure 5.** Resin Repair Ready to Paint. (Source: Repair Care International)

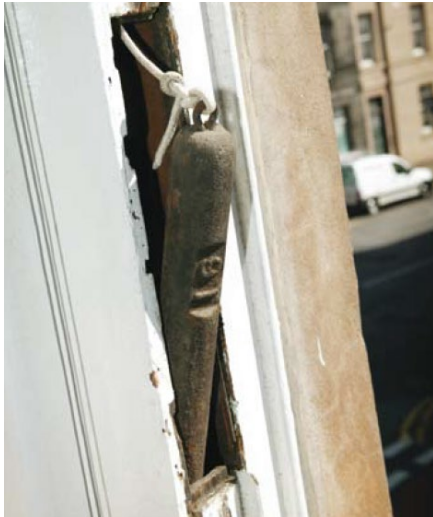
**Figure 6.** Access pocket to weights (Source: Historic Scotland)

- 3.8.1. Following repairs to the sashes, sills and pulley lining, the penultimate step is to restore original easy functionality of the sash windows. This can be achieved by fixing/replacing stiff or corroded pulleys, changing the sash cords, and accurately rebalancing the counterweights. The pulley linings can be waxed to also improve the sash's vertical movement.
- 3.8.2. The final step will be to re-apply the parting bead and staff beads, with a draught excluding pile strip. The strips reduce heat loss through uncontrolled air changes. As most modern windows have two seals, the draught stripping can be doubled up by adding them to the edges of the sash frame too.

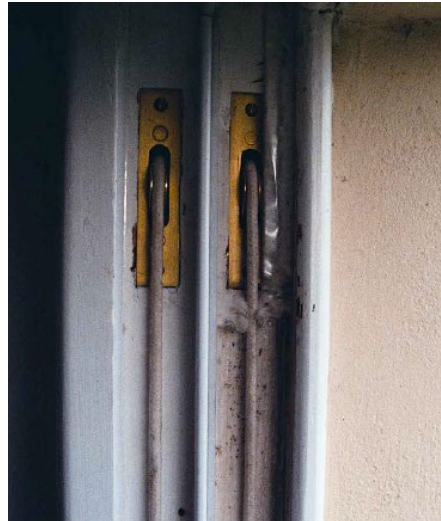
**Figure 7.** Brass Pulleys and Sash Cords. (Source: Historic England)

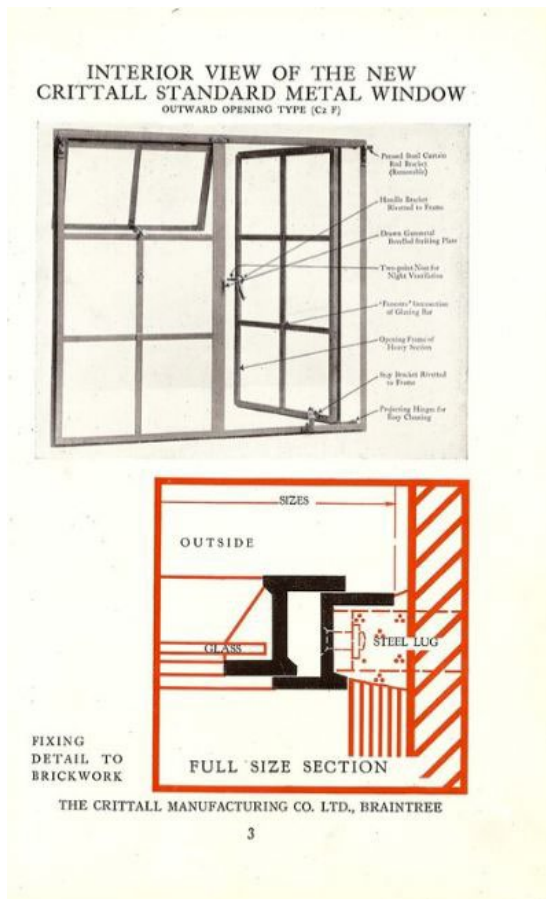
**Figure 8.** Page from 1928 Crittall Catalogue showing the “New Standard Metal Window” (Source: Building Technology Heritage Library)

- 4.1. The existing steel windows were installed as part of the 1960s modernisation works to both wings. Following rebuilding of extensions on the West Wing, they survive only on the East Wing's rear elevations.
- 4.2. The steel windows are of the Homelight / Universal Range and design which was advertised in sales catalogues by Crittall between 1912 and 1964. The absence of any corrosion suggests the frames are galvanised, which was added to Crittall manufacturing process from 1939 onwards.

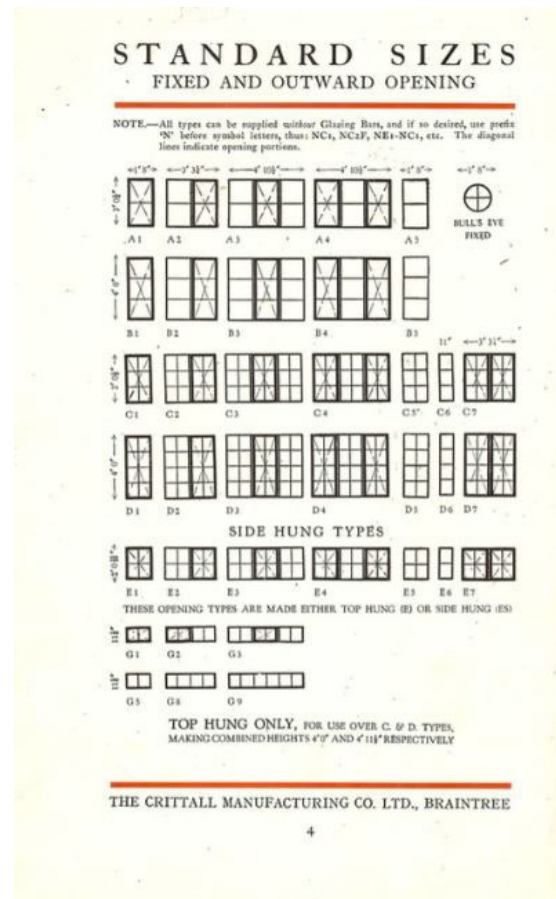
**Figure 9.** Page from 1928 Crittall Catalogue showing standard sizes (Source: Building Technology Heritage Library)

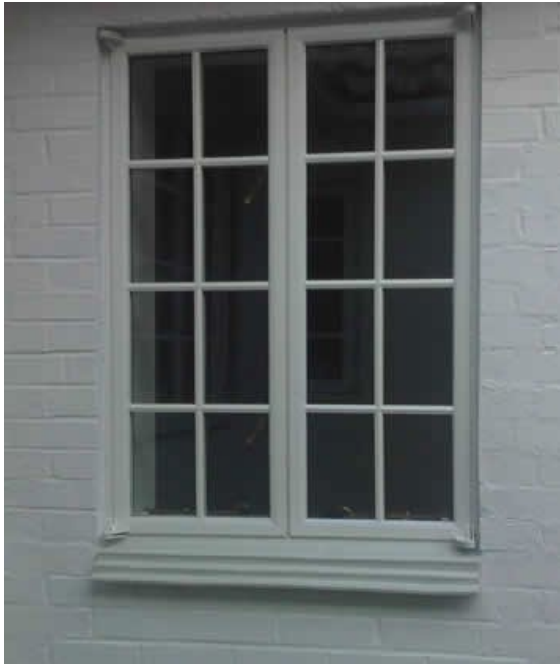
**Figure 10.** Thermally Broken Steel Window, achieves near identical sightlines to original Crittall windows (Source: Met therm Website)

- 4.3. The possibility of using secondary glazing was explored. However, it was felt that in several scenarios sliding secondary glazing would be the only sensible solution. The horizontal sliders can be difficult to operate, especially when reaching across furniture.
- 4.4. As the Crittall windows date from the 1960s they are of limited historic significance. However, they are an appropriate form of fenestration, and it would make sense to retain the character of the 1960s extensions as distinct from the later 2000 extensions to preserve legibility.
- 4.5. We propose to replace the existing single glazed steel windows, which do not have any form of draught seals, with modern thermally broken steel windows with double glazing designed to replicate the appearance of Crittall windows.

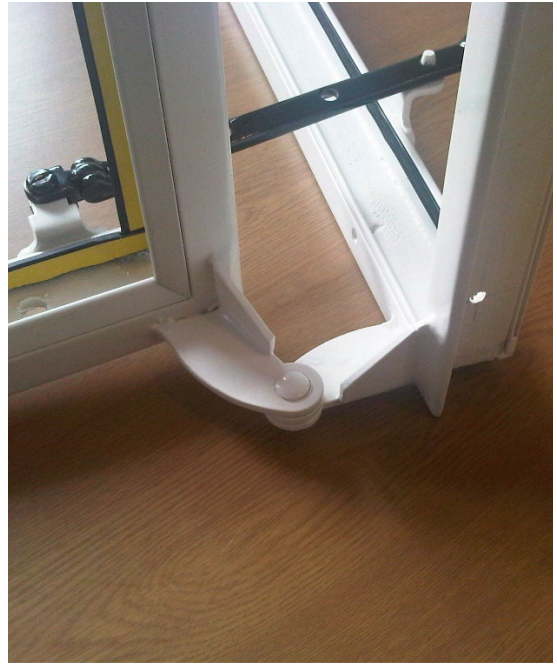
**Figure 11.** Projecting hinges and original ironmongery can be replicated. (Source: Met therm Website)

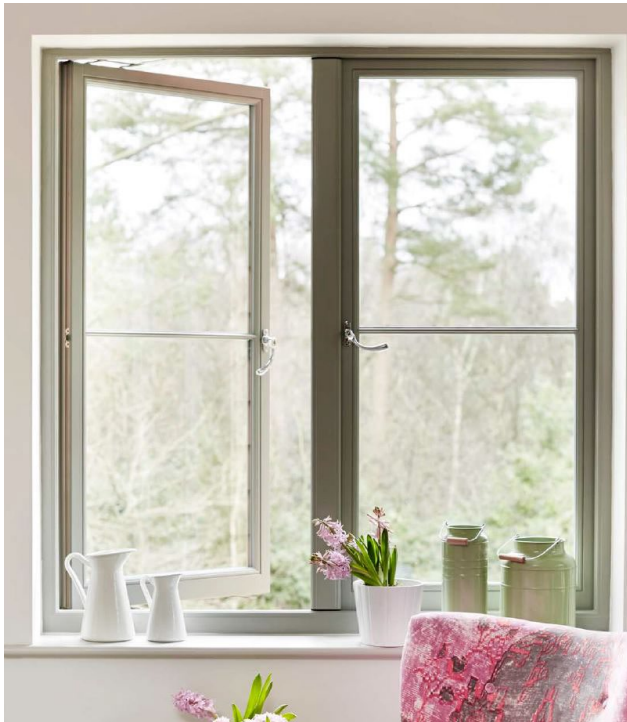
**Figure 12.** More finely detailed modern casement window. (Source: Bereco)

- 5.1. The existing double glazed timber casements date from works undertaken circa 2000. These windows are of poor design and detract from the overall character and appearance of the listed building.
- 5.2. We propose a new double glazed timber casement as a replacement. These can have ovolo glazing bars of a correct style and width. These can achieve a more refined and elegant appearance. These windows can accommodate slim and standard double-glazing units.
- 5.3. We would consider the proposals like-for-like with the existing and proposed being a modern timber double glazed casement, but with enhanced aesthetic properties.

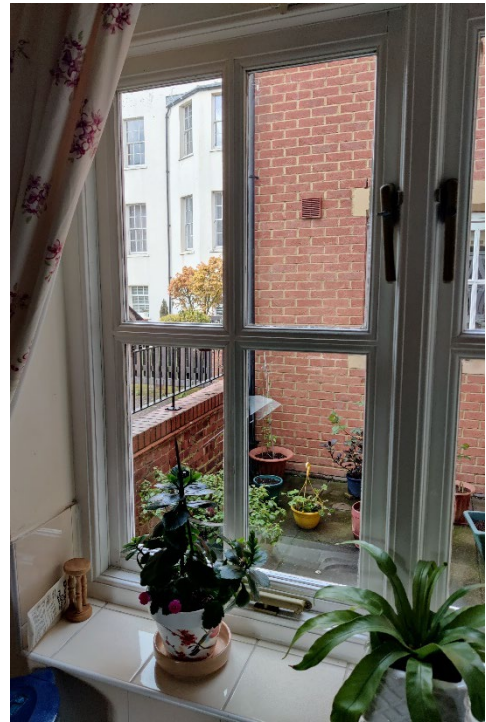
**Figure 13.** Thick and intrusive glazing bars of existing windows. (Source: Bridges Associates)
