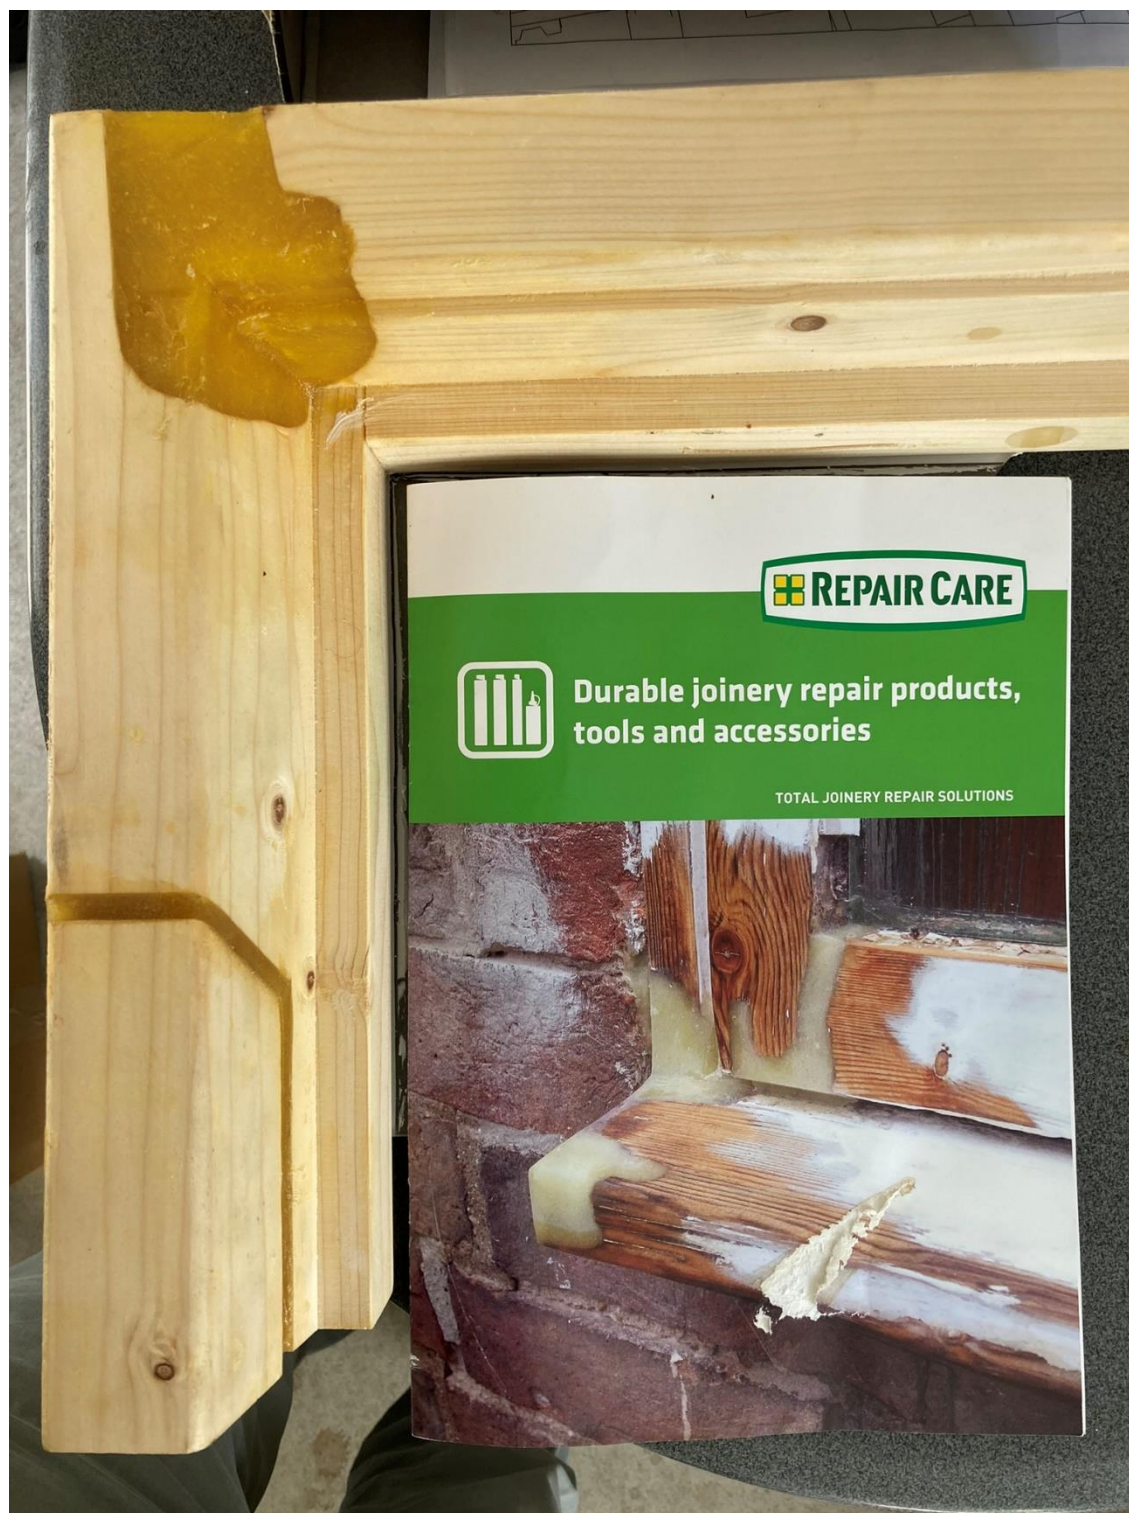
Window frame resin repairs training piece. Maximises retention of original fabric.  
Thick joints reduce risk of failure at joint

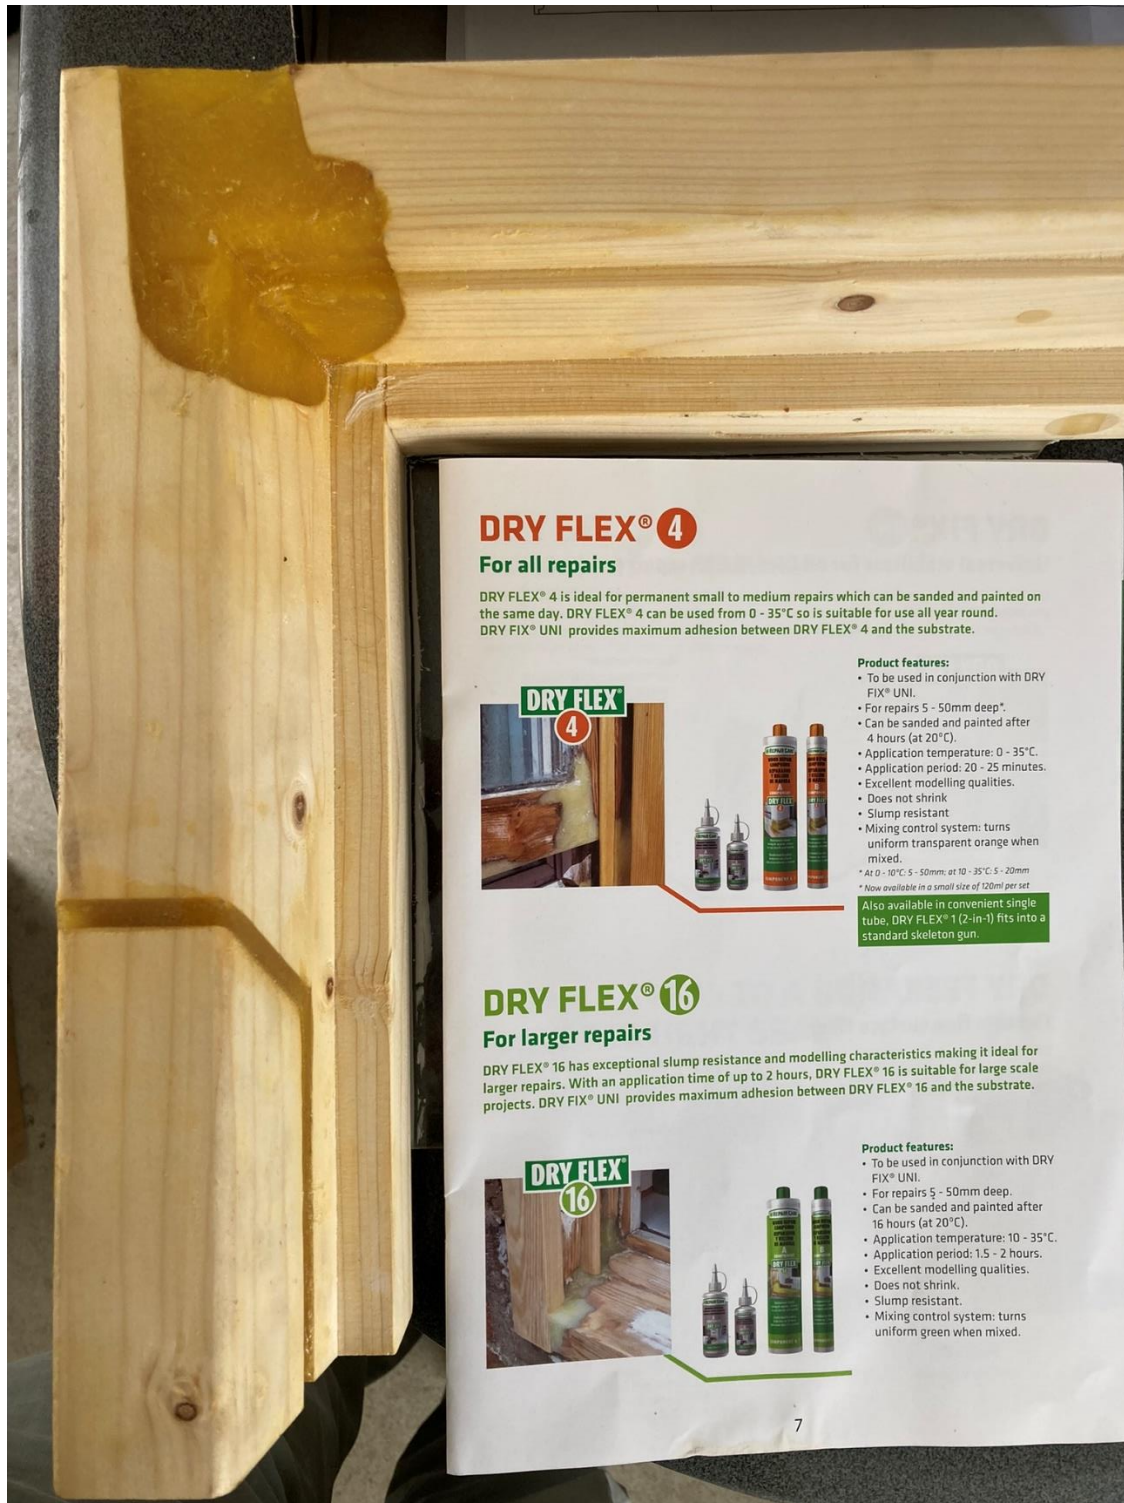
Window frame resin repairs training piece. Maximises retention of original fabric.  
Thick joints reduces risk of failure at joint.

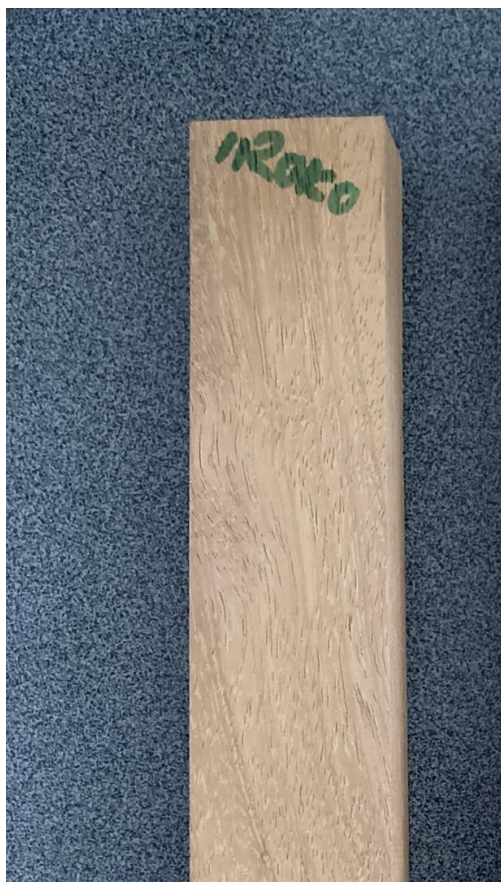
Timber for replacement work: paint finish gloss white

1. Sills: Iroko
2. Frames: sound sections salvaged from window frames too damaged to repair or Iroko

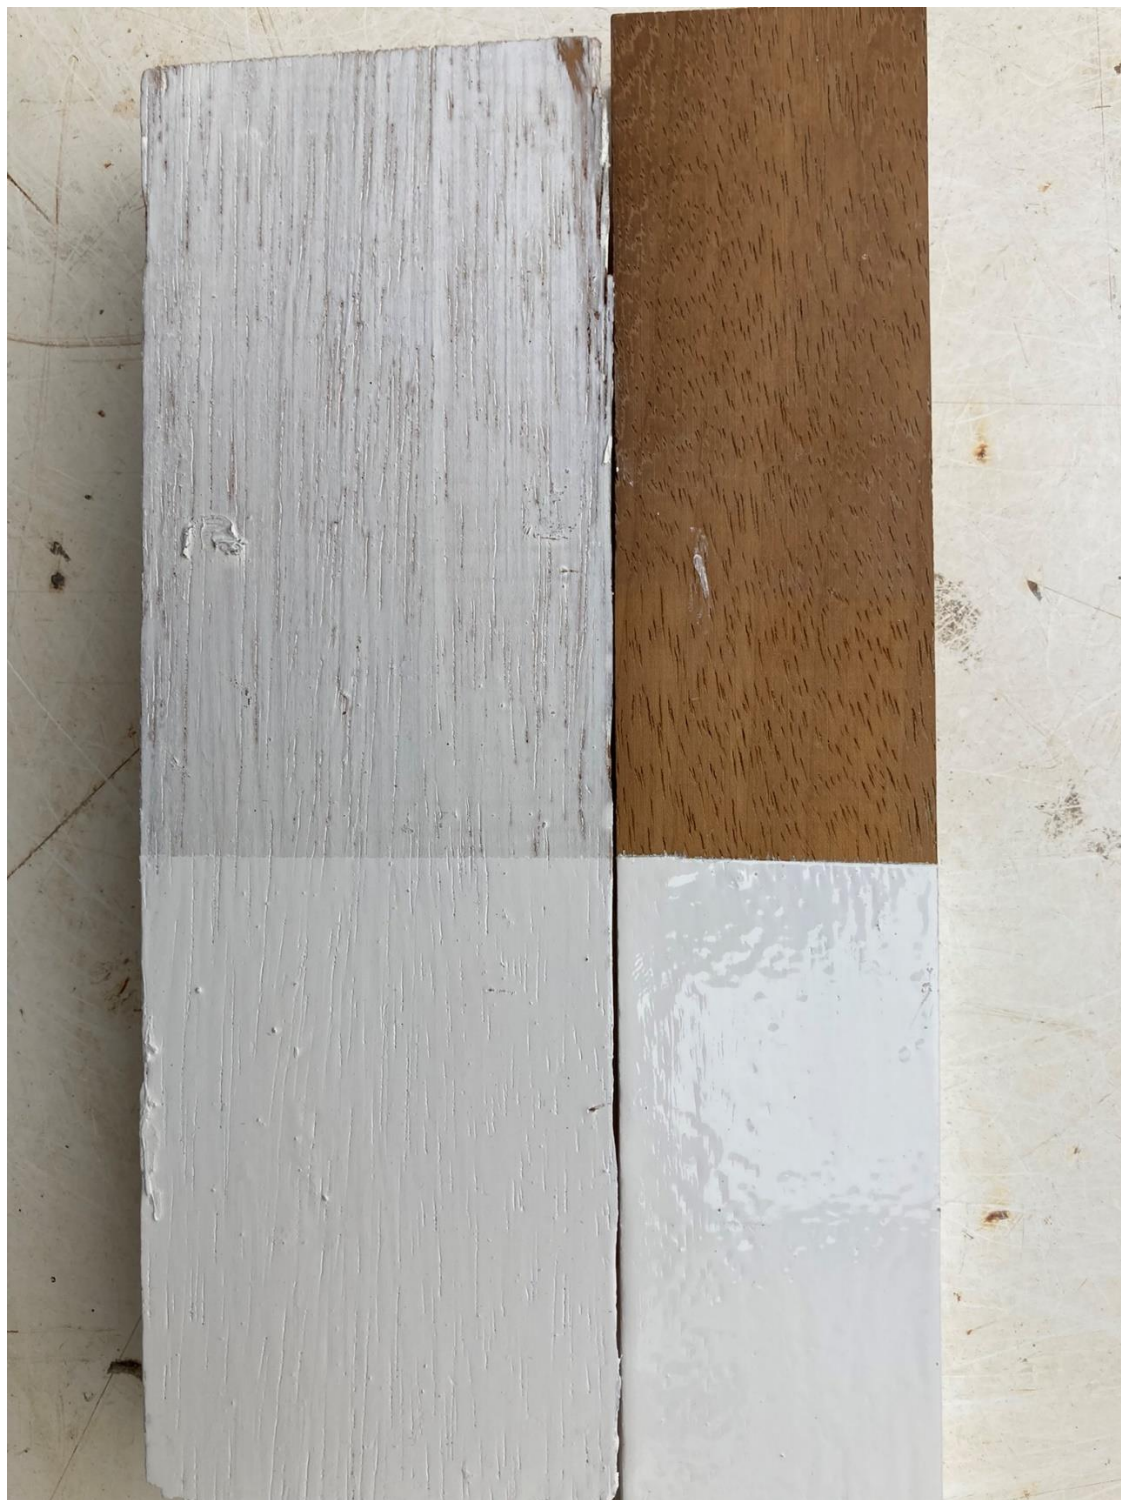
Paint build up on new or stripped back timber:

Anti-clockwise from top right : bare wood, primer, undercoats, top coat. White 0000-N BS 00E55

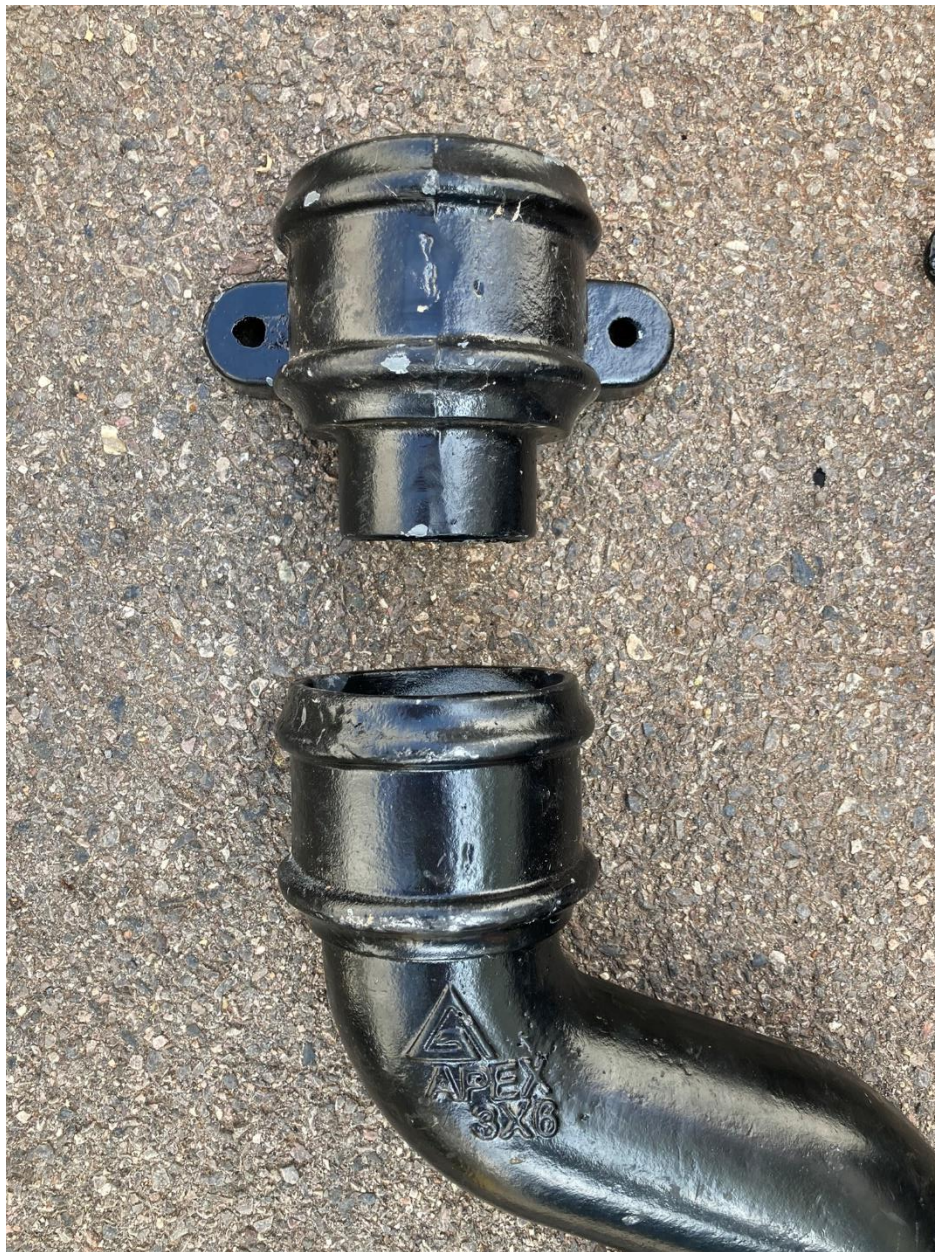
Replacement rainwater goods: gloss black

1. Alumasc APEX Cast Iron for replacement of components within a drop
2. Alumasc Aluminium proposed only where full drop to be replaced.

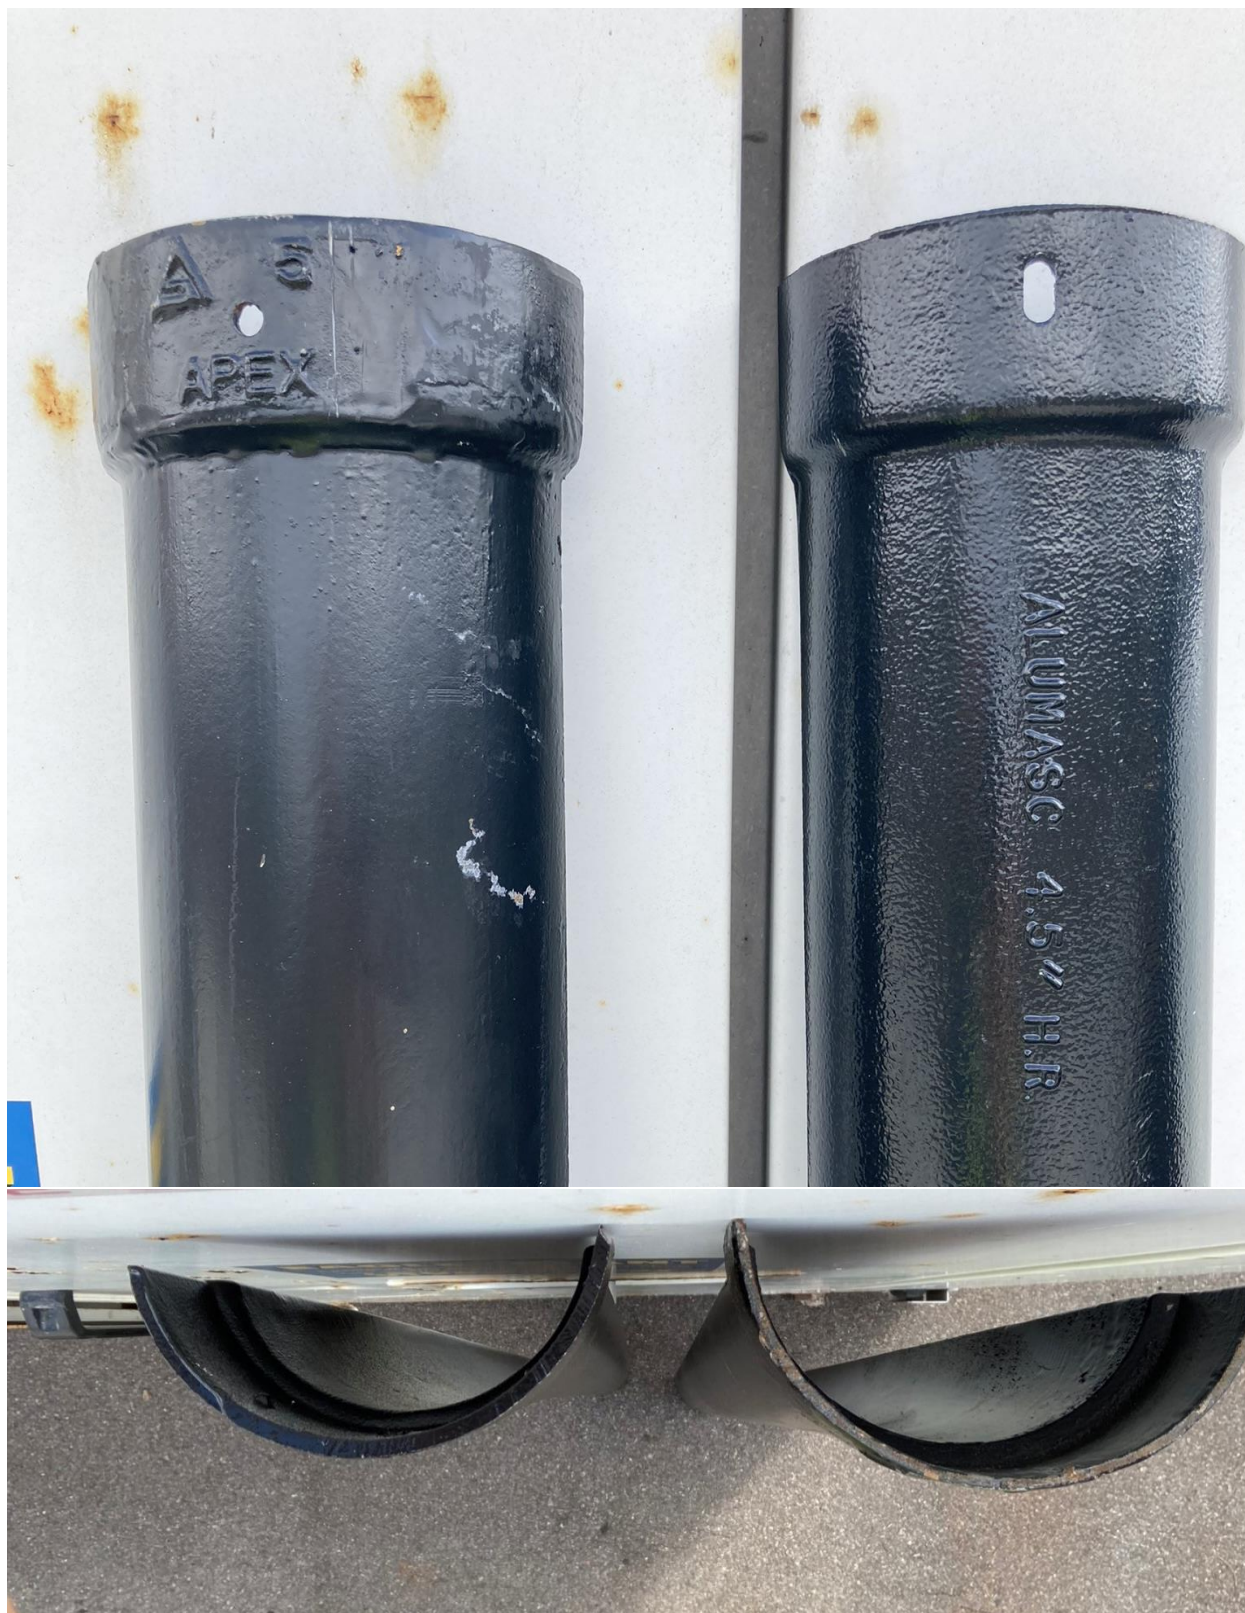
Guttering: 1. APEX Cast Iron – smooth finish

2. Alumasc Aluminium shows textured finish but smooth available and proposed to match cast iron

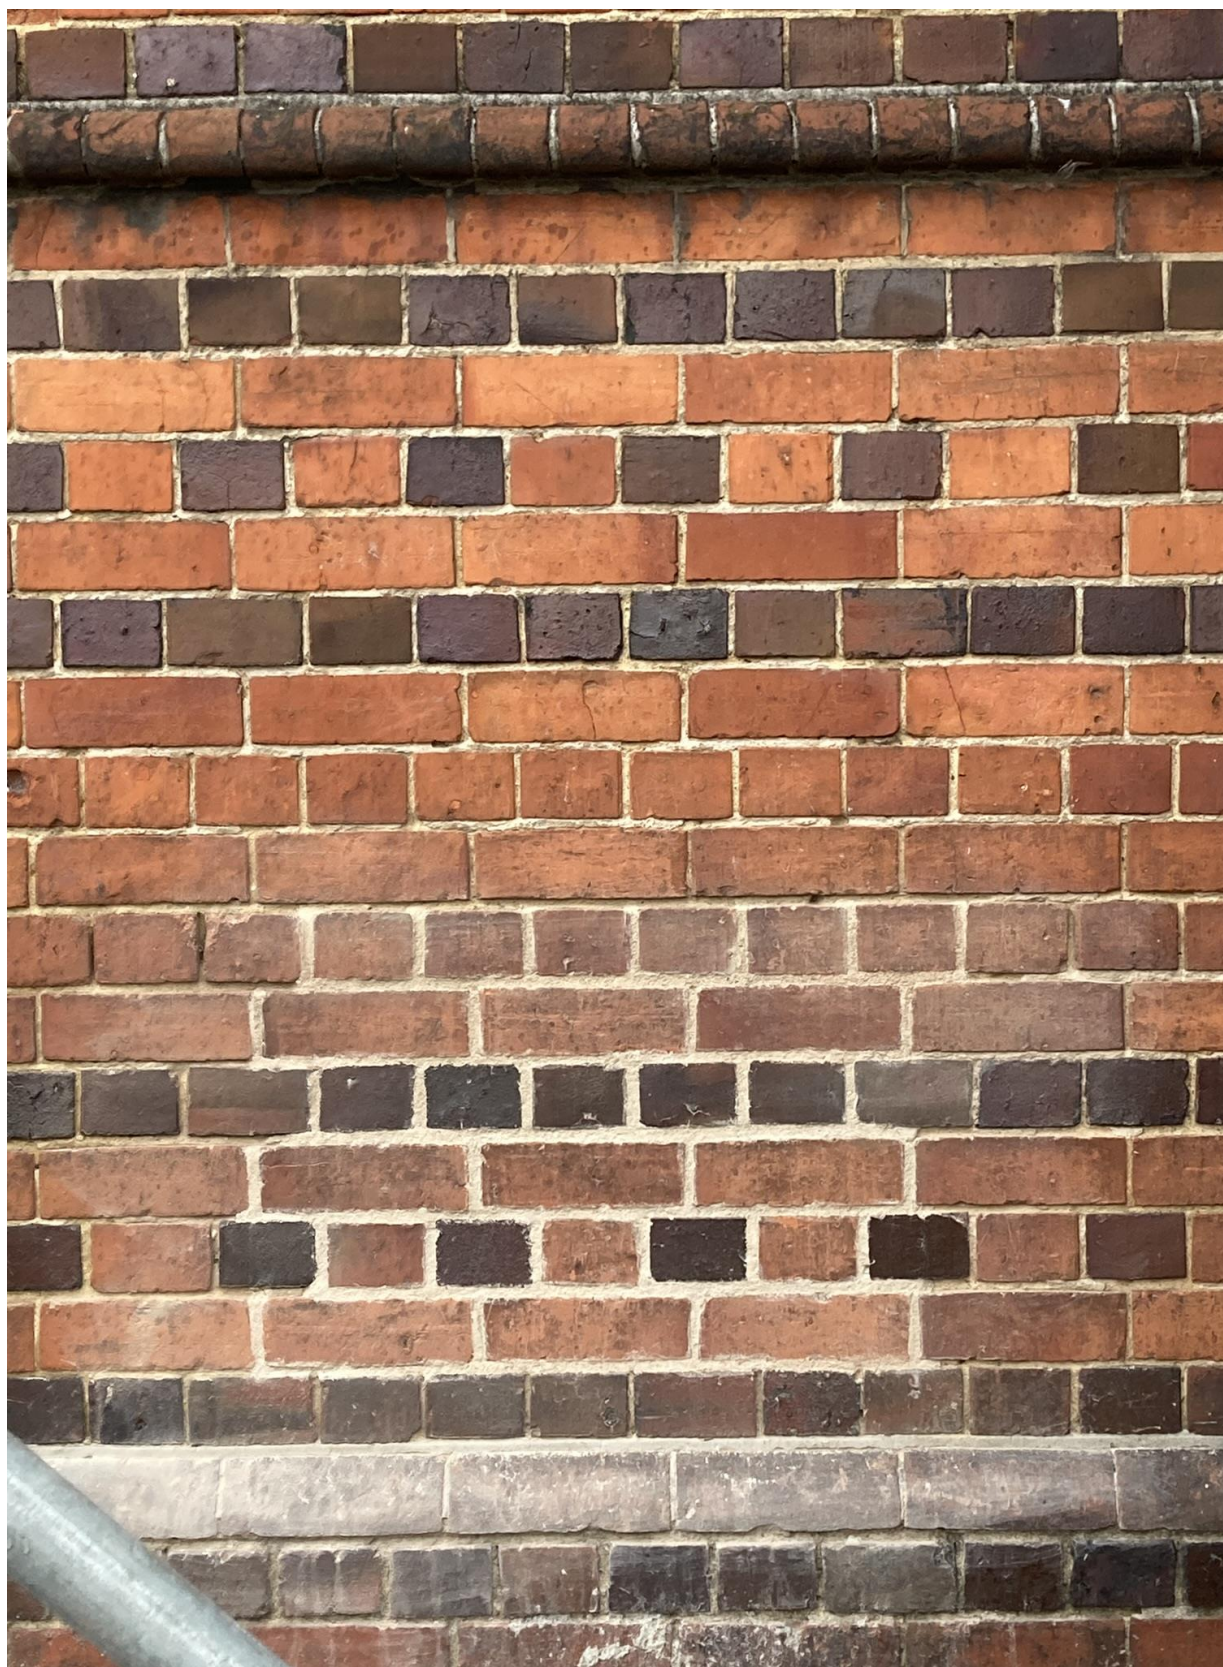
Sample of re-pointing using Morestead sand with NHL 3.5
