# Design and Access Statement

Wellbeing Centre  
17 Craven Road, Reading

For Royal Berkshire Hospital NHS Foundation Trust

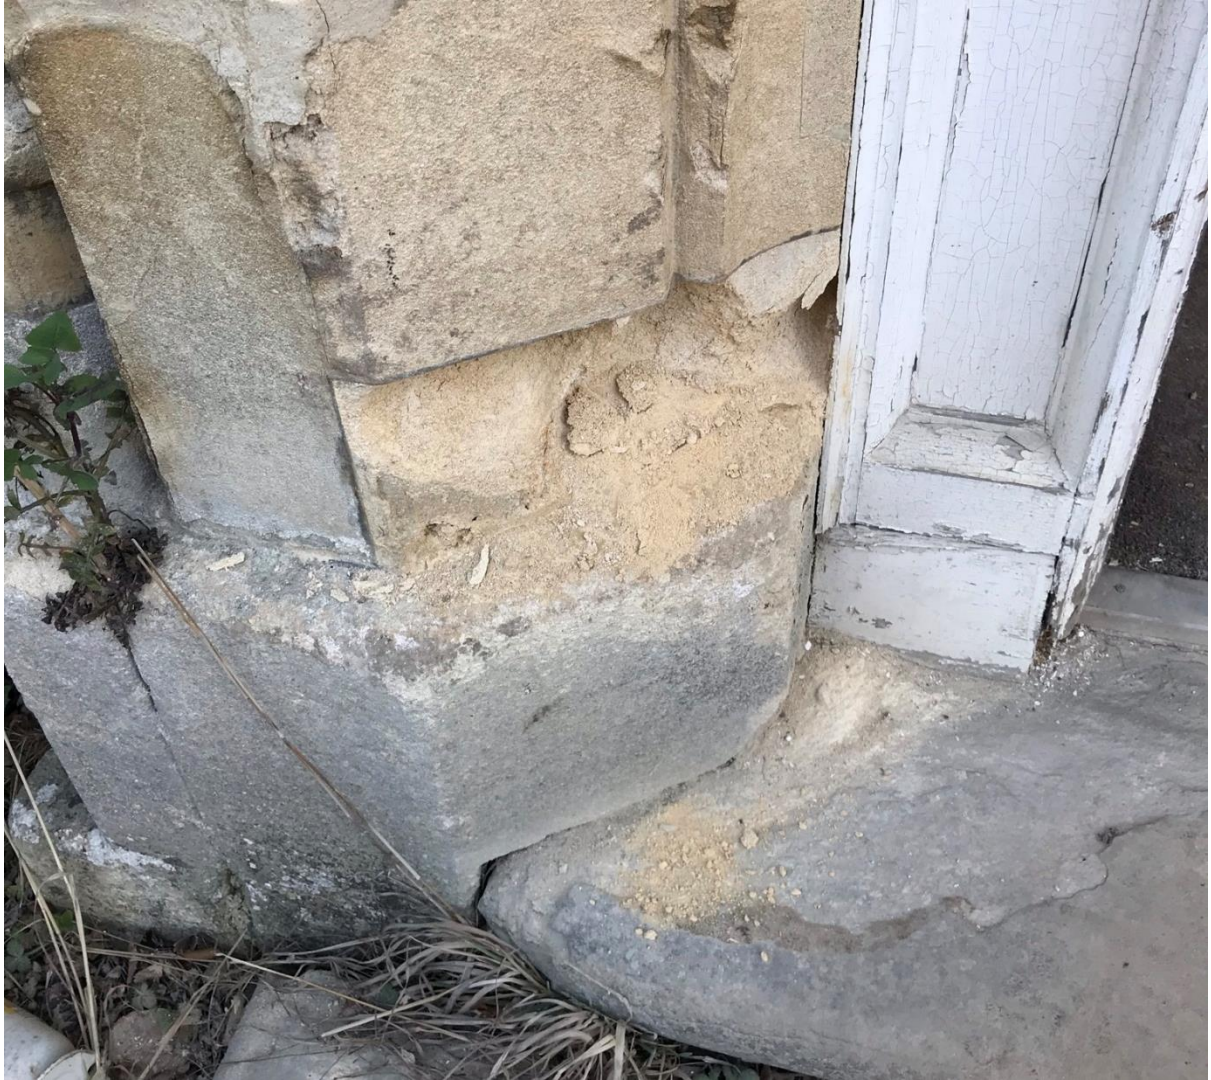
*Stone beside main entrance*

There are a few examples of severely eroded stones which we intend to replace, as well as filling in some holes which were once ventilation holes for the plant room. All these repairs and replacements are shown on the elevation drawings.

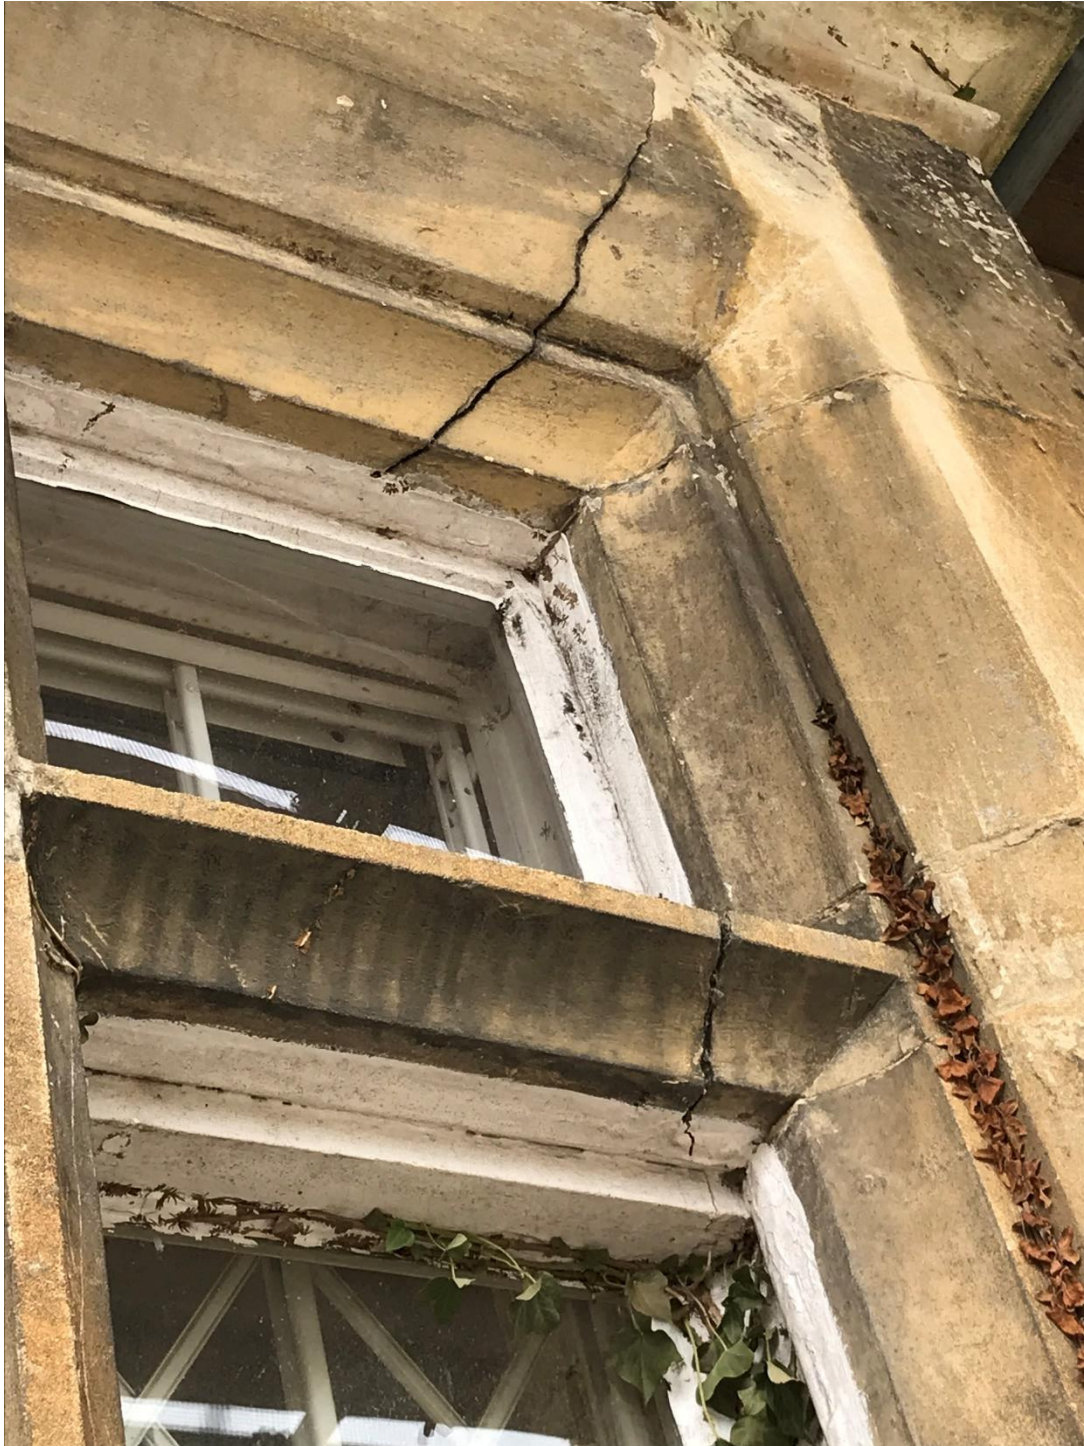
*Example of cracking to transom and window head*

A survey has been carried out by OG Stonemasonry to determine the extent of repair works required to the external fabric of the building. Fortunately, the external stone is in better condition than the internal fabric, and our proposed works comprise some stone cleaning, re-pointing and some pin repairs to cracked mullions and transoms and also to re-bed the coping stones.

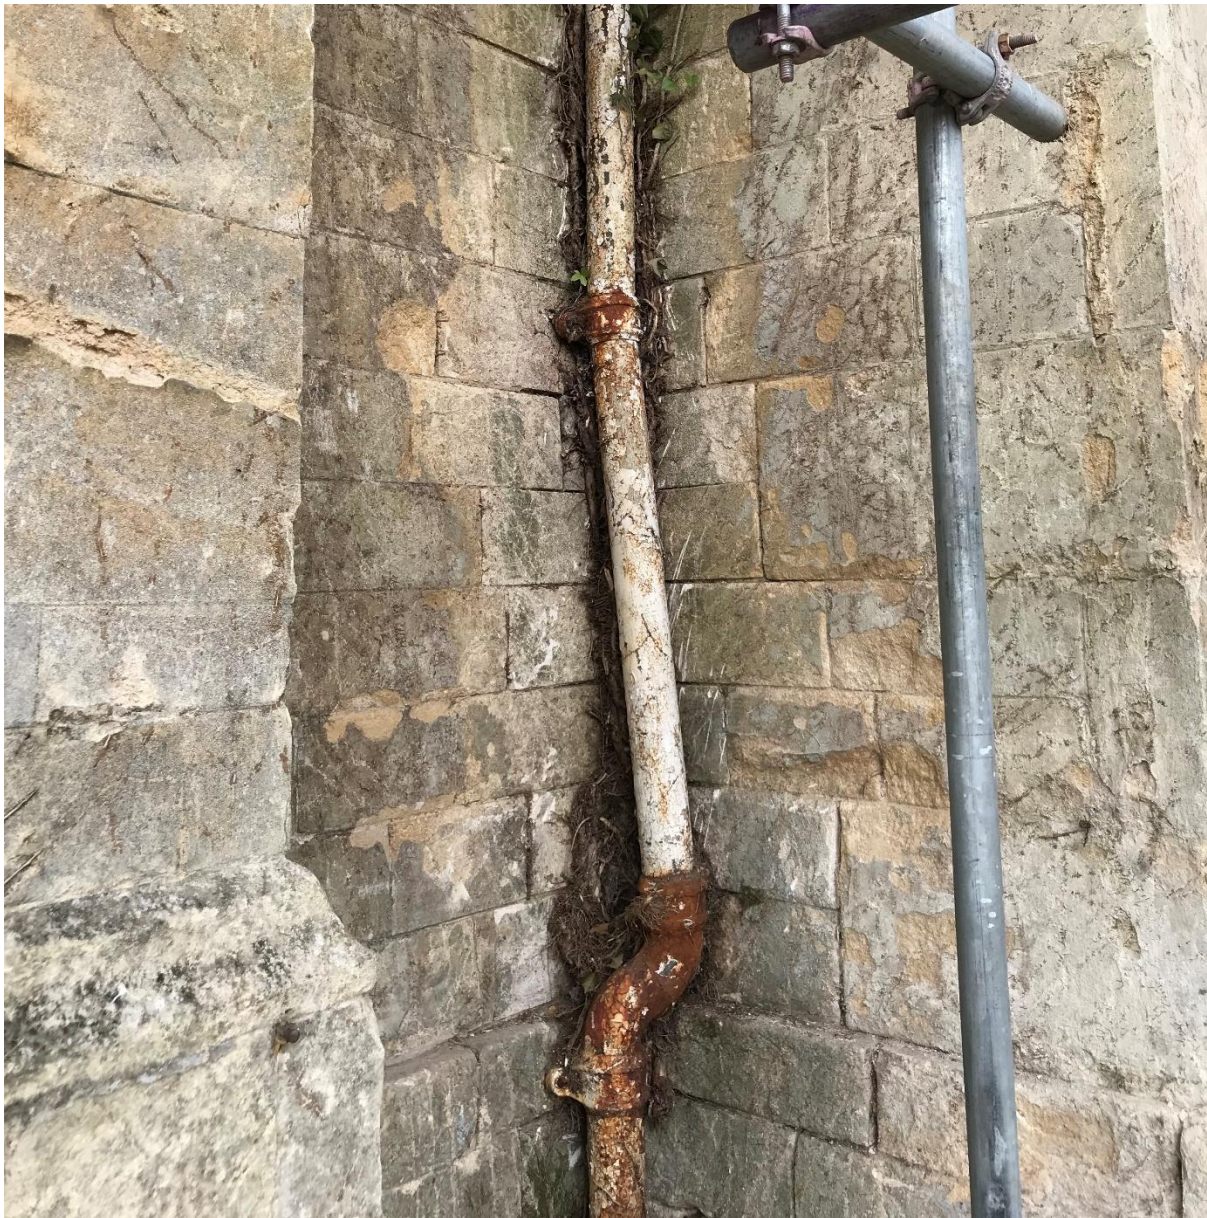
*Rainwater pipe to east elevation after ivy has been removed.*

However, further inspection on site has identified shortcomings in the disposal of rainwater off the roof which has in part led to the internal water ingress problems. We propose one new outlet, hopper and downpipe on the front (west) elevation as shown on the elevation drawings. Existing cast iron pipe that were hidden by ivy have been found to be in a poor state of repair and it is proposed to replace these. There are also two upvc downpipes which will also be replaced in cast iron.

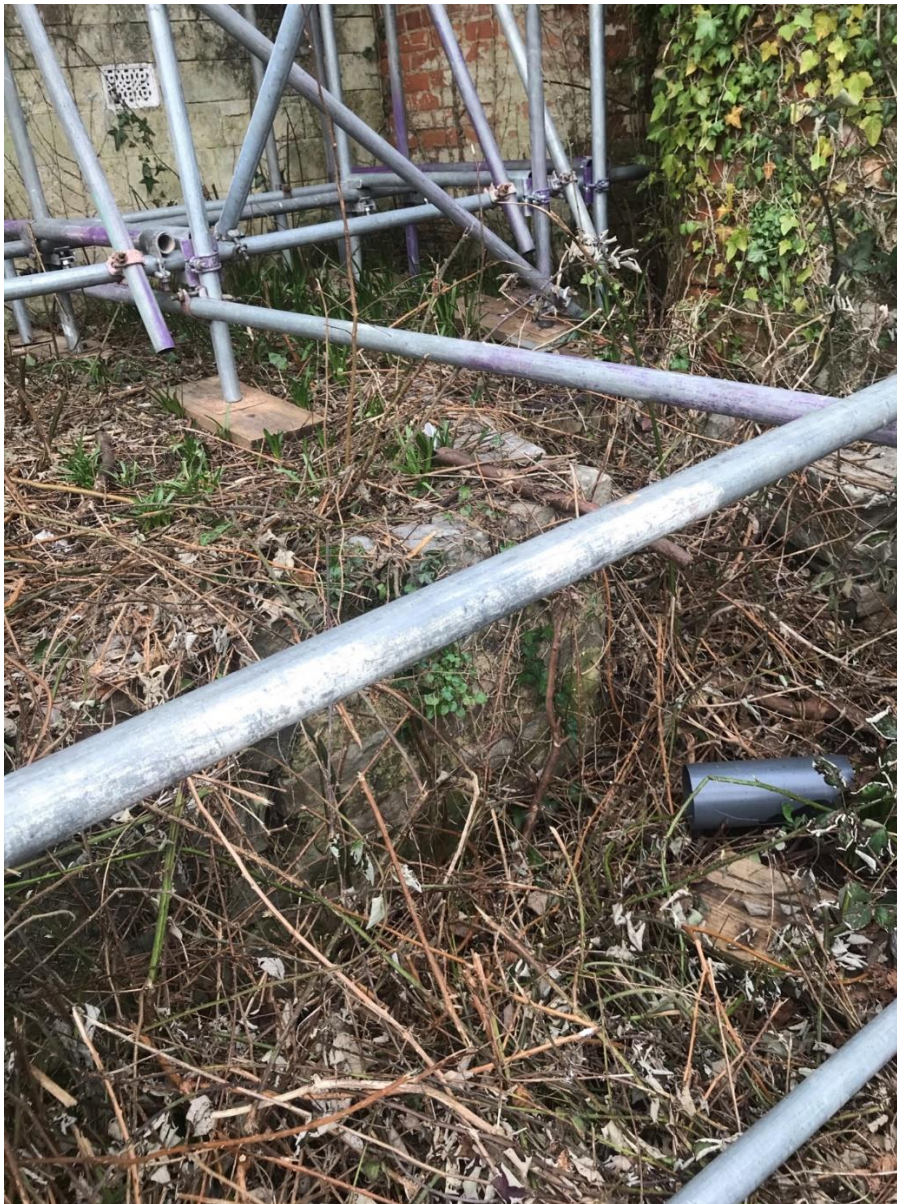
*Remains of existing retaining wall*

There is a raised terrace to the rear of the building (east) overlooking the garden. This terrace is formed by a curved retaining wall, which has in the main collapsed due to neglect.

Our new retaining wall follows the same shape in plan, and comprises a concrete foundation and wall, which will be faced in the original stone salvaged from the garden. The concrete wall will allow a cast iron balustrade to be fitted to the top of the wall to allow the terrace to be used safely by the staff.

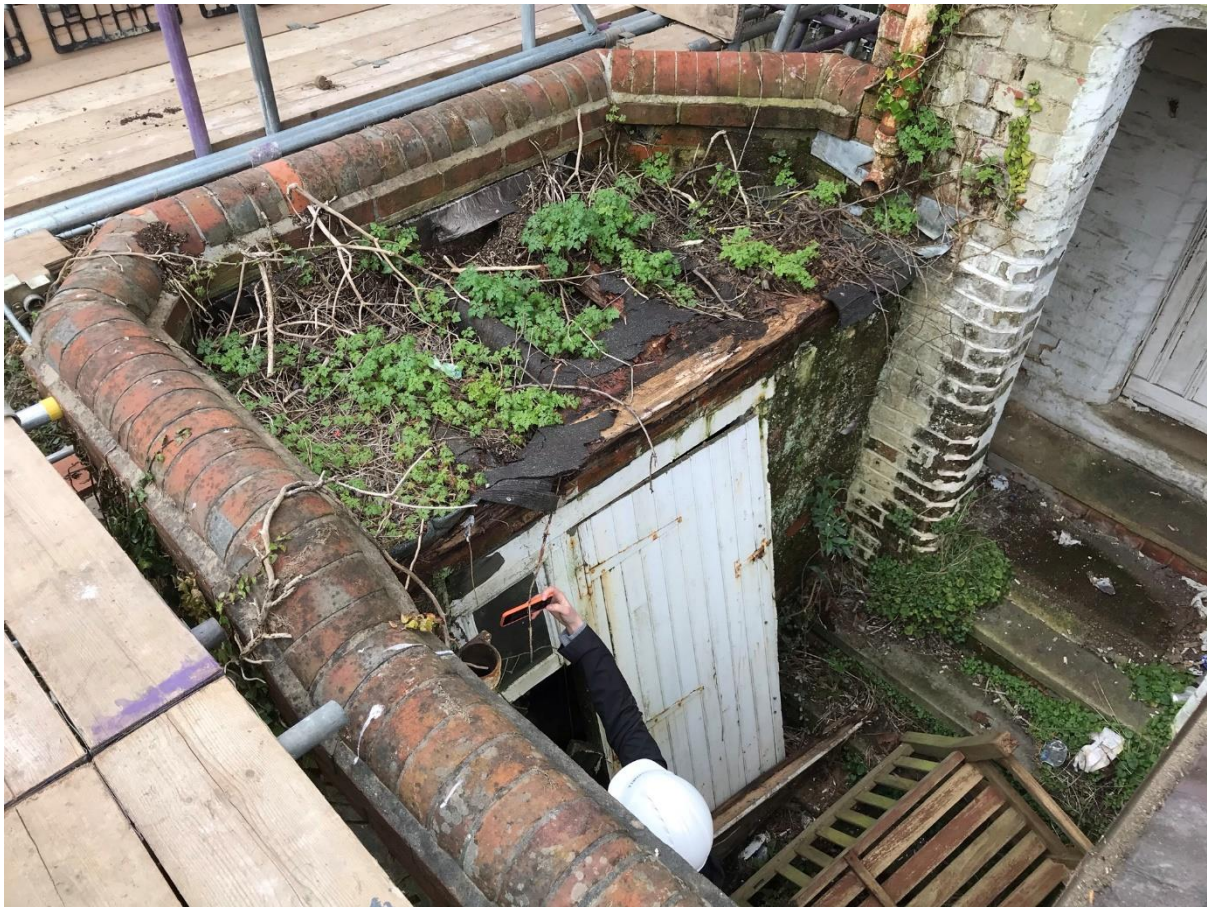
*Courtyard area with structure G22 to be demolished. Note rainwater discharge from main roof onto roof of this structure.*

There are two outbuildings in the brick extension to the rear of the property. The more substantial of these, designated G21 on our plans, will be retained and refurbished as plant space. Opposite this is G22, a lean-to structure that has collapsed due many years of rainwater from the main roof discharging onto the roof of this structure with no downpipe to take it away. We propose to demolish this structure, increasing the size of the courtyard which will be paved in blue brick pavers to match the adjacent external areas. The rainwater pipe from the main roof will be extended and will be connected to new drainage.

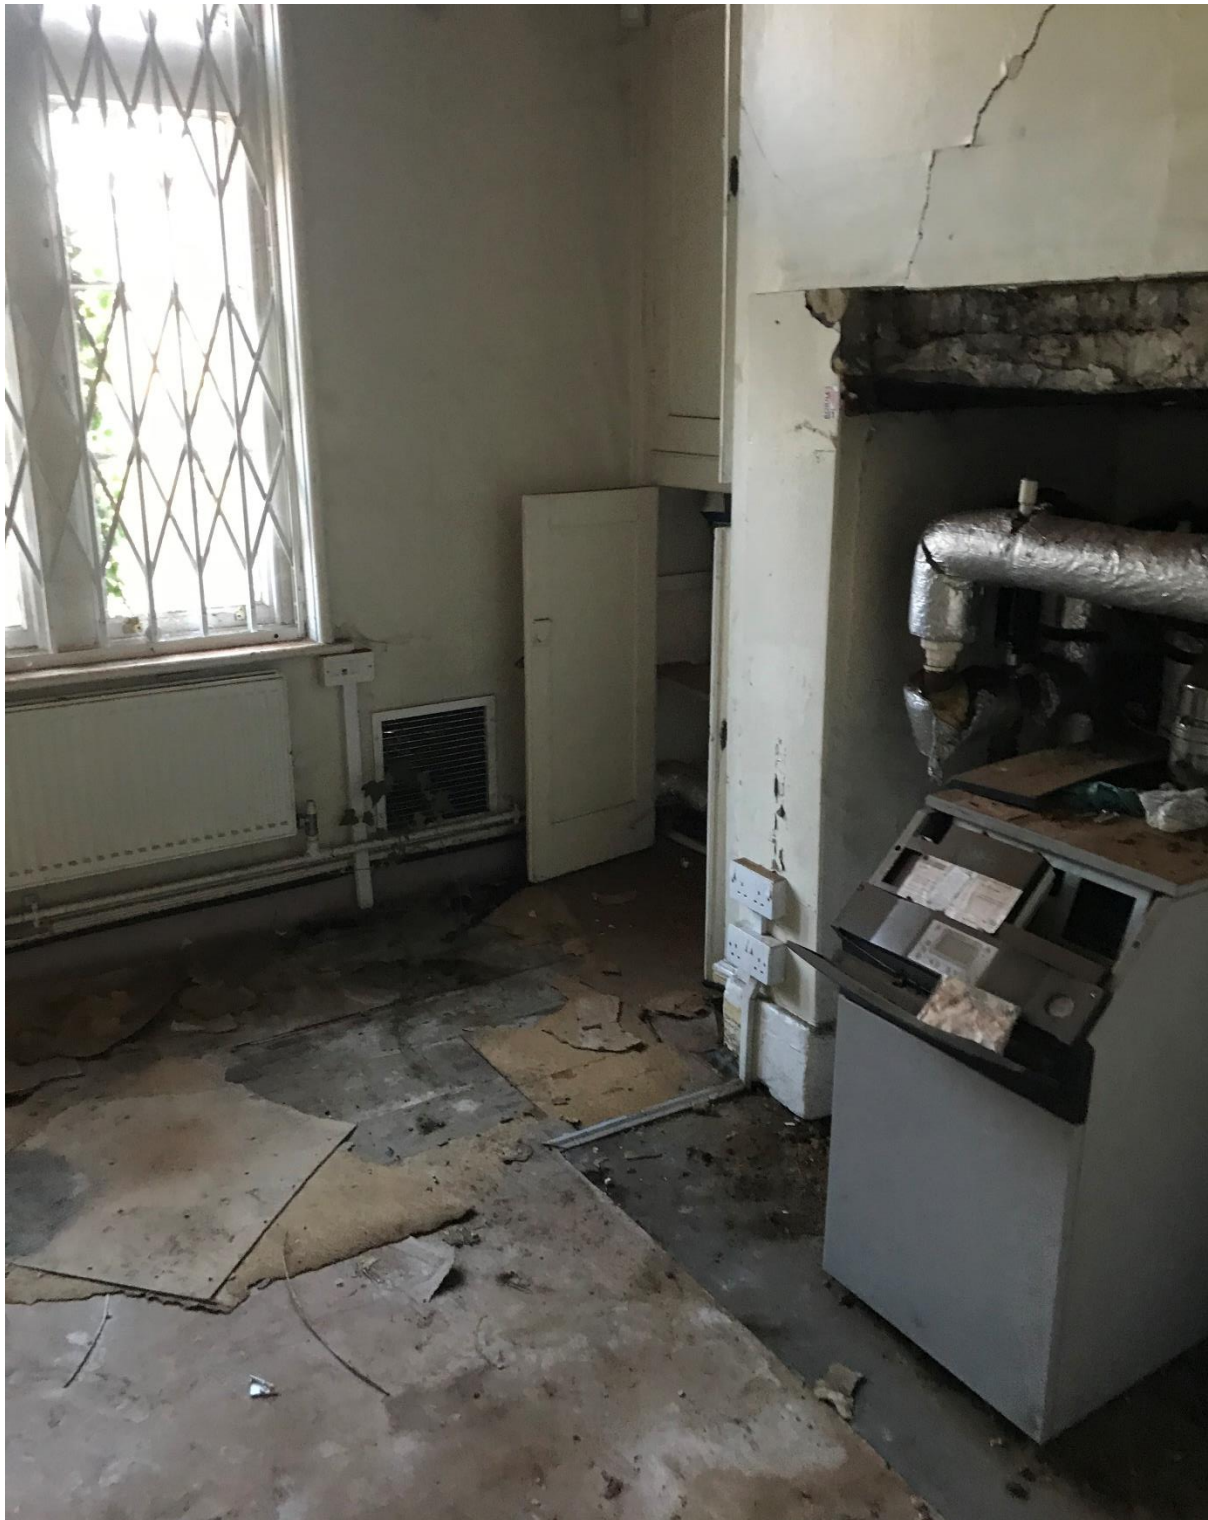
*Rear room in front of chimney breast is location for new platform lift*

Choosing the location of the lift to provide maximum access with the least effect on the building has been a major design challenge. Its chosen location is to the rear in a room that was previously the plant room. This room has in the past been modified removing most of its original features: the ceiling has been replaced with plasterboard without any cornice detail and the room has also suffered fire damage from a faulty boiler.

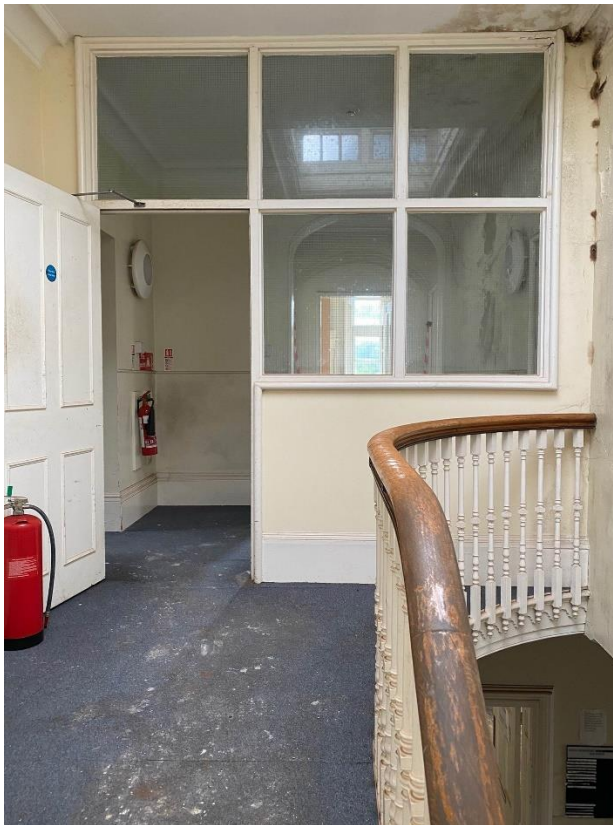
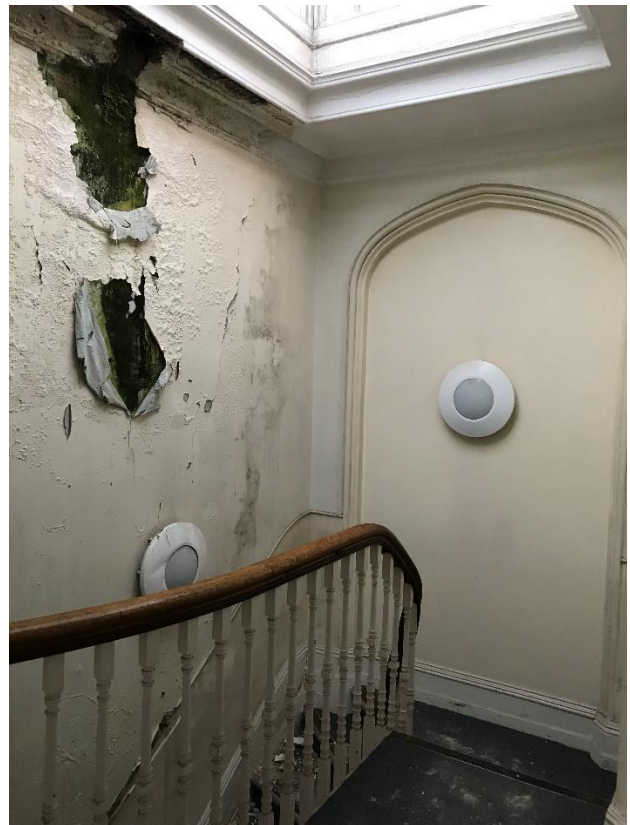
*The glazed screen at the top of the stairs (left) and the archway between F01 and F10 (right)*

The modern glazed screen at the top of the staircase has been removed due to the timber being infected with dry rot. We are hoping not to have to install a new screen (discussions are ongoing with the Building Control Officer) to restore the landing to its original configuration. We also hope to open up the archway between the stair F01 and corridor F10, again subject to building control advice. This archway originally gave access from the stair F01 to corridor F10 and the north end of the building, and will provide natural borrowed light from the lantern into corridor F10 as well as reinstating the view of the lantern and curved stair from this viewpoint.
