# Risk Assessment of Ground Under Existing Centre

## Rivermead Leisure Centre New Build, Reading

Contract No./Report Type: 21-069/RA  
Produced for Pellikaan Construction Ltd

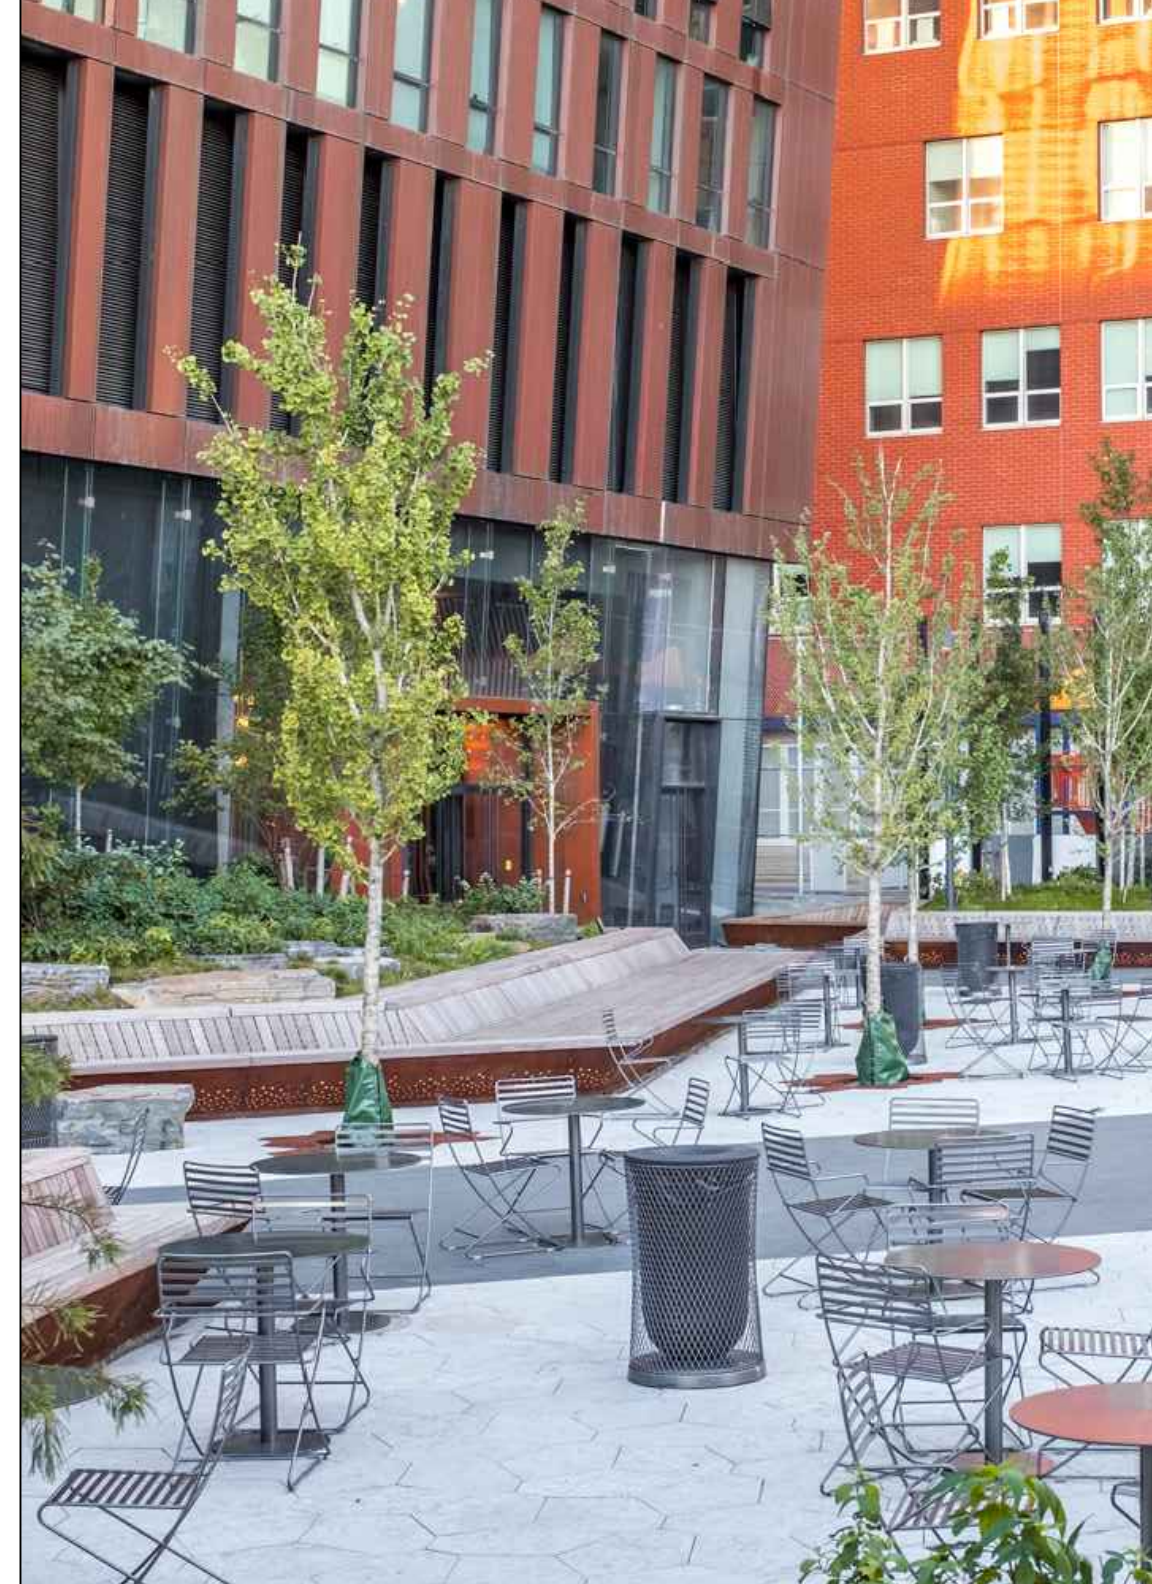
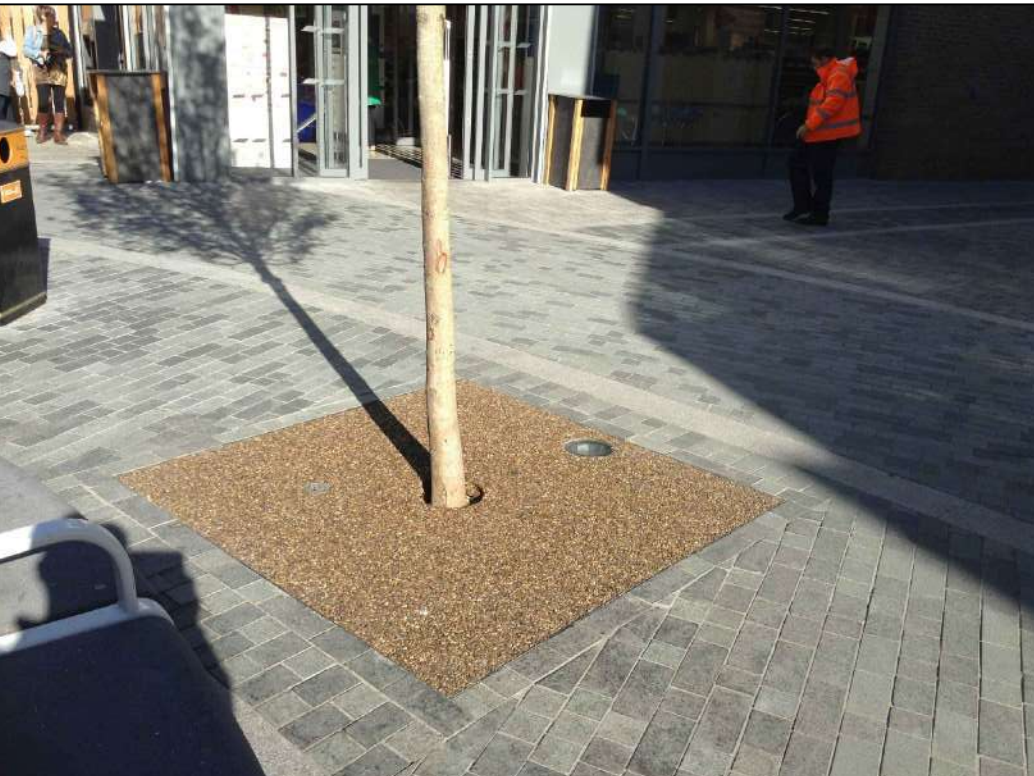
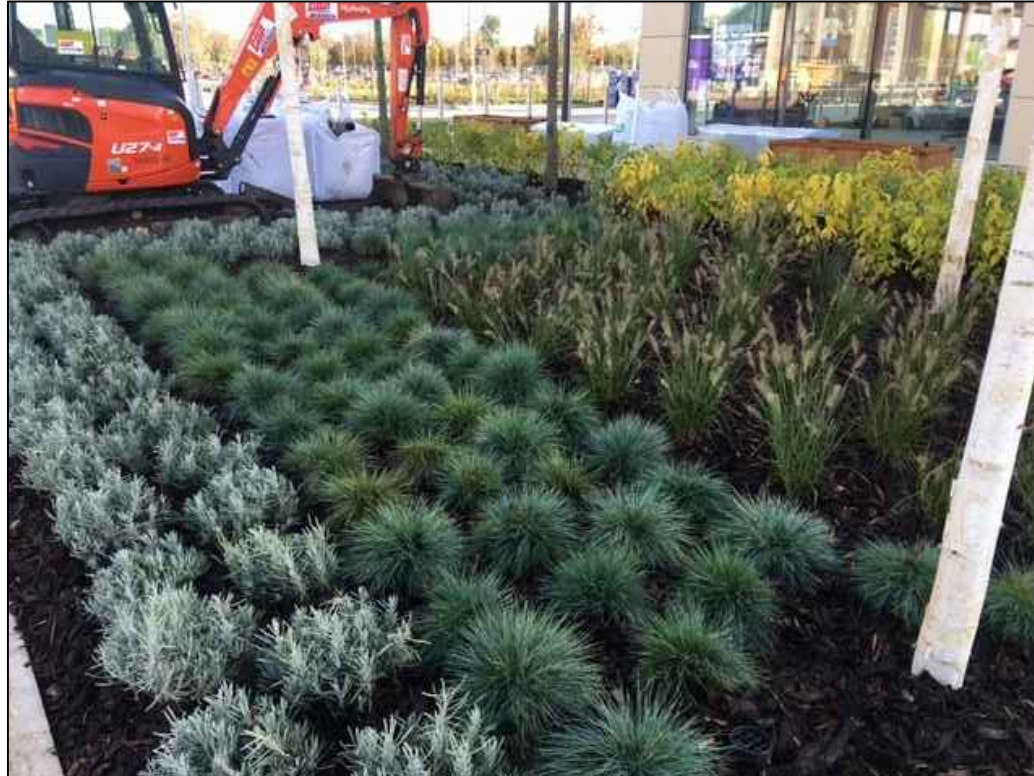
Title: Outline Landscaping Proposal

- Not shown on the RBC Tree Survey
- Shall be part of GLL development boundary but within GLL demise
- Trees to be protected and retained as requested by LPA
