## REMEDIATION STRATEGY

### RIVER ACADEMY READING

REC REFERENCE: 1-CO108720

REPORT PREPARED FOR: MACE GROUP LTD

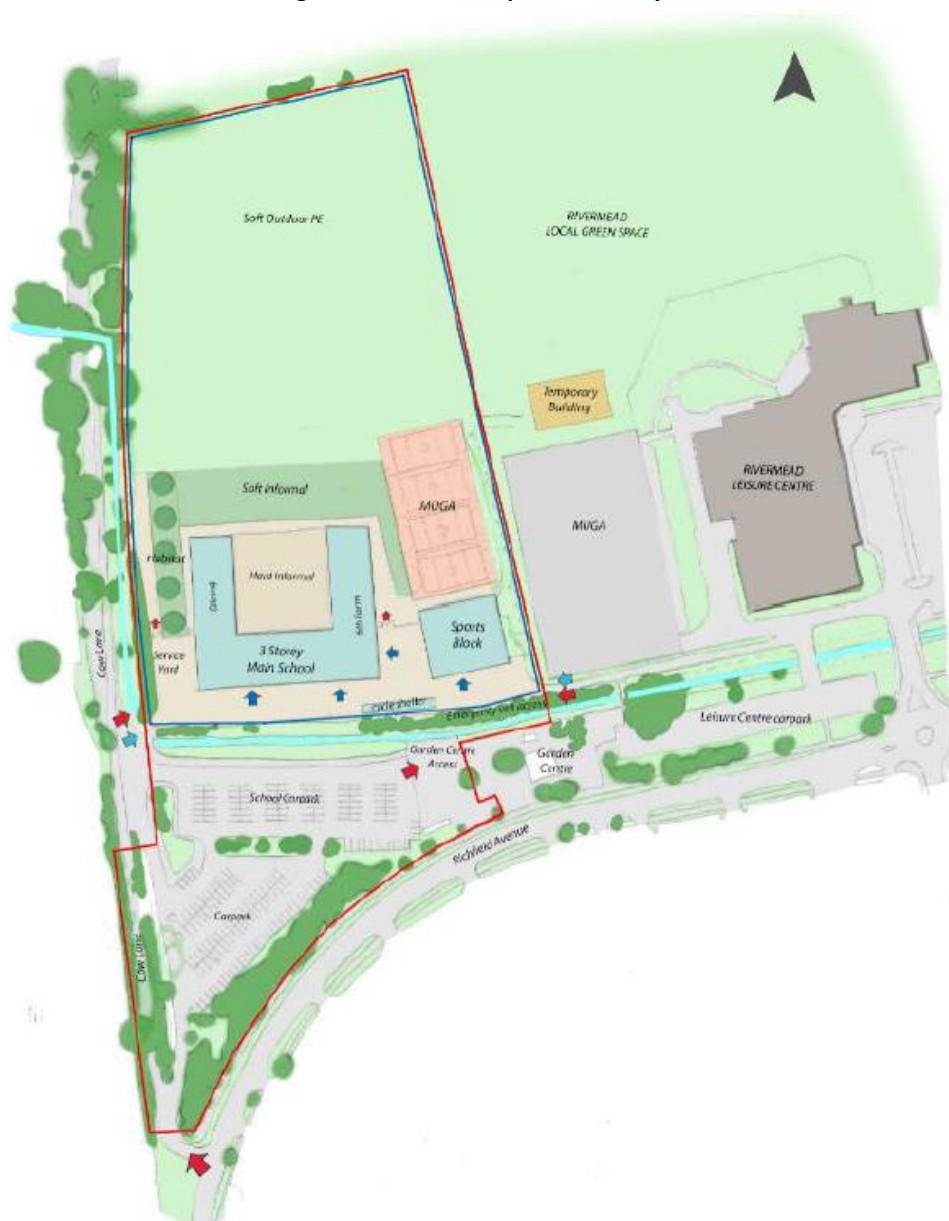
**Figure 3.1**      **Proposed Site Layout**

A proposed site layout plan is included in Drawing No. 1-CO108720-002 and reproduced as Figure 3.1 below.

REC understands that the proposed development comprises the construction of a new secondary school with associated outdoor athletics facilities within the northern portion of the site and staff and visitor car parking spaces the south of the proposed school structures. The layout is to comprise of two separate structures forming a “main” building and a sports hall. Proposed development (ref. 1CO108720-002) layout for the site can be found presented within Appendix III.

Assessment of the four proposed site uses has been undertaken separately. It is considered, given similar ground levels across the site with the exception of the proposed car park, historical landfill covering the entirety of the site, that there is no advantage to altering the current proposed development layout. Although it is recommended that buildings are not placed within the area of the proposed car park due to the increased flood risk.

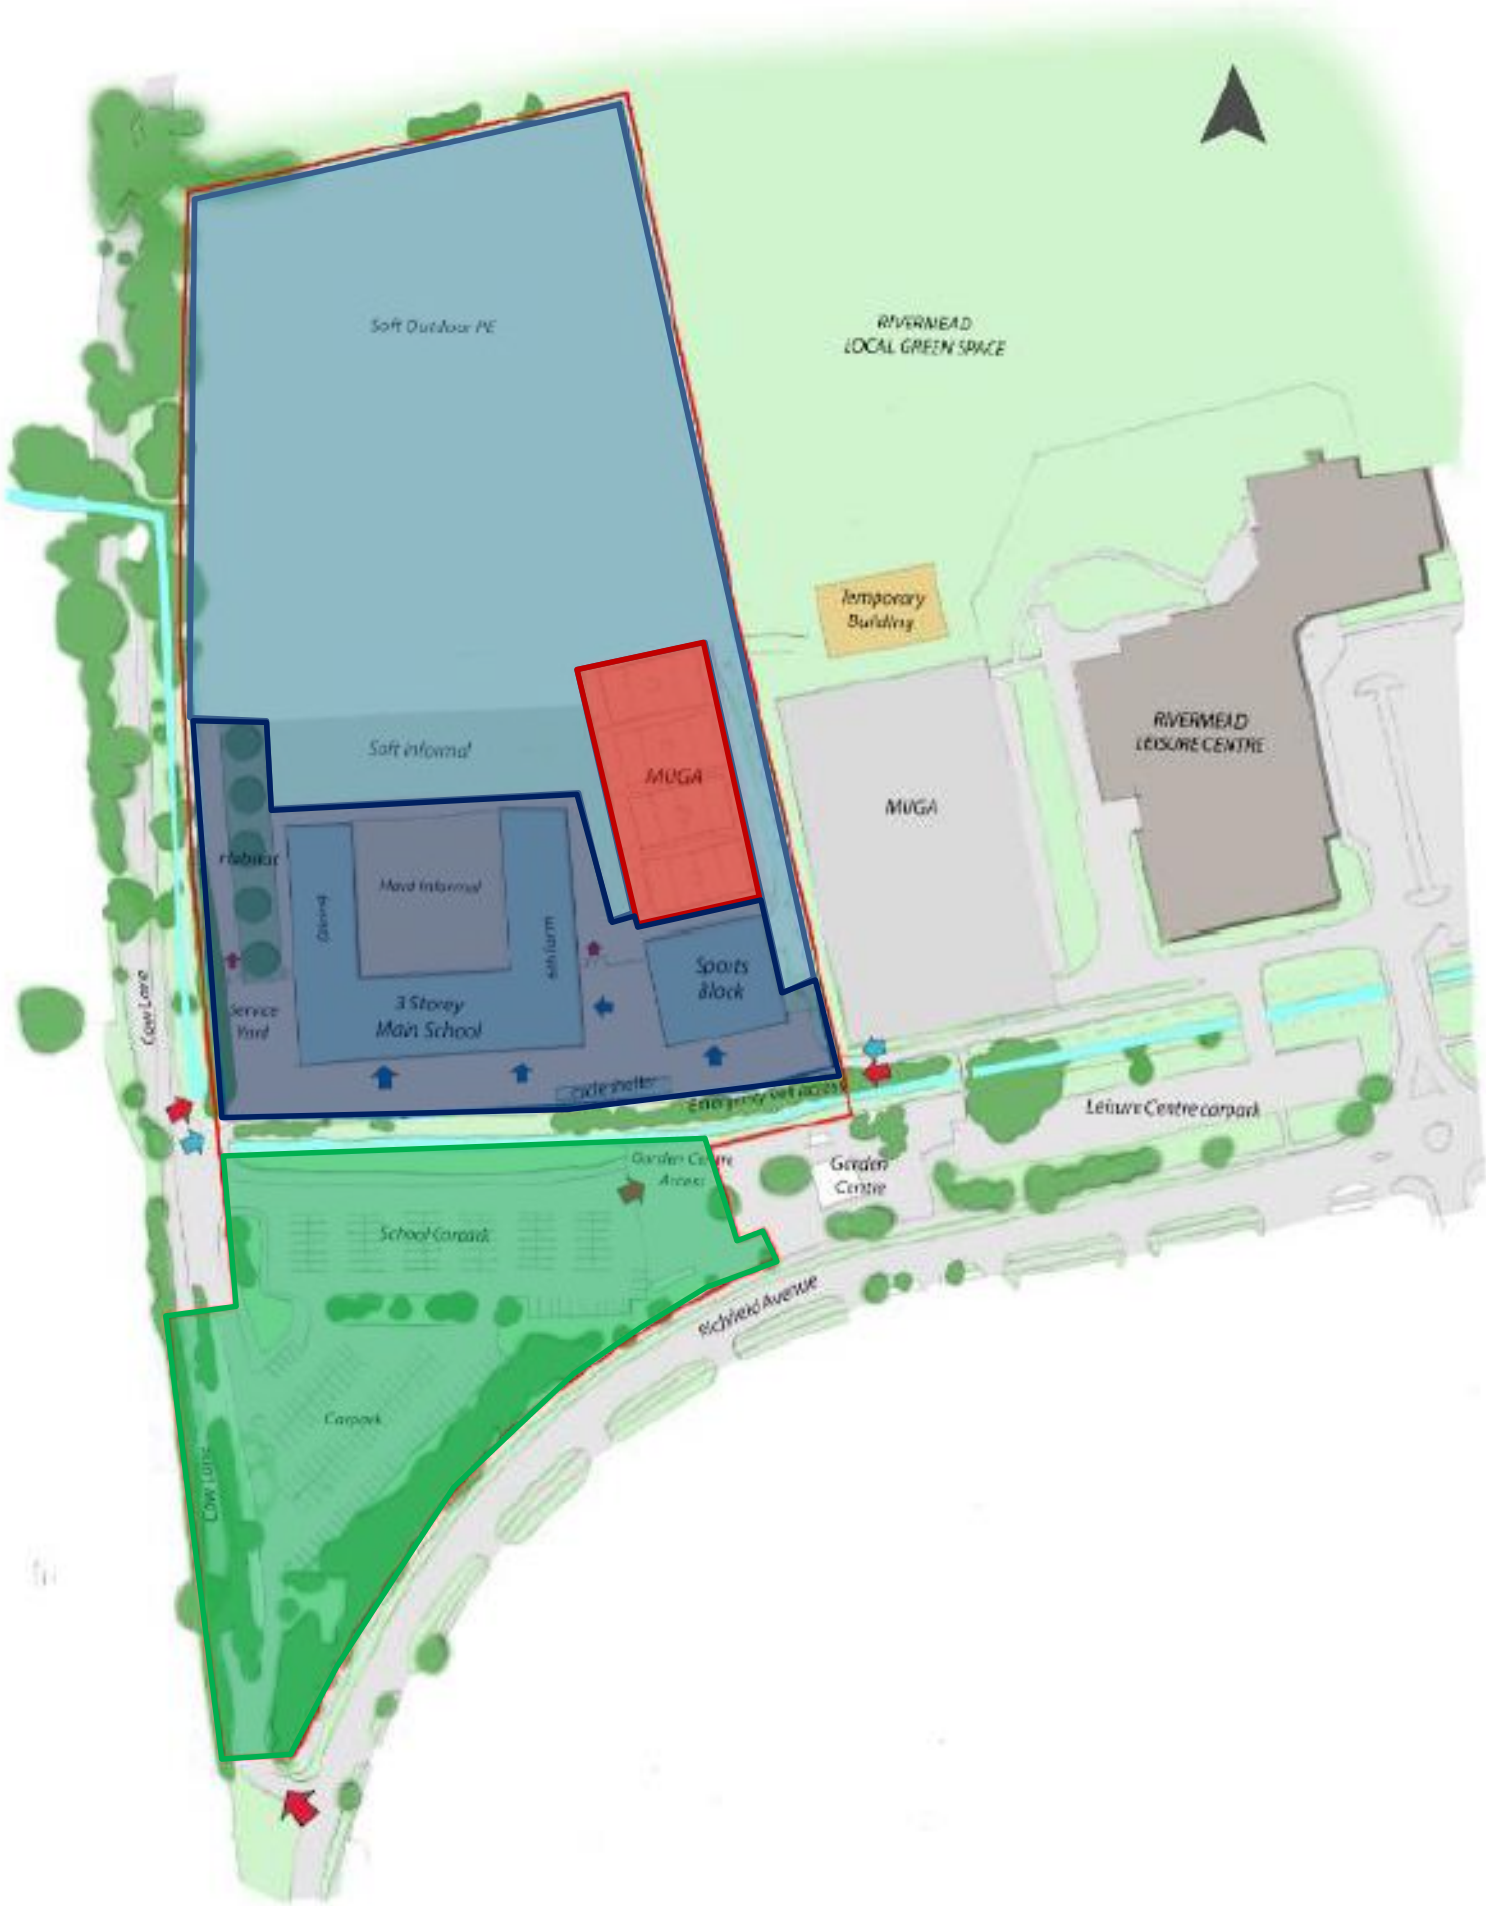
- Gas monitoring for assessing passive venting requirements.
  - Option to raise ground level due to flooding potential.
  - Hardstanding breaks pathway.
