# 43A CHURCH ROAD, CAVERSHAM, BERKSHIRE

## HERITAGE STATEMENT

**PROJECT:** 43A Church Road, Caversham, Berkshire

**DOCUMENT TITLE:** Heritage Statement

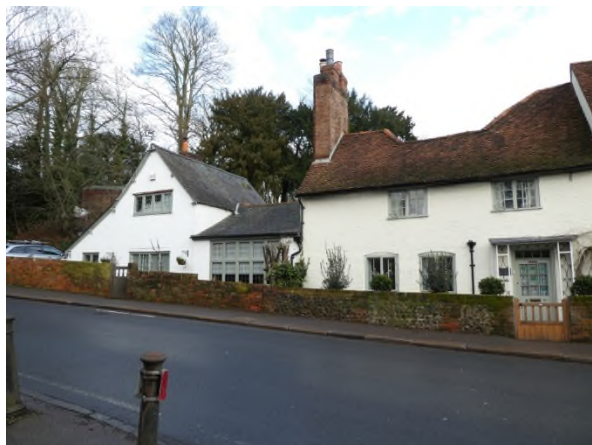
Figure 1: 43 Church Road (right) and 43A Church Road (left)

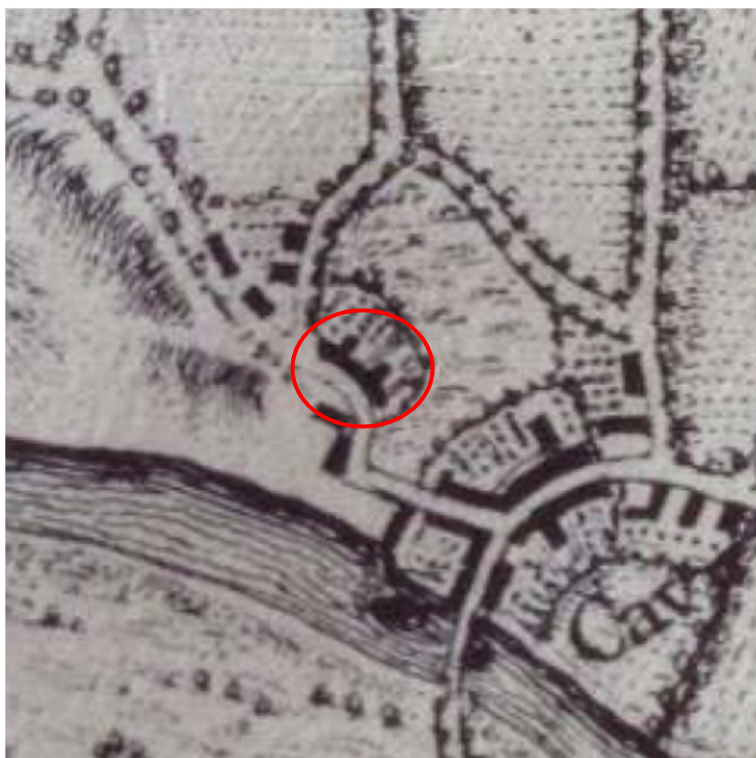
- 3.2.1 John Rocque's map of Berkshire provides the earliest available cartographic evidence for 43 and 43A Church Road. This map shows a building with a long, linear footprint with wings to the rear on the northern side of Church Road. An L-plan building is shown on the opposite side of the road which relates to the Grade II listed Caversham Court Stables.

Figure 2: Extract from John Rocques map of Berkshire (1761)

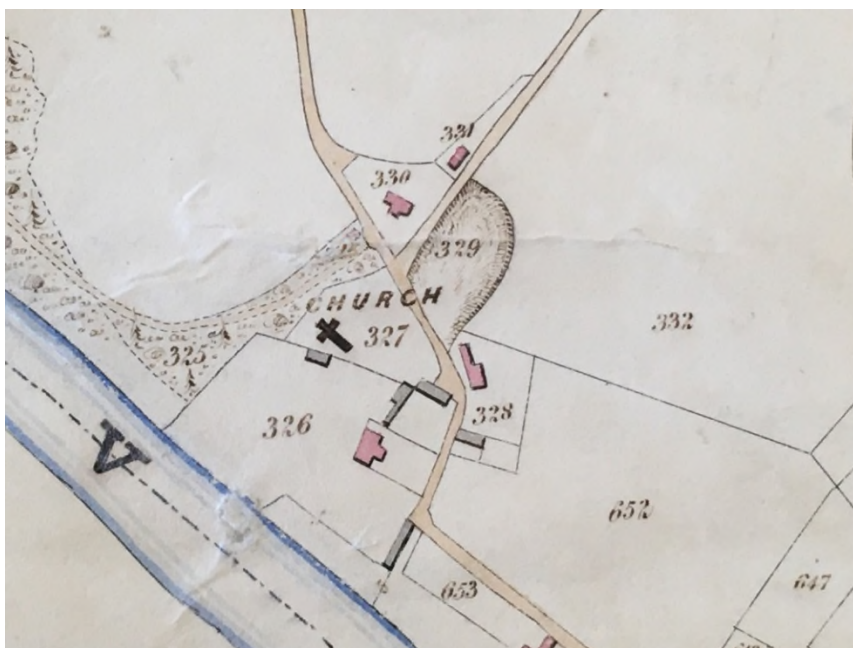
- 3.2.2 A Plan of Caversham (1844) shows 43 and 43A Church Road (marked 328) on the south-eastern side of a chalk pit (marked 329). The footprint of the building is clearly wider at the south-east end (i.e. 43 Church Road) and narrower on the north-west side (43A Church Road). The Rectory (demolished) and an L-plan layout of outbuildings (including the Grade listed Stables) are shown on the southern side of Church Road adjacent to 43/43A Church Road.

Figure 3: Extract from a Plan of Caversham (1844)

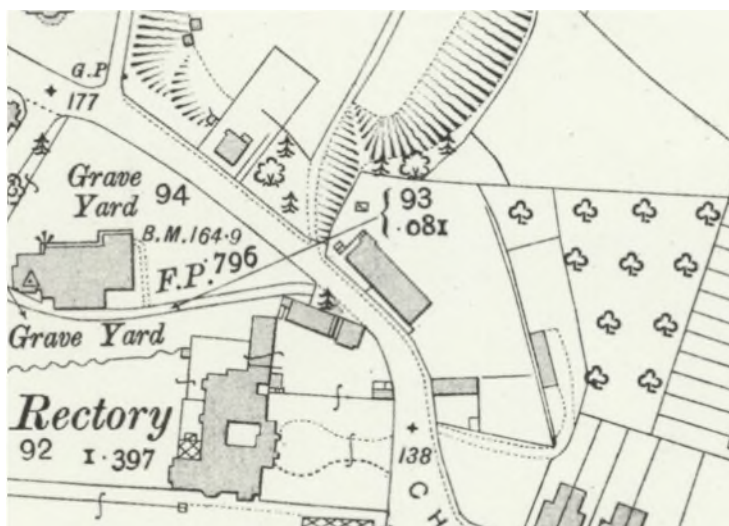
- 3.2.4 The 2<sup>nd</sup> and 3<sup>rd</sup> editions of the Ordnance Survey maps (1899 and 1913) do not show any clear changes to 43/43A Church Road. There is a small outbuilding, possibly including a greenhouse, and a small enclosure to the north and north-east of 43A Church Road shown on the 1913 map.

Figure 5: Extract from the 3<sup>rd</sup> edition of the Ordnance Survey map (1913)

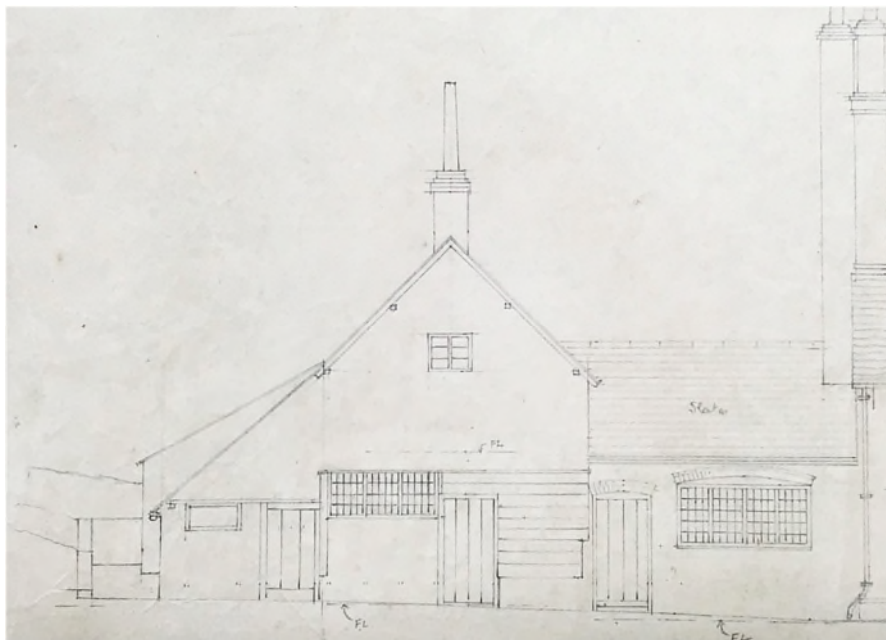
- 3.2.5 Survey drawings of Banksfoot (43/43A Church Road) were produced in August 1920 as part of a scheme of alterations undertaken by W Nicholas, the owner. The 1 ½ storey element at the centre of 43A Church Road includes a small casement window to the upper floor and a slightly off-centre plank door with what appear to be leaded lights with mullions to the right. Part of the ground floor elevation to the right of the door is finished with weatherboards. There is a lean-to structure to the left which also includes a plank door and window opening. The single storey structure to the right includes a plank door and four-light window, both with segmental arched heads.

Figure 6: Front elevation of 43A Church Road in 1920

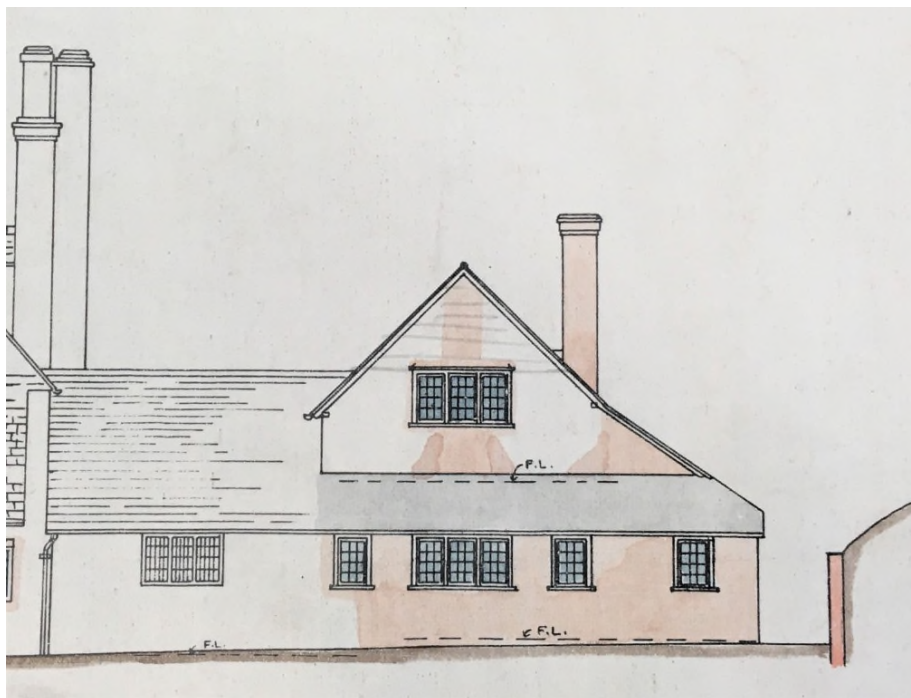
- 3.2.9 The drawing detailing the proposed rear elevation shows that the rear stacks, bread oven and associated lean-to rood structures were demolished and replaced with a new lean-to. A replacement chimney was inserted along the north-west wall of the kitchen (now living room). The lean-to did not incorporate any of the existing structures to the rear.

Figure 10: Proposed rear elevation (1920-21)

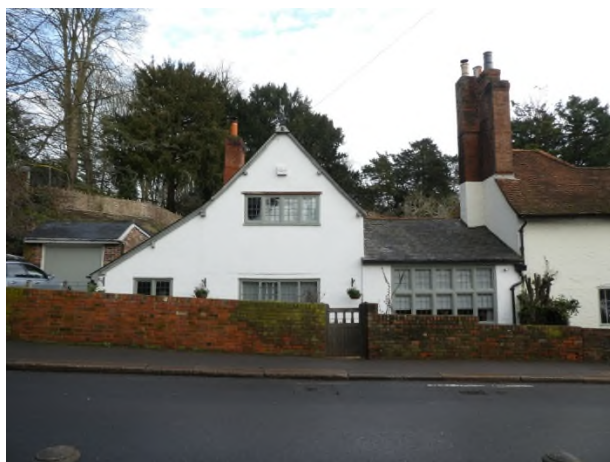
- 4.1.1 The front elevation includes the predominantly rebuilt lean-to on the left hand side. The pattern of brickwork matches that of the rear lean-to, i.e. mostly stretcher bond. This brickwork extends (at ground floor level) to the left hand edge of the large window to the kitchen on the right hand side of the elevation. Below and to the right of this window is older header bond brickwork which is possibly 18<sup>th</sup> century. There is a straight joint where No. 43A abuts No. 43. The ground floor window to the current living room was recycled from the current kitchen as part of the early 1920s work. The window details, such as catches with decorative back plates, differ from the early 1920s window details.

Figure 13: Front elevation

- 6.2.7 The low profile and physical separation of the proposed extension will allow the continued appreciation of the listed building from a rear aspect. Views from Church Road to the rear of 43A Church Road are limited (**figure 13**). As stated above, the proposed zinc roof will reflect the appearance of the existing natural slate roof finishes of the listed building. The vertical boarding of the south-west elevation of the proposed extension will be partly visible in glimpsed views from Church Road but this will be broken up by the slate roof over the proposed staircase to the upper floor of the extension.

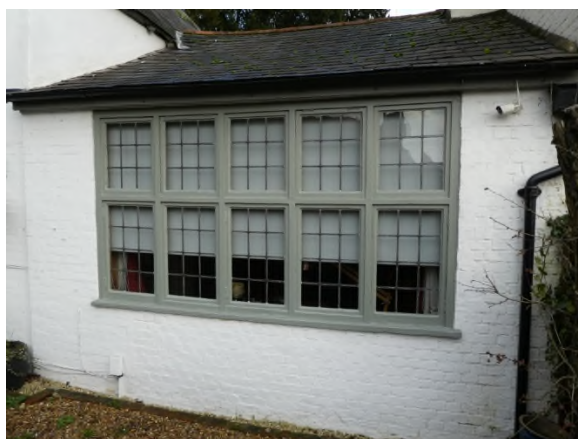
Figure 14: Change from stretcher bond to header bond on the left hand side of the 1920s window

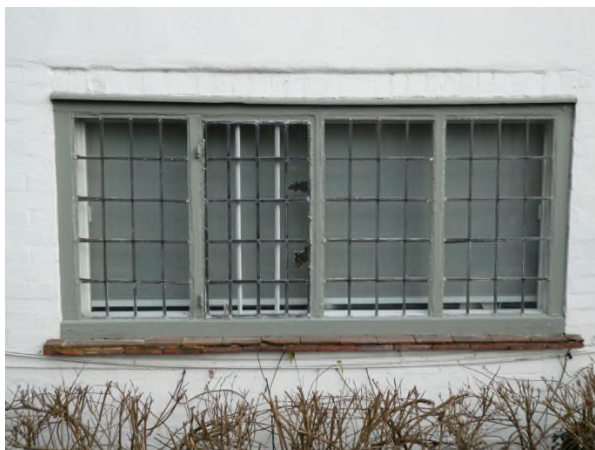
Figure 15: Window from the kitchen re-used for the living room as part of the 1920s works

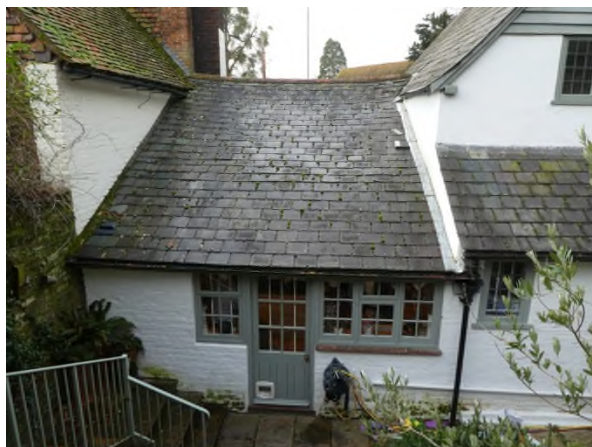
- 4.1.2 The rear elevation includes the single storey element with white painted brick, slate roof, modern windows and rear door. The brickwork is in Flemish garden wall bond and the brick dimensions are similar to later 18<sup>th</sup> and 19<sup>th</sup> century sizes. The central 1 ½ storey element is partly masked by the early 1920s lean-to extension. The upper part of the elevation is partly rendered but includes weatherboards in the gable apex and an early 1920s window with leaded lights. The early 1920s lean-to is constructed of brick in predominantly stretcher bond and includes the early 1920s pattern of windows.

Figure 16: Left hand side of the rear elevation

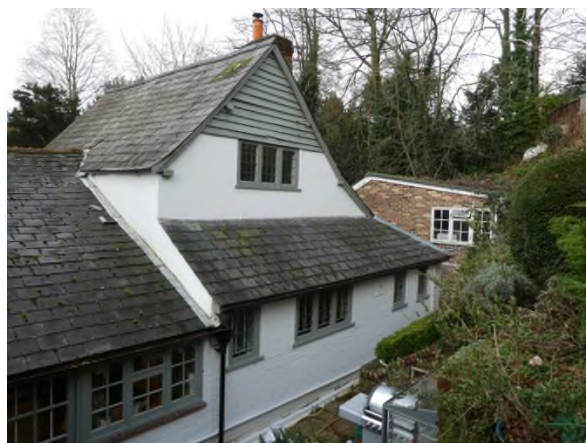
Figure 17: Phase 1 structure with 1920s lean-to

- 6.2.2 It is proposed to partially demolish the rear lean-to extension to create a larger linking space between the existing house and the proposed extension (**figure 17**). This would impact on 1920s fabric only, including windows. The revised scheme includes the removal of a corner section forming a pillar. There would not be a particularly greater degree of loss of definition or impacts on the proportions of spaces than was included in the pre-application submission. There were no concerns raised at pre-app in relation to the removal of these sections of wall. This element of the listed building is of early 20<sup>th</sup> century date and is considered to be of low heritage significance.

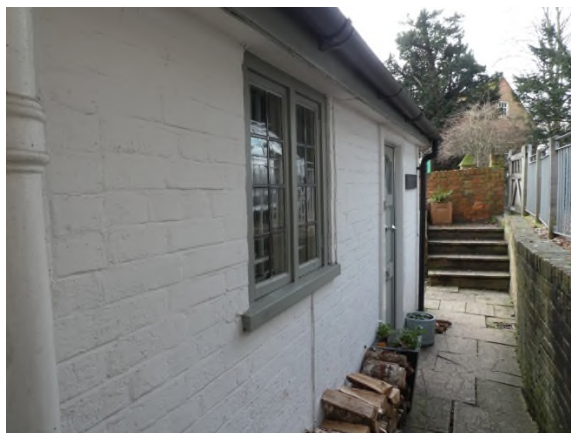
- 4.1.3 The side elevation is largely blank. There is an infilled door opening in line with the side gate. This door opening was originally created as part of the early 1920s alterations. The right hand side of this elevation includes a window and door opening. The window is of 1920s date but the original plank door has been replaced with a modern panelled door.

Figure 18: Right hand side of the north-west elevation with modern door to the right

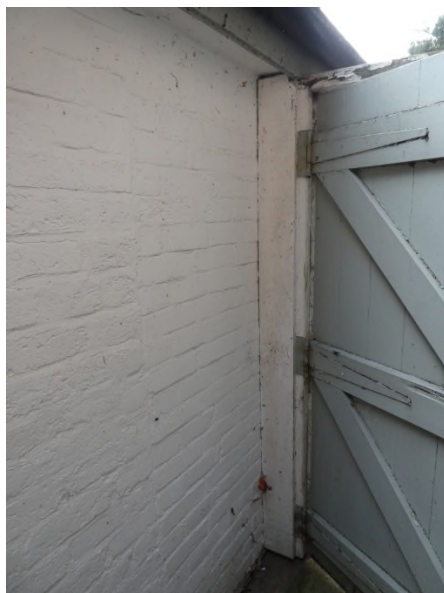
Figure 19: Blocked door opening on the left hand side of the north-west elevation

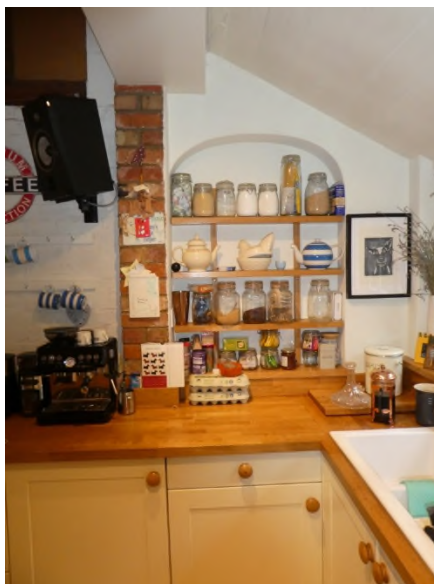
- 4.2.1 The kitchen is a single open space. The original passage on the north-east side has been removed at some point during the course of the 20<sup>th</sup> century. The windows and door leading to the back garden are modern replacements. There is a blocked opening with curved head on the right hand side of the north-west internal wall that relates to the creation of access between the staircase hall at No. 43 and the kitchen (now living room) at No. 43A. At the centre of this room there is a door opening which was blocked up as part of the early 1920s work and is now used as a cupboard. There is a large open fireplace with segmental arched brick head on the south-eastern side of the room. The existing and proposed drawings from 1920 suggest a much smaller fireplace for a coal grate. This suggests modifications to the existing fireplace since the 1920s.

Figure 20: Infilled door opening created in the early 1920s

- Removal of a ground floor wall to the bathroom.
- 6.1.2 Both doors to be blocked up in the wall between the kitchen and living room represent later 20<sup>th</sup> century changes to the house and are therefore not considered to be of interest. The insertion of a door to the rear of the kitchen would reinstate a door opening created as part of the early 1920s works (**figure 20**). These works are considered to have a neutral impact on the significance of the listed building.

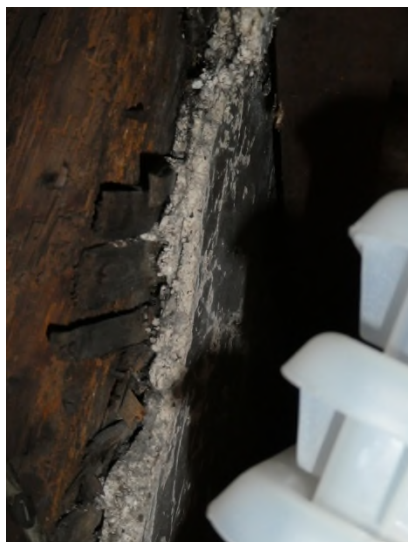
Figure 22: Lath and plaster finish on the upper part of the wall on the north-west side of the kitchen

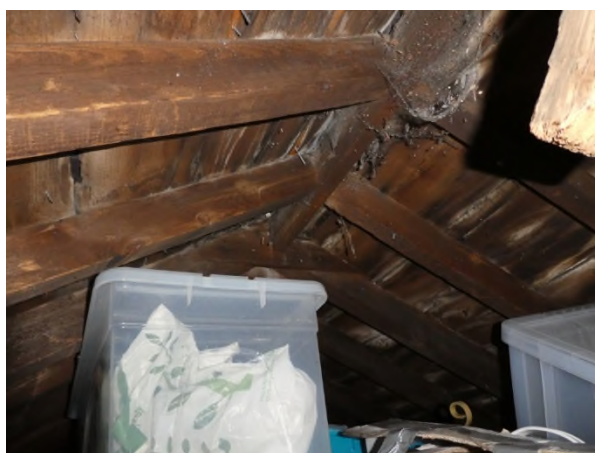
- 4.2.3 The roof structure over the kitchen is shallow pitched and includes common rafters with a ridge plank and sarking boards over. The timbers are machine sawn softwood.

Figure 23: Roof structure over the kitchen

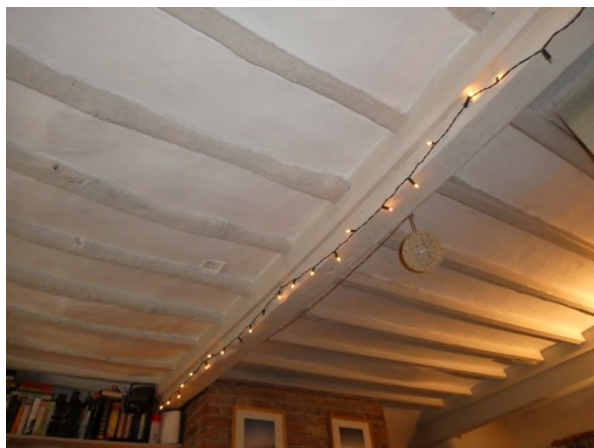
- 4.2.4 The Living Room is accessed from the kitchen through a door opening which appears to have been created post-1920s. The architrave is typical of early 20<sup>th</sup> century design but remains popular today. The door is early 20<sup>th</sup> century style. The ceiling of the living room includes two chamfered transverse beams. There are chamfer fillets on each side of these beams which were added as part of the 1920s work to provide additional support to the joists. The beam at the north-eastern end of the room was inserted as part of the early 1920s work following demolition of the chimney stacks on this side of the building. Some of the joists include chamfers with runout stops. These are approximately 75mm wide. The details of the ceiling structure suggest an early 18<sup>th</sup> century date.

Figure 24: Chamfered beams and joists in the living room

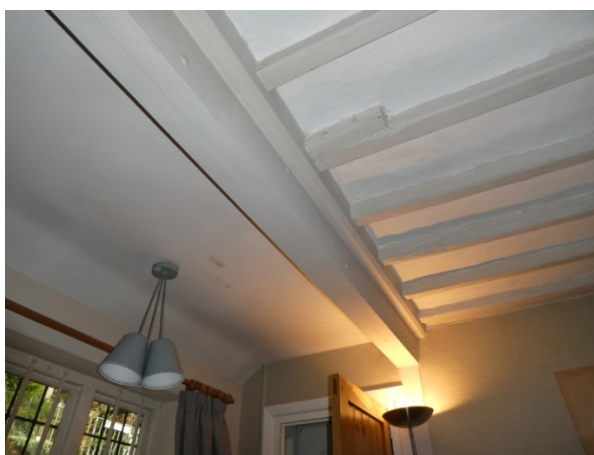
Figure 25: 1920s beam on the north-eastern side of the living room

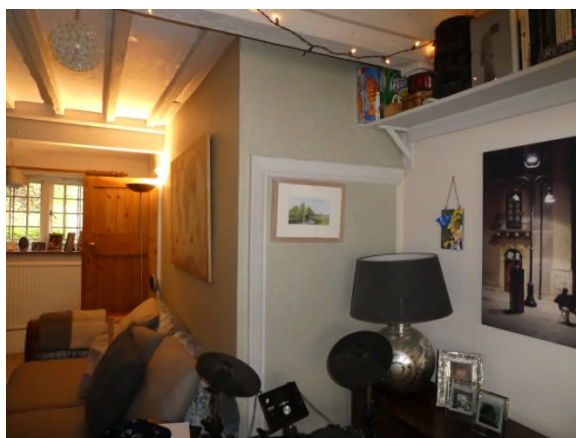
- 4.2.5 The area below the early 1920s staircase is enclosed and the associated cupboard is accessed from the kitchen. The partitions of the cupboard under the stairs are formed of breeze blocks. A 1920s chimney breast/fireplace occupies the north-western side of the room. The doorway on the right hand side of the chimney breast leads to a bathroom. The 1920s plans show that this was designed to provide access to a porch flanked by a fuel store, boiler room and W.C. The door architrave is characteristic of 1920s style.

Figure 26: Enclosure to the 1920s staircase

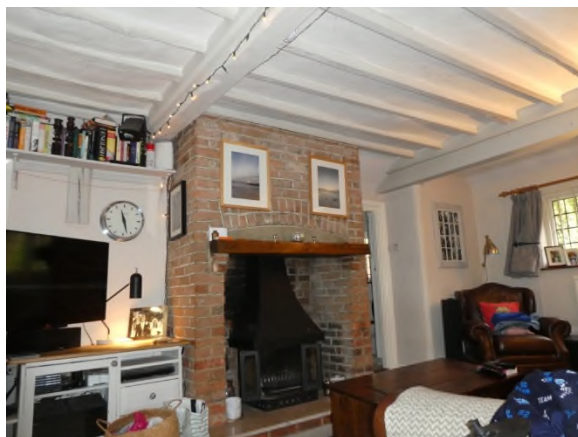
Figure 27: 1920s fireplace

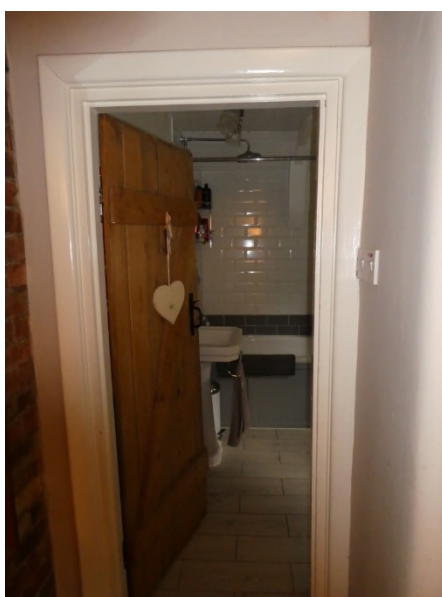
Figure 28: Door opening to the bathroom (formerly a porch in the 1920s)

- 6.1.3 The removal of the partition on the south-east side of the ground floor bathroom would impact on 1920s fabric which is considered to be of low significance (**figure 28**). This area relates to the 1920s alterations and has already been substantially altered in the later 20<sup>th</sup> century to accommodate a bathroom.

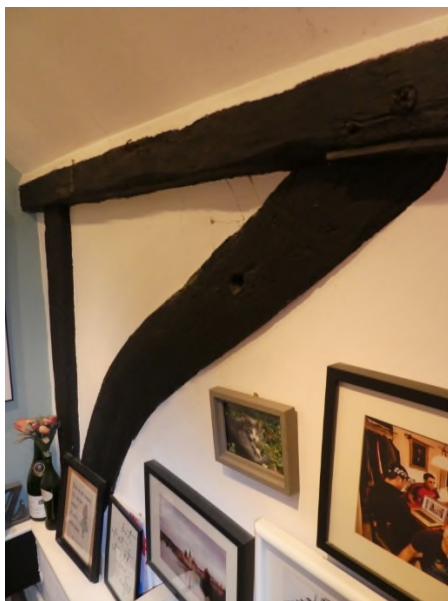
- 4.2.6 An interesting feature on the first floor is the ogee brace visible at the head of the stairs. This type of wall frame feature is characteristic of 16<sup>th</sup> century building techniques. It is incompatible with the stud framing visible from within the kitchen. Further stud framing with a lath and plaster finish on the north-western side of the living room can be observed from within the roof void of the lean-to on the north-west side of the house.

Figure 29: Ogee brace on the first floor

5.2.3 The evidence of the roof structure over the first floor bedrooms (clapsed purlin), the fabric of the first floor wall frames (stud with lath and plaster finish) and the form of the ceiling beams and joists suggest an early 18<sup>th</sup> century date for this phase of the building's historic development. There are, however, a number of anomalies, including an ogee brace and

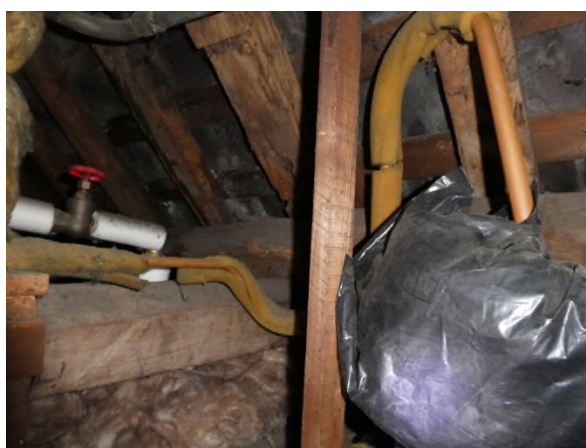
- 4.2.7 The roof void over the first floor bedrooms includes a collared truss and clasped purlins. The apex of the common rafters appear to have a bridled joint and a small number of the rafters are flatways. The flatways rafters are a further indication of c. 16<sup>th</sup> century techniques but it is currently unclear whether this represents re-use. The ceiling joists are narrow softwood and are probably of later 19<sup>th</sup> century date.

Figure 31: Clasped purlin roof structure over the first floor bedrooms

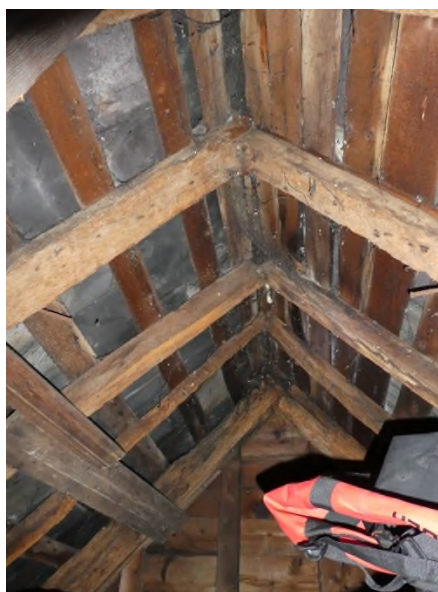
Figure 32: Mix of flatways and on-edge rafters

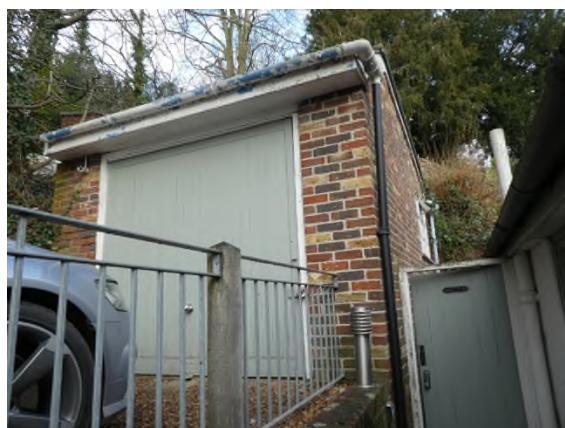
- 6.3.1 It is proposed to demolish the existing garage and construct a replacement garage. The existing garage was built in 1979 and is of poor quality design. The demolition of the garage would enhance the setting of the listed building character and the character and appearance of the St Peter's Conservation Area.

Figure 33: Late 1970s garage
