## **PHASE 3 REMEDIATION STRATEGY**

**Proposed Educational Development**

**Ranikhet Academy, Pey Road, Tilehurst, Reading**

**Report No: 6671/P3**

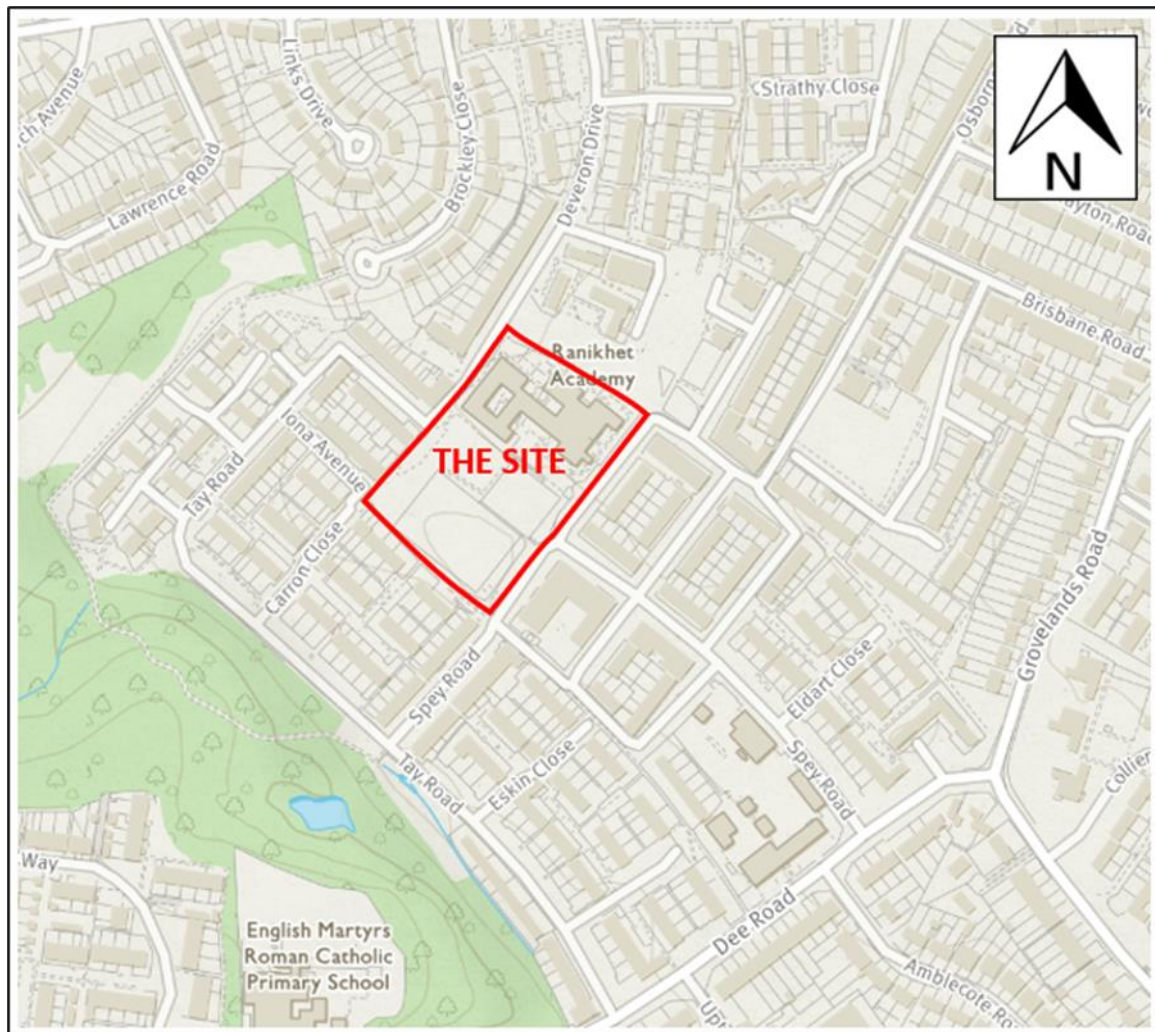
**Drawings 1.1:** Site Location Plan

The site is centred approximately on National Grid Reference (NGR) SU 68377 73603. The site location is presented in **Drawing 2.1** below.
