office refurbishment/alterations  
149/150 friar street and 2/4 queen victoria street, reading  
design and access statement  
(including brief planning statement and heritage statement)  
*Issue 01 dated 9 July 2018*

The refurbishment of, and alternations to, the  
existing premises for continued office use.  
Works to include window and door repairs and  
reinstatement, ceiling repairs and restoration,  
removal of modern partitions, opening up of  
various smaller spaces, restoration of the original  
staircase and landing arrangement, replacement  
of the roof linings, general decoration and  
incorporation of new WCs, kitchens and services

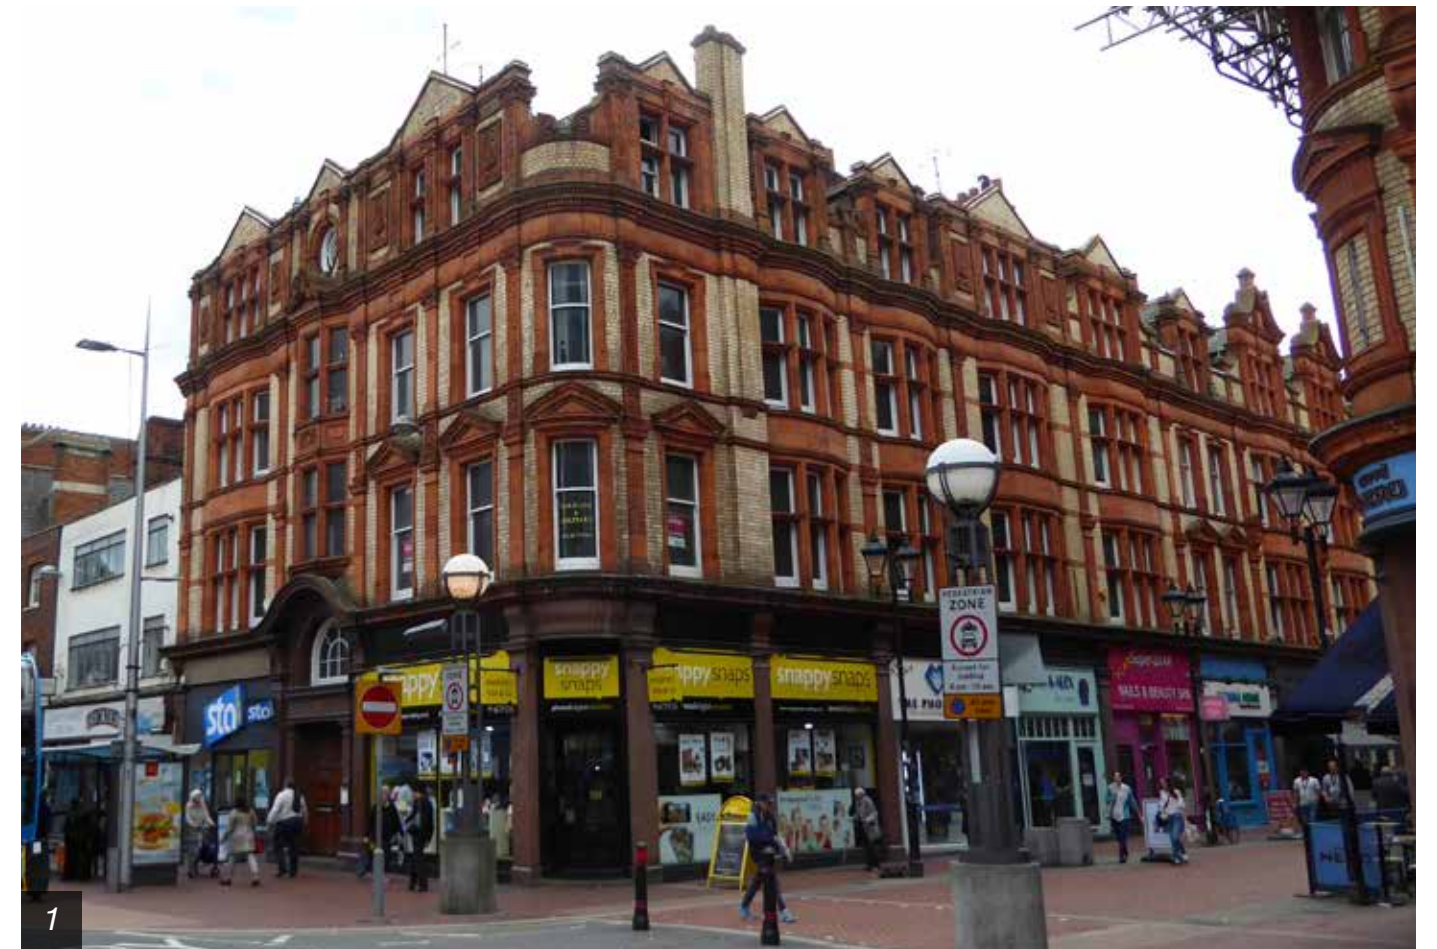
Fig 1: Exterior view

The striking elevations comprise of buff/yellow brick and sculpted terracotta ornamentation with a slate pitched roof, which in turn forms part of the impressive and civic set-piece street. The offices contain many impressive historic features, however later adaption has led to some harmful (and mostly reversible) alternations.

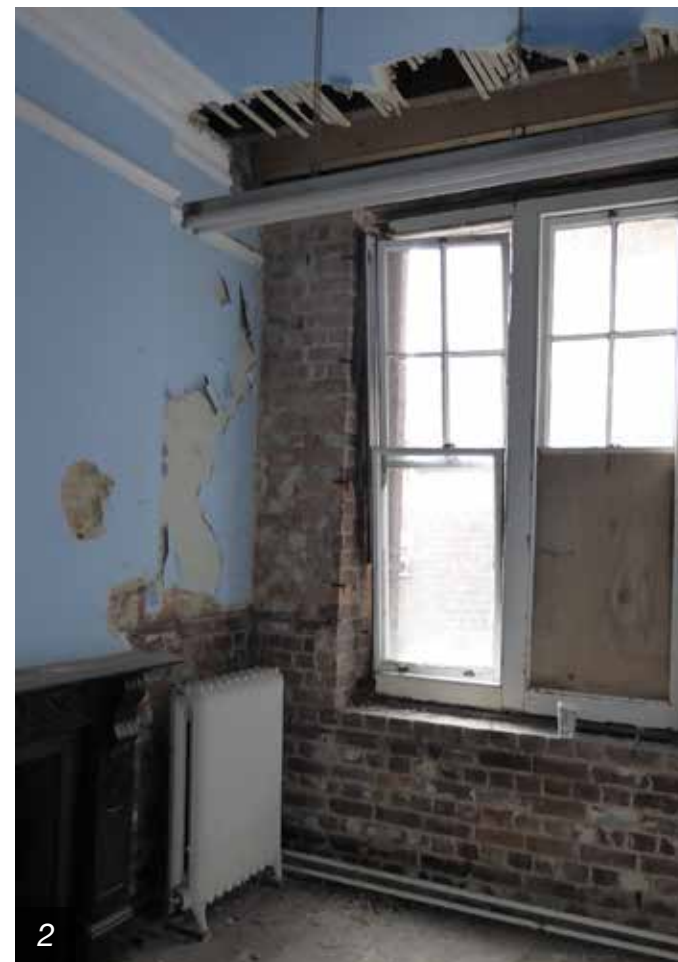
Fig 2: Interior view - typical first/second floor damaged fabric

Generally, interiors are in a poor state of repair due to neglect and lack of occupation. There are signs of significant water ingress, roof damage, lost and damaged windows, ceilings and other linings damaged or missing. Despite this, the original character is very much present, and the building presents an exciting opportunity to create distinctive and appealing development.

Aside from some notable instances of alteration, the primary concern and harm to the asset has arisen from lack of use and water ingress. It is clear that the building has undergone a period of abandonment, allowing water ingress from the roof and gutter systems. The consequences have included joist replacement, loss of windows and floors, partial loss of ceilings and plasterwork, and complete loss of the third-floor ceilings. Moreover, the roof appears to be time-expired and likely to fail again, risking ongoing damage. Generally the building is in a poor decorative state with defunct services and unsuitable for occupation.

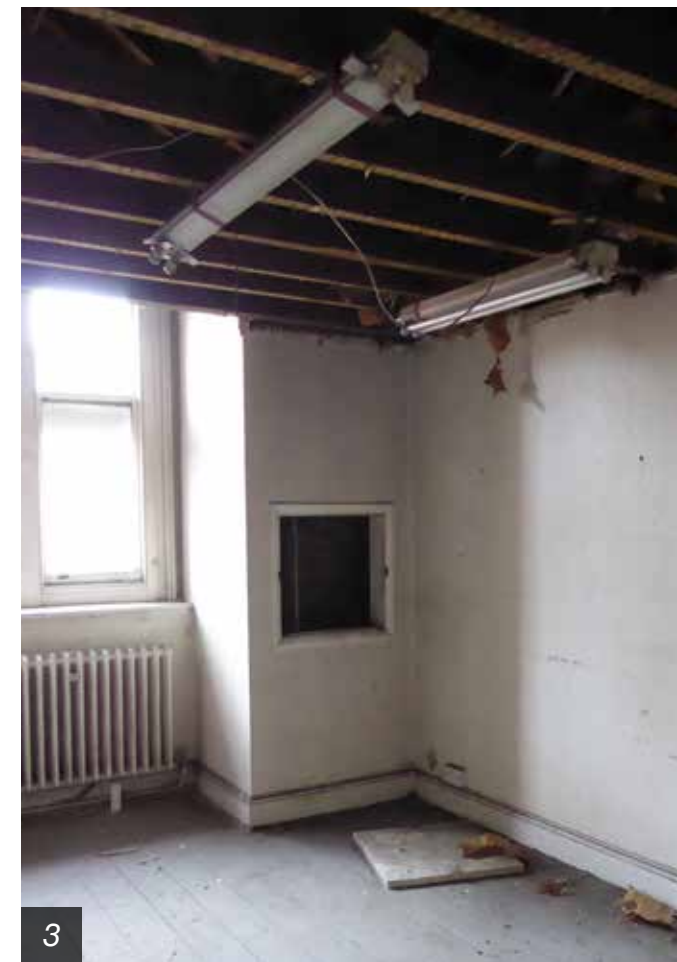
Fig 3: Interior view - Typical third floor showing damaged fabric/removed ceilings.

The third-floor is of a lesser architectural order, with accommodation off the staircase becoming simpler in fashion including lower heights, simpler mouldings and cast-iron surrounds in lieu of slate surrounds. An open trough gutter runs through the mansard void (a presumed source of water damage throughout the building).

The roof structure is exposed to the third floor, the ceiling having previously been removed following (we surmise) considerable water damage.

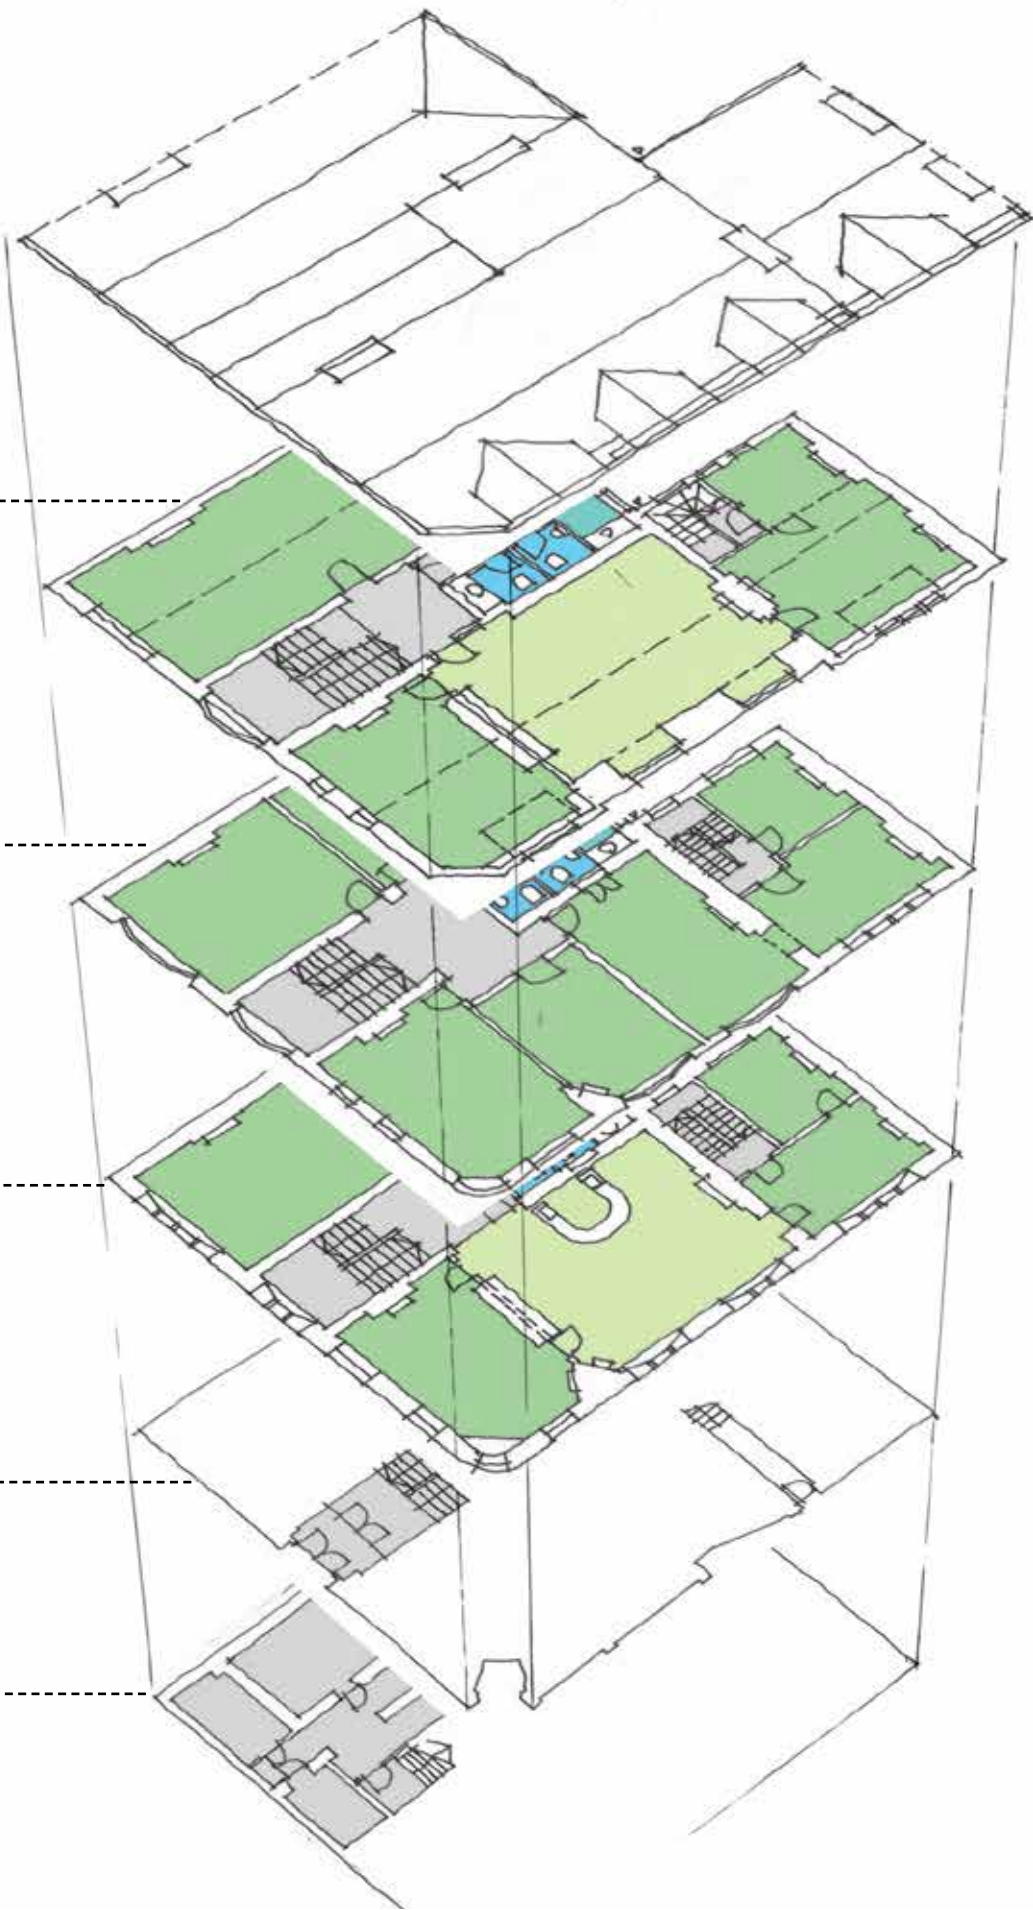
**Ground floor** -----  
*Building entrance, and escape staircase.*

**Basement** -----  
*Service area, with ancillary accommodation including refuse, bike storage and showers.*

*Fig 1: Sketch perspective aerial view - proposed building organisation.*

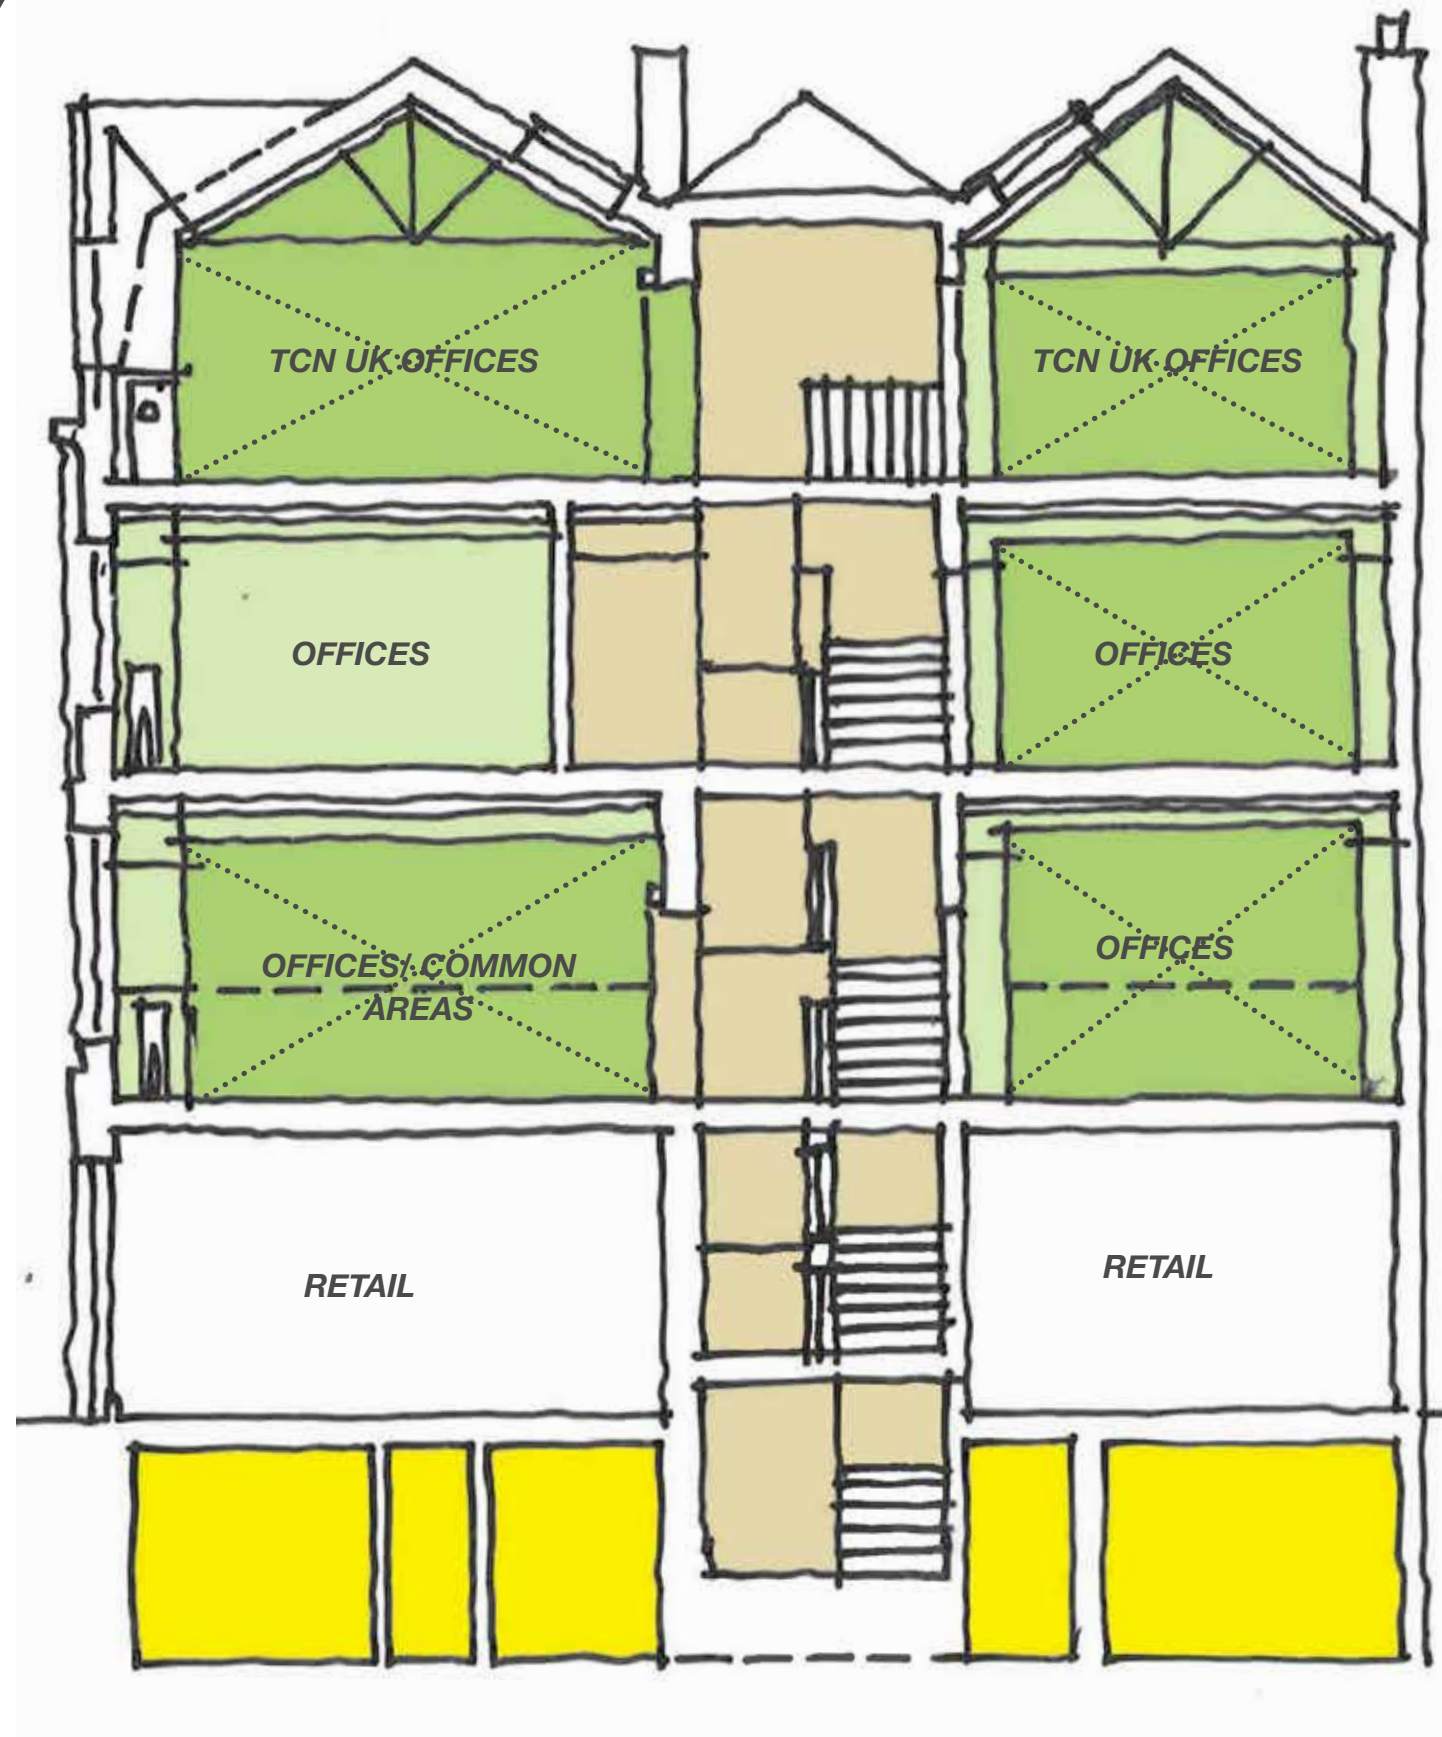
## 3.06 REFURBISHMENT STRATEGY

**Walls/Fires:** Repair/paint plaster. New openings. Existing fireplaces retained.

**Flooring/skirting:** Repair/paint timber skirtings. Existing timber floorboards refurbished/exposed.

**Ceiling:** Existing plaster ceilings repaired/painted including cornice.

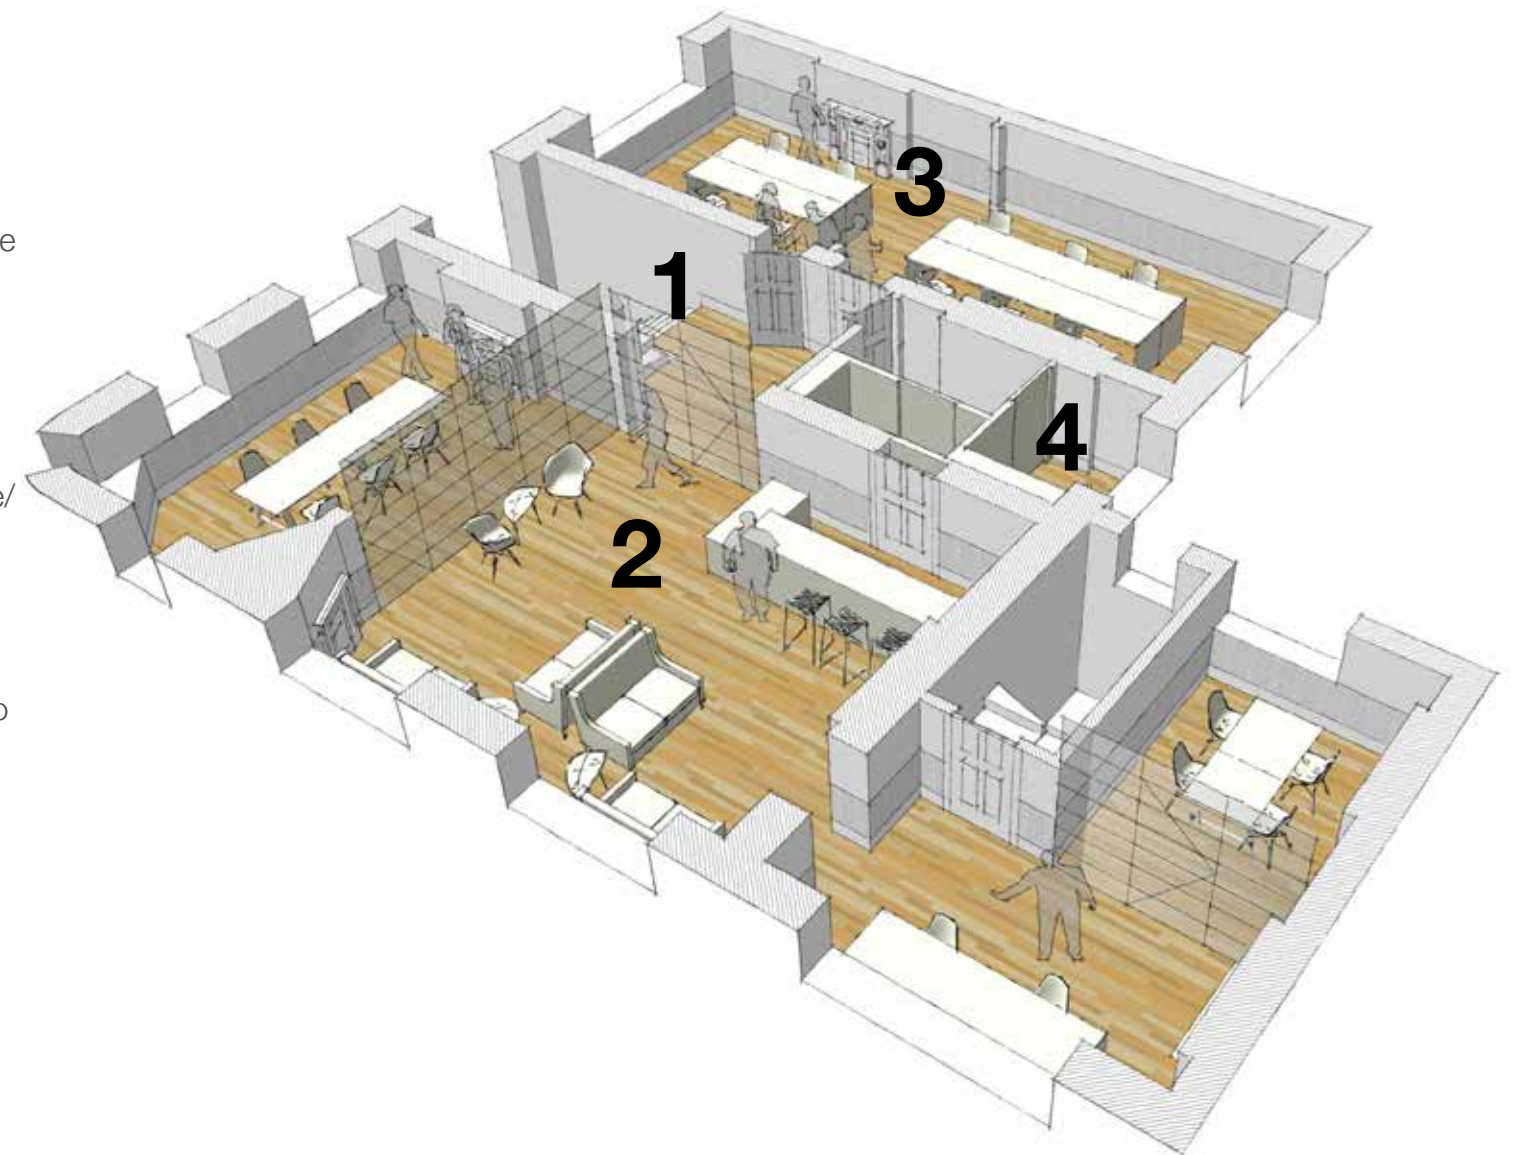
Provides WCs and cloakroom, accessed from the stair landing.

Fig 1: CAD image - first floor

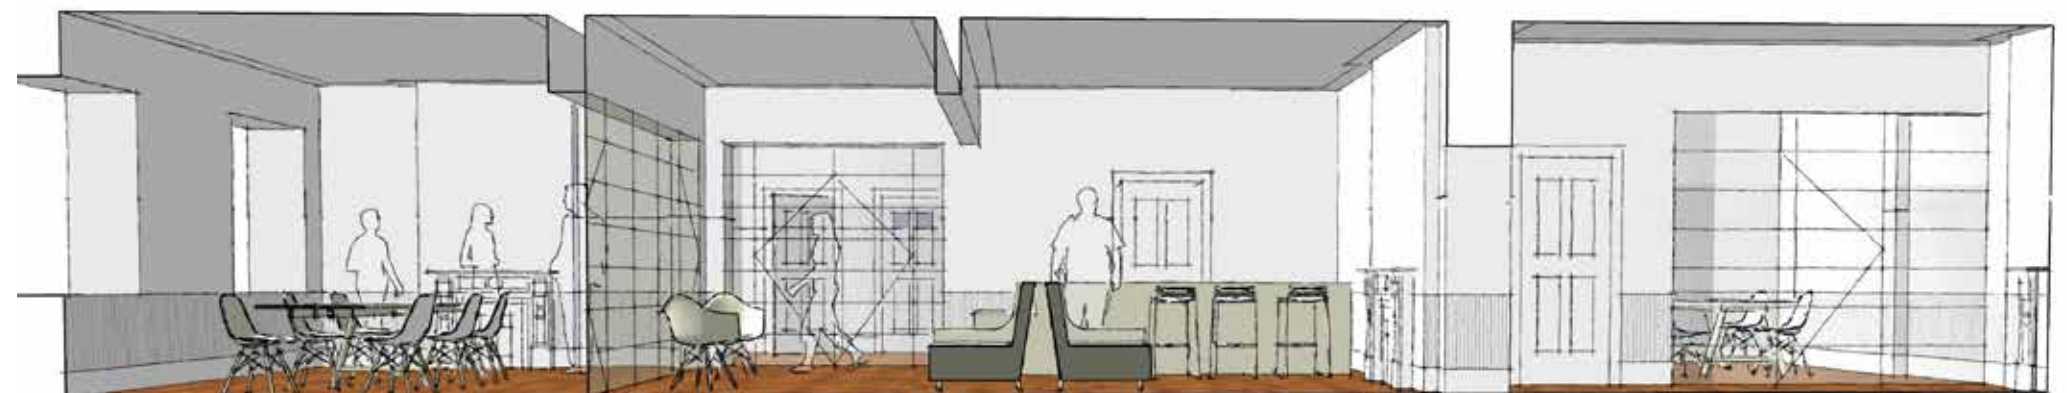
Fig 2: CAD view/section - first floor

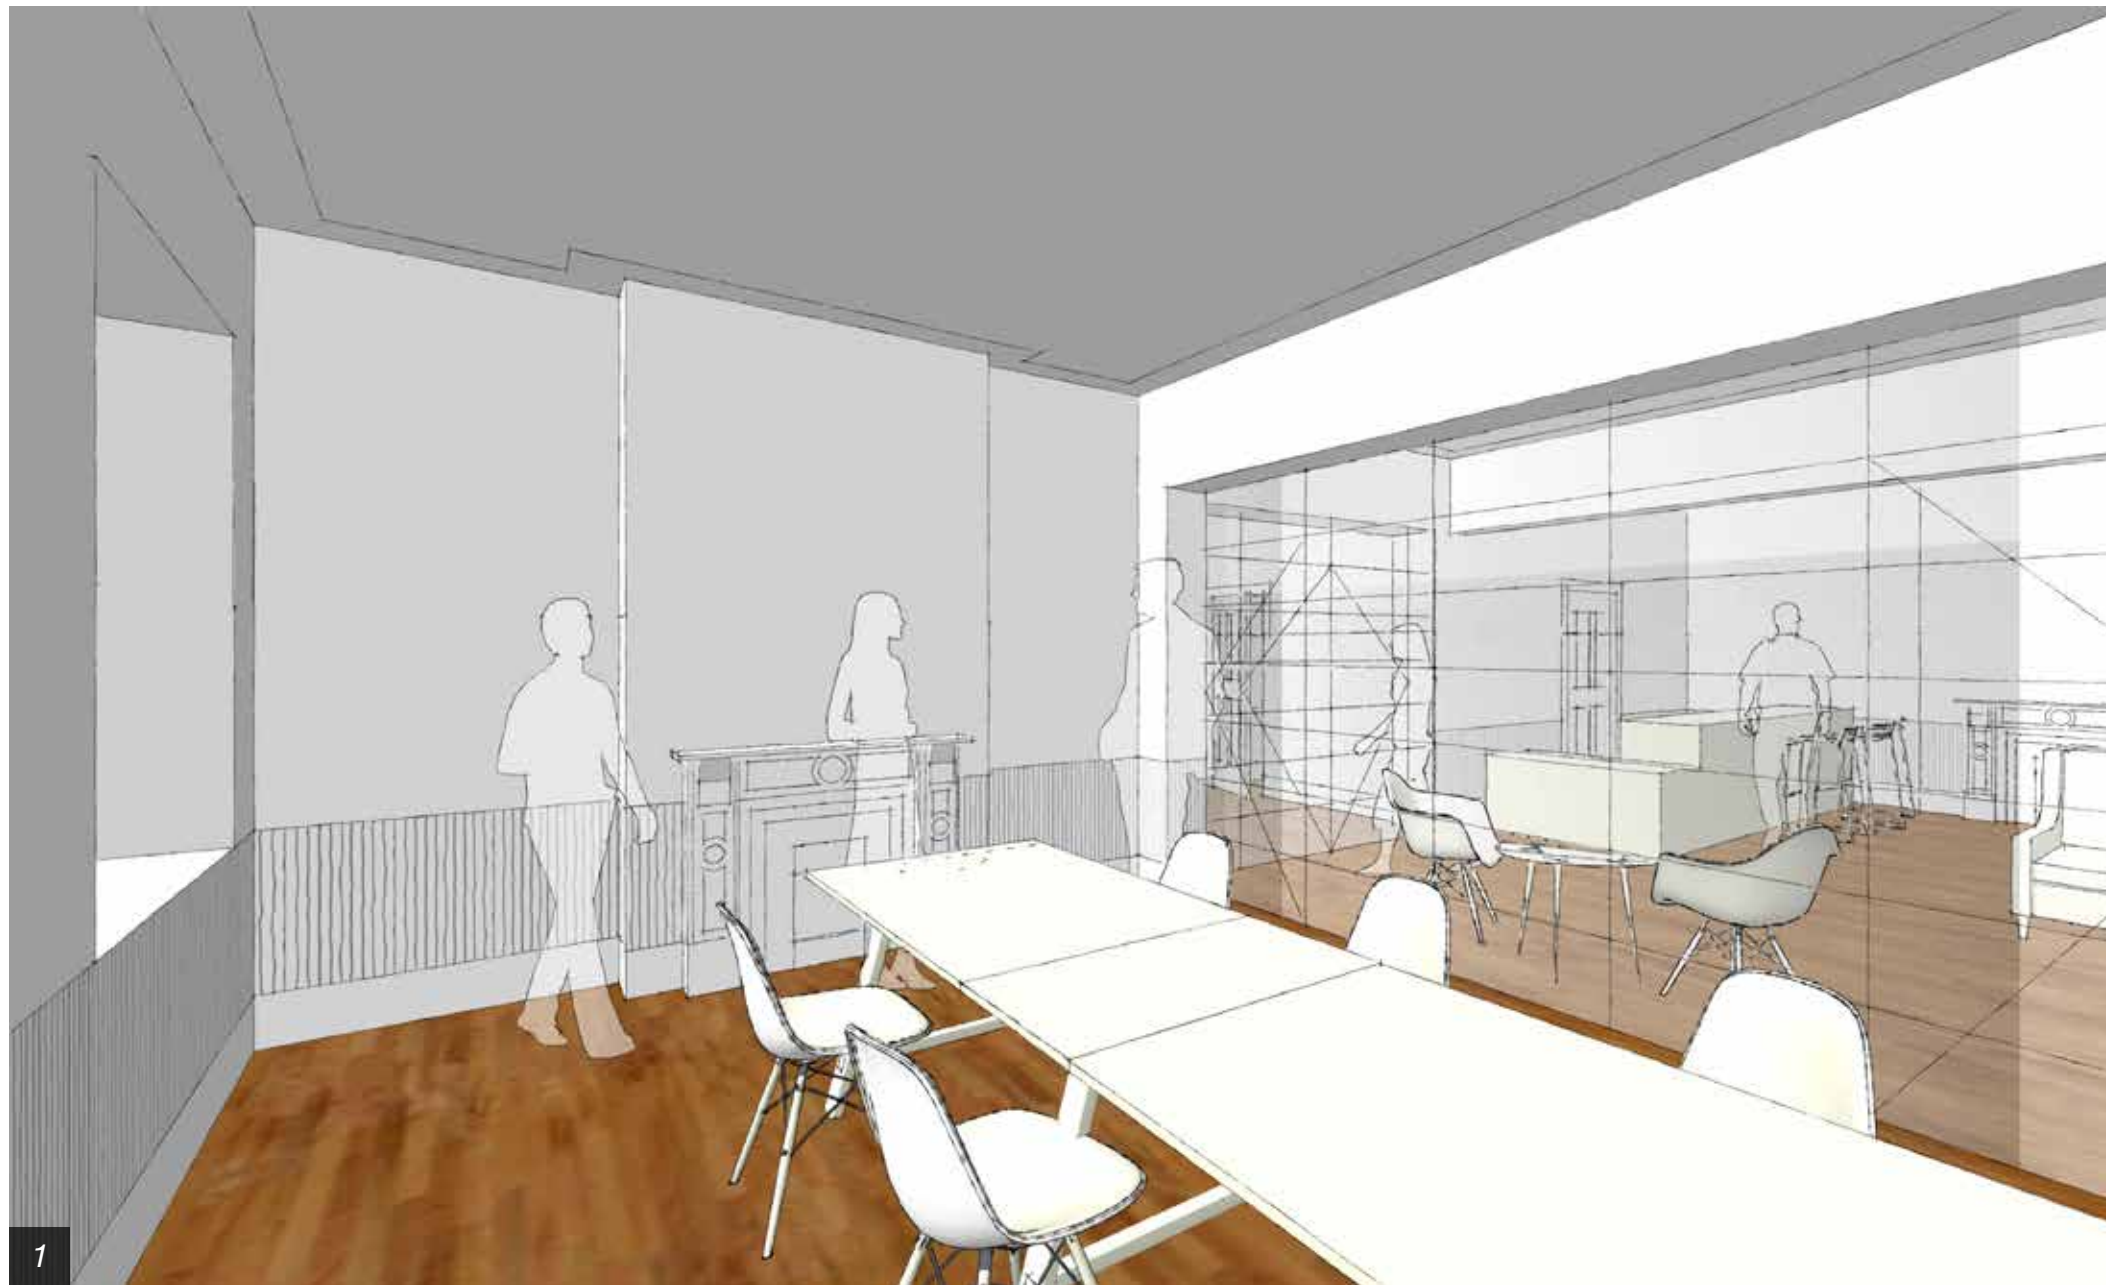
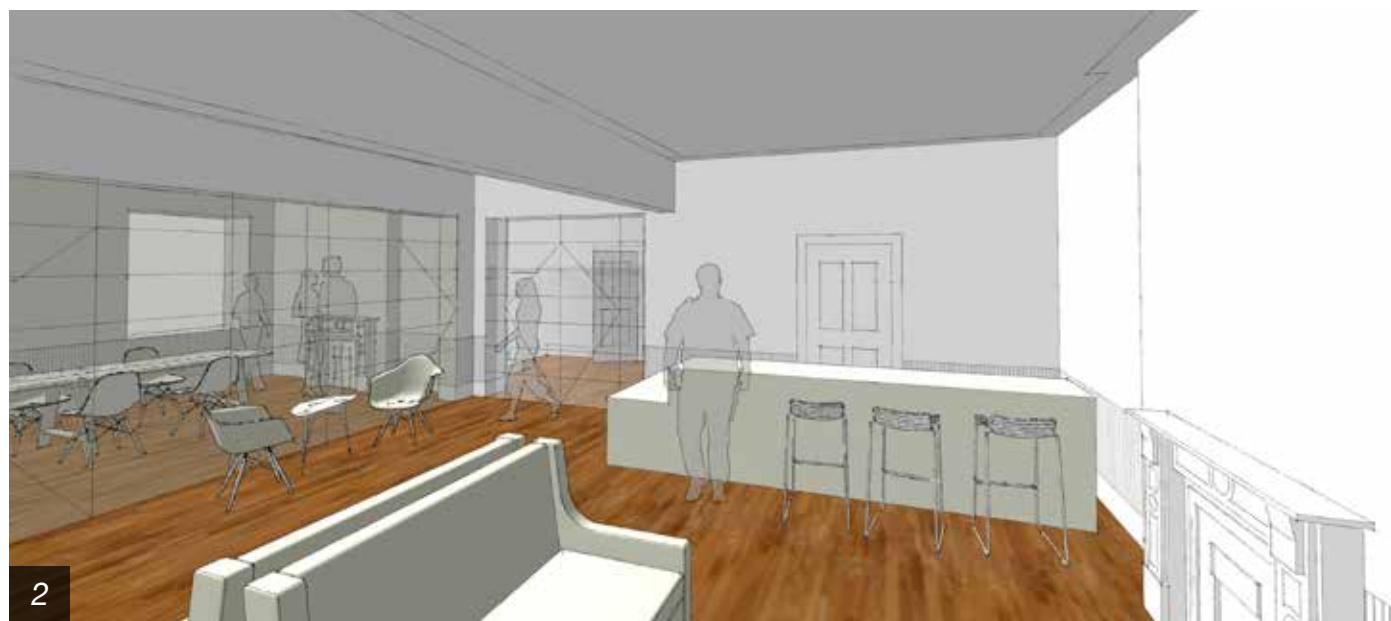
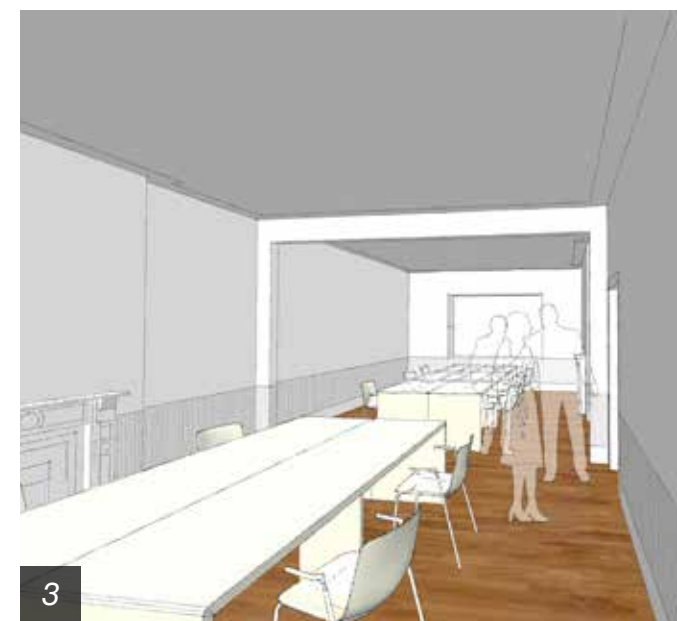
Fig 1-2: CAD image - first floor  
Fig 3: CAD image - first floor shared workspace

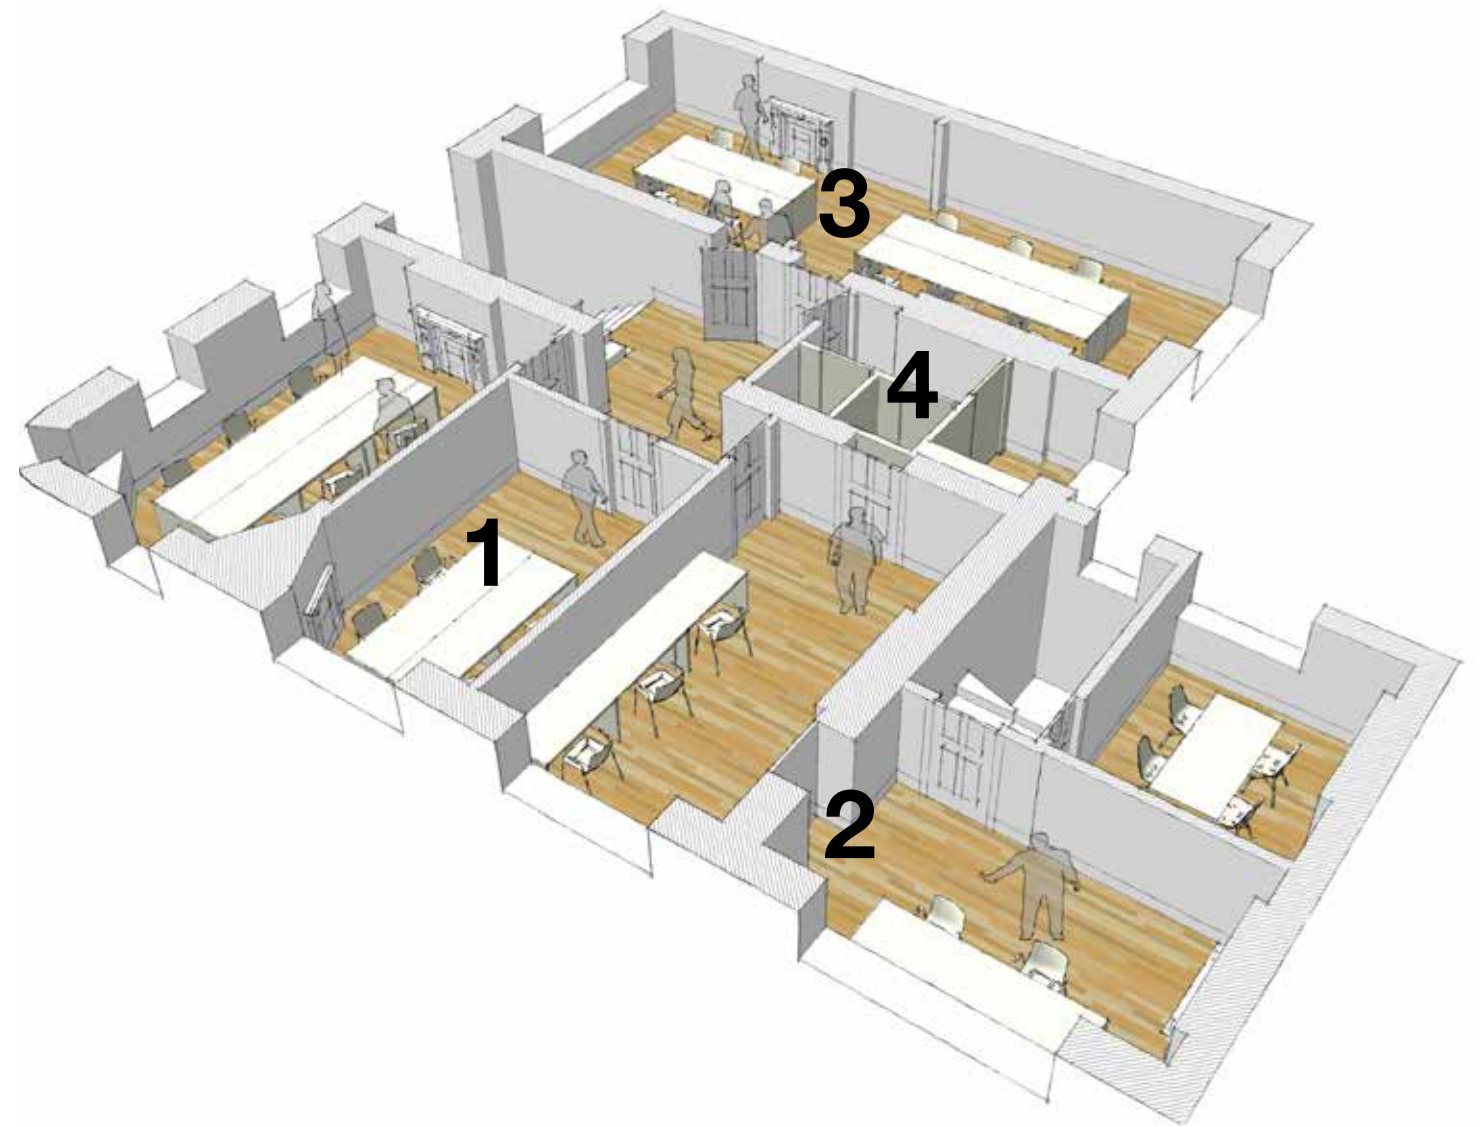
Provides WCs, cloakroom and tea point, accessed from the stair landing.

Fig 1: CAD image - second floor offices

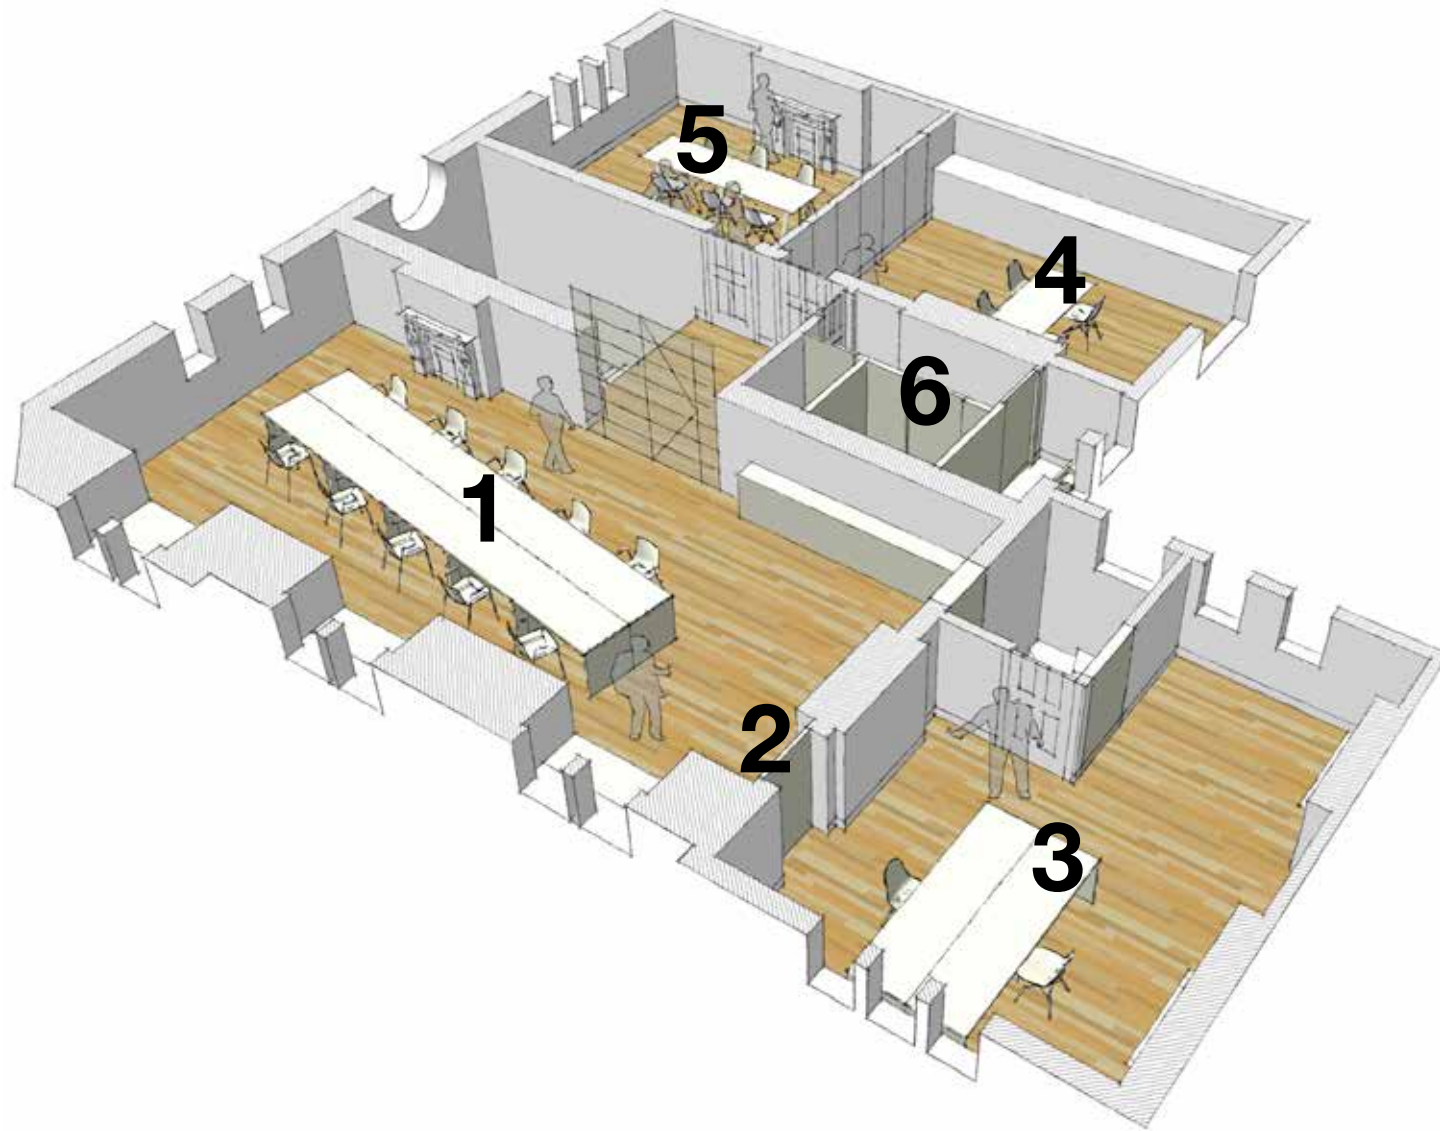
Providing WCs, cloakroom accessed from the stair landing.

Fig 1: CAD image - third floor offices

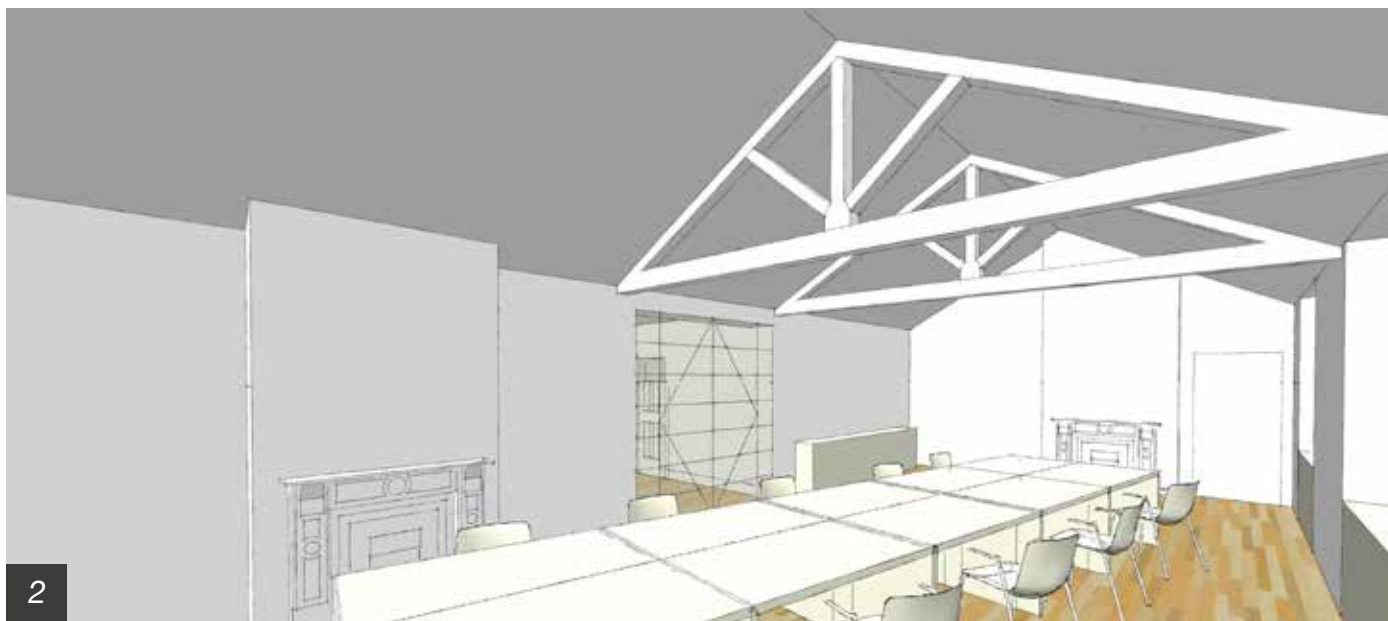
Fig 2: CAD view- third floor office

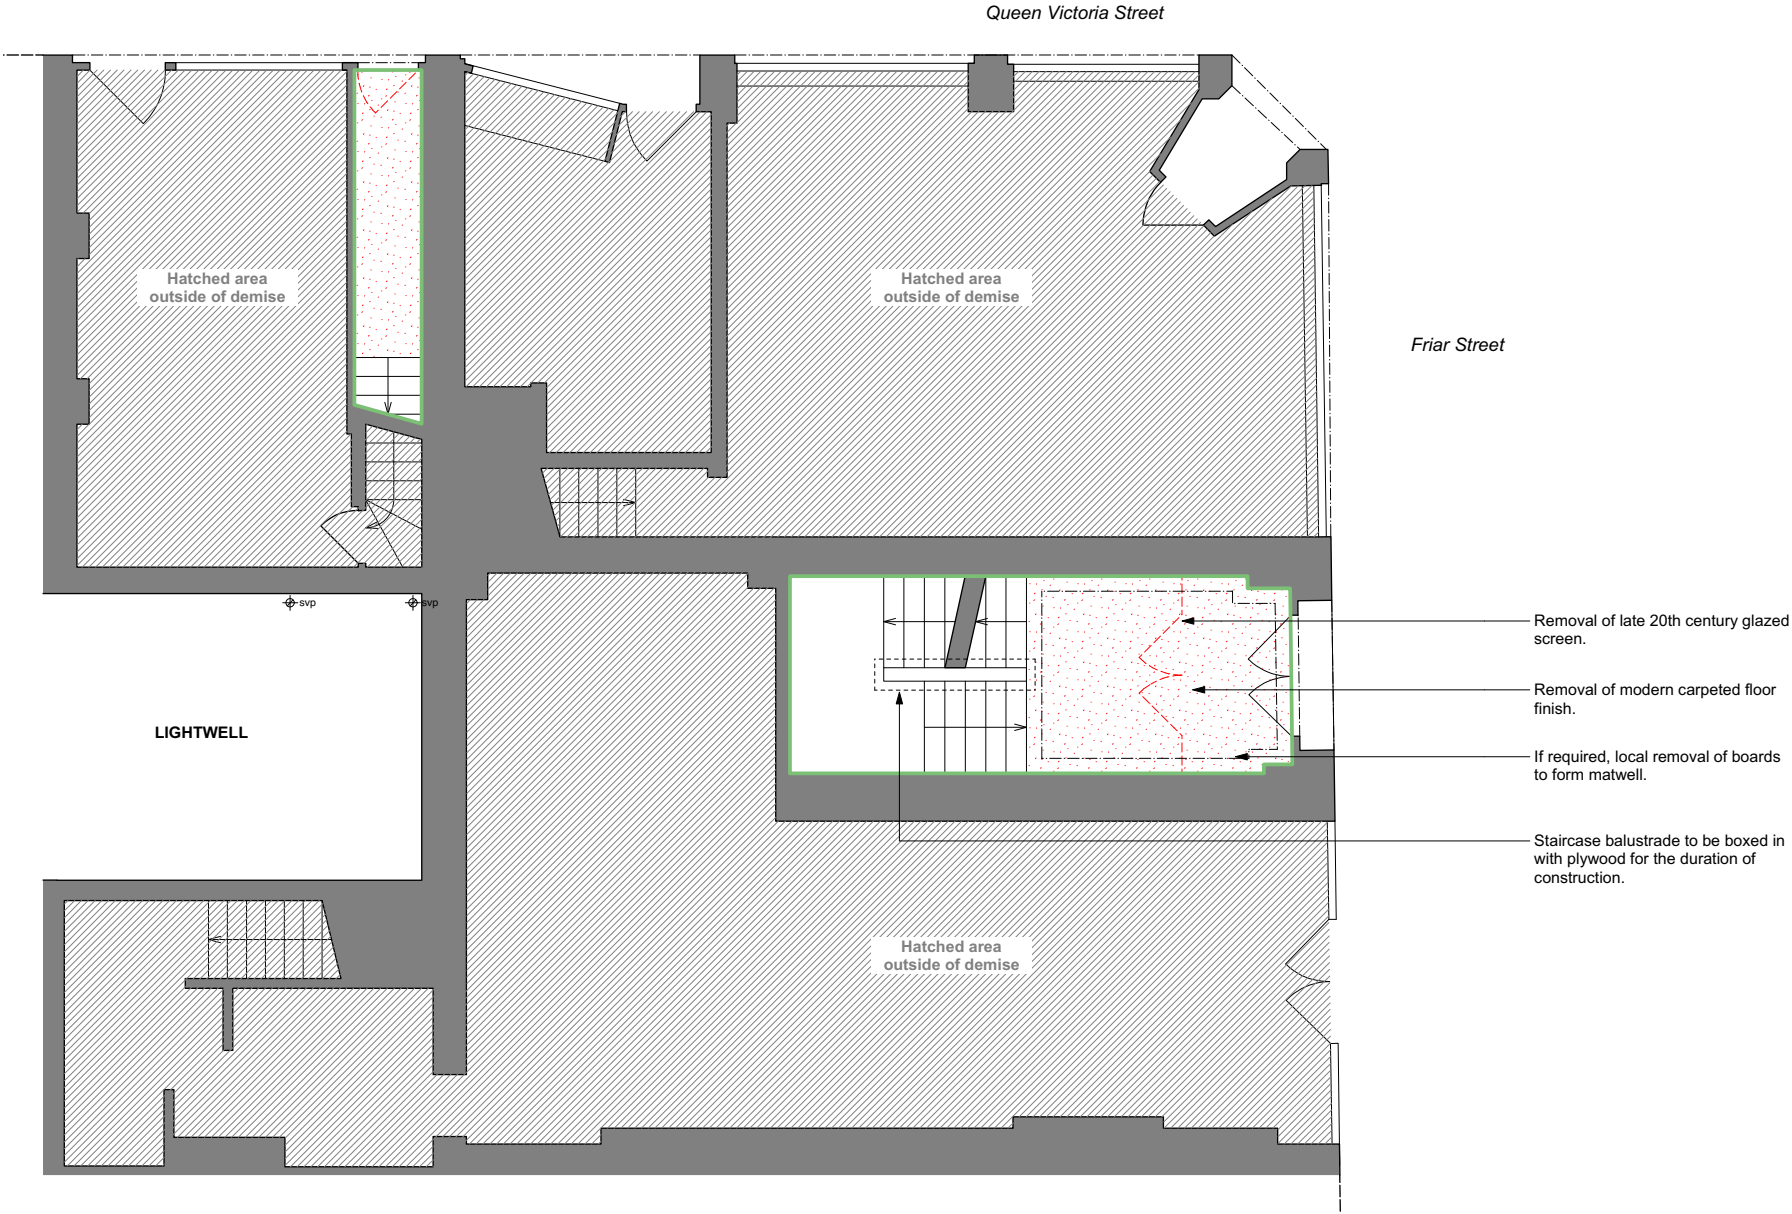
01: demolition ground floor plan 1:50

Fabric to be salvaged
