office refurbishment/alterations  
149/150 friar street and 2/4 queen victoria street, reading  
design and access statement  
(including brief planning statement and heritage statement)  
*Issue 01 dated 9 July 2018*

The refurbishment of, and alternations to, the  
existing premises for continued office use.  
Works to include window and door repairs and  
reinstatement, ceiling repairs and restoration,  
removal of modern partitions, opening up of  
various smaller spaces, restoration of the original  
staircase and landing arrangement, replacement  
of the roof linings, general decoration and  
incorporation of new WCs, kitchens and services

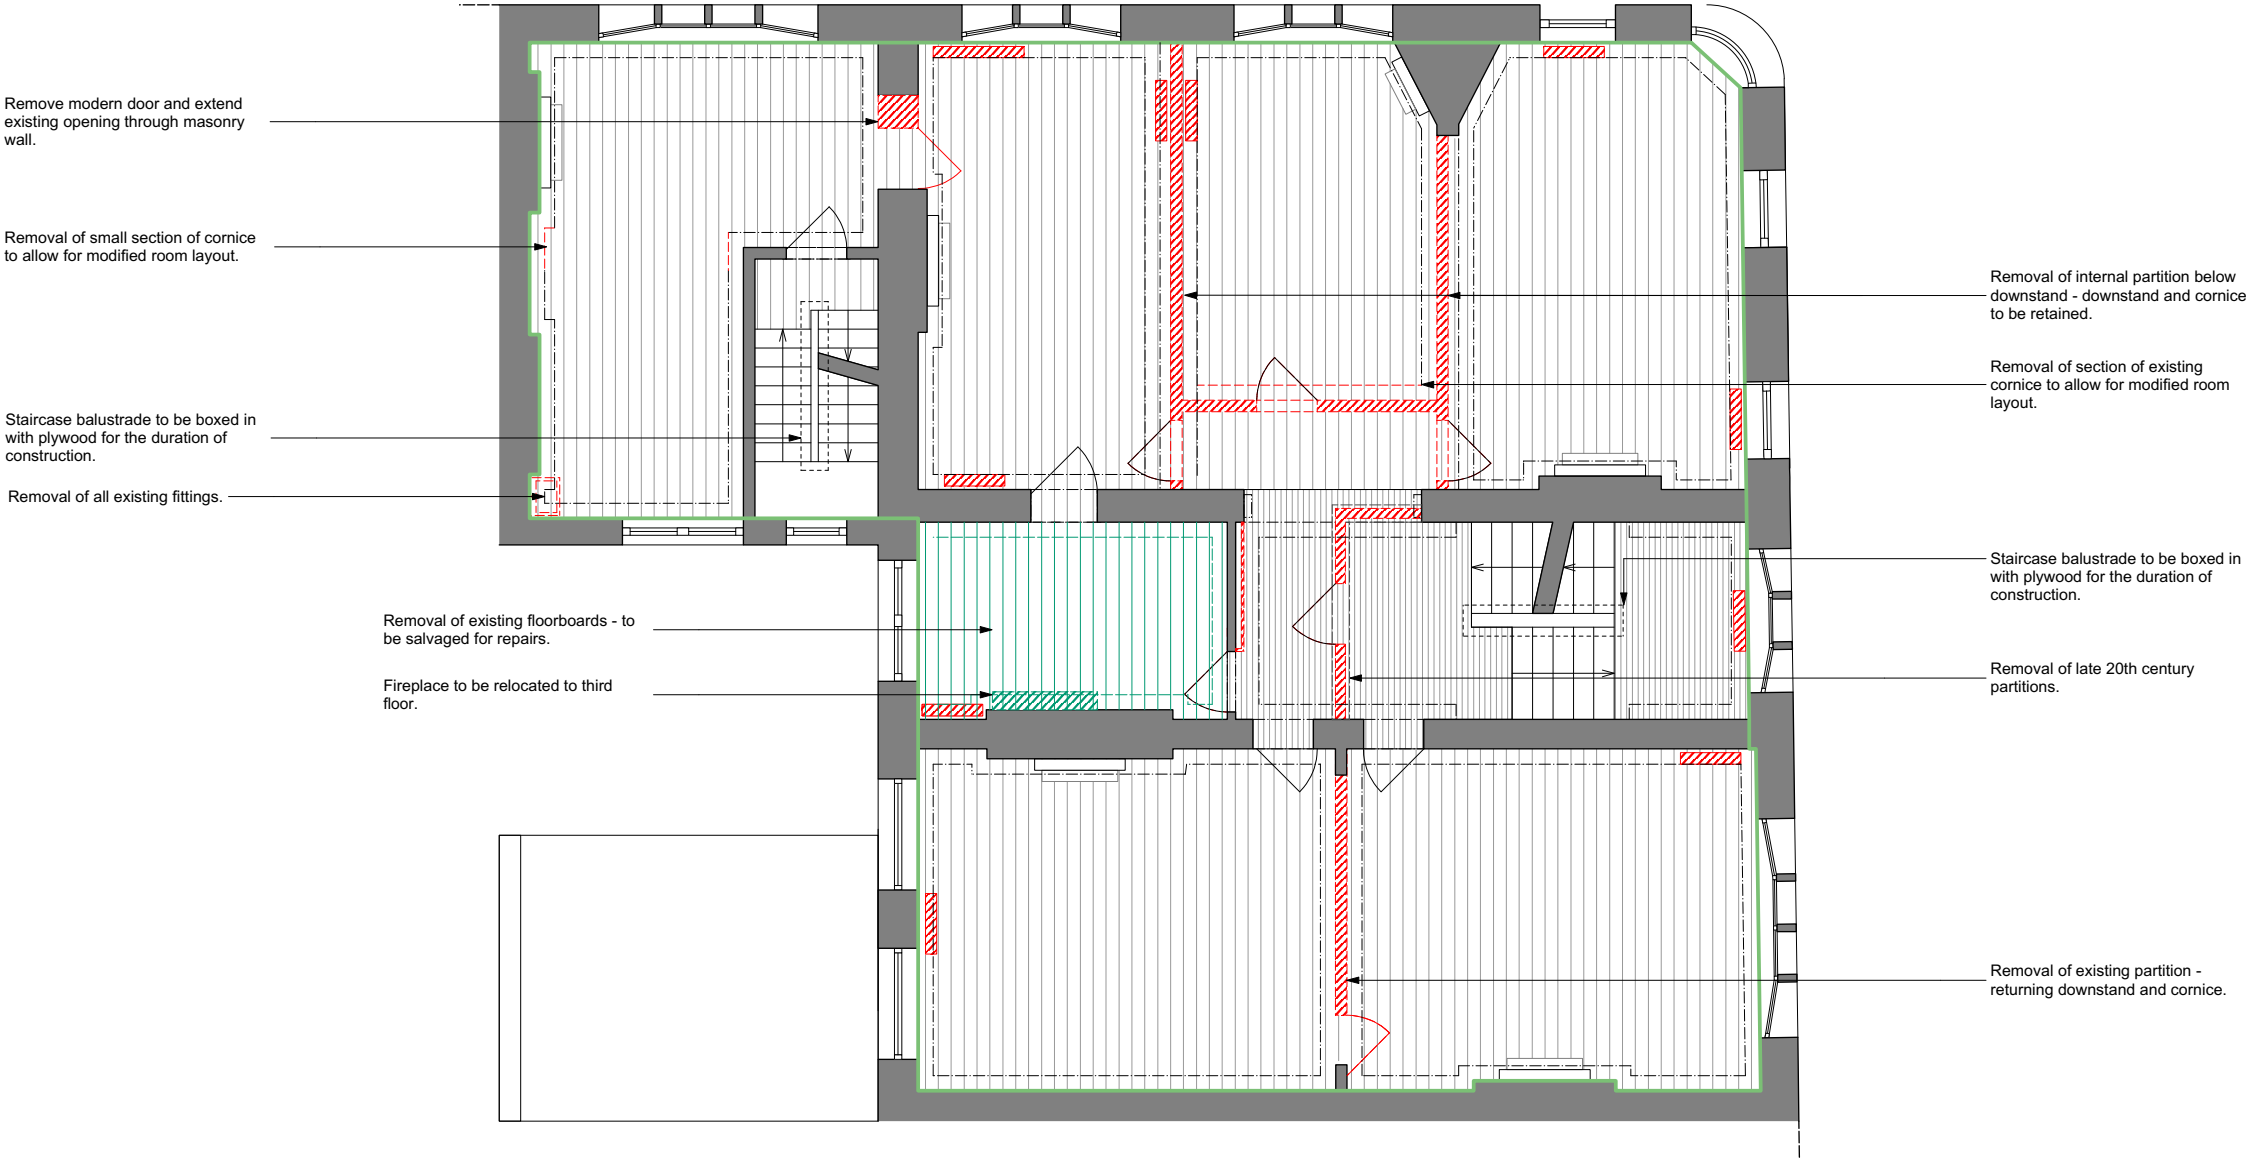
01: demolition first floor plan 1:50

Fabric to be salvaged

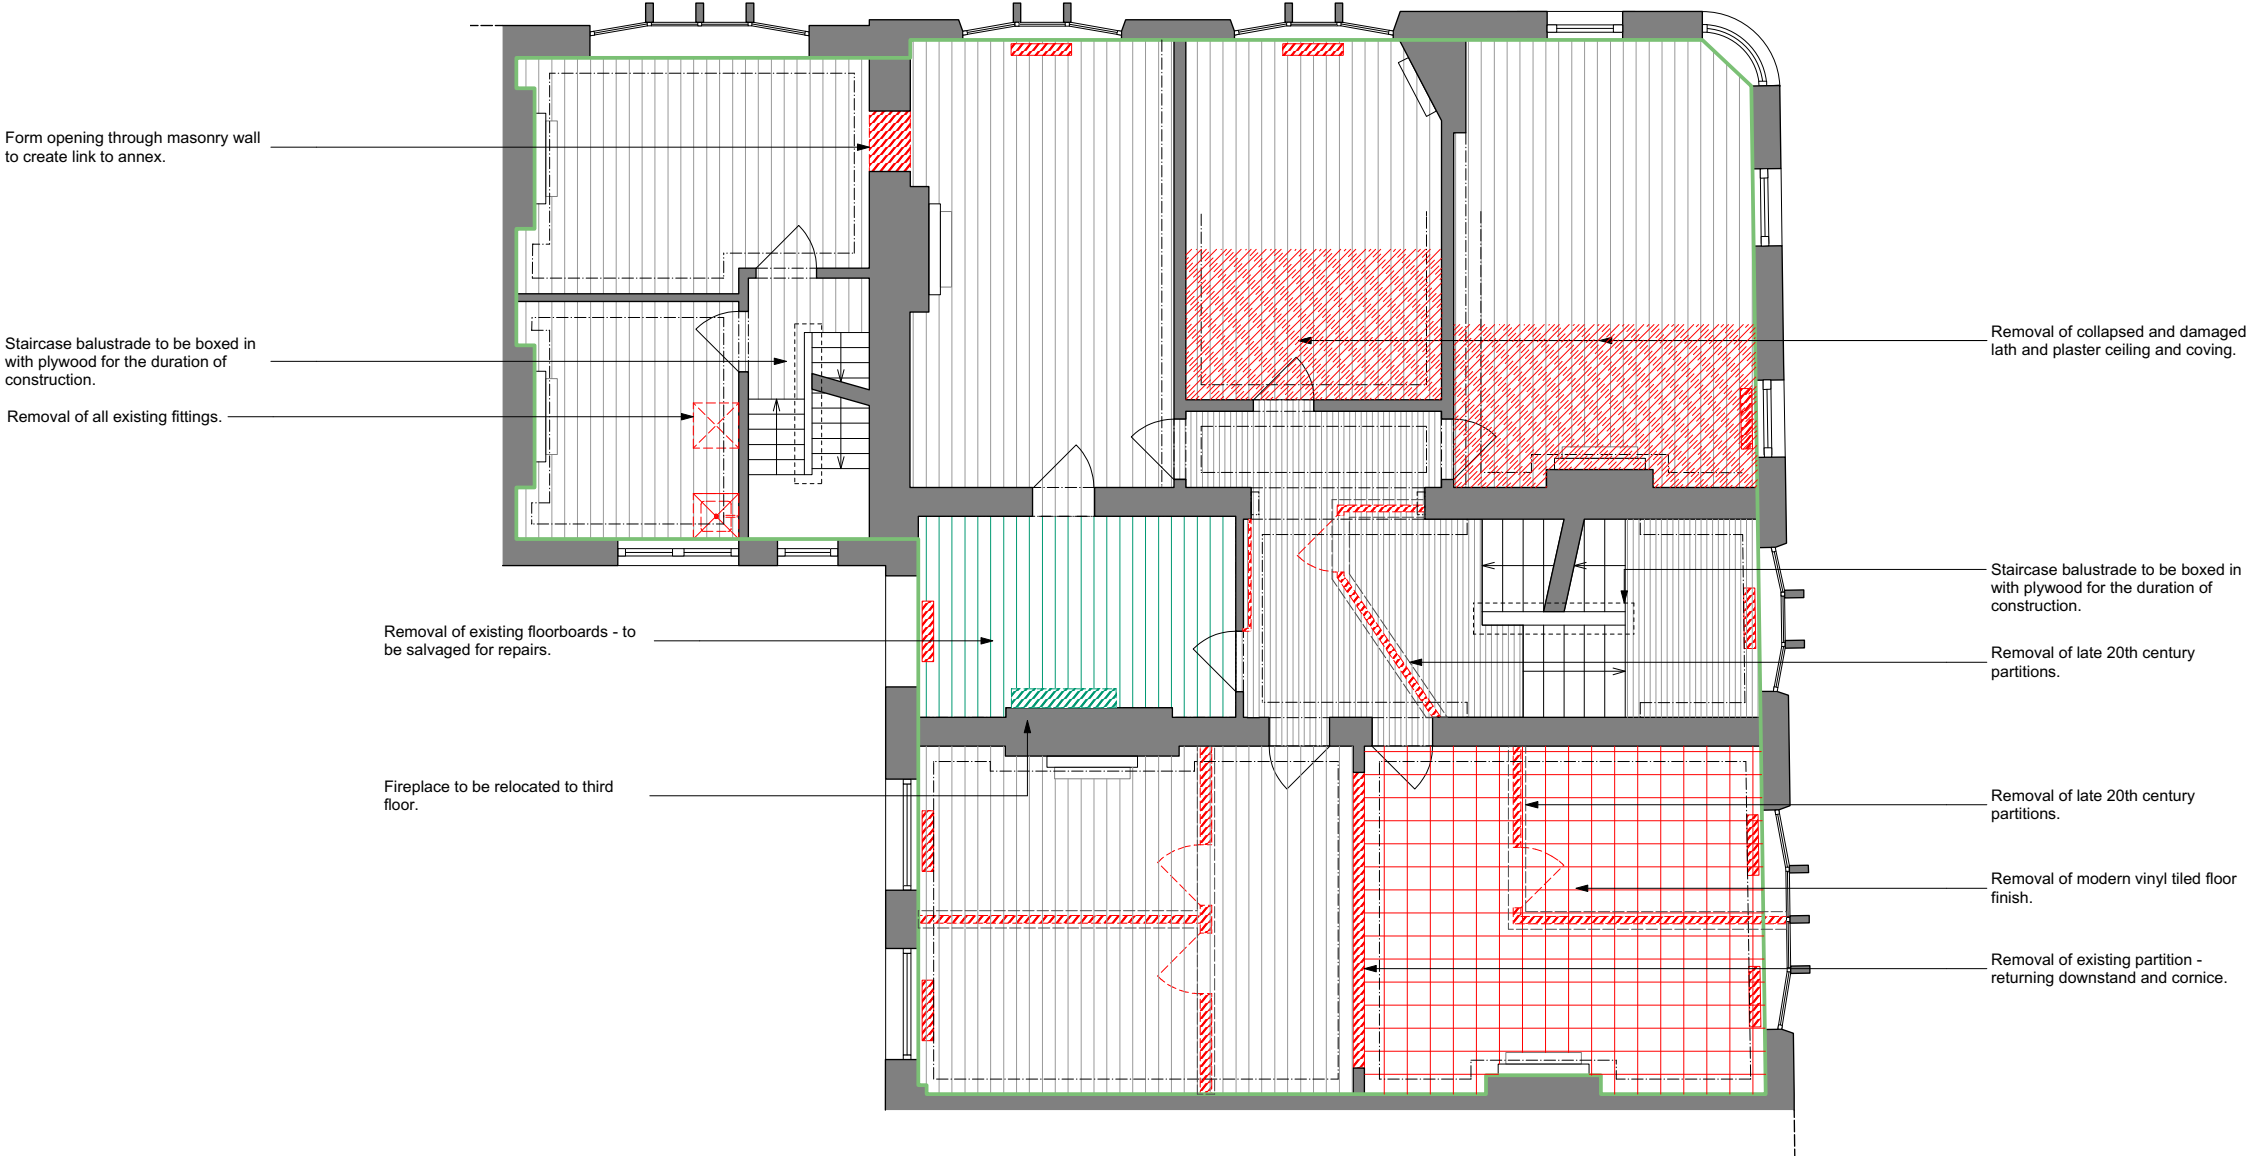
01: demolition second floor plan 1:50

Fabric to be salvaged

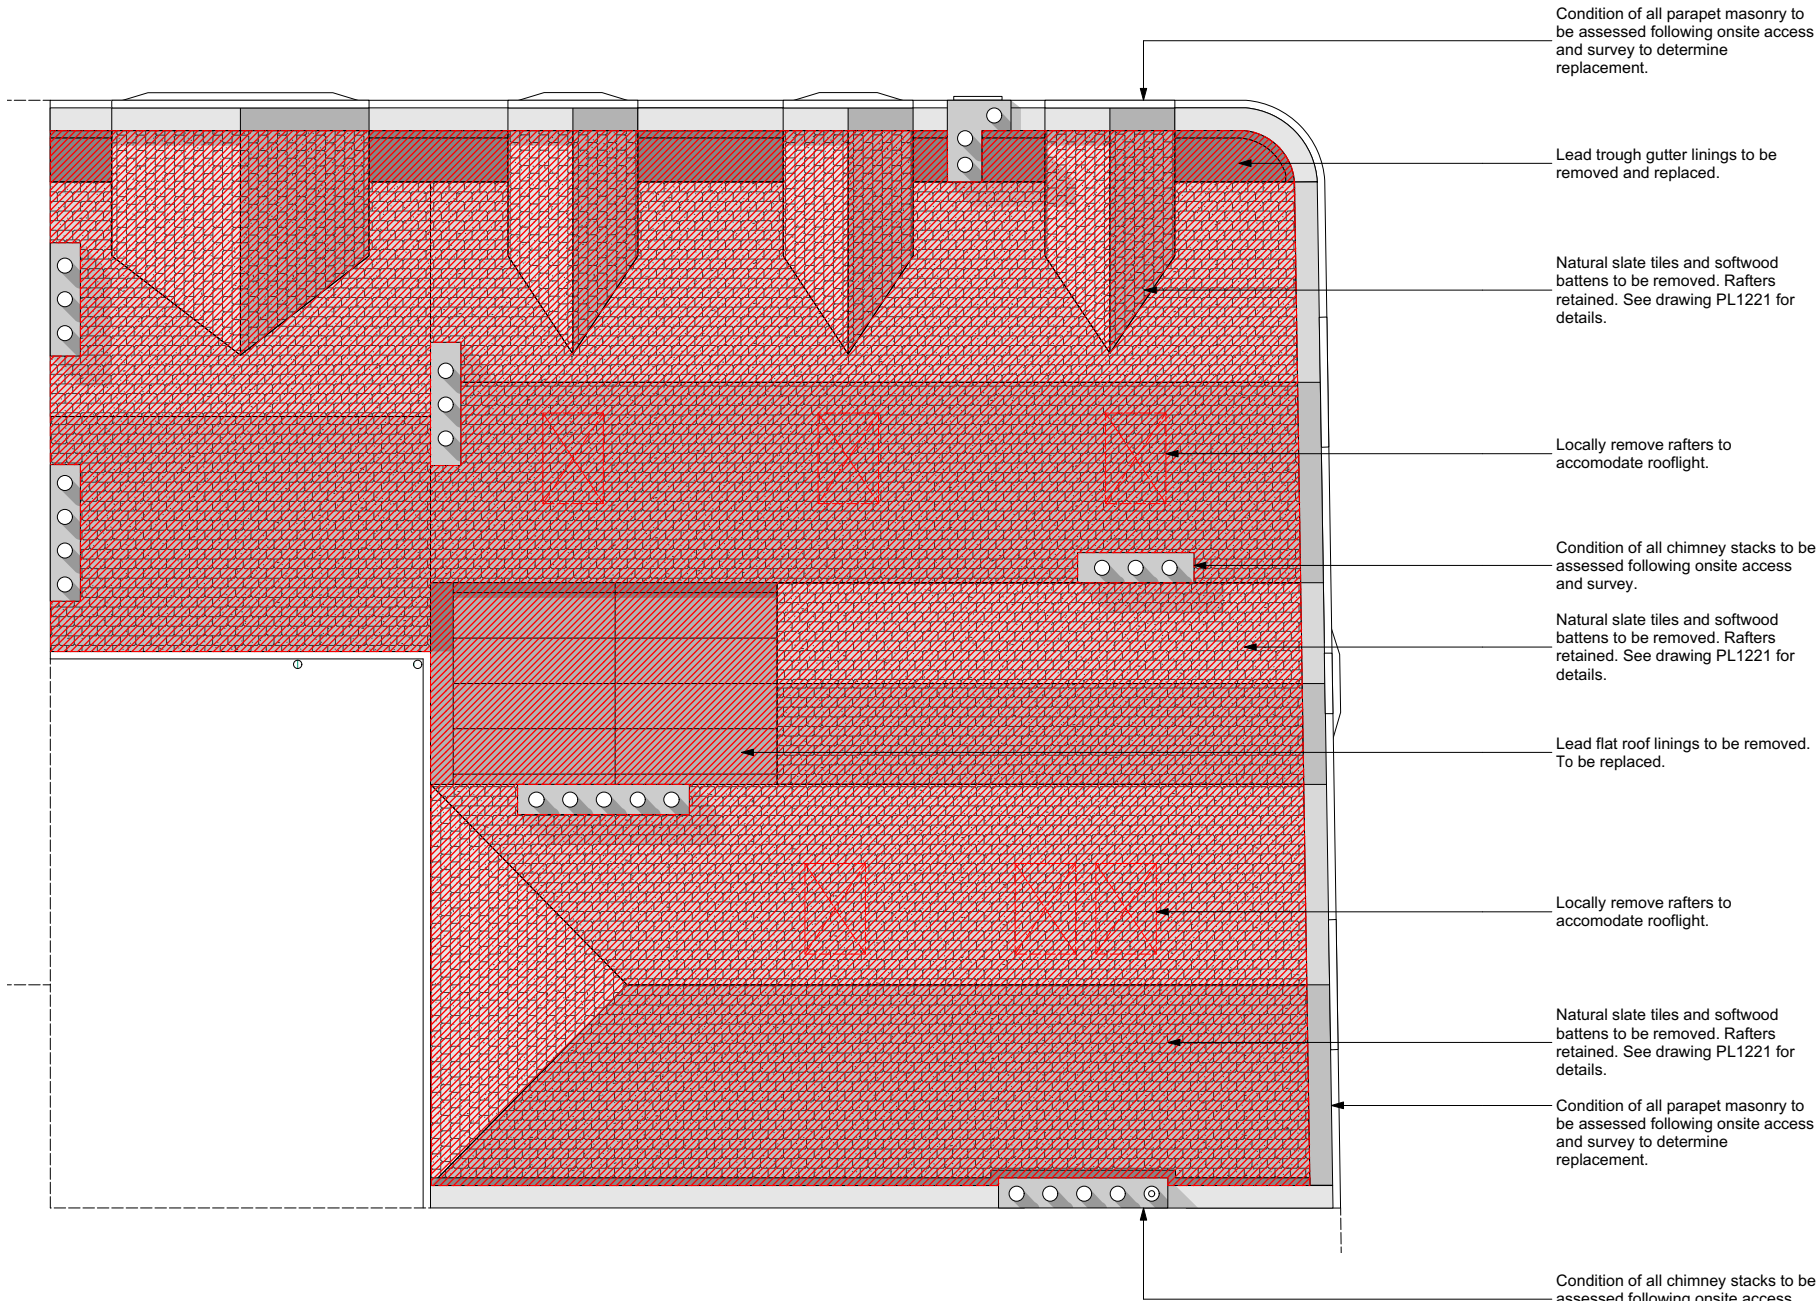
01: demolition roof plan 1:50

Fabric to be salvaged

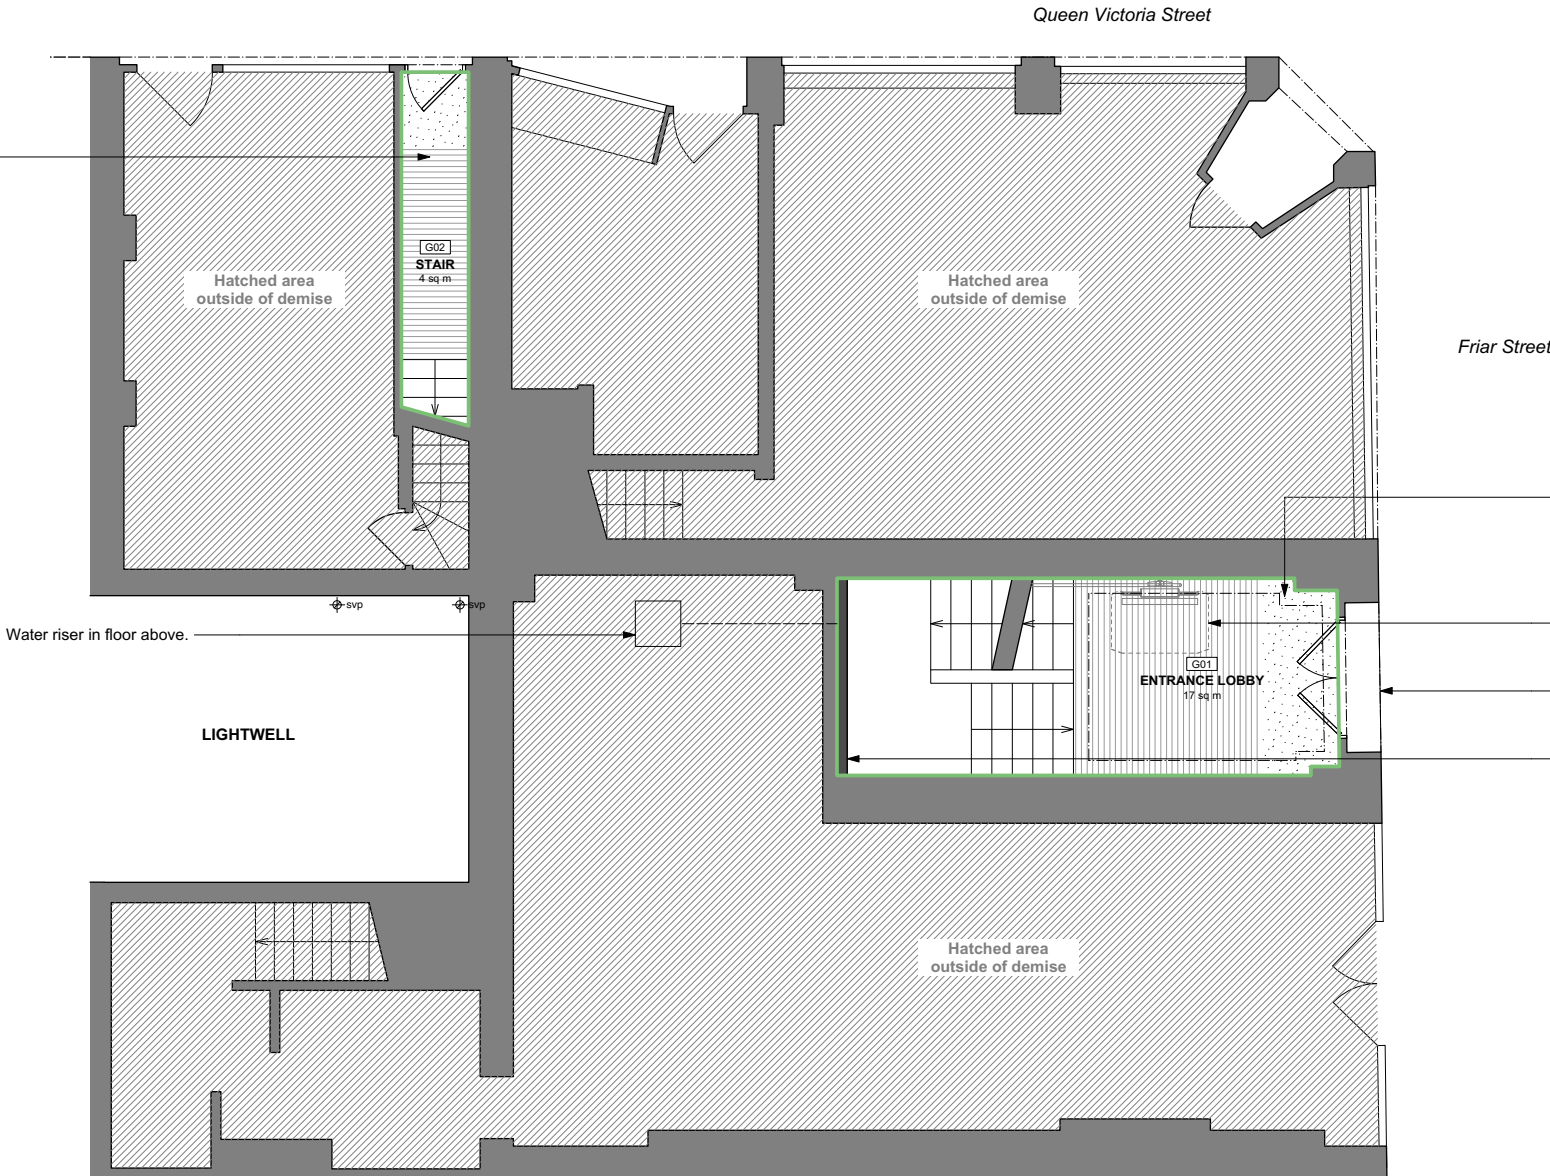
New drainage run

New matwell (allow for local removal of floor screed / deck to accomodate sunken matwell).

New platform lift and associated running rail installed within staircase, to provide GF to FF access.
