office refurbishment/alterations  
149/150 friar street and 2/4 queen victoria street, reading  
design and access statement  
(including brief planning statement and heritage statement)  
*Issue 01 dated 9 July 2018*

Application description:

The refurbishment of, and alternations to, the  
existing premises for continued office use.  
Works to include window and door repairs and  
reinstatement, ceiling repairs and restoration,  
removal of modern partitions, opening up of  
various smaller spaces, restoration of the original  
staircase and landing arrangement, replacement  
of the roof linings, general decoration and  
incorporation of new WCs, kitchens and services

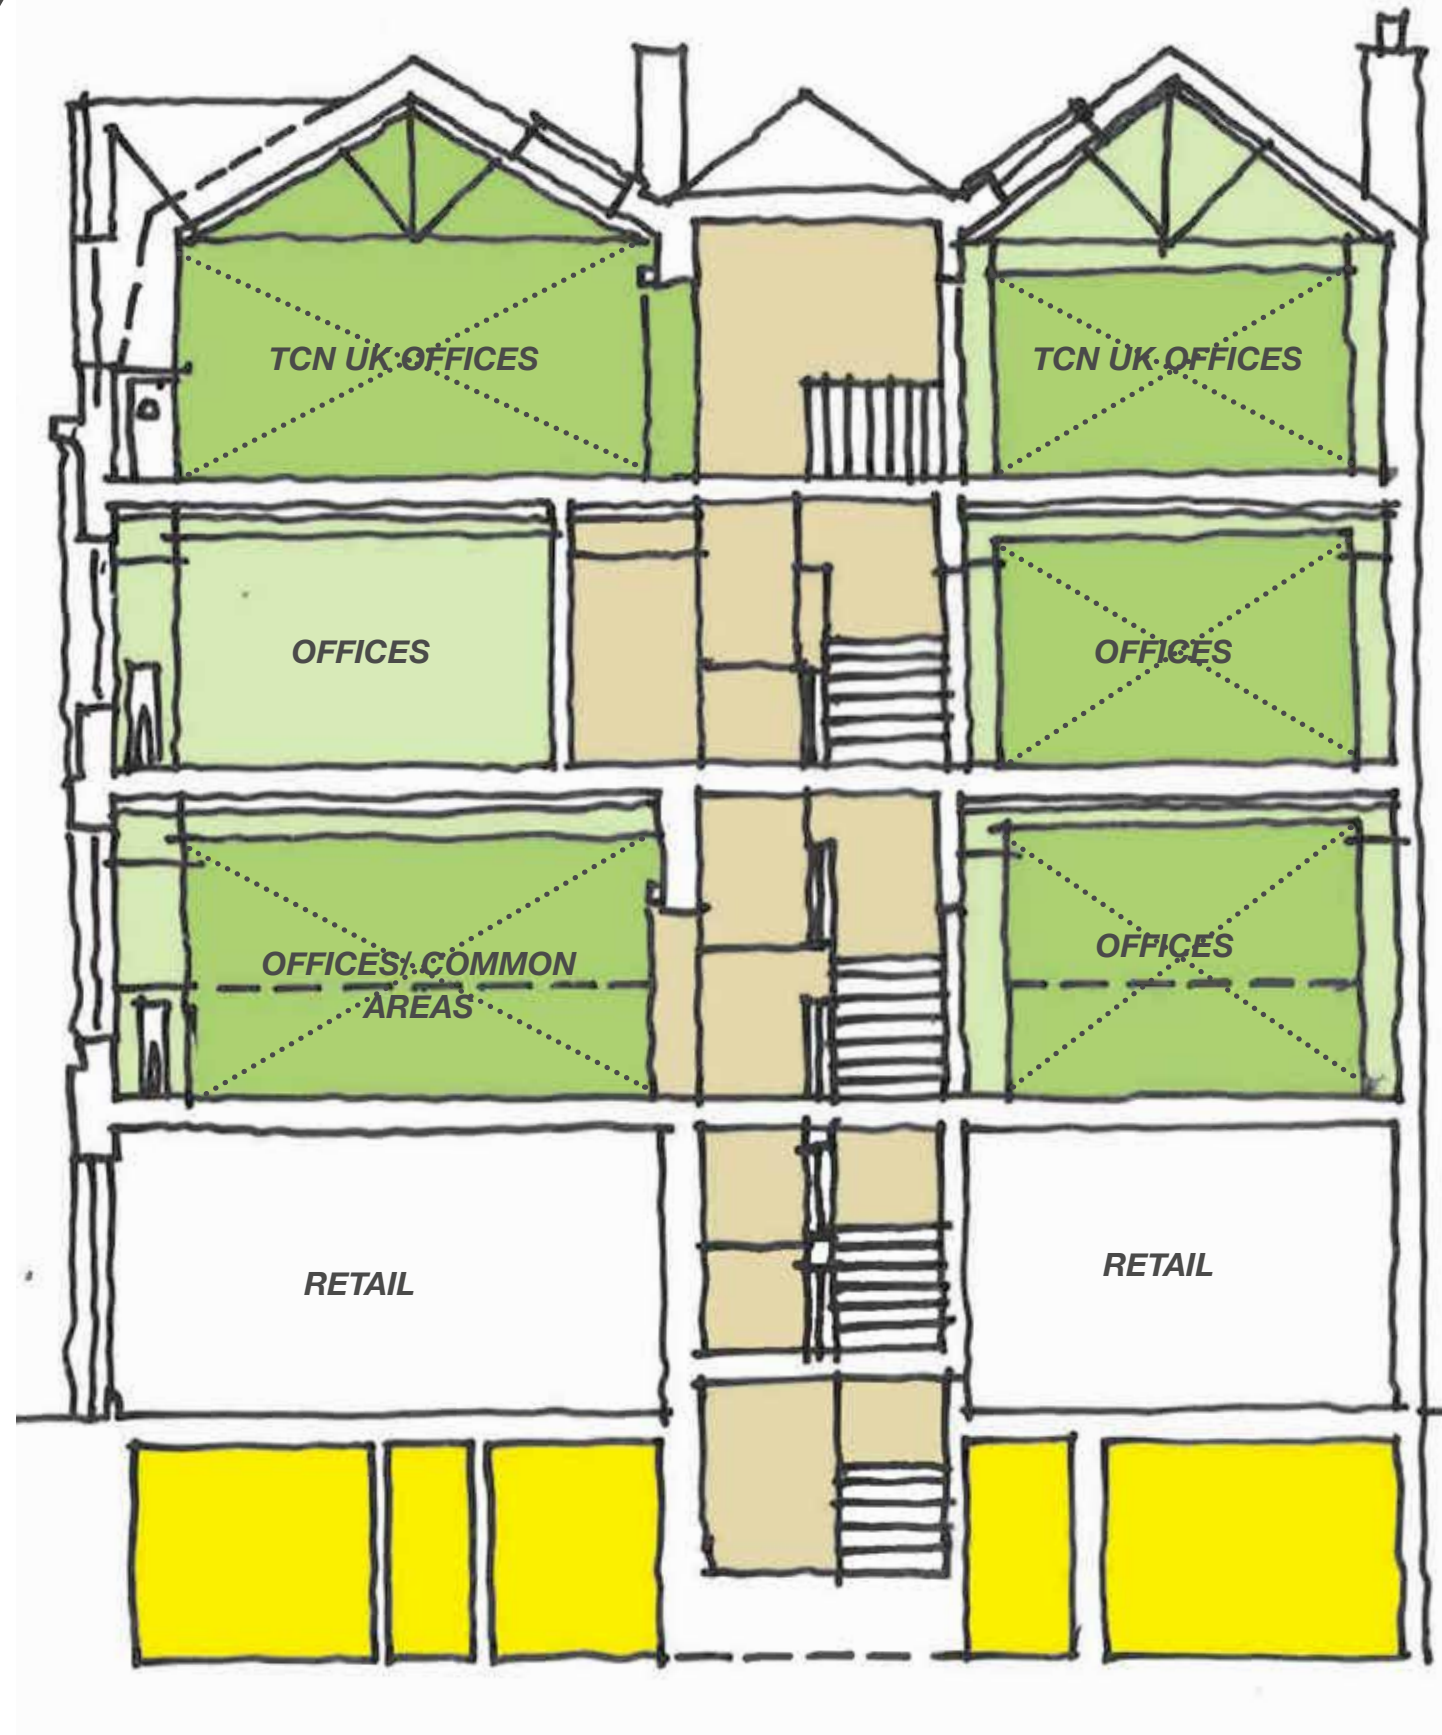
## 3.06 REFURBISHMENT STRATEGY

**Walls/Fires:** Repair/paint plaster. New openings. Existing fireplaces retained.

**Flooring/skirting:** Repair/paint timber skirtings. Existing timber floorboards refurbished/exposed.

**Ceiling:** Existing plaster ceilings repaired/painted including cornice.

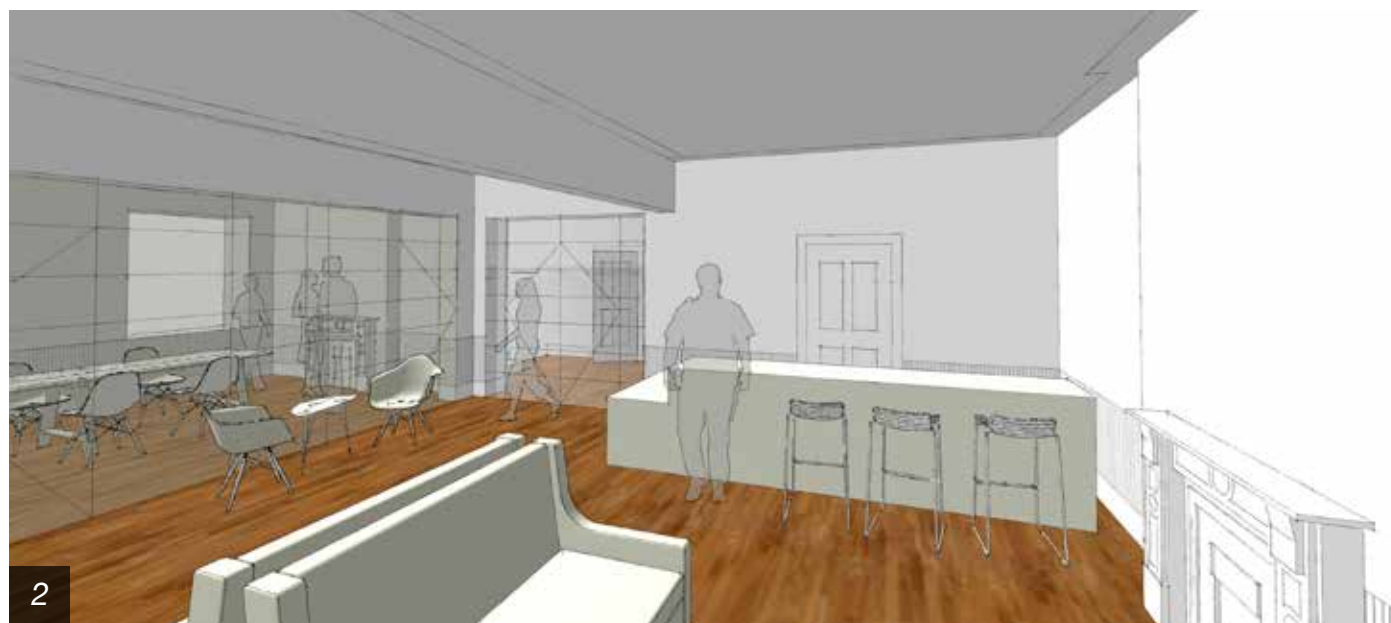
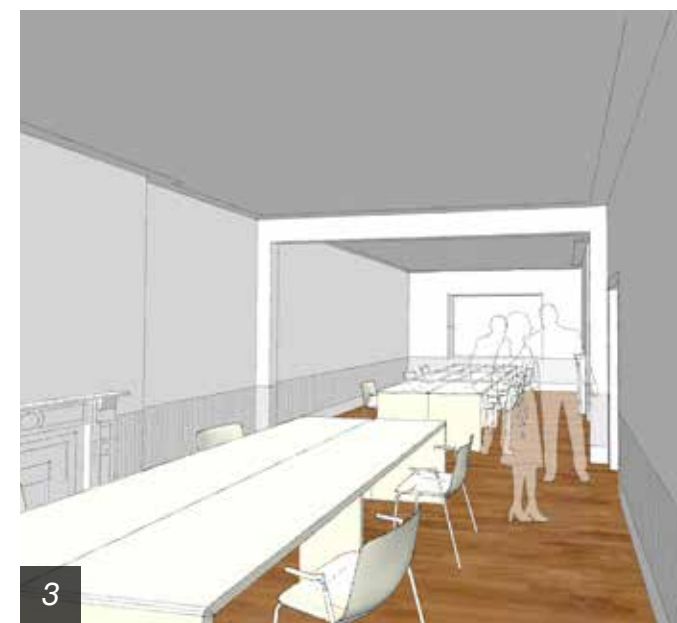
Fig 1-2: CAD image - first floor  
Fig 3: CAD image - first floor shared workspace

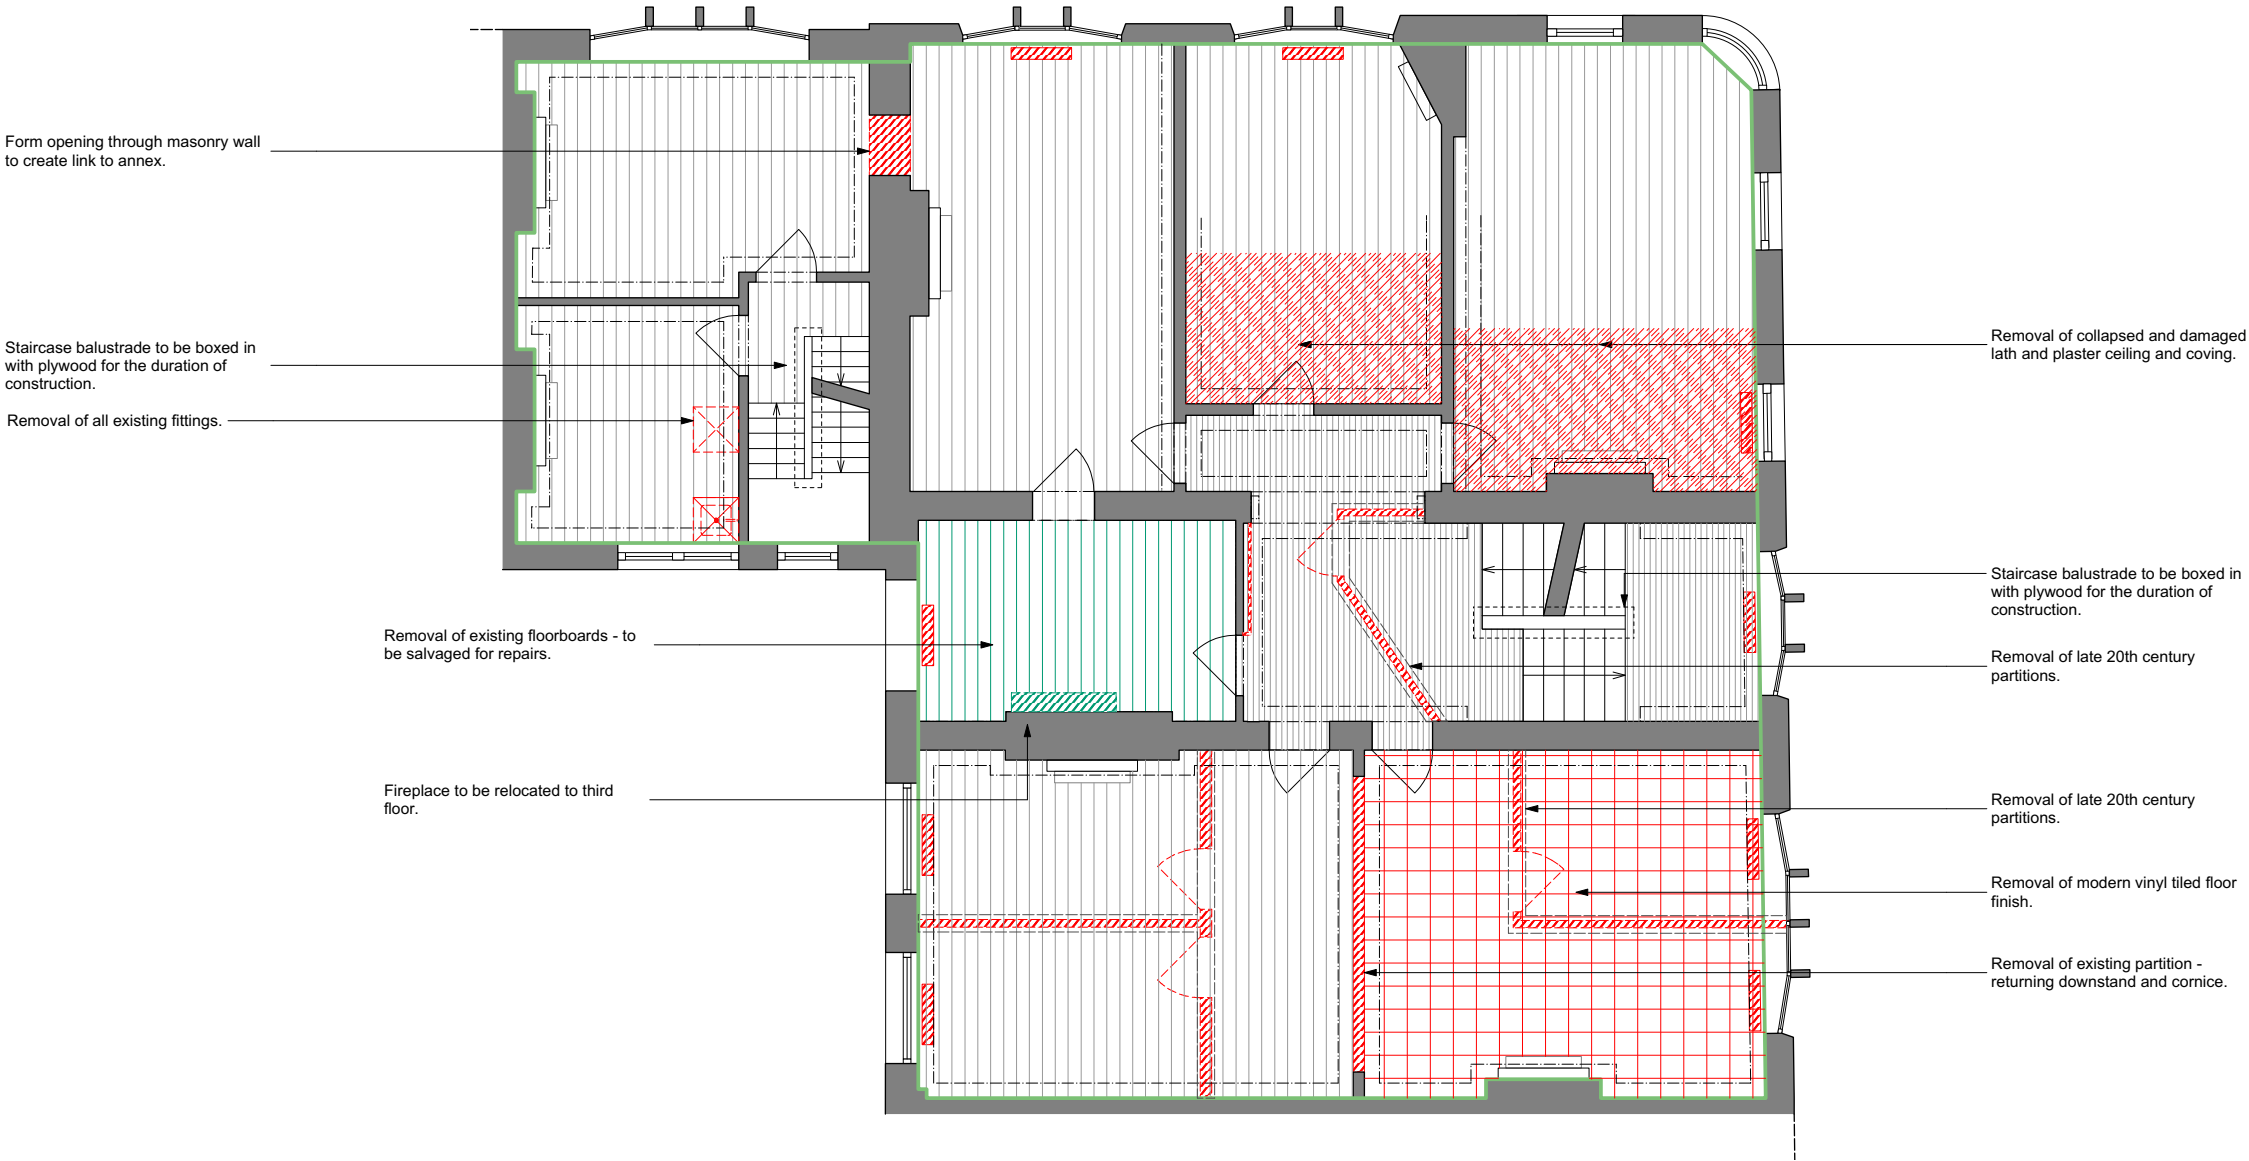
01: demolition second floor plan 1:50

Fabric to be salvaged

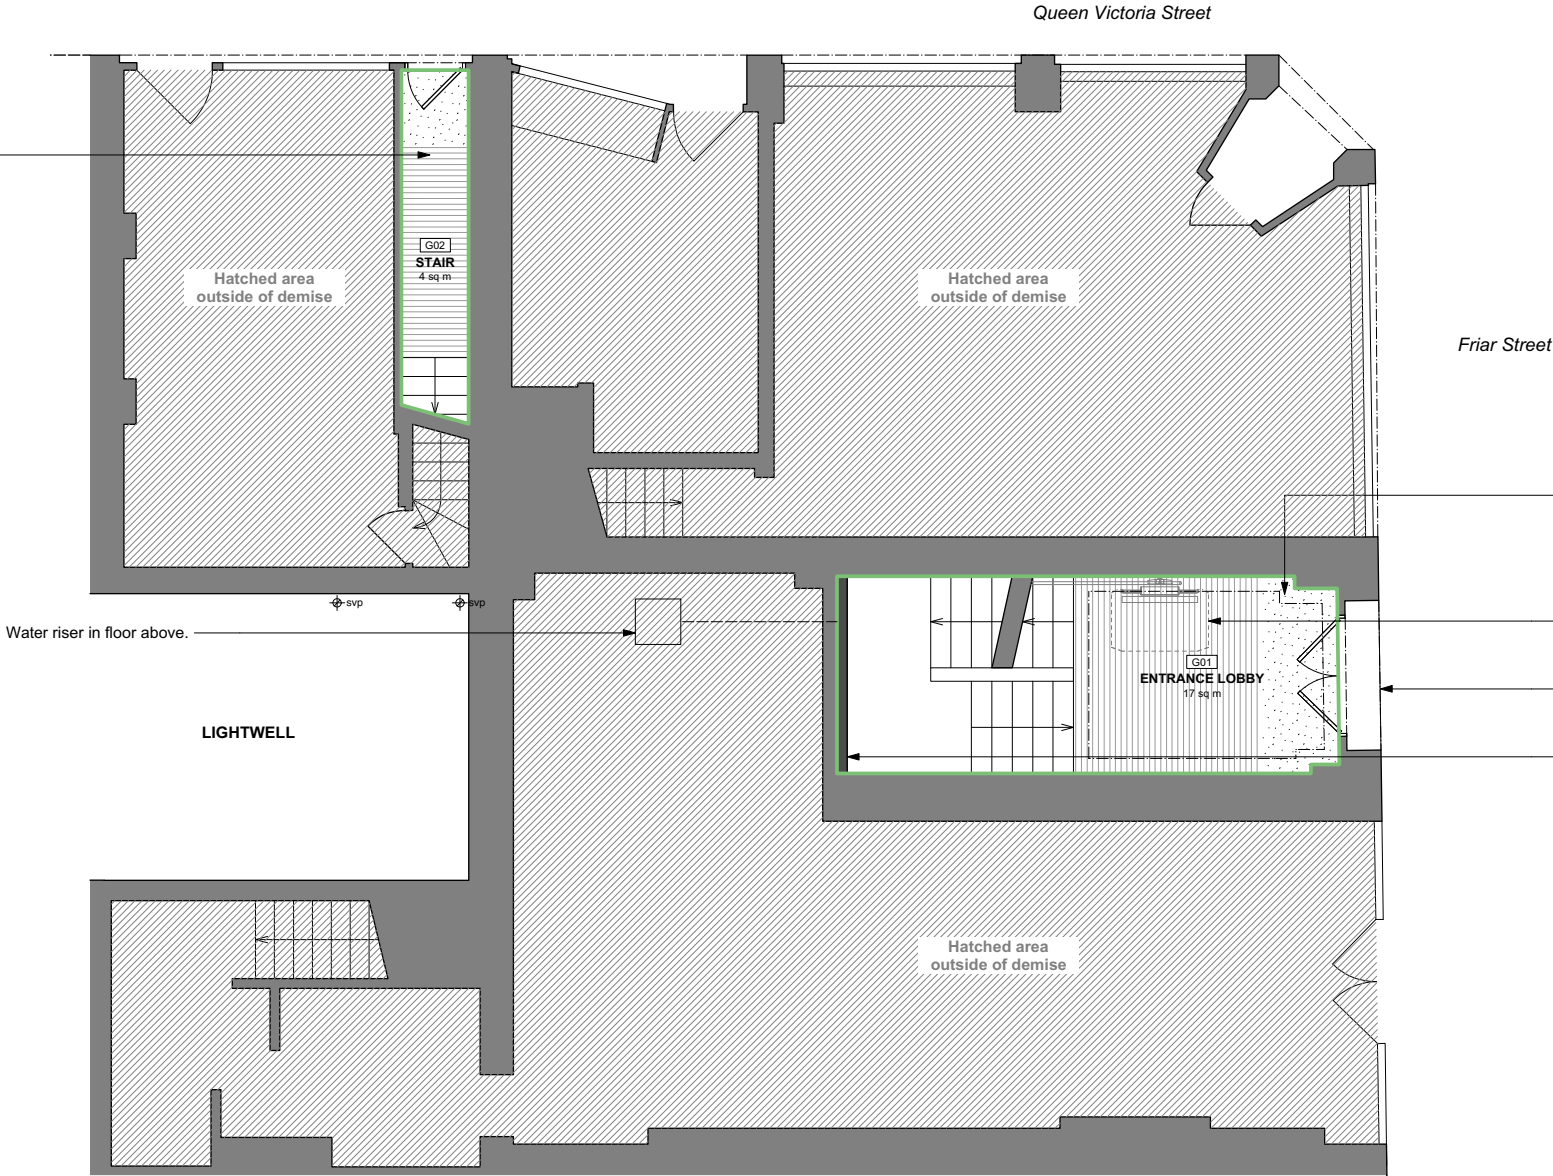
New matwell (allow for local removal of floor screed / deck to accomodate sunken matwell).

New platform lift and associated running rail installed within staircase, to provide GF to FF access.

New external entrance lighting, intercom and replacement new entrance signage (details TBC).

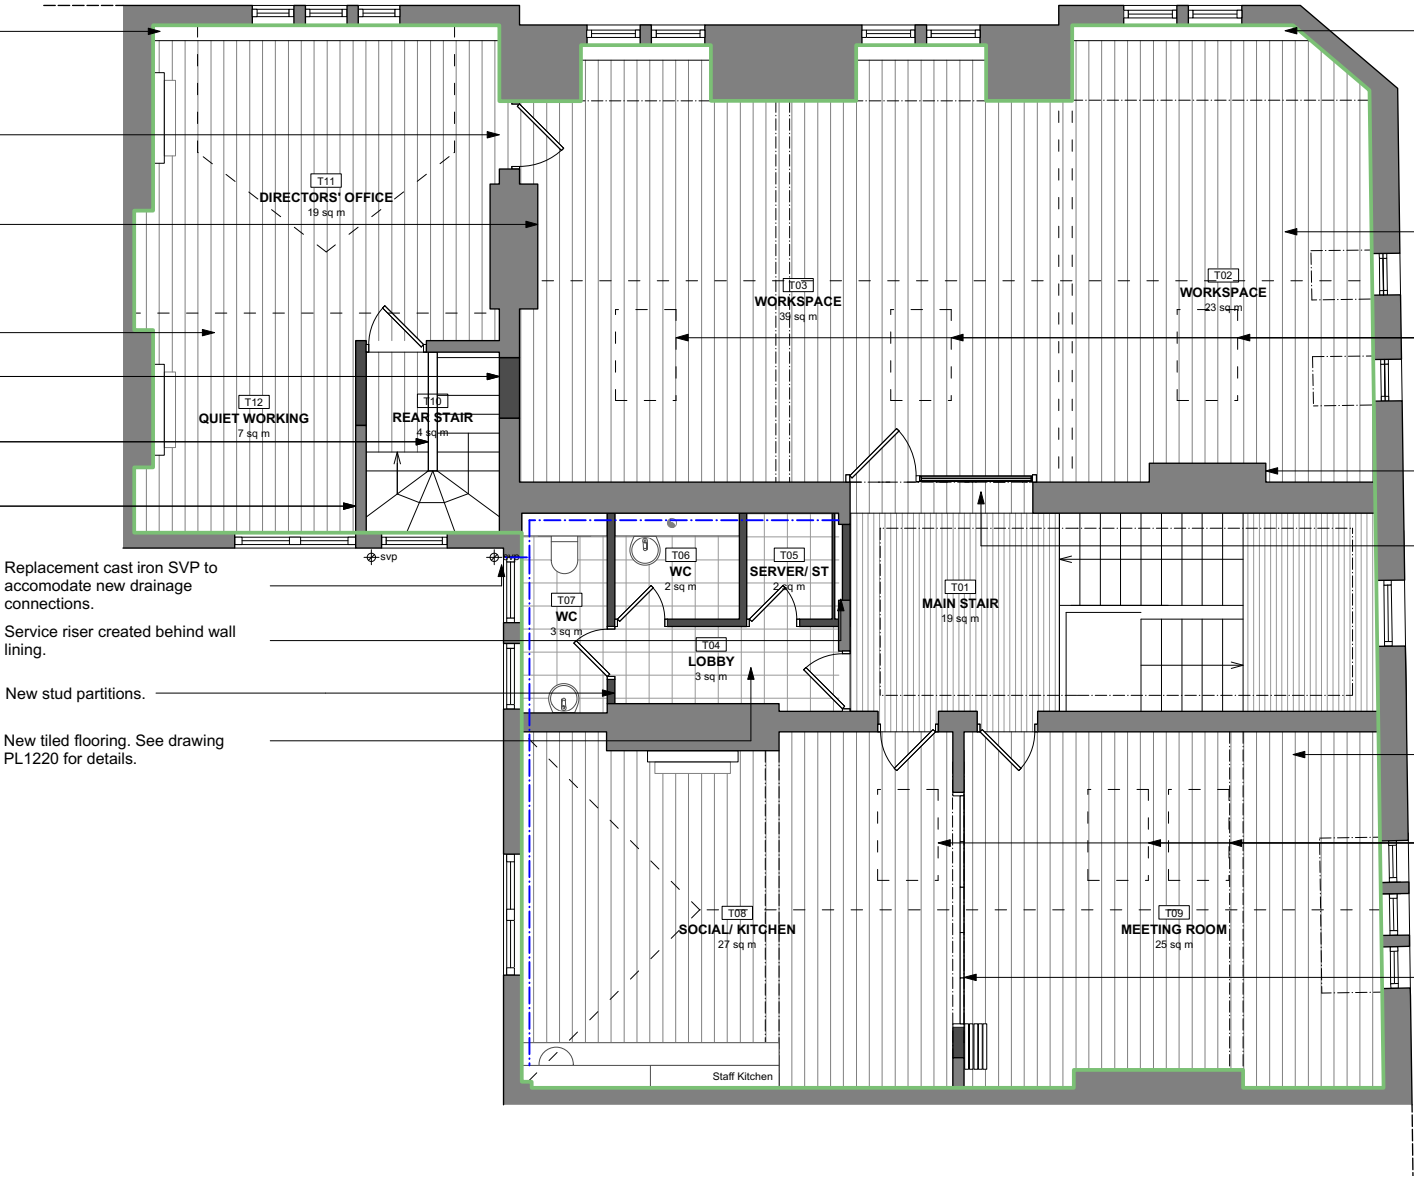
**01: proposed third floor plan 1:50**

New tiled flooring. See drawing PL1220 for details.

Timber sliding folding doors installed within new opening, with steel beam above to provide running track fixing.
