Existing Premises

Following a visual survey of the existing premises the following has been observed:

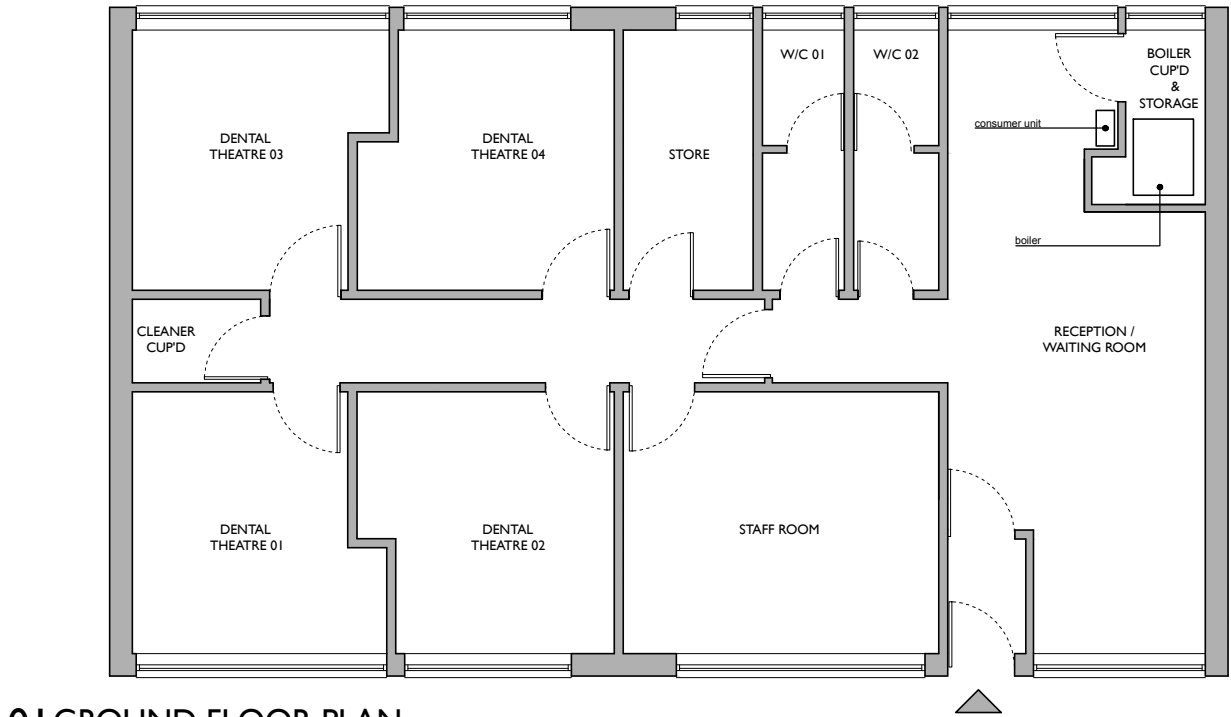
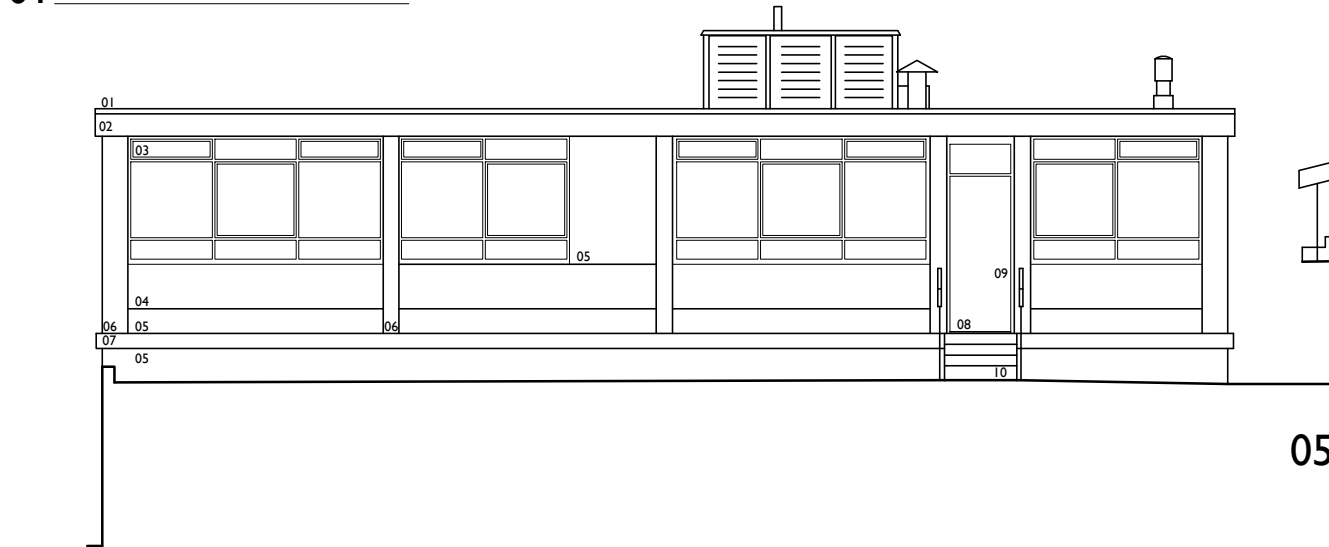
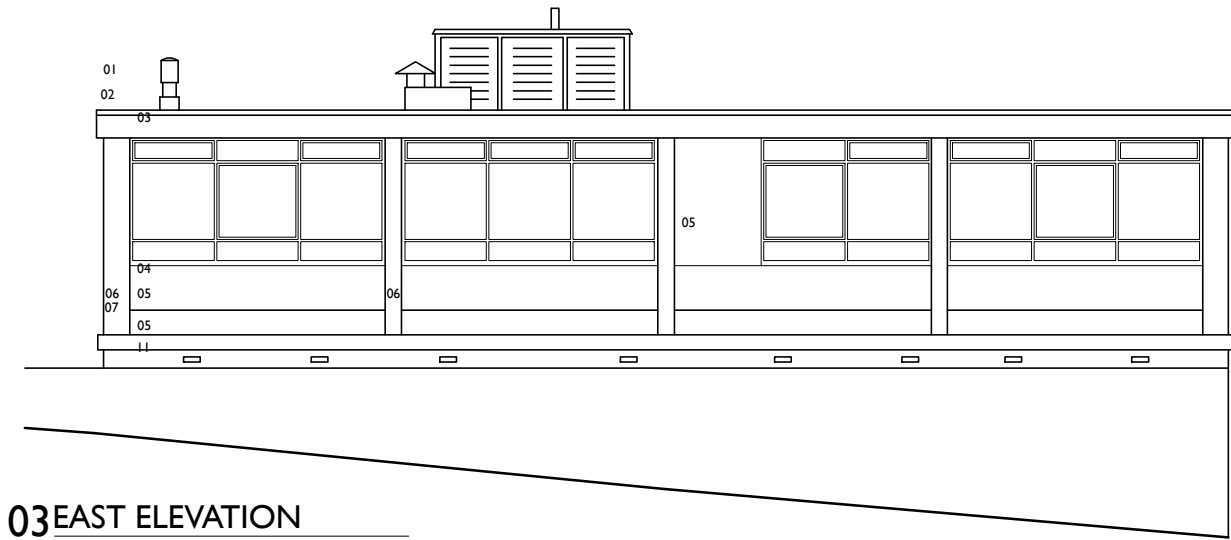
KEY

- 01 Bitumen roof covering
- 02 Painted plywood fascia
- 03 Painted steel windows
- 04 Pre-cast panel with inset stone
- 05 Brick type 01
- 06 Brick type 02
- 07 Concrete plinth
- 08 Timber panel door
- 09 Timber handrail on painted metal support spindles
- 10 Cast in-situ concrete stair
- 11 Painted cement render retaining wall
