# 108 LONDON STREET, READING, BERKSHIRE

## HERITAGE STATEMENT

**PROJECT:** 108 London Street, Reading Berkshire

**DOCUMENT TITLE:** Heritage Statement

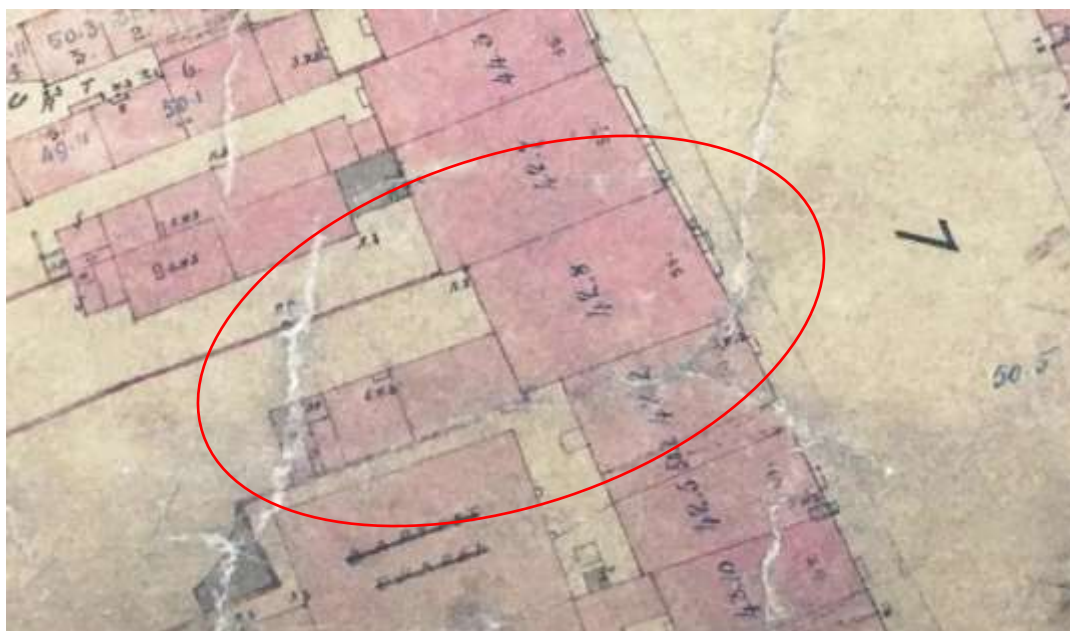
Figure 1: Extract from the Reading Board of Health map (1853)

3.2.2 By the late 18<sup>th</sup> century London Street had become one of the fashionable parts of town. Many of the elegant house from the 18<sup>th</sup> and 19<sup>th</sup> centuries which lined both sides of the road still survive. The earliest detailed map which shows the footprint of No. 108 London Street is the Reading Board of Health map (1853). This shows the double depth plan of the main part of the house and a narrower wing projecting from the southern side of the rear elevation.

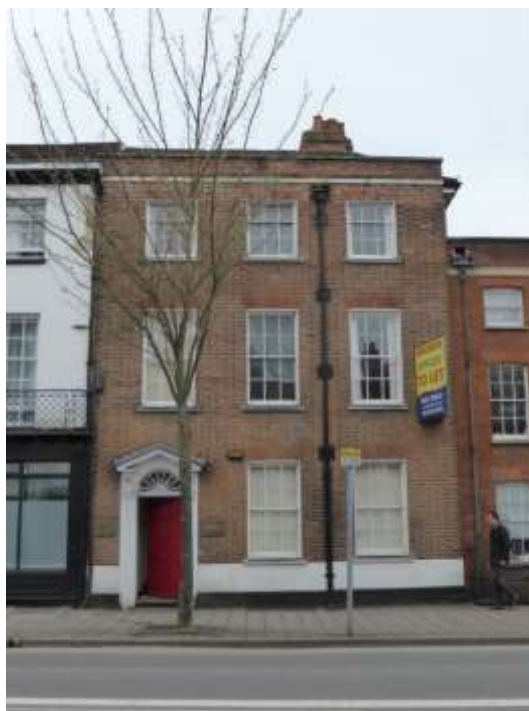
Figure 3: Front elevation of 108 London Street

- 4.1.1 The east, or front, elevation is of brick construction in Flemish bond with a stucco plinth. The appearance of the parapet and flat arch brick heads of the windows on the second floor suggests that this may have been rebuilt. Curiously, the eaves of the hipped roof on the right hand side project beyond the line of the parapet. This includes a box fascia which hints at alterations to the roof. A fragment of the upper part of the north elevation is visible to the right and this has a tile hanging finish.

- 4.1.2 The window openings are typical of the later 18<sup>th</sup> century with flat arch brick heads and 6 over six sash windows with slender glazing bars. The sash windows on the third floor include horns which indicate a c. 1850 or later date. The relative proportions of the window openings reflect the status of each floor. Of note are the taller, more slender appearance of the windows on the first floor, demonstrating the *piano nobile* or principal floor of the house. The front entrance is to the left and this includes a fanlight with semi-circular opening which suggests a later 18<sup>th</sup> century date.

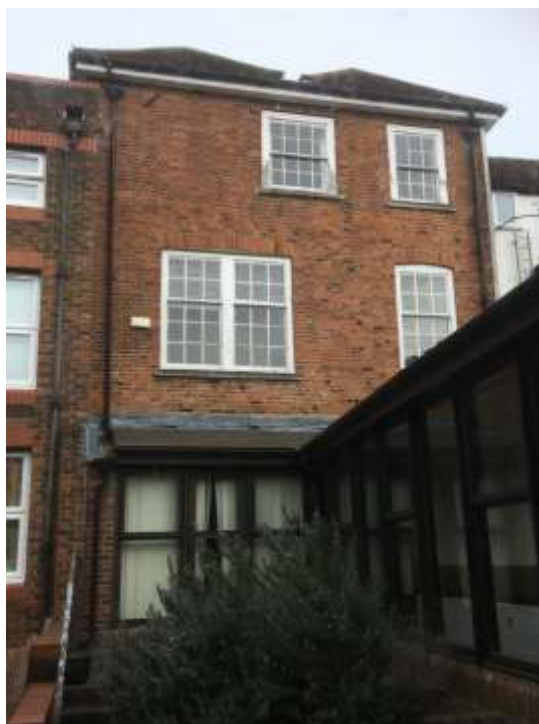
Figure 4: Rear elevation of 108 London Street

- 4.2.1 The west elevation is the rear elevation of the house. The ground floor is masked by modern additions, but the first and second floors provide details of brick construction in English bond. This is a highly unusual form of brick bonding for the period 1700-1799 and would generally indicate a 17<sup>th</sup> century or earlier date or brickwork dating from the Victorian era. It is not clear if the rear elevation has been rebuilt. The style of window openings are not consistent stylistically with those on the front elevation (see below).
- 4.2.2 The window openings on the second floor include closer bricks and are thought to be original. The exposed sash boxes are very chunky in appearance and is an anachronistic detail for an 18<sup>th</sup> century house. The large opening with a pair of sash windows to the left is a 20<sup>th</sup> century insertion.

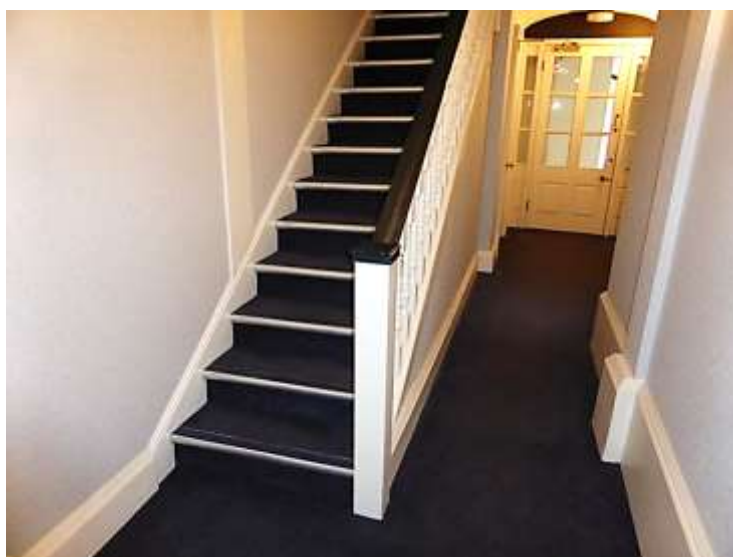
Figure 5: Staircase in G1

- 4.3.1 The entrance hall with staircase to the left and hall leading to ground floor rooms to the right is a classic 18<sup>th</sup> century floor plan for town houses. There is a short lobby with elliptical fanlight and 20<sup>th</sup> century doors. The open well staircase is also a 20<sup>th</sup> century replacement, probably inserted in the 1930s. The mouldings and height of the skirting in the front part of the entrance hall suggests a later 19<sup>th</sup> century date. The lower skirting to the rear of the entrance hall has similar mouldings but appear to be associated with the remodelling of the staircase in the 20<sup>th</sup> century.

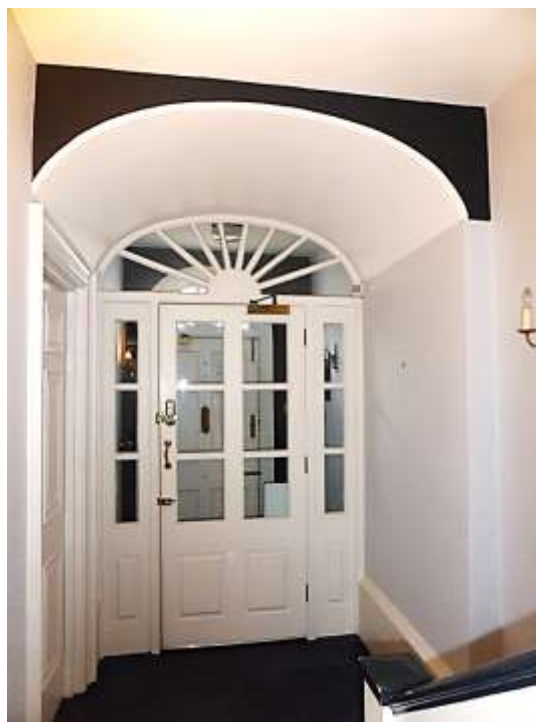
Figure 6: Lobby with 20<sup>th</sup> century internal door and fanlight in G1

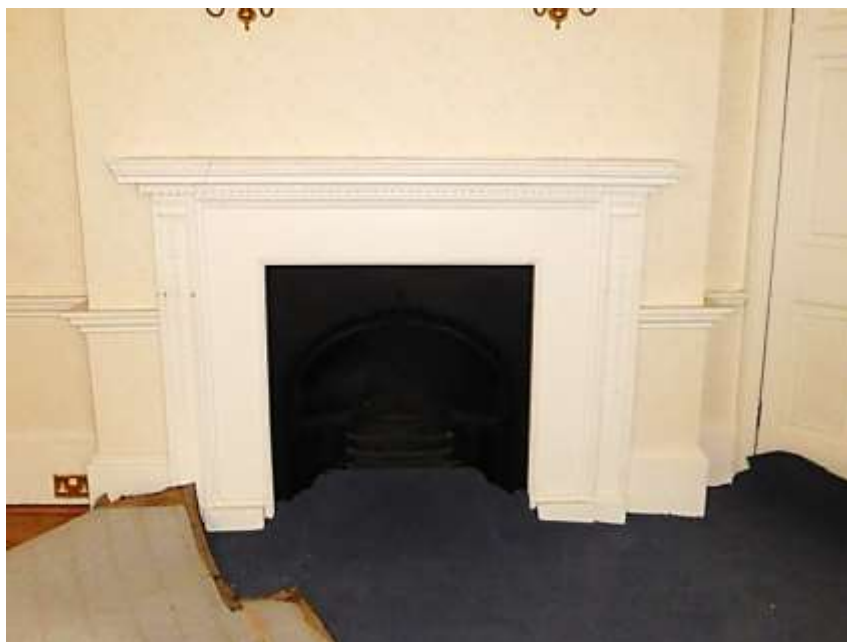
Figure 7: Modified late 18<sup>th</sup> century fire surround with refurbished 19<sup>th</sup> century register grate in G2

- 4.3.3 The focus of G2 is the fireplace which is located centrally along the wall between G2 and G3. The fireplace is embellished with fire surround which includes variants of anthemion on cyma recta, dentils, leaf and dart ornamentation and bead variations. The form and detailing is typical of later 18<sup>th</sup> century design. However, the surround appears to be missing a frieze below the mantelshelf and suggests that it has either been modified or imported from another building. It is, therefore, not clear if the fire surround forms part of the original design of the interior. It is clear that it has been re-set as the backing is partly of plasterboard.

- 4.3.4 Other details which demonstrate substantial intervention to the fireplace are the missing hearth and the refurbished cast iron hob register grate. The area between the grate and the position of the hearth is plated over, as is the register above. Both the missing hearth and the non-function grate demonstrates that the fireplace in G2 modified for show rather than to provide a source of heating, probably in the 20<sup>th</sup> century.

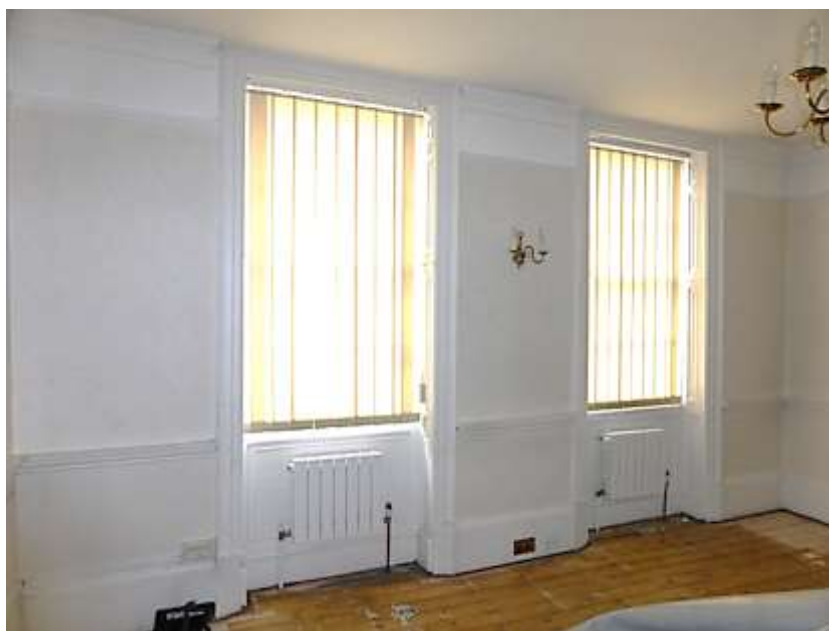
Figure 8: Panelled window recesses with low skirting in G2

- 4.3.5 G2 is decorated in a late 18<sup>th</sup> to 19<sup>th</sup> century manner with dado rail, picture rail and cornice. The simple form of the cornice suggests an early 19<sup>th</sup> century date rather than 18<sup>th</sup> century. The dado rail, however, appears to be later, possibly 20<sup>th</sup> century, while the form of the skirting is characteristic of later 19<sup>th</sup> and 20<sup>th</sup> century designs. This style of panelling, i.e, sunk panels with inner mouldings, in the window recesses and the simple torus skirting are consistent with 19<sup>th</sup> century forms. The floorboards are 20<sup>th</sup> century.

- 4.3.6 In summary, Room G2 appears to contain some earlier features, e.g. skirting boards, panels in the window recesses and possibly the cornice, but the rest of the interior appears to have been remodelled in the 20<sup>th</sup> century, using recycled and replacement fixtures and fittings, the former either re-used from within the house or imported from another building.

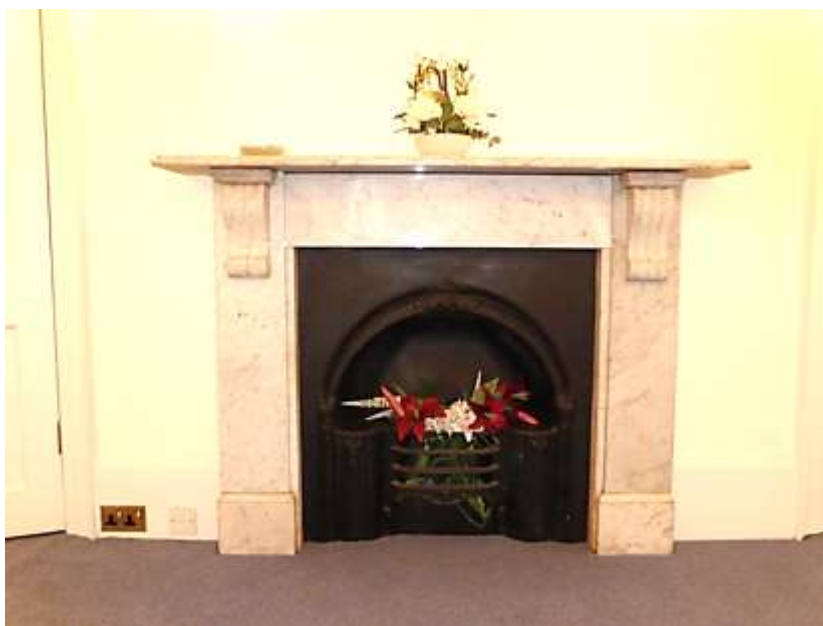
Figure 9: Re-set Victorian fireplace surround and refurbished register grate

- 4.3.7 The fireplace surround in G3 is green marble. The simple form and employment of ornate brackets supporting a marble mantelshelf is typical of Victorian designs and remained popular into the 20<sup>th</sup> century. Evidence of the fabric demonstrates that this surround is set into a plasterboard finish. The back edge of the mantelshelf is roughly cut which suggests that it has been imported from another building. The cast iron register grate with side hobs is also consistent with Victorian design. Similar to G2, the hearth has been removed and the cast iron grate has been refurbished with a fixed register and the area below the grate plated over. These details demonstrate that the cast iron grate was inserted for show rather than to function as a coal grate.

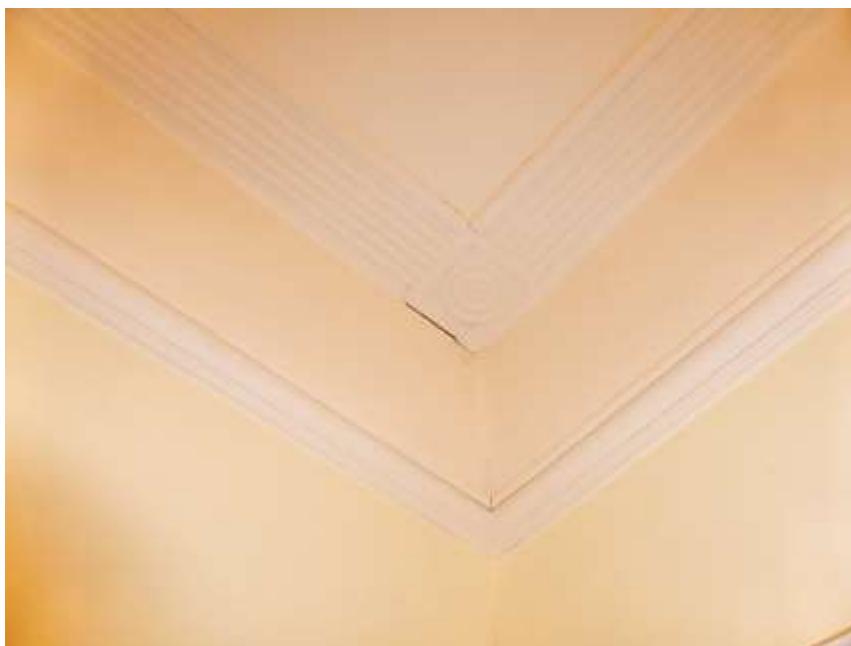
Figure 10: Plaster cornice with reeding and roundel ornamentation

- 4.3.8 Similar to G2, the walls of this room are articulated by a late 19<sup>th</sup> to early 20<sup>th</sup> century style skirting, a picture rail and cornice. The cornice is characterised by reeding which terminates in a roundel in each corner of the room. This type of ornamentation was popular in the Regency period and continued in use in to the early years of Victoria's reign.

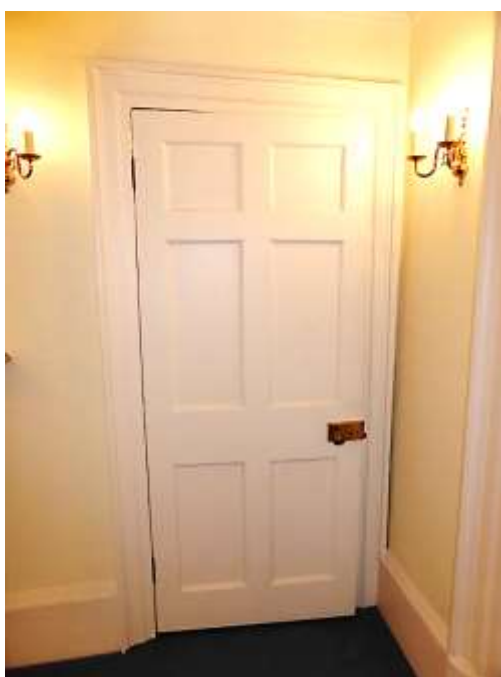
Figure 11: Six panel cupboard door in G3

- 4.3.9 The six panel cupboard door on the left hand side of the chimney breast includes brass door furniture with a Union mortice lock and door knobs but no escutcheons and is of later 20<sup>th</sup> century date. The mouldings of the architrave are consistent with the design of other door architraves associated with the 20th century alterations to the house, including the large opening along the rear wall of G3. By contrast, the door on the right includes a brass rim lock and the door architrave is reminiscent of 19<sup>th</sup> and early 20<sup>th</sup> century designs. There is evidence for a torus type skirting board within this cupboard. This contrasts with the much higher skirting in G3 which appears to be a later insertion, probably of later 19<sup>th</sup> or early 20<sup>th</sup> century date.

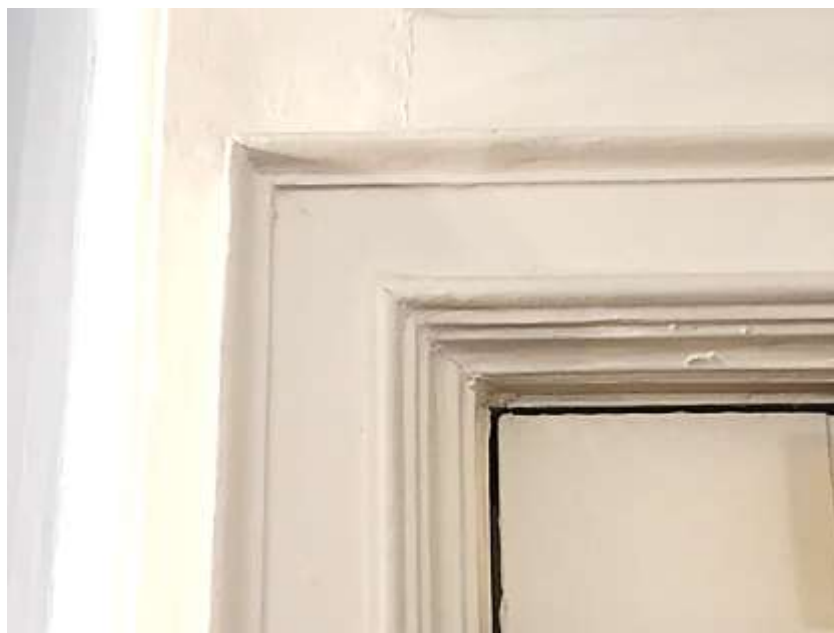
Figure 12: Architrave of door opening between the landing (F3) and F1

- 4.4.1 The door architraves between the landing (F3) and F1 and F2 include schemes of mouldings that are consistent with others identified as of 20<sup>th</sup> century date within the building. The mouldings on each side of the door between F1 and F3 are different which suggests a composite architrave created from two sources. The doors to F1 from the landing (F3) and between F1 and F2 are of the two-panel type and are both 20<sup>th</sup> century replacements.

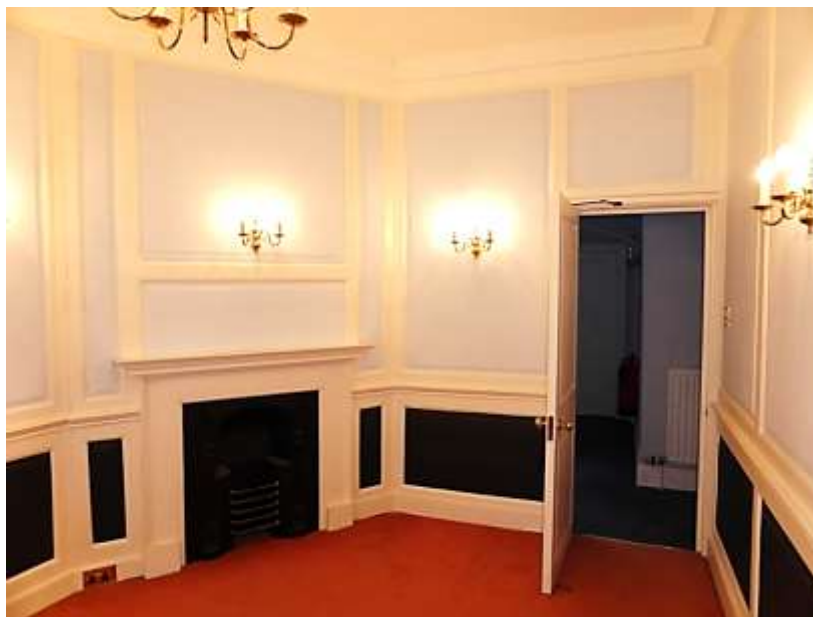
Figure 13: Full-height panelling and corner fireplace in F1

- 4.4.2 F1 is characterised by large large-panel panelling. The panelling design includes a scheme of one large upper panel over each lower panel, a dado rail, a moulded plaster cornice and a plain skirting board. The panels include an ovolo moulding and fielded panels, a simple design which is characteristic of later panelling. The cornice includes a central square projection with a small drip projecting from the bottom which is reminiscent of late 17<sup>th</sup> and early 18<sup>th</sup> century cornices. The dado has a profile similar to bolelection mouldings which is also characteristic of late 17<sup>th</sup> and early 18<sup>th</sup> century forms.
- 4.4.3 Although the panelling is reminiscent of c. mid-18<sup>th</sup> century designs, there are a number of anomalies which are discussed in more detail in the assessment of impacts section below.

Firstly, the panelling blocks the central sash window opening on the front elevation. Also, some of the construction details appear incongruous. For example, the proportions of the top rail appears cramped in relation to the very heavy cornice. The execution of the cornice is poor, with the detailing at the angles appearing disjointed. The bullnose skirting is another odd detail. The replacement floorboards appear to run beneath the panelling. As noted above, the two door architraves are of different design and they do not therefore form part of a coherent design. Also, the panels in the window recesses are characterised by sunk panels rather than fielded panels which further suggests the panelling is a later, probably 20<sup>th</sup> century, insertion.

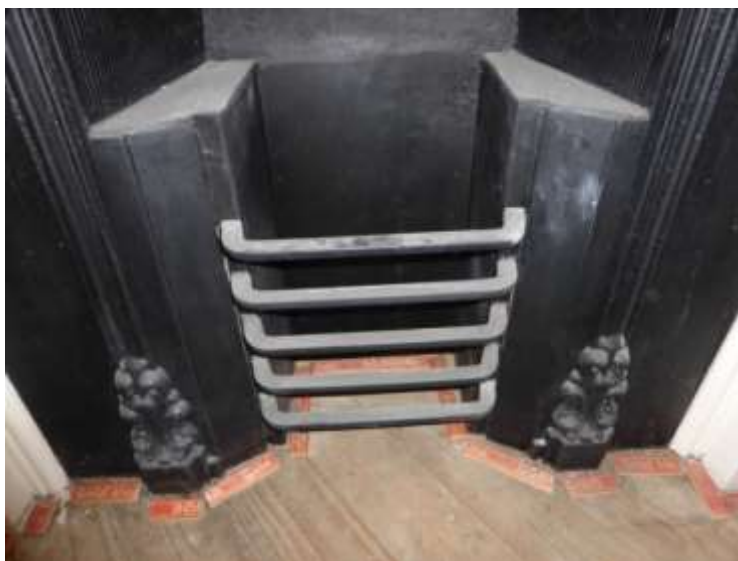
Figure 14: 20<sup>th</sup> century floorboards running under the refurbished coal grate in F1

- 4.4.3 The fireplace surround in F1 is very simply detailed and of 18<sup>th</sup> century style but modified. The mantelshelf is moulded and has been applied over the wall panelling. It appears that a frieze is missing which has impacted on the overall composition. The cast iron hob register grate is of c. mid-19<sup>th</sup> century design but has been modified and includes a fixed register and a missing fire bar and grate. The hearth has been removed and floor boards inserted. It is clear that the cast iron grate was inserted for decorative purposes rather than as a functioning fireplace. The tongue and groove floorboards in this room are 120mm wide and are considered to date from the 20<sup>th</sup> century.

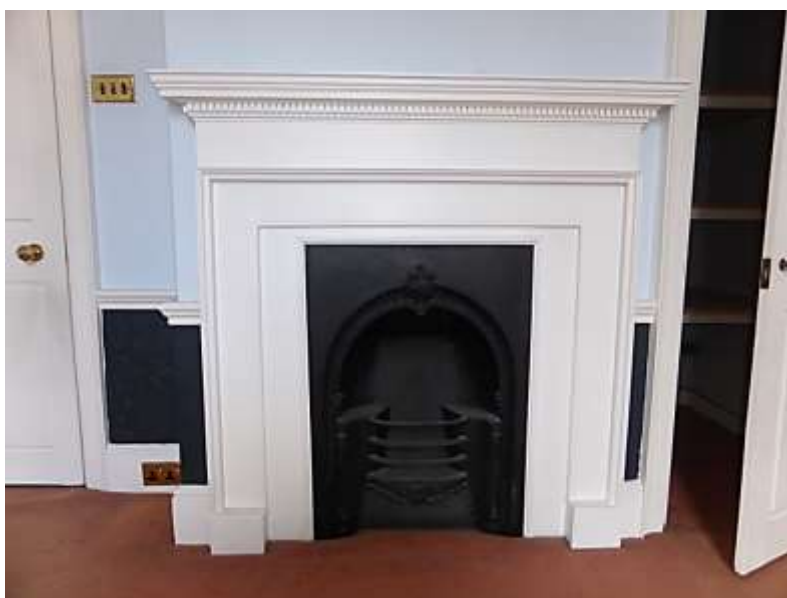
Figure 15: Fireplace in F2

- 4.4.2 F2 contains a chimneybreast with simple fire surround comprising a frame of mouldings with frieze and mantelshelf with dentils and cyma recta mouldings. These details are consistent with a late 18<sup>th</sup> to early 19<sup>th</sup> century date. The fireplace has been partly infilled and a c. mid-19<sup>th</sup> century register grate with side hobs inserted. Similar to all of the other cast iron gates, this example has been refurbished and plates inserted to replace the register and the space between the gate and hearth. Again, the hearthstone has been removed and 20<sup>th</sup> century floorboards run beneath the grate, demonstrating a decorative rather than functional purpose. The fire surround is fixed against a plasterboard backing so has clearly been re-set.

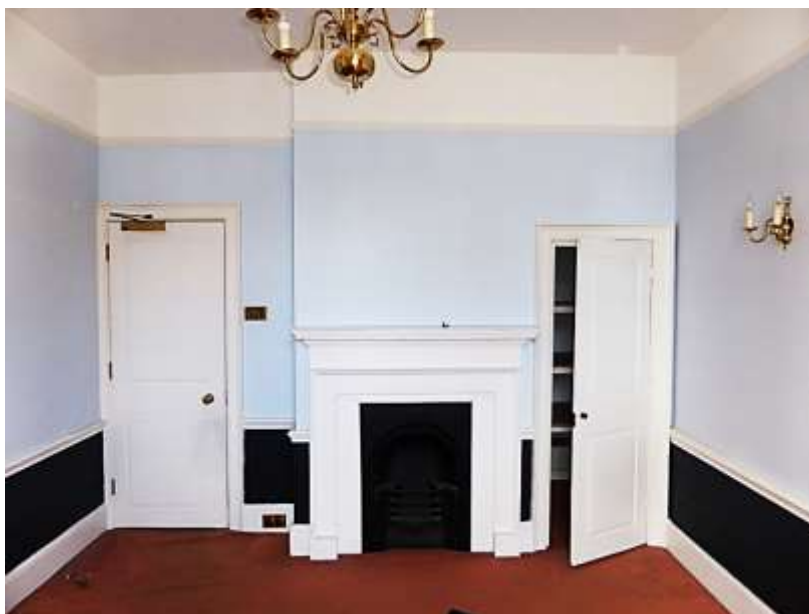
Figure 16: Decorative scheme in F2

- 4.4.3 This is quite a plain room with dado rail and picture rail, but no coving or cornice. Below the dado rail is textured wallpaper. This type of wall treatment was in vogue in the later 19<sup>th</sup> and early 20<sup>th</sup> centuries. However, the evidence from a wall light fitting suggests that the upper

part of this wall, at least, is finished with modern plasterboard. The dado has a similar moulding profile to the example in G1 but appears to have been modified.

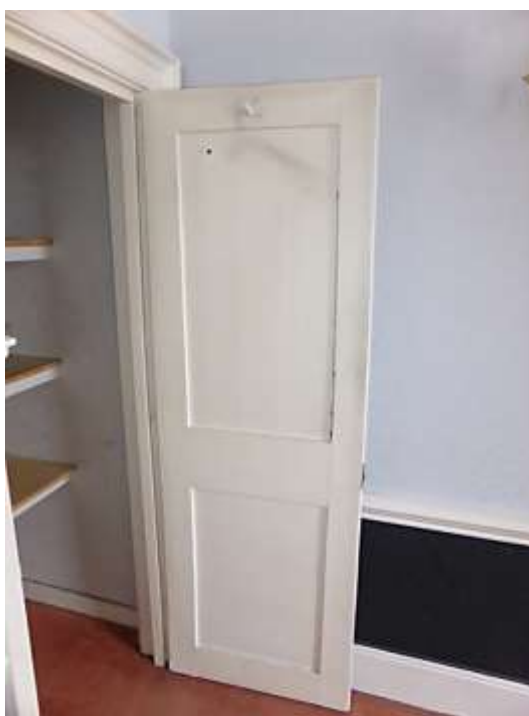
Figure 17: Late 19<sup>th</sup> or early 20<sup>th</sup> century cupboard door in F2

- 4.4.4 The two panel cupboard door appears to date from the later 19<sup>th</sup> or early 20<sup>th</sup> centuries. The door leading from the landing is a 20<sup>th</sup> century replacement/insertion.

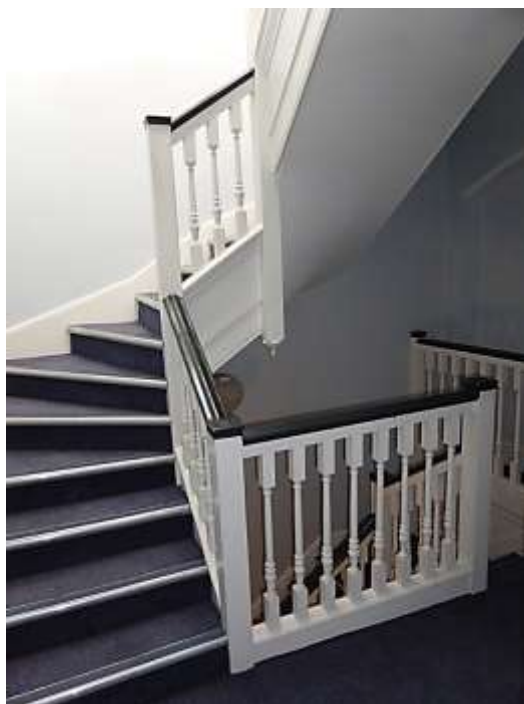
Figure 18: Staircase in F3

- 4.4.5 The layout of the landing area provides access to two rooms at the front of the house (F1 and F2) and on to the rear (F4). The staircase was remodelled in the 20<sup>th</sup> century. There is a wide

segmental arch on the rear side of the landing which also appears to be a 20<sup>th</sup> century alteration.

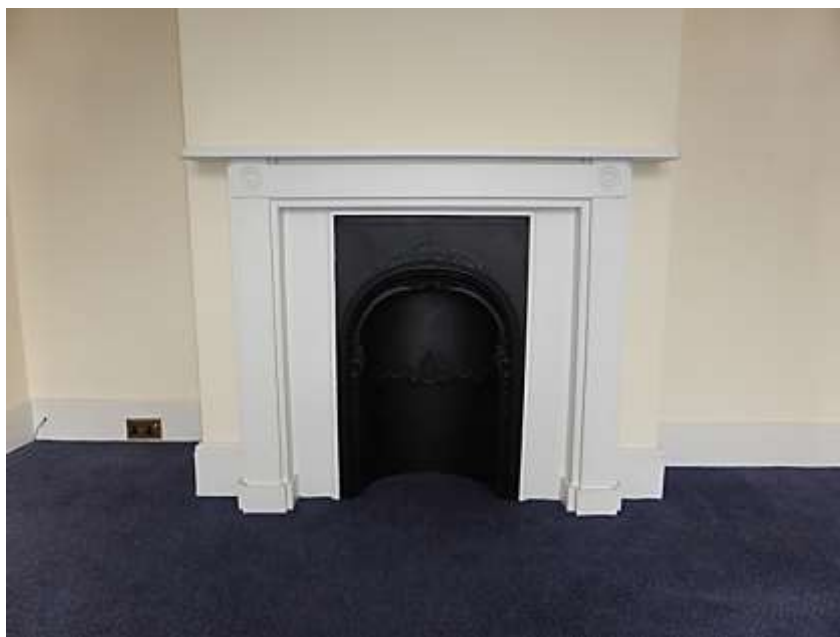
Figure 19: Early 19<sup>th</sup> century style fire surround with roundels and refurbished cast iron grate in F5

- 4.4.5 The fireplace in F5 has plain jambs and roundels and is characteristic of designs dating from c. 1800-1840. However, the details, particularly the frieze don't appear to align correctly, and this suggests modification. Indeed, as with all of the other fireplaces, the hearth has been removed and replaced with floorboards and the chimney piece as a whole is fitted against a plasterboard backing. Also the cast iron surround does not include a grate or a register. Other internal features of this room include a dado rail and low torus skirting.

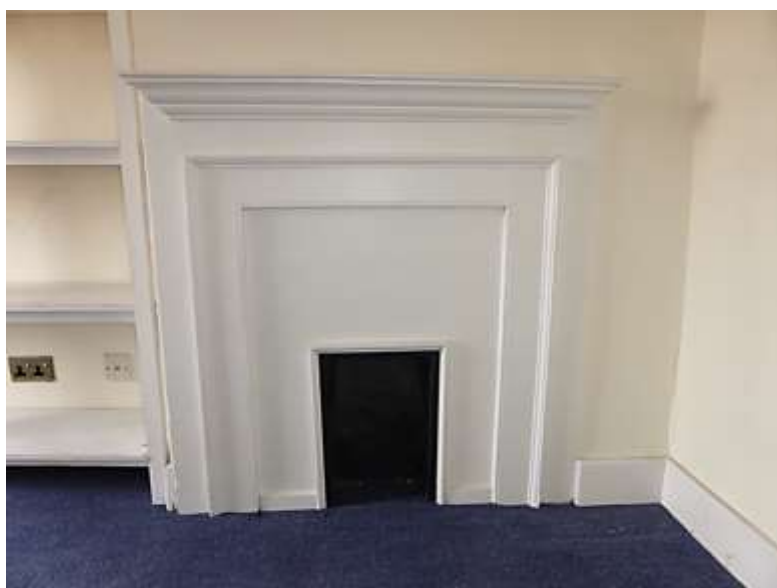
Figure 20: Georgian fire surround in S1

- 4.5.1 There is a chimney breast with fireplace along the south wall of S1. The simple detailing of the surround reflects its position and is consistent with later 18<sup>th</sup> and early 19<sup>th</sup> century design. The mantelpiece includes cyma recta mouldings which are also employed in the fireplace surround in G2. Like all of the other fireplaces in the house, the original size of the fireplace has been reduced. With the exception of simple bullnose skirting, there are no other internal decorative features.

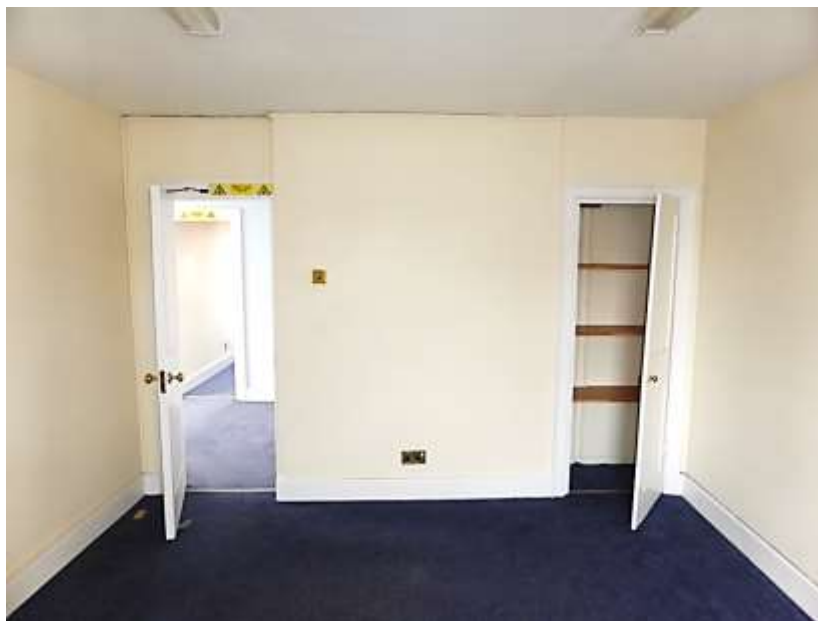
Figure 21: Chimney breast with cupboard door to the right in S2

- 4.5.2 S2 is accessed from the landing (S3) through a later 20<sup>th</sup> century two-panelled door. Although the architrave mouldings are reminiscent of 18<sup>th</sup> and 19<sup>th</sup> century examples, they are similar to examples in Rivington's Building Construction published in 1904 (p. 130) and could, of course, be later than this. The cupboard door on the right hand side of the chimney breast is also a two-panel design and, perhaps dates from the later 19<sup>th</sup> to early 20<sup>th</sup> centuries. No other features of interest were observed.

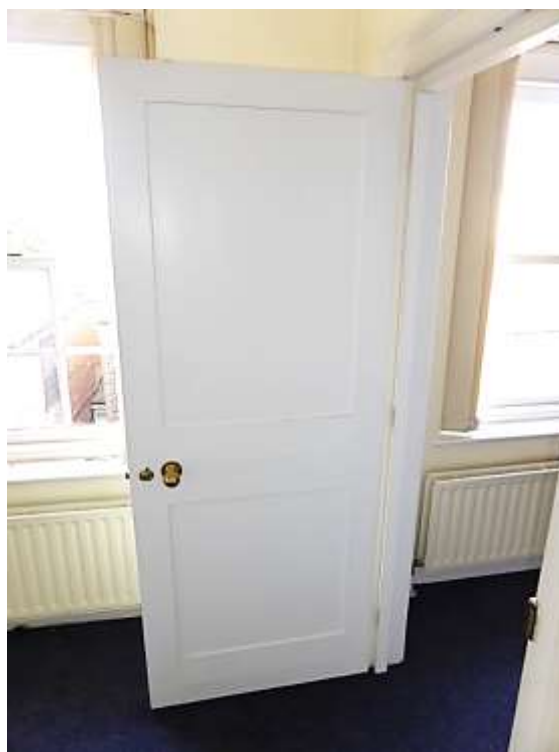
Figure 23: Late 19<sup>th</sup> to early 20<sup>th</sup> century two panelled door between S4 and S5

- 4.5.4 The door between S4 and S5 appears to be of similar age to the other two panel doors of similar thickness, i.e. later 19<sup>th</sup> or early 20<sup>th</sup> century.

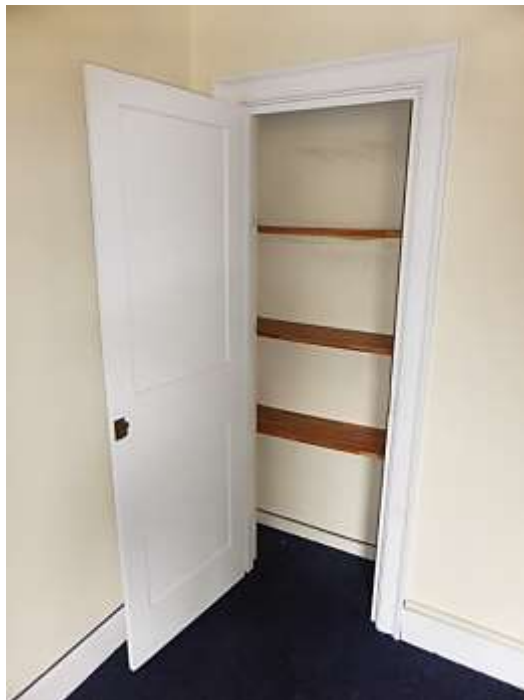
Figure 24: Late 19<sup>th</sup> century two panelled cupboard door in S5

- 4.5.5 A two panel cupboard door on the left hand side of the chimney stack is similar to other cupboard doors and narrow thickness doors and is probably of later 19<sup>th</sup> to early 20<sup>th</sup> century date. No other features of interest were noted.

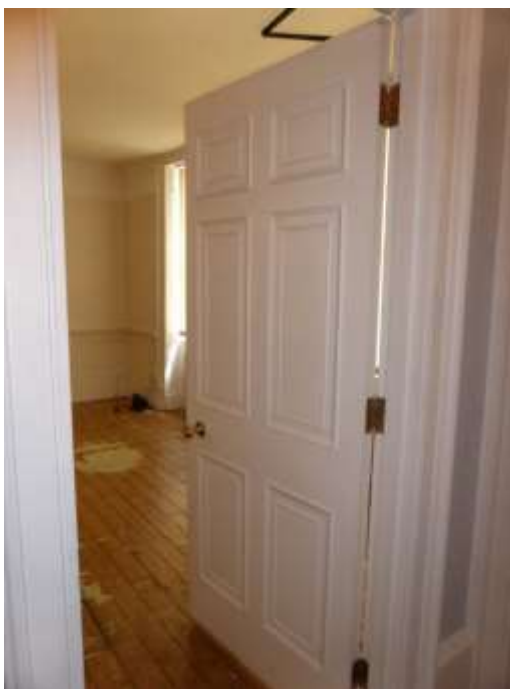
Figure 25: 20<sup>th</sup> century six panelled door from the entrance hall (G1) to G2

- 6.1.2 The door to G2 from the entrance hall (G1) is 20<sup>th</sup> century as demonstrated by the door knobs and mortise lock. This door is therefore associated with later 20<sup>th</sup> century alterations to the building and considered to be of low significance. The position of the door opening does, however, reflect the original layout of the building. The impact of this change will be mitigated by either retaining the door architrave or replacing it with an appropriate design so that the door position is preserved from within the entrance hall (G1).

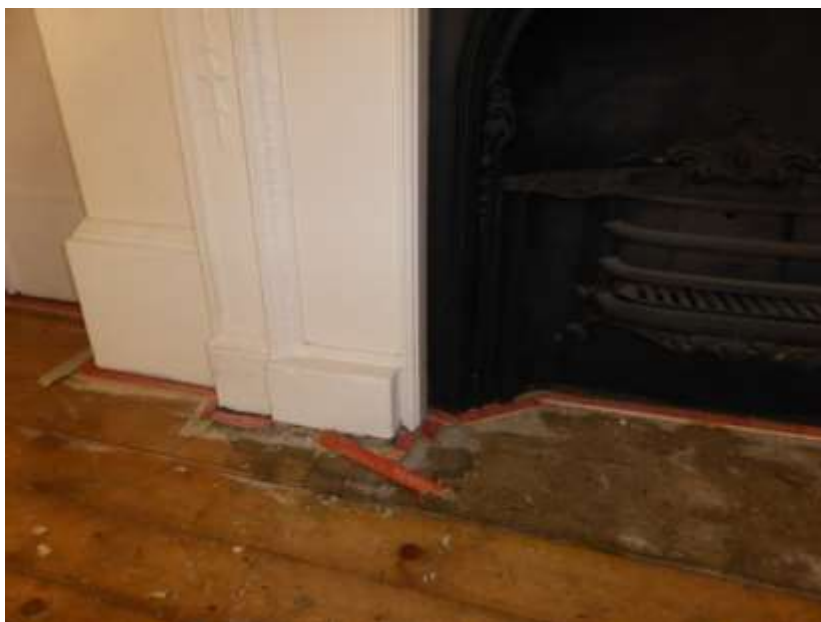
Figure 26: Chipboard hearth in G2

- 6.1.3 The fire surrounds in G2 and G3 have been modified and possibly imported from another building (G3). The cast iron grates are of mid to late 19<sup>th</sup> century but have been refurbished as non-functioning features and appear to be associated with 20<sup>th</sup> century alterations to the building. The area above the fireplaces has a plasterboard finish which requires investigation. The removal and reinstatement of the fireplaces and cast iron grates would not have harmful impacts on the significance of the listed building. Indeed, investigation of the chimney breast will contribute to an understanding of the 20<sup>th</sup> century alterations to the listed building.

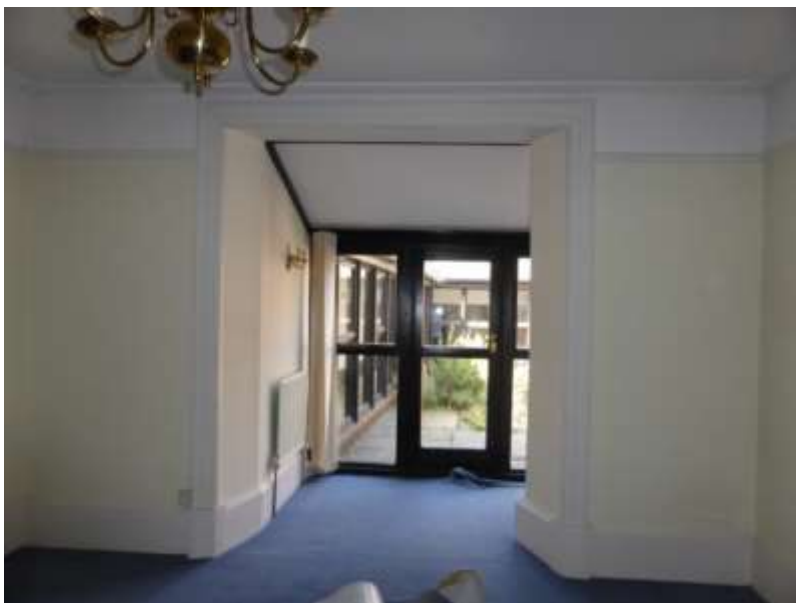
Figure 27: 20<sup>th</sup> century opening to a former conservatory on the rear wall of G3

- 6.1.4 It is proposed to widen the existing large opening on the western side of G3. This opening is thought to be associated with the construction of a conservatory on the rear elevation of the

building in the 1930s-50s. The opening and associated architrave is therefore considered to be of low significance. The widening of the opening would require the removal of a small area of historic fabric. The alignment of the wall would be preserved by retaining a nib. The early 19<sup>th</sup> century cornice would not be impacted by this element of the proposals.

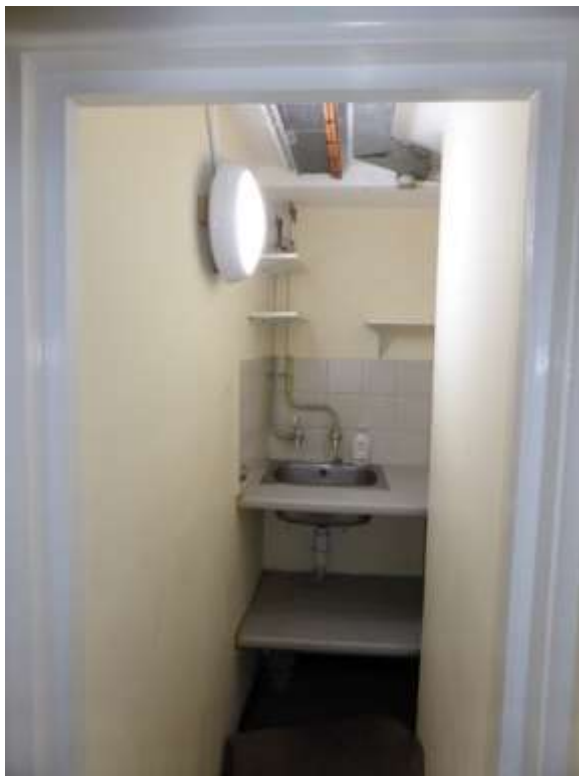
Figure 28: Modern door frame to G4

- 6.1.5 It is proposed to reconfigure the western end of the entrance hall (G1) and G4 to create a bathroom. This would require the removal of a partition between G1 and G4. This partition appears to be a modern insertion. The door frame at the entrance to G4 is modern and the skirting boards associated with this wall do not match those in the main part of the entrance hall (G1). A 20<sup>th</sup> century part glazed door at the western end of the entrance hall (G1) would also be removed. None of these alterations would impact on historic fabric.

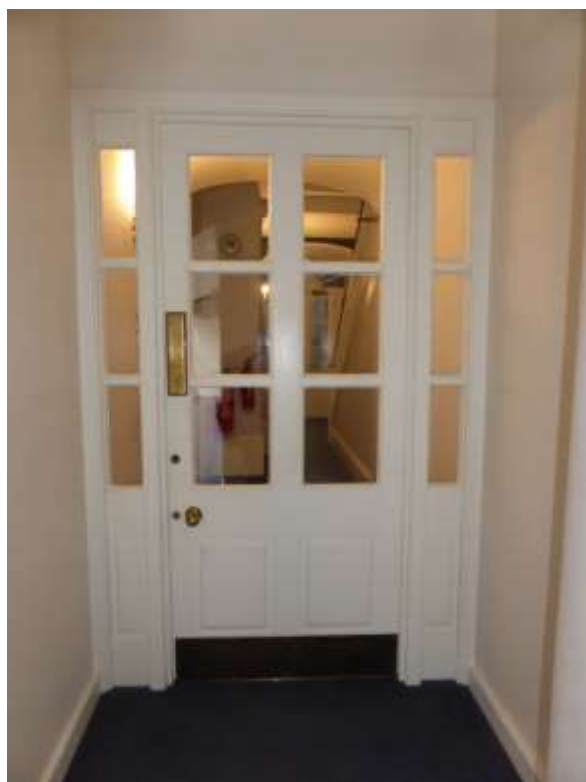
Figure 29: 20<sup>th</sup> century internal rear door in G1

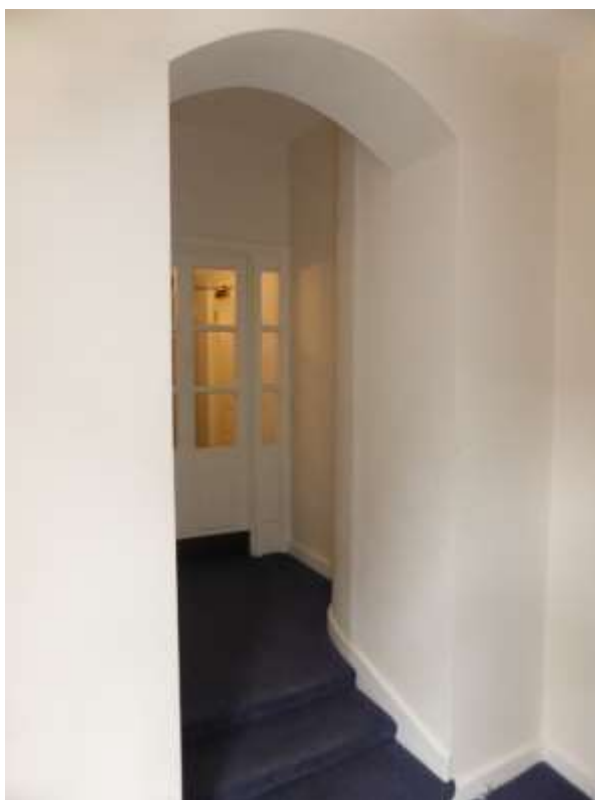
Figure 30: Door opening with segmental arch head at the rear of the entrance hall (G1)

- 6.1.7 An opening with a segmental arch head in the original rear wall would be filled-in. This may have been the original access from the main house to the extension to the rear. The infilling of this opening would not impact historic fabric. The change will be mitigated by leaving offsets so that the form of the door opening remains legible.

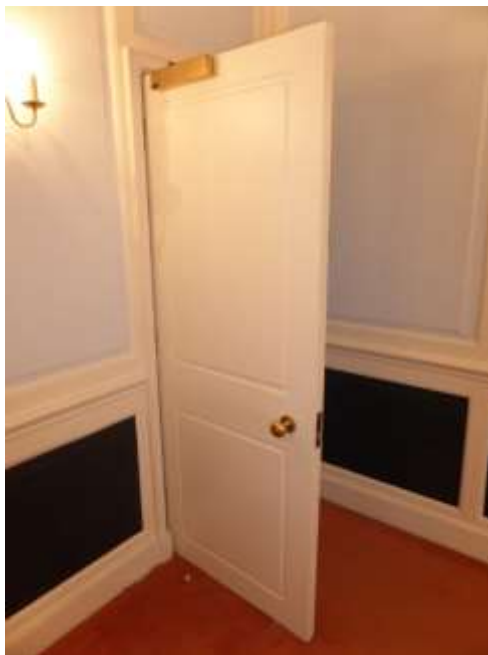
Figure 31: 20<sup>th</sup> century door from the landing (F3) to F1

6.2.2 The two-panel door from the landing to F1 includes the same brass door furniture as the majority of the doors at 108 London Street and is of later 20<sup>th</sup> century date. The pattern of mouldings for the architrave is not consistent on both sides of the frame which suggests a composite door surround. The blocking of this door opening would not impact on historic fabric. Changes to the layout of the first floor in the 20<sup>th</sup> century have compromised the

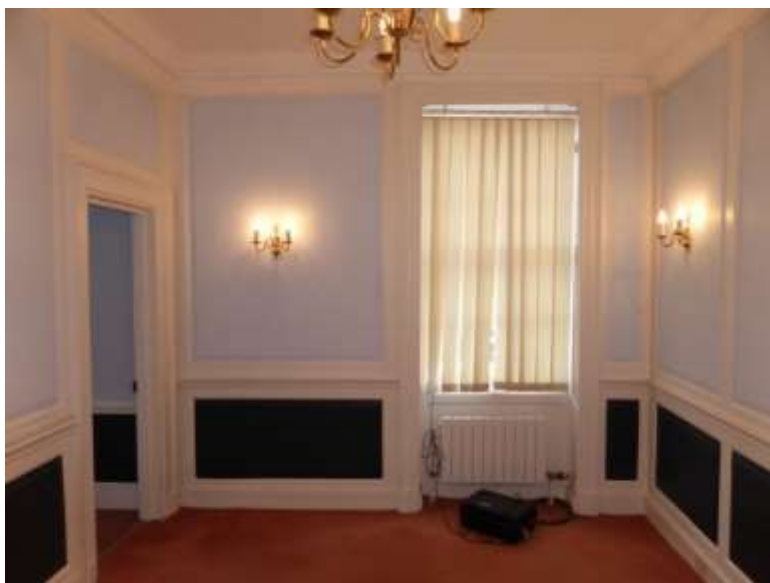
Figure 32: Blocked sash window to the right in F1

- 6.2.3 Removing the partition between F1 and F2 represents a substantial change to the floor plan of the building as it exists today. However, there are a number of details that demonstrate that the wall panelling was a later alteration. Firstly, the panelled partition between F1 and F2 blocks the central window on the first floor. Also, the presence of a partition in this location appears to be at odds with the kind of large reception room for entertaining that you would expect for a building of this period. The use of full-height panelling as a form of decoration, generally associated with dining rooms or parlours in the first half of the 18<sup>th</sup> century, appears anachronistic for a building of later 18<sup>th</sup> century date.

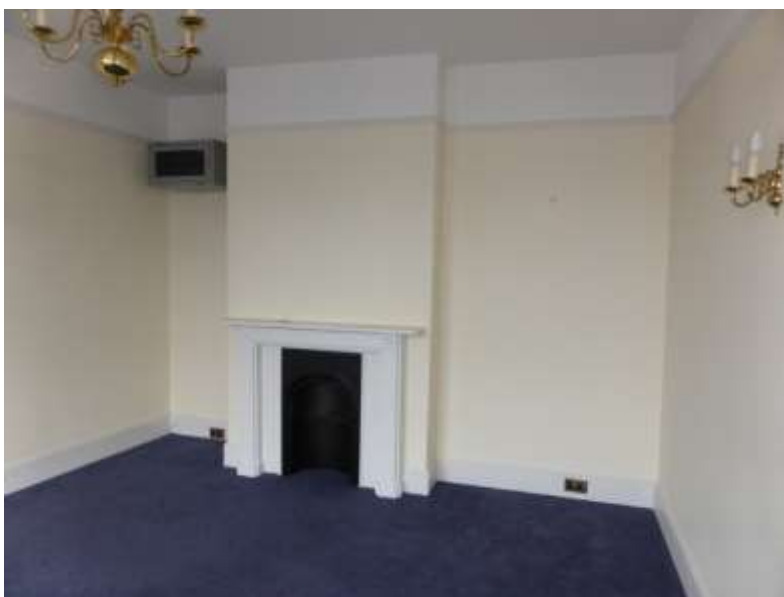
Figure 33: Breach to be created in the wall to the right of the chimney breast in F5

- 6.2.7 The creation of a door opening on the right hand side of the chimney breast in F5 would require a small breach through a partition. Apart from the Regency style fire surround and cast iron grate, this room is characterised by torus skirting and a plain picture rail. Torus skirting has a long date range so is not particularly diagnostic but the lack of dado or cornice in combination with a picture rail and skirting suggests a 20<sup>th</sup> century date. Indeed, the large window opening appears to be contemporary with the large opening in the west wall of G3, i.e. 1930s -1950s. Also, as noted elsewhere, the wall alignments do not match those of the original configuration on the ground floor. Based on this evidence it is concluded that the proposed opening would not impact on significant historic fabric.

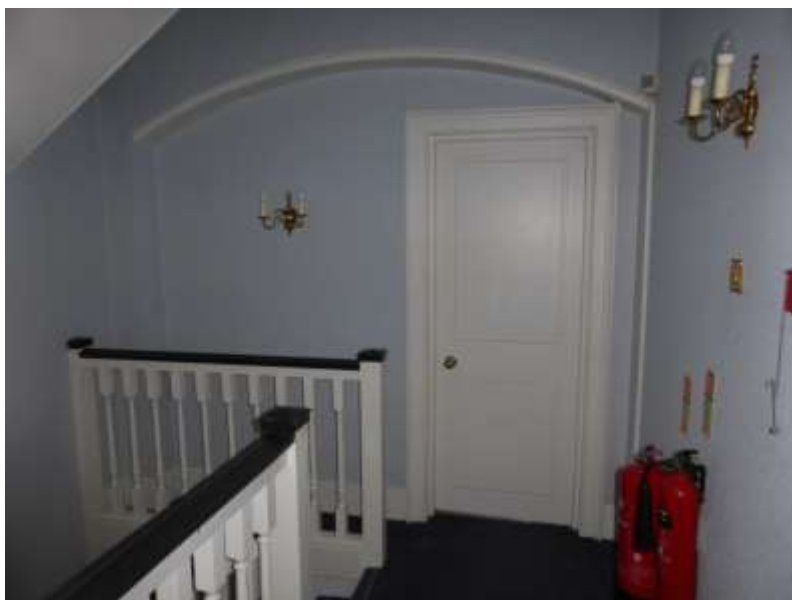
Figure 34: 20<sup>th</sup> century door and stud and plaster infill at F4

- 6.2.8 The two-panel door from the landing to F4 includes the same brass door furniture as the majority of the doors at 108 London Street and is of 20<sup>th</sup> century date. The architrave mouldings also match the pattern of 20<sup>th</sup> century doors observed elsewhere in the building. This door is also set within what appears to be an infill of a perhaps earlier 20<sup>th</sup> century segmental arched opening. The infilling of this door would neither impact on historic fabric or on the historic plan form of the building.

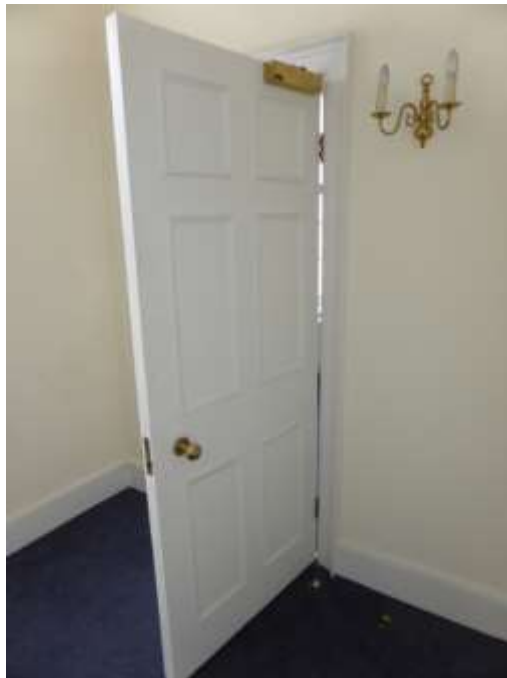
Figure 35: 20<sup>th</sup> century six panelled door in the partition between F4 and F5

- 6.2.9 It is proposed to remove the partition between F4 and F5 to create an open kitchen/lounge area. Although there is little evidence to suggest that this is an original partition, the door and architrave are of 20<sup>th</sup> century date and the torus skirting is evident in areas which have been identified as part of 20<sup>th</sup> century alterations, it is likely that it reflects the original layout of the

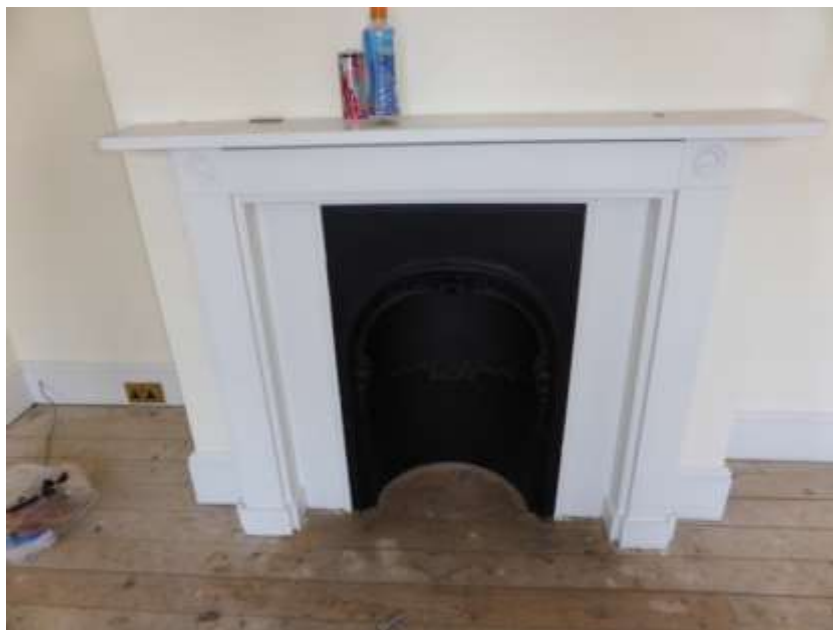
Figure 36: Hearth replaced by floorboards in F5

6.2.9 All of the fireplaces have been subject to alteration. This appears to be associated with the insertion of replacement floor boards that extend below the hearths. The fireplace in F1 includes a refurbished cast iron register hob (19<sup>th</sup> century), and a modified surround of later 18<sup>th</sup> century style and no hearth. The fireplace in F2 includes a relatively complete later 18<sup>th</sup> century fire surround, refurbished cast iron grate (the register has been removed and plated over) and no hearth. The fireplace in F5 includes a refurbished cast iron surround with no grate and no hearth. The wooden surround is early 19<sup>th</sup> century style but the construction appears odd and may be of 20<sup>th</sup> century date. The removal and reinstatement of the fireplaces and cast iron grates would not have harmful impacts on the significance of the listed building. Indeed, investigation of the chimney breast will contribute to an understanding of the 20<sup>th</sup> century alterations to the listed building.

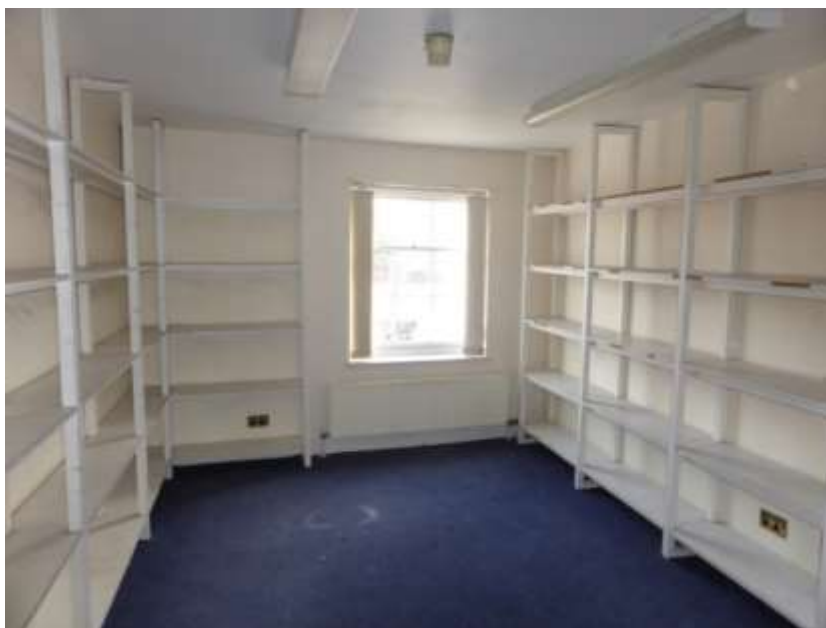
Figure 37: Blocked sash window opening to the left in S1

6.3.2 Similar to the partition between F1 and F2 on the first floor, the partition between S1 and S2 has blocked the central window on the second floor. There are no features of merit. The bullnose skirting is characteristic of modern interior joinery. Historically, lower status rooms such as basements and attics were fitted with simple square edged boards. The position of the wall concealing the central sash clearly shows that it is a later, in this case 20<sup>th</sup> century, alteration and its removal would not negatively affect the significance of the listed building.
