# 108 LONDON STREET, READING, BERKSHIRE

## HERITAGE STATEMENT

**PROJECT:** 108 London Street, Reading Berkshire

**DOCUMENT TITLE:** Heritage Statement

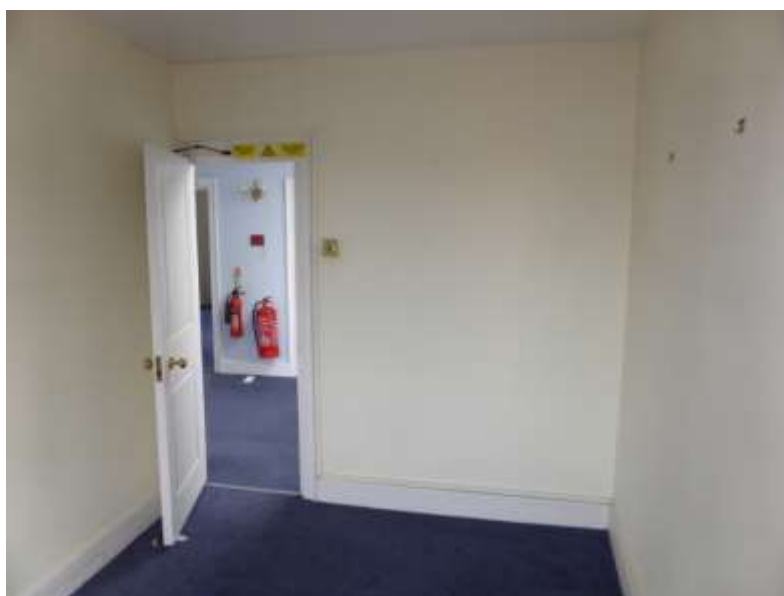
Figure 38: Two panelled door to S4 from the landing (S3)

- 6.3.3 The proposed layout for these rooms would further sub-divide this space to create a bathroom. However, the change would have the benefit of opening up the central sash window so that it can be appreciated as part of the internal character of the first floor.
- 6.3.4 The blocking of a doorway between S3 and S4 would impact on a 20<sup>th</sup> century two panel door. The asbestos survey report shows that the partition between S3 and S4 is finished with plasterboard which further demonstrates recent changes in this area. There would be no impacts on important historic fabric.

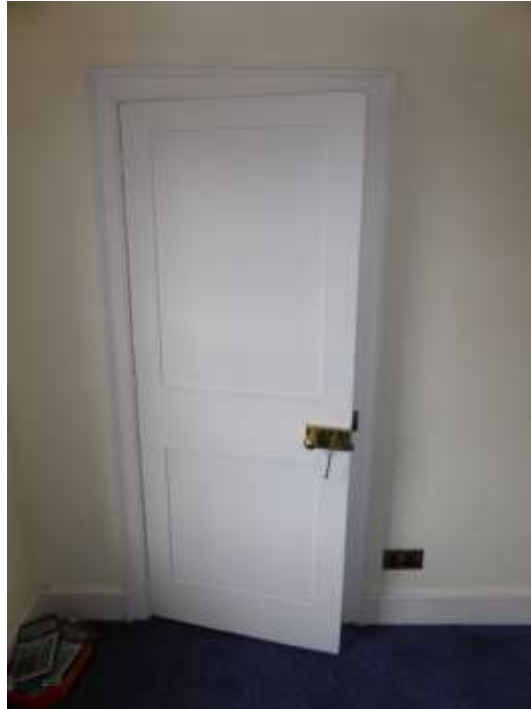
Figure 39: Early 20<sup>th</sup> century door in partition between S4 and S5

- 6.3.5 It is proposed to remove the partition between S4 and S5 to create an open kitchen/lounge area. There is little evidence to suggest that this is an original partition. The door has a brass rim lock similar to the door in the partition between F1 and F2 and the architrave is consistent with 20<sup>th</sup> century designs. The bullnose skirting is evident in areas which have been

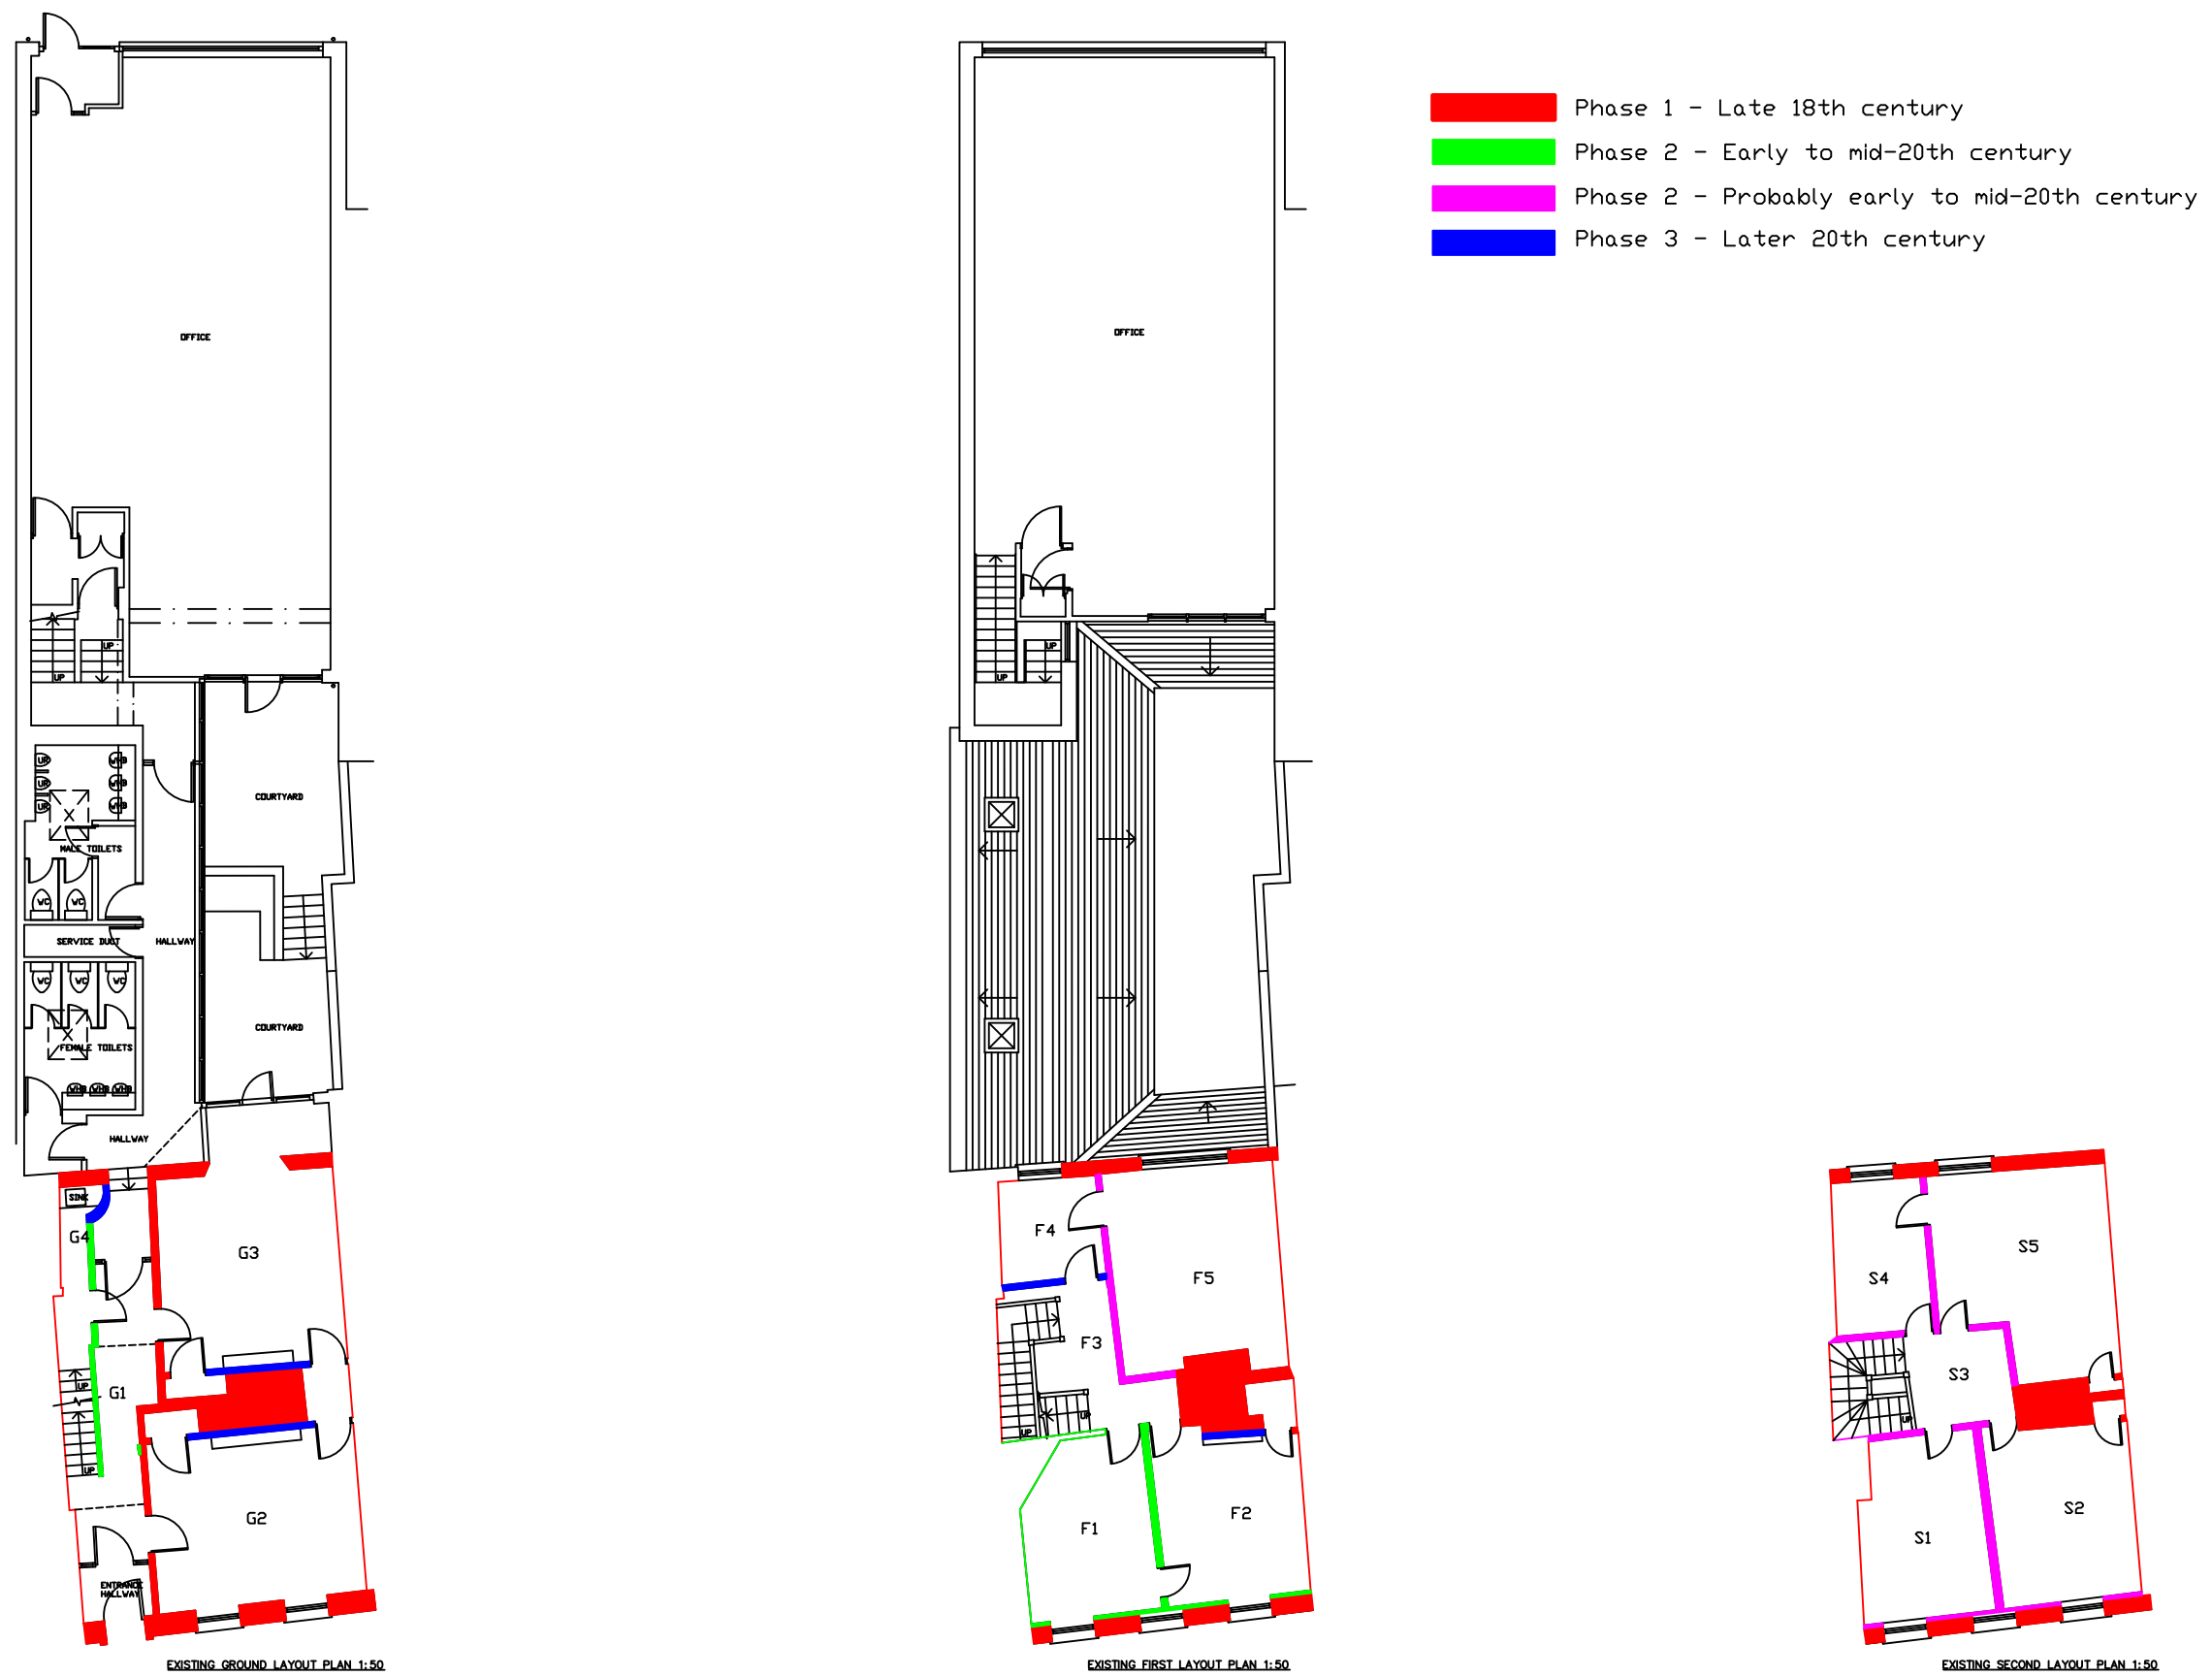
Figure 40: Ground, first and second floor phase plans and room key
