**Dee Park  
Regeneration**

Temporary Youth  
Centre and Police  
Facility

Design & Access  
Statement

DPR(Temp Y&PF)  
AR 001

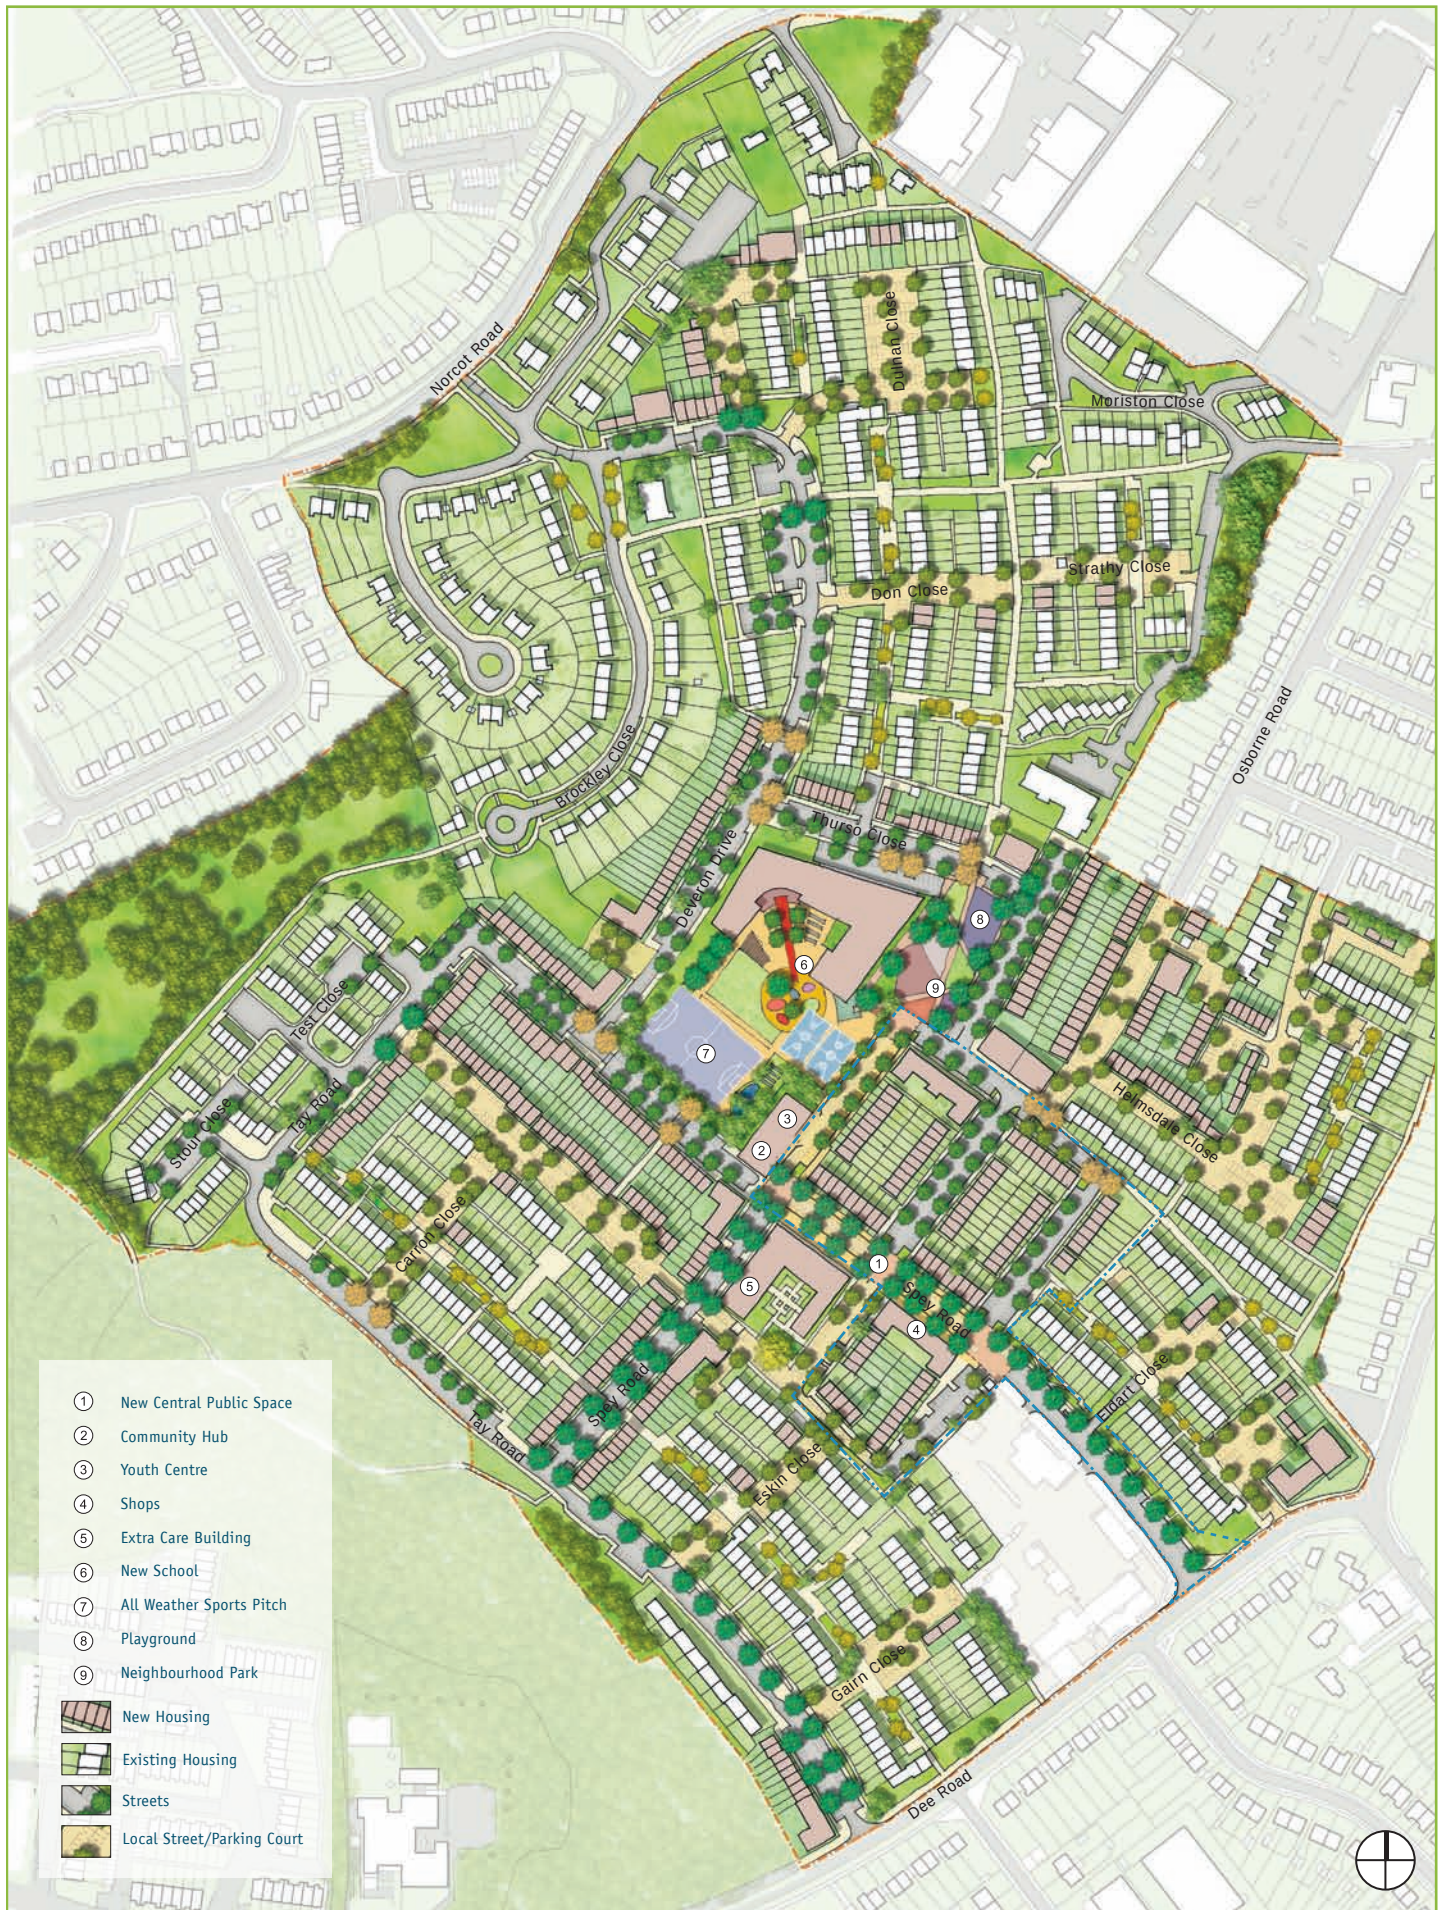
Dee Park Illustrative Outline Masterplan (2009), as amended by S73 Application (2013).

Included in the future phases of the Dee Park Masterplan is the provision for a new community building that will provide new facilities for a youth centre and base for the local police, and will be located at the heart of Dee Park.

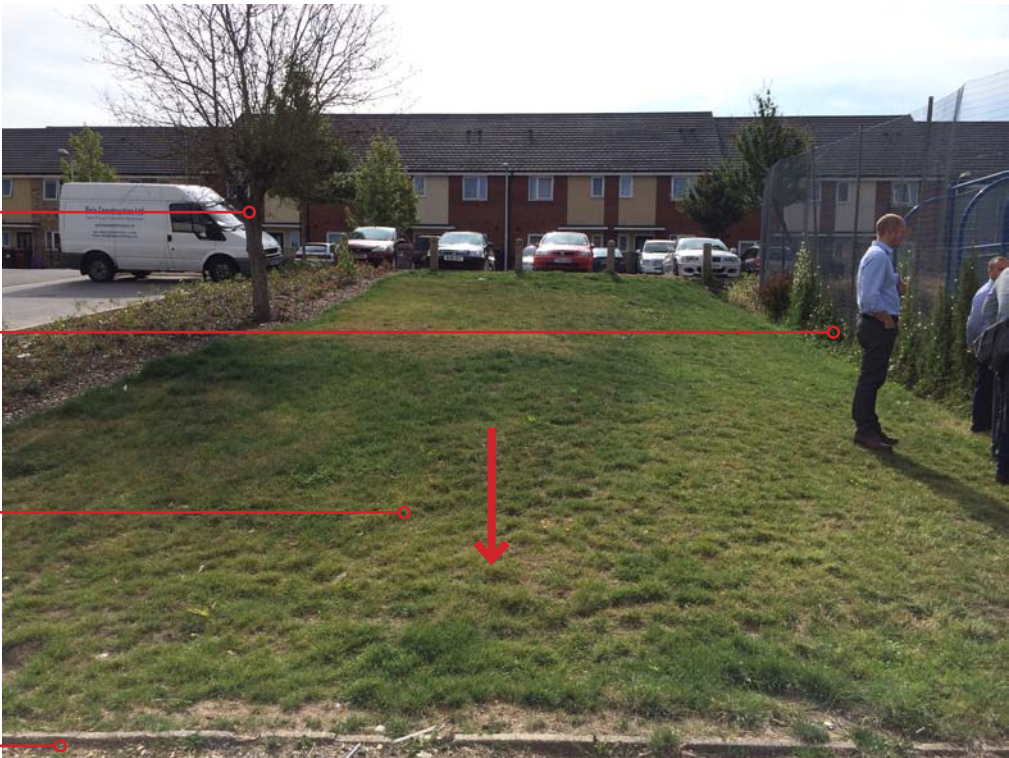
Photo of site facing east

Existing ball court  
boundary fence

Existing Cockspur  
Thorn tree (in poor  
consition)

Existing footpath

Sloping ground  
(high to low)

The existing Cockspur Thorn tree is proposed to be removed owing to the current poor condition. For further details, please refer to the Tree Inspection Report prepared by RGS Arboricultural Consultants accompanying this application (Appendix A).

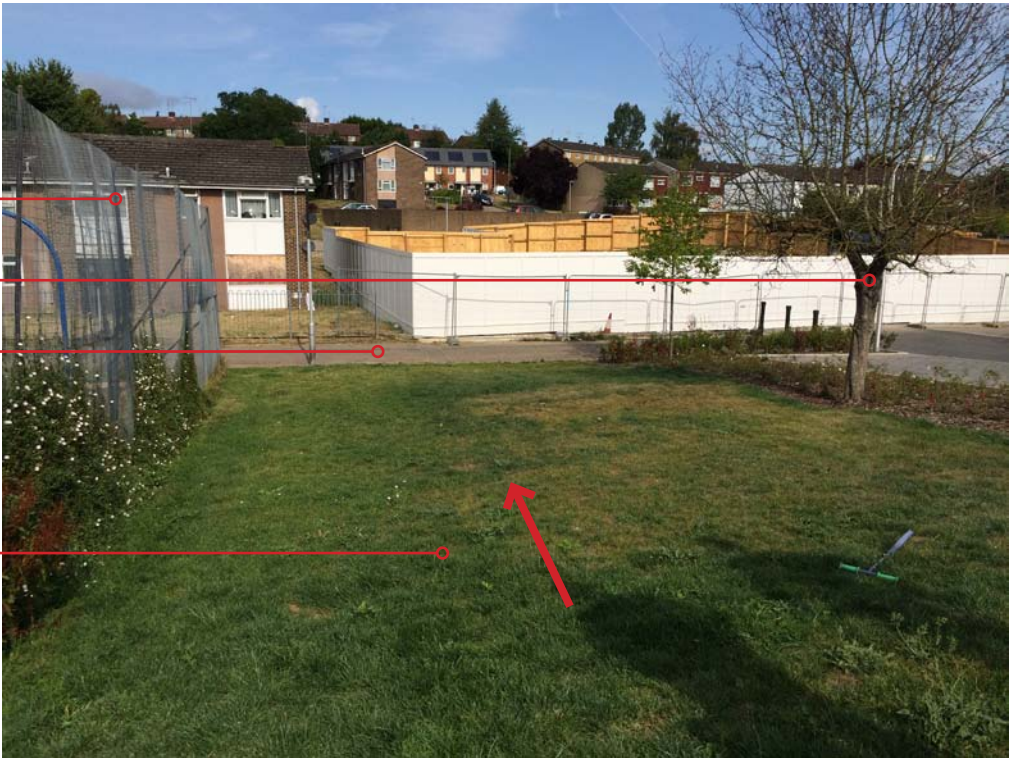
Existing Cockspur  
Thorn tree (in poor  
consition)

Existing ball court  
boundary fence

Sloping ground  
(high to low)

Existing footpath

Photo of site facing west

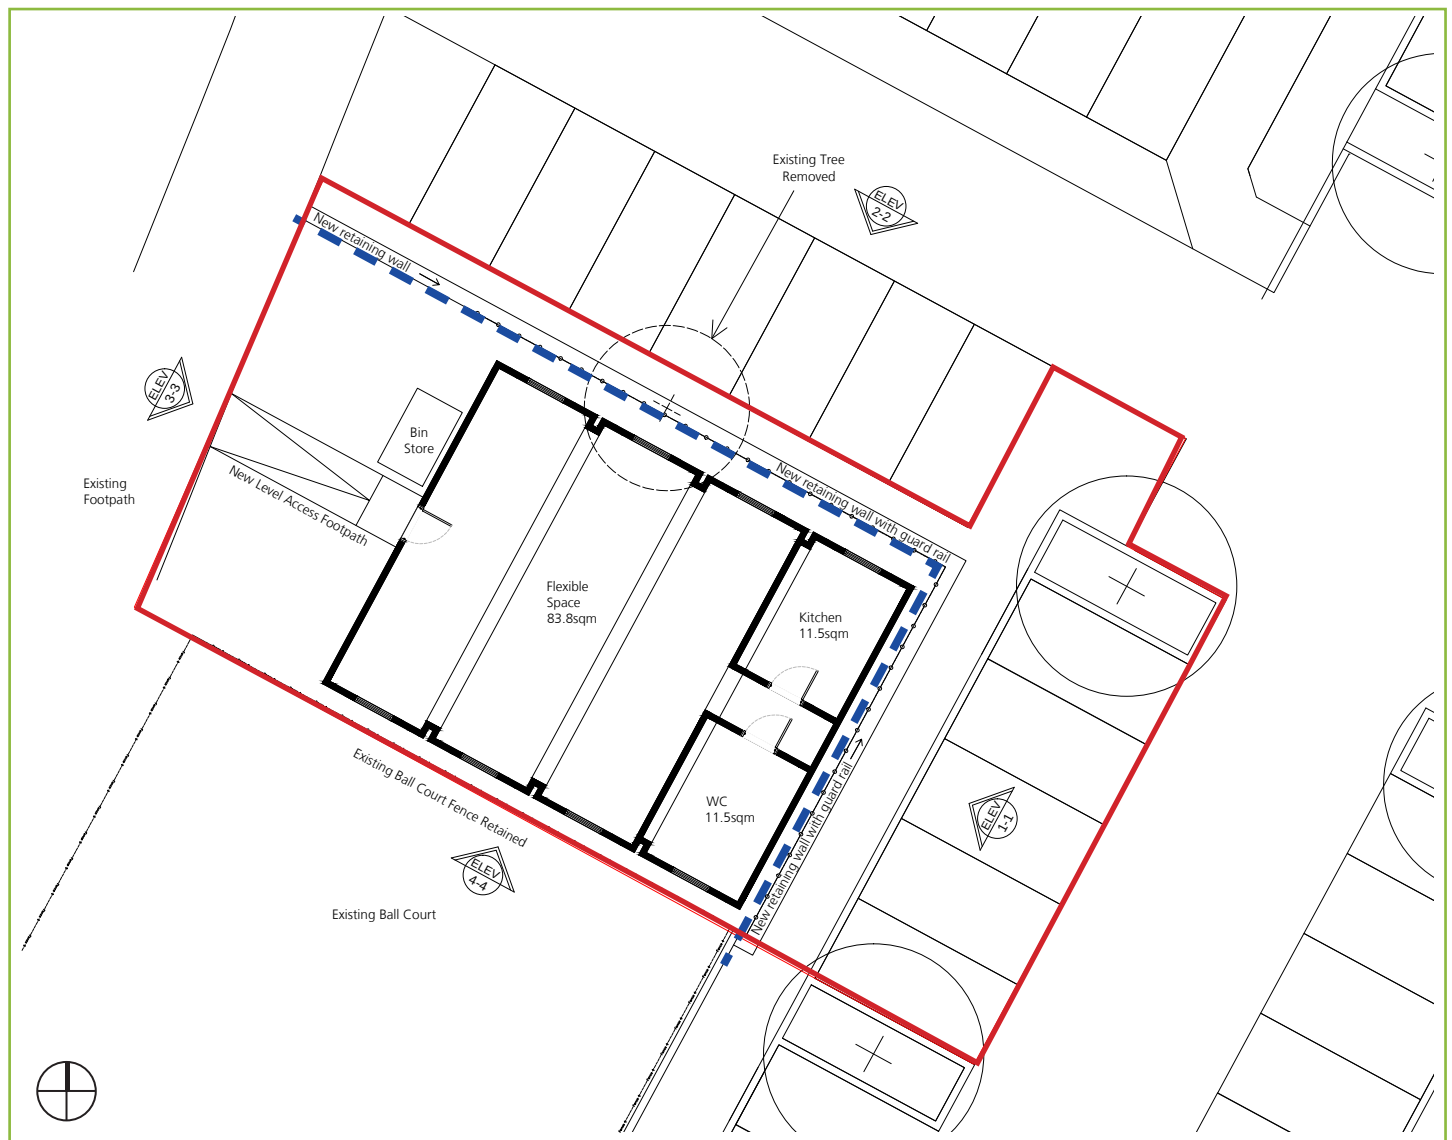
Proposed Ground Floor Plan - Youth Facility  
 (scale 1:200)

- Site boundary
- - - Retaining wall

The existing site slopes down from east to west. As the youth centre will be larger in area than the police facility, it is proposed to be located on the ground floor adjacent to the existing ball court.

The temporary facility will be 5.1m in height at its tallest. The proposed temporary relocation site has an existing sloping topography that will be excavated from the lowest point in order to provide a level site condition.

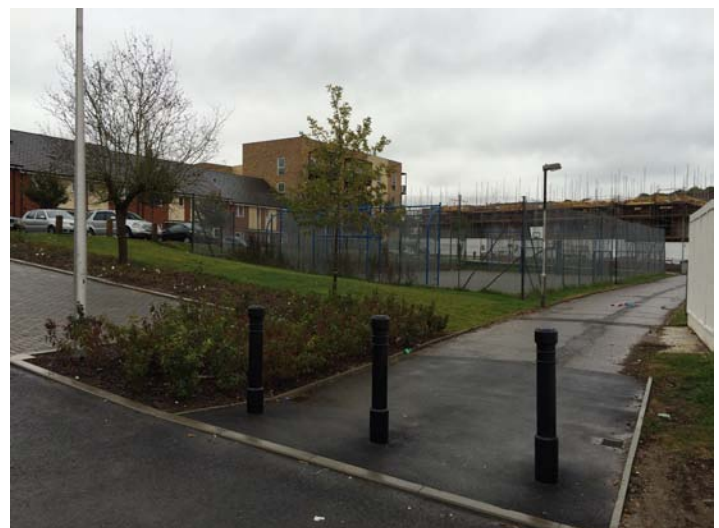
Photo showing existing footpath to the east of the site.

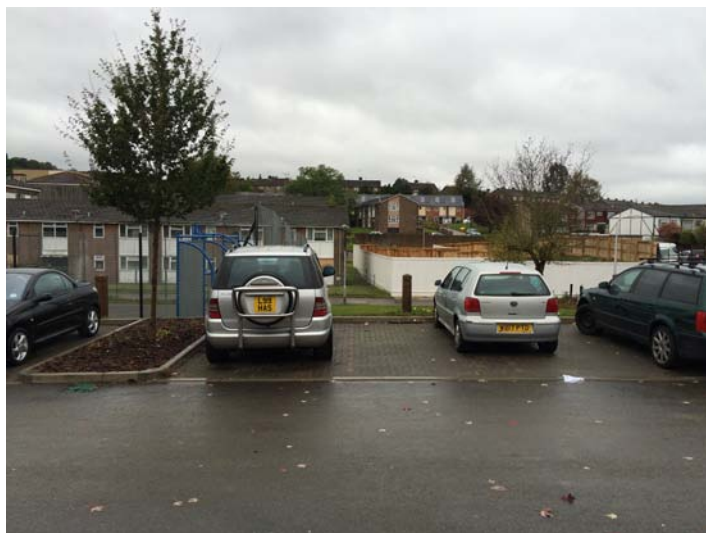
Photo showing proposed location of access to Police Facility. An existing parking bay would be temporarily suspended to keep the access point clear.

An existing un-allocated parking bay will be redesignated as a mobility bay to serve the facility. There are further un-allocated bays within Glenmore Place that could be used by visitors to the facility. No additional parking spaces will be provided. When the temporary facility closes, the mobility bay parking space will be undesignated.

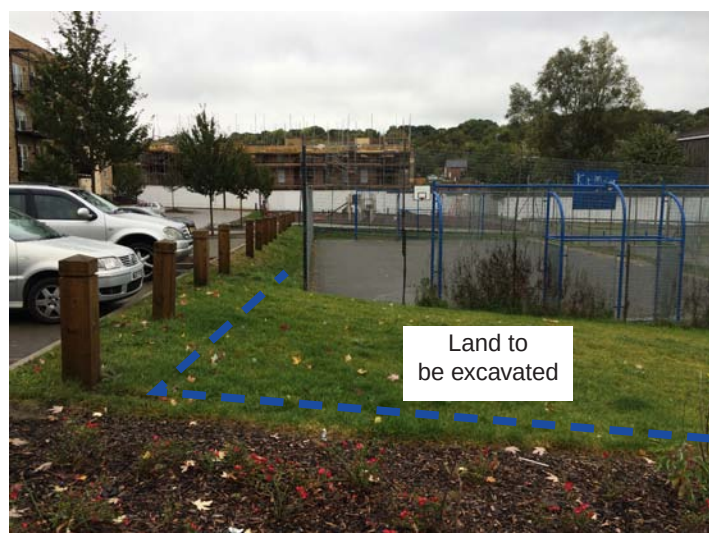
Photo showing existing verge and proposed location of retaining wall and guard rail.

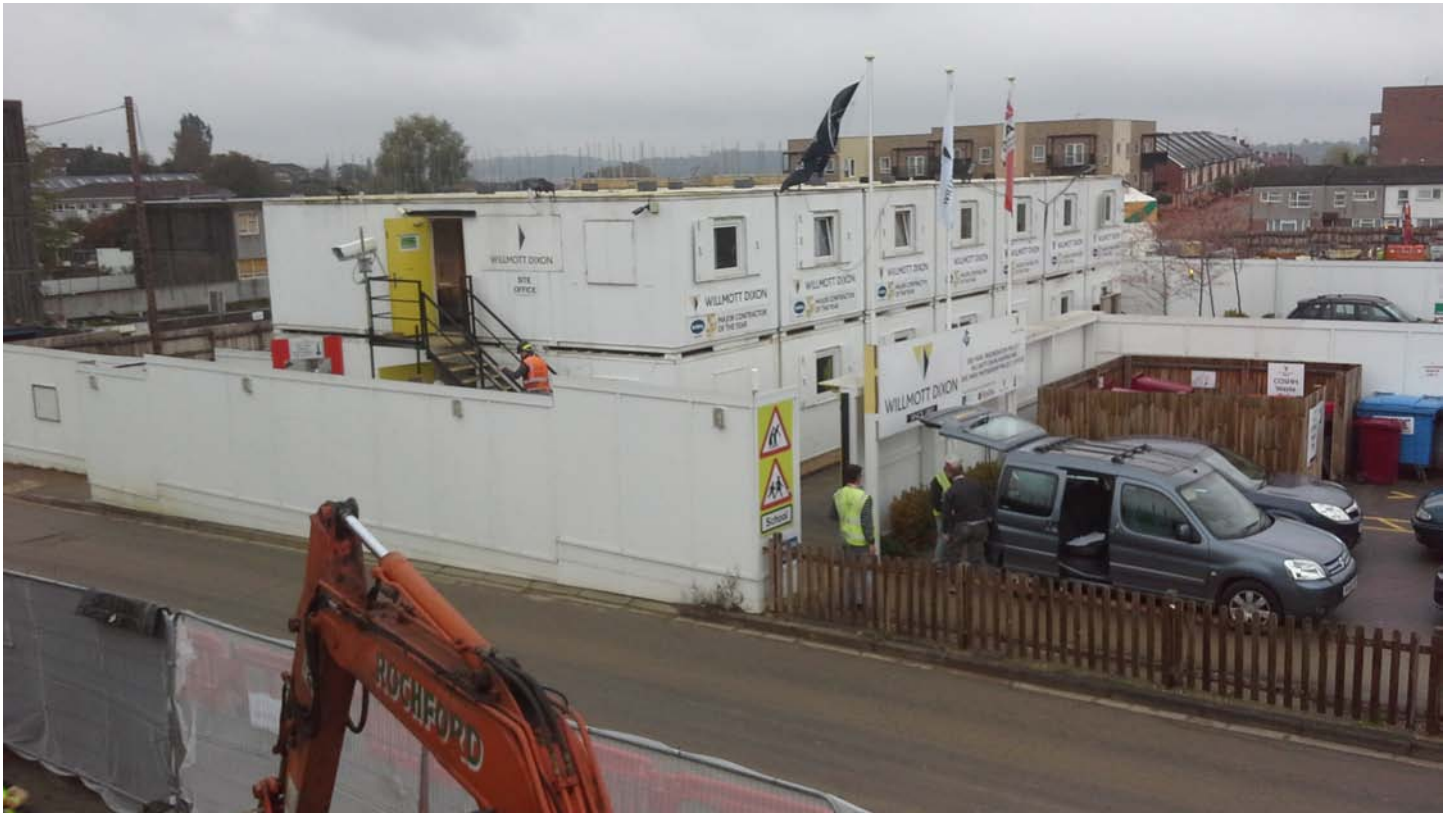
Photo showing the proposed type of modular accommodation units that are to be used to provide the temporary Youth and Police Facility.

Proposed Area for Youth Facility = 114.3sqm  
(4 portakabin units)

Proposed Area for Police Facility = 55.2sqm  
(2 portakabin units)

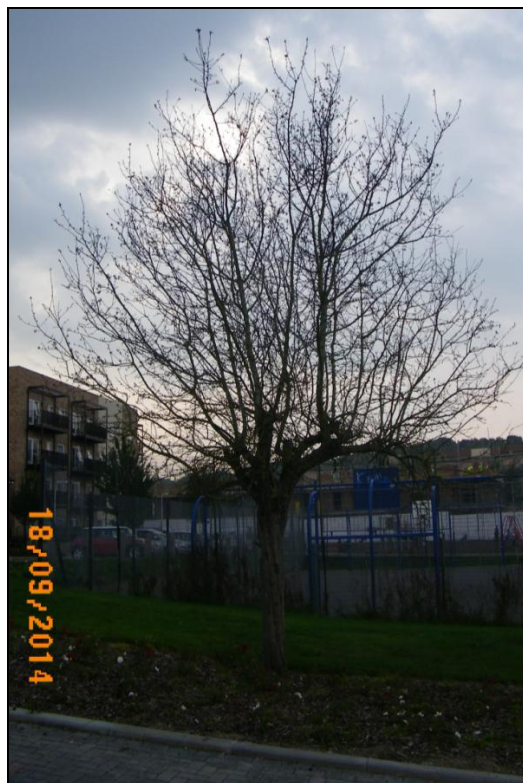
Fig.1 Subject tree (Cockspur Thorn) as seen from car park, looking north-west

**The first subject tree** is a semi-mature Cockspur Thorn (Fig. 1), which is approximately 15-20 years of age. It is approximately 7.5 metres in height and has a broadly symmetrical crown. We were informed that the tree was transplanted approximately 18 months previous to our inspection.

The tree is located on the edge of a mixed bed, with approximately half of the root area grass and half mulched bed. The tree has a stem diameter of 250mm at 1.5 metres, a fair structural condition but very low vigour. It has been previously reduced unsympathetically and the crown is thus of poor form. The tree is in a state of decline, as it has failed to fully flush (produce leaf) this year, and any leaves that it has are very small and most are dead. The rootstock is producing sucker growth at the base (Fig. 2) which indicates the extent of low vigour and the poor state is thought to have been exacerbated by recent dry weather conditions following the earlier transplantation.

- 5.1 Subject tree 1, the Cockspur Thorn is in such a poor physiological condition that it is very unlikely to recover, hence removal and replacement with a similar species is to be recommended.
- 5.2 Subject tree 2, the Cherry is displaying minor signs of root loss in the form of localised upper crown dieback, its stability has not been jeopardised by the loss of major roots however. It would be prudent however to re-assess the tree's condition within two years of the date of this report.

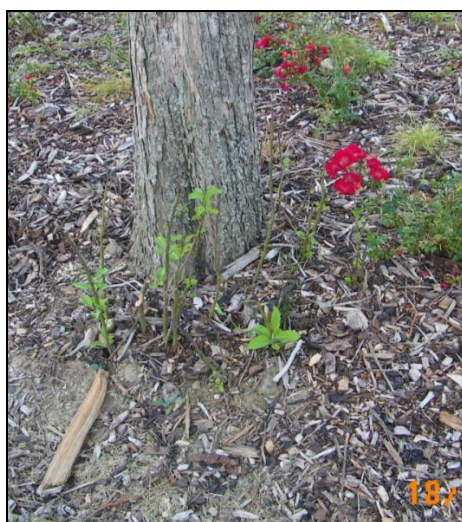
Fig.2 Subject tree producing live suckers from the rootstock

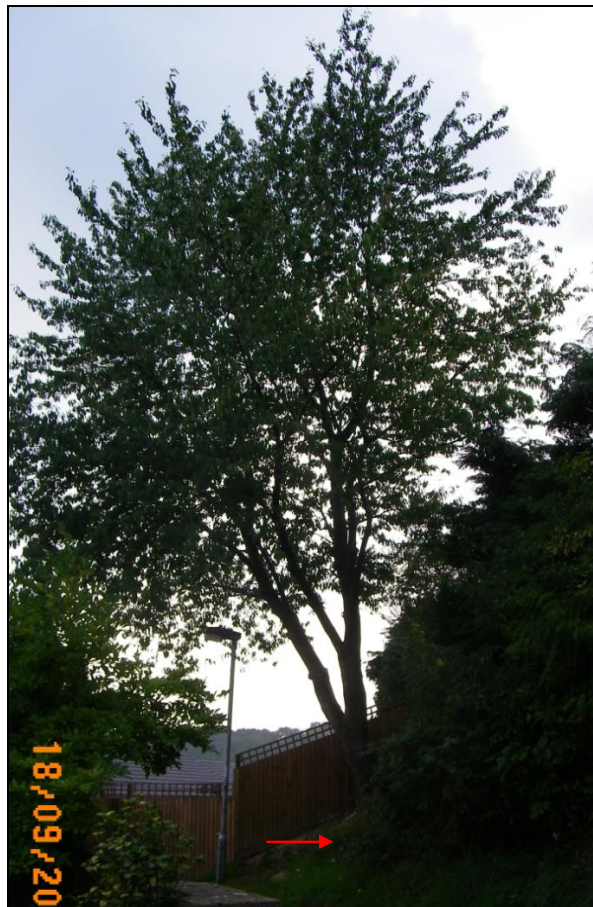
Fig.3 Subject tree (Cherry) looking south, location of root severance arrowed

**The second subject tree** is a mature Cherry (Fig. 3) located upon a sloped verge consisting mostly of long grass and mixed shrubs. It is approximately 40-50 years of age and is approximately 18 metres in height. It has a broadly symmetrical crown with a stem diameter of 540mm at 1.5 metres, is of fair to poor structural condition and of normal vigour. The main cause for concern regarding this tree is the recent root severance caused by a utility installation on the east side of the tree (Fig. 4). Minimal major roots have been severed, however one severed major root with a diameter of 40mm is visible, and approximately a fifth of the fibrous roots have been effectively severed. The tree has two stems from 2 metres above ground, and has *Phelinus* sp. fungal fruiting brackets on a northern primary limb at 5 metres. The crown is also displaying small leaves and a thin upper crown on the south-east side, the tree also leans to the east.

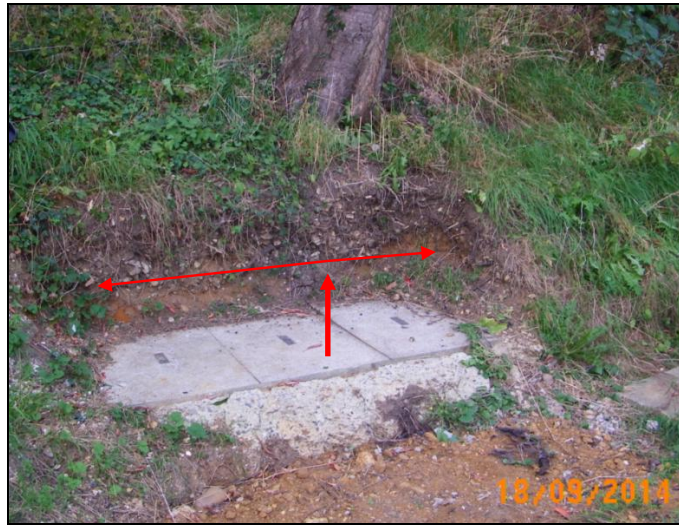
Fig.4 Subject tree, showing recent root severance (arrowed), looking west
