## Heritage Statement

### Design & Access Statement

Planning and Listed Building Consent Application re: returning roof to slate at  
3 Christchurch Road, RG2 7AA

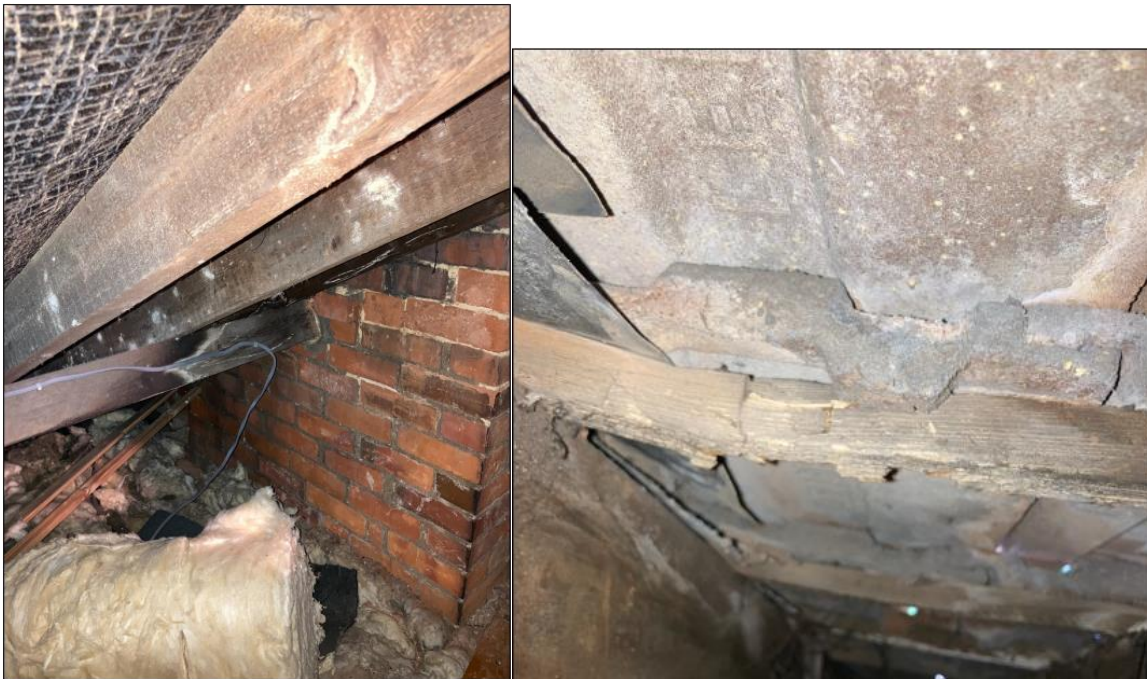
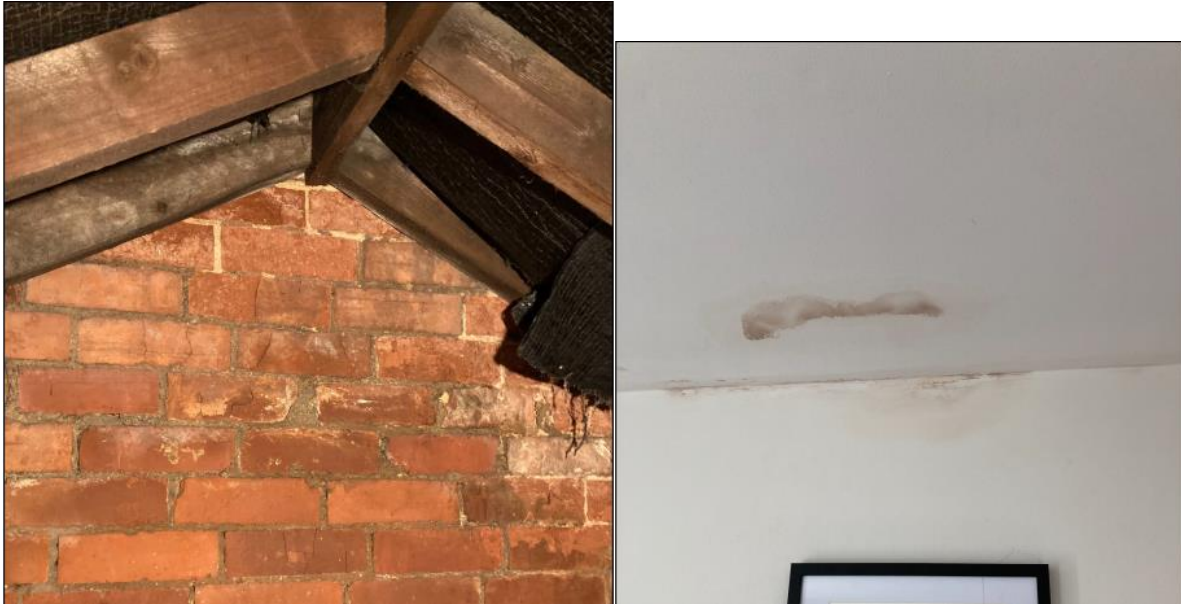
8. We do not believe that the roof at the Property has undertaken significant repair work since its installation.
9. Since purchase in June 2022, the roof has demonstrated significant water ingress, impacting both the wooden batons, structural beams and the walls to the Property. Photos previously provided to the Council and provided again, in part, below for ease of reference:

10. We are advised that the issues with water ingress arise as a result of deteriorated lead flashing together with broken brick tiles and degrading wooden batons. We are also advised that, without urgent remedial works, the structural beams may also deteriorate and require work (we have not been advised that this work is required as of now).
11. In light of the urgent need for the repairs, we have considered the possibility and cost of returning the roof of the Property to match both the listing and that of the adjoining properties. We are advised that undertaking the repair works only may, in itself, require significant replacement of the existing red concrete tiles. We are therefore seeking permission to return the roof back to slate, as per the original design and likely look of the Property.

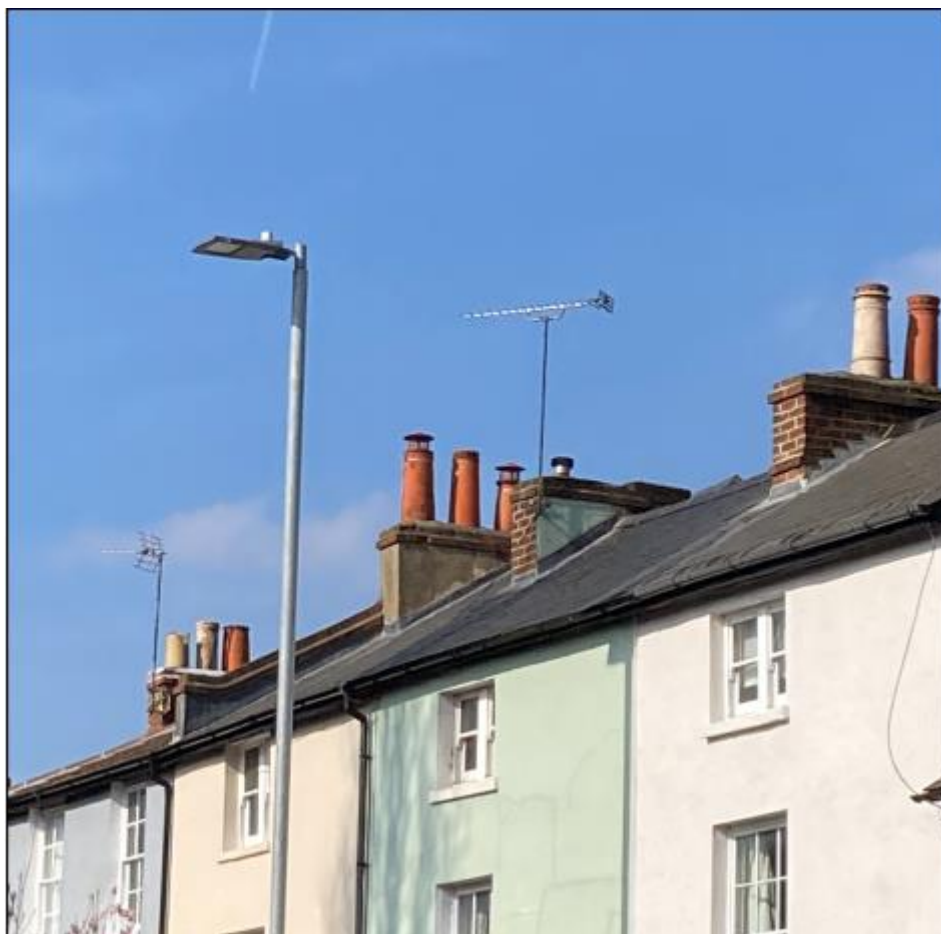
- a. The listing and the Conservation Area description are concerned with the outward appearance of the Property. Both (erroneously) already record the Property as having a slate roof. The proposed works will bring the Property within the descriptions given, whereas in its current form it falls outside.
- b. See photos immediately below re: the appearance of 5-9. The proposed works would seek to bring the Property within a similar appearance.
