# Long Term Monitoring and Maintenance Plan

River Academy, Reading

| Report Title | Long Term Monitoring and Maintenance Plan, River Academy, Reading |
| Report Reference | 130321-S05 |

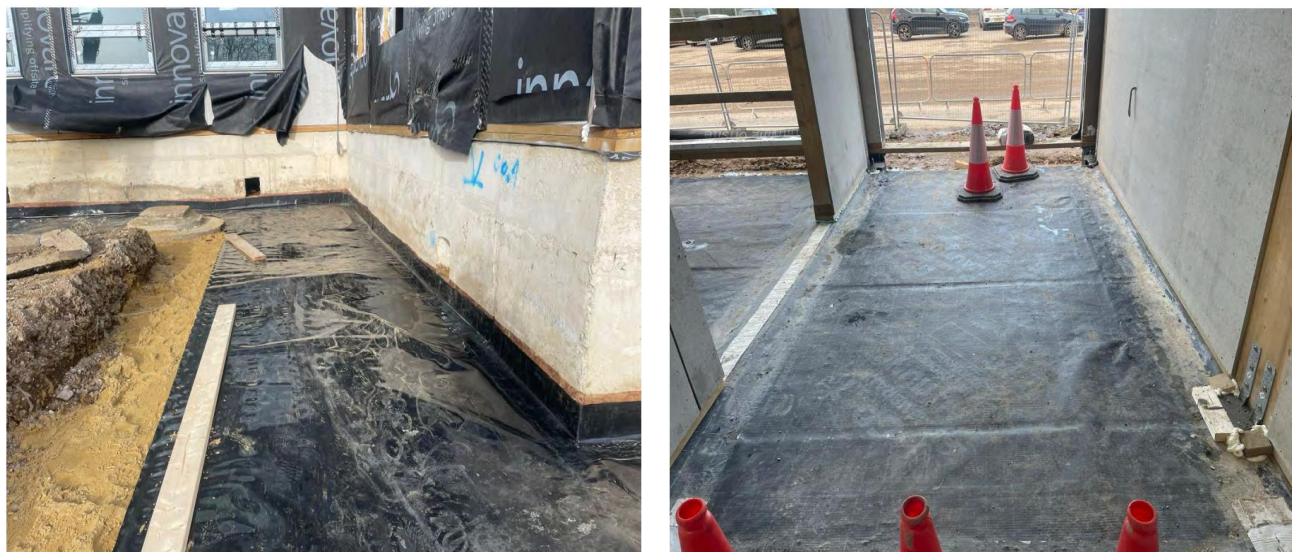
Figure 01 - Photographs of Geomembrane Cover

Given the mitigation measures utilised, any future digging/excavation work within the vicinity of school buildings and infrastructure must be completed under competent supervision to protect the integrity of the gas membrane cover. Care should be taken to prevent the damage or puncture of the installed measures. Figure 01 (below) provides example photographs of the geomembrane installed.

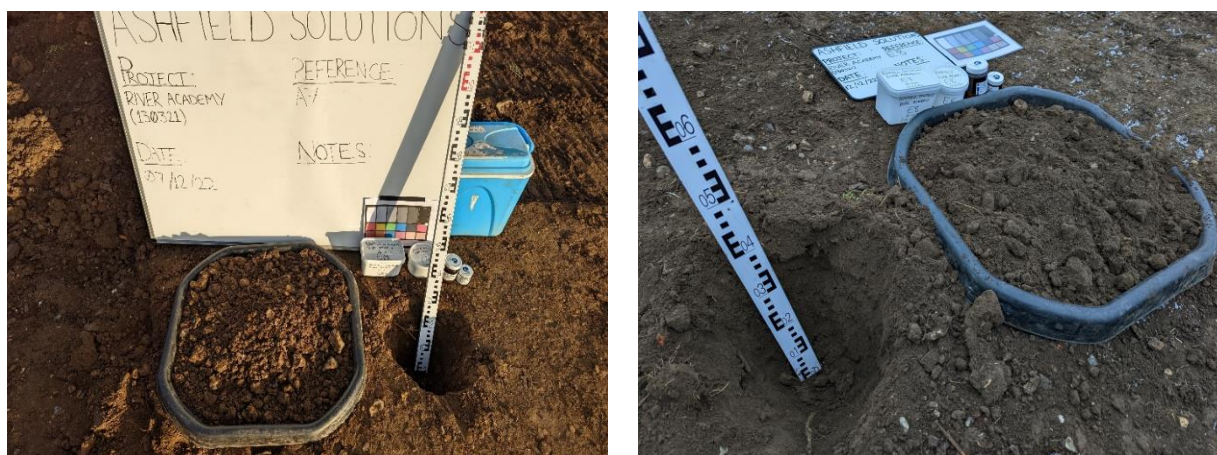
Figure 02 - Photographs of Imported Soil for Cover System

Figure 02 below shows photographs of the imported soil used for the cover system.

drainage layer consisting of a 300mm of clean gravel to ensure trees are not planted into the landfill mass itself. Trees should be regularly inspected to ensure that roots are not overgrown and to check for any further unforeseen risks. Signs for this can include exposed tree roots and cracks in the ground surface. Additionally, collapsed trees should be monitored as roots could rip up the cover layer, exposing landfill material. Signs of exposed landfill material includes rubbish and litter within the soil. Please refer to Figure 02 for a photograph of the landfill material.

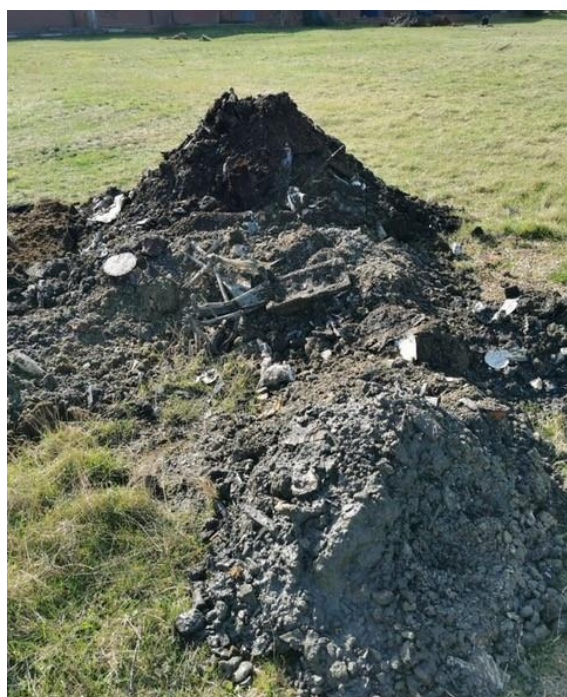
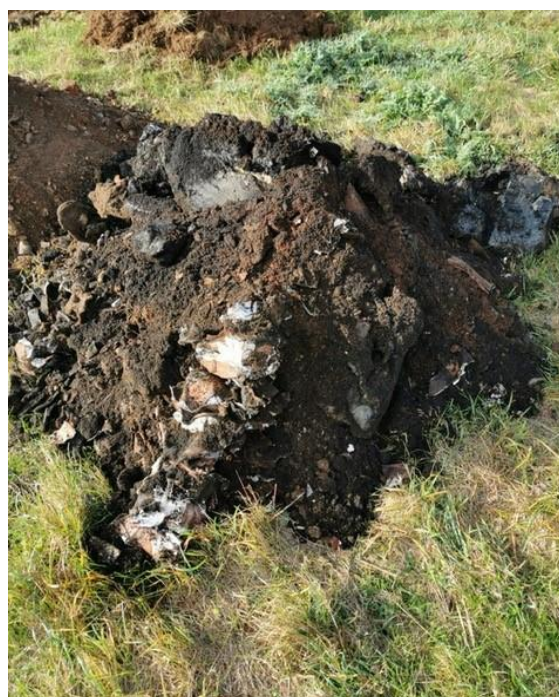
Figure 03 - Photograph of Landfill Material Present on Site

Figure 03 shows photographs of landfill material to look out for. Signs of landfill material can include soil with exposed rubbish and general waste. If landfill material is detected, it must be cordoned off to protect school users and advice must be sought from an appropriately qualified and competent geoenvironmental consultant.

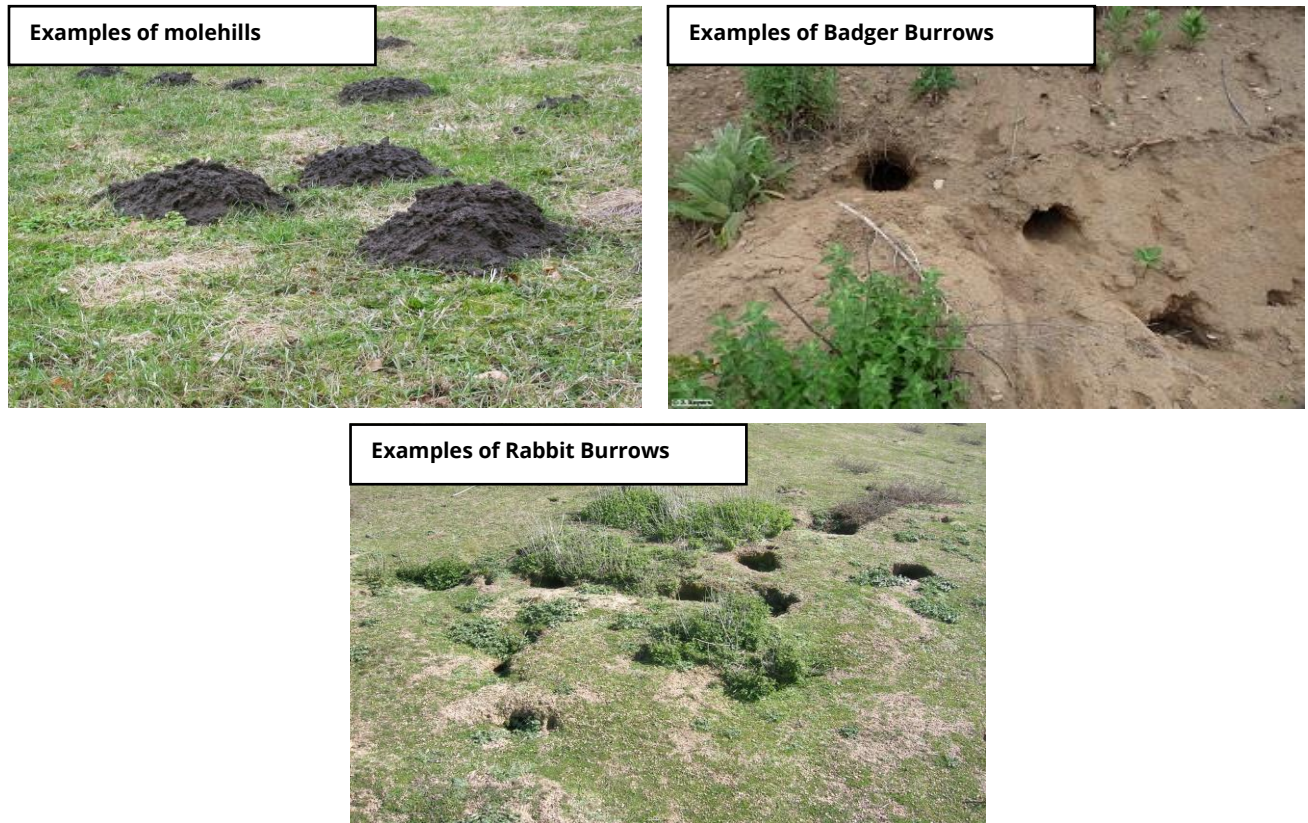
Figure 03 - Photographs of Examples of Animal Burrows

native shrubs. For locations of these areas on site, refer to Drawing 02 for a Landscape Plan. Please refer to Figure 03 for photographs of examples of types of burrows by different animals.

With regards to burrowing animals, routine monthly inspections should be scheduled, as well as the infilling of burrows and adoption of standards pest control measures. Burrows are likely to be identified in areas where vegetation is overgrown. Pest control measures can include ensuring vegetation is kept trimmed and tidy or anywhere that can provide cover for burrowing animals. Examples of burrowing animals can include moles, badgers and rabbits. Badger burrows are commonly found along exposed banks. Mole burrows look like small mound shaped hills and rabbit burrows can be found in grasslands and forests, particularly in areas of long grass and tend to form a series of holes with underground channels. Key areas for wildlife on the site include the planted hedgerows, meadows and

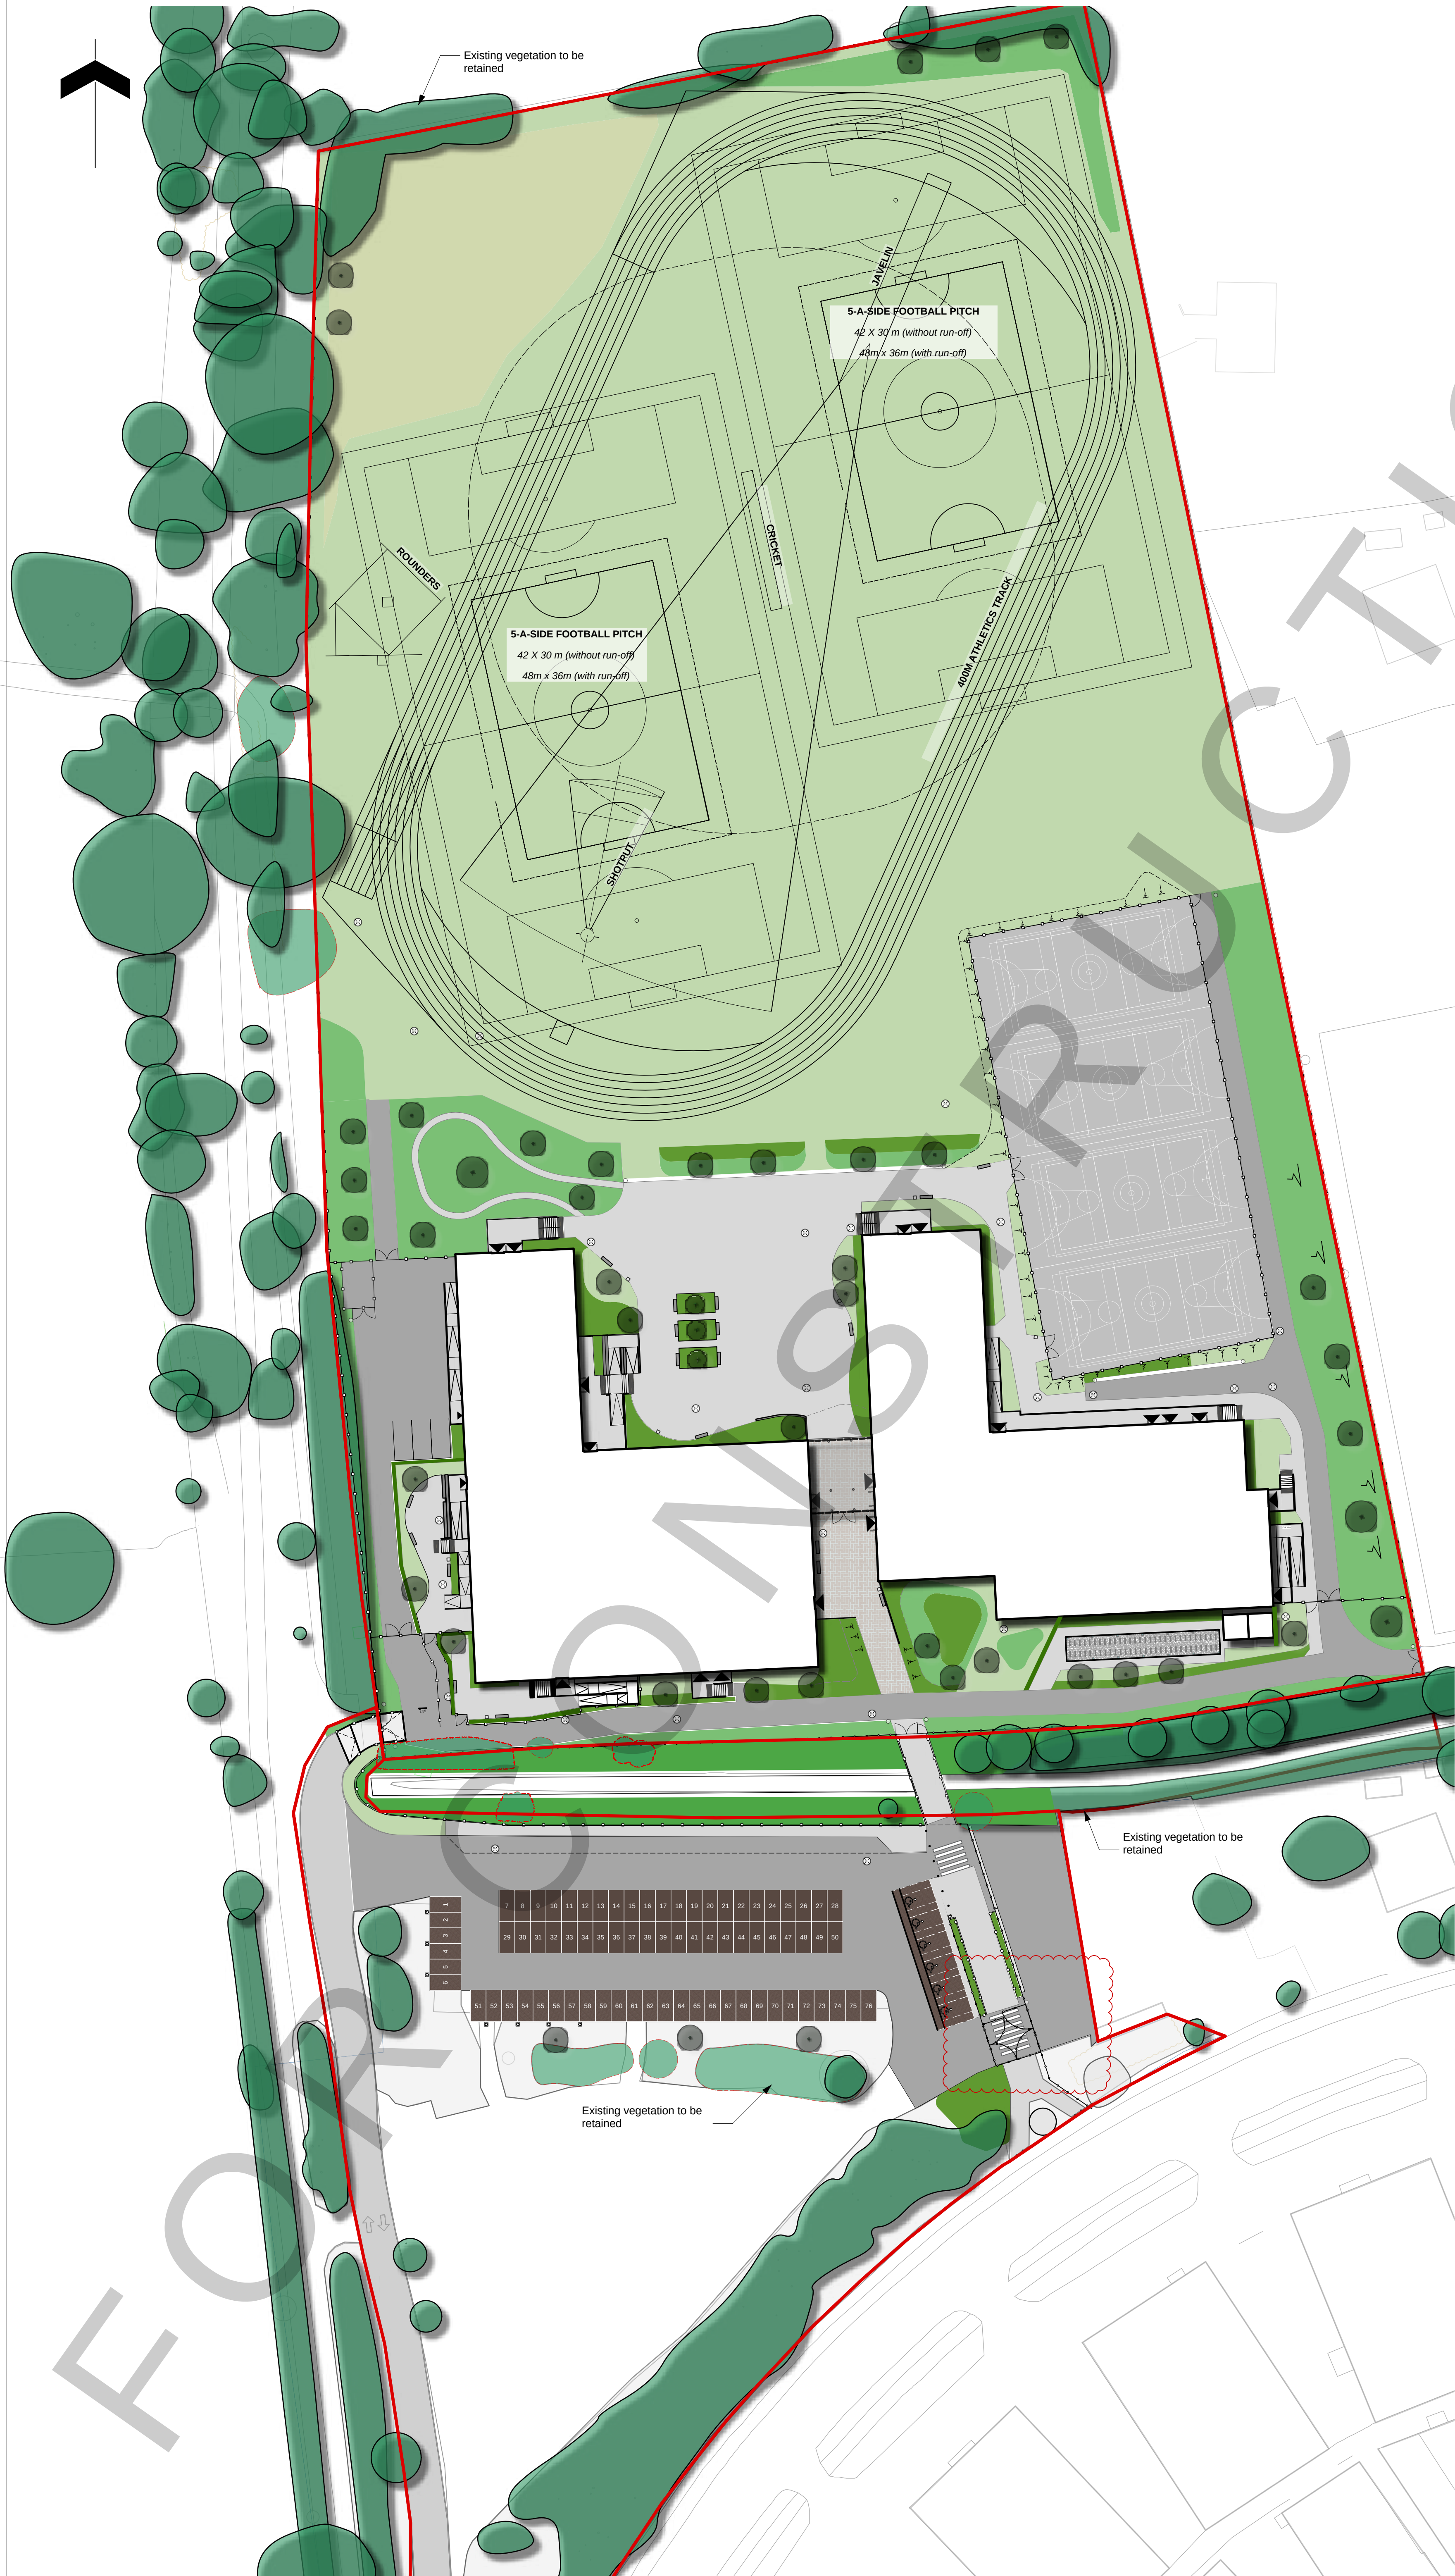
Landscape Plan

## Drawing 02
