# THE FISHERY, THE WARREN, CAVERSHAM, READING, BERKSHIRE

## HERITAGE STATEMENT

**PROJECT:** The Fishery, The Warren, Caversham, Reading, Berkshire

**DOCUMENT TITLE:** Heritage Statement

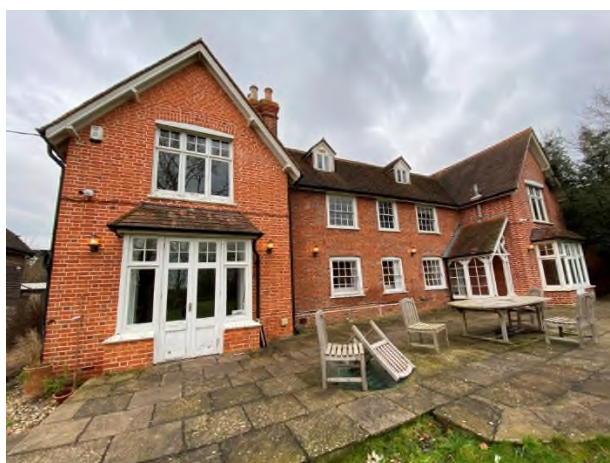
Figure 1: South elevation of The Fishery

- 4.1.5 **Balustrade to bays on the south elevation** – This element of the proposed scheme would reinstate a lost feature and represents a beneficial change (**figures 1 and 6**). The pre-application comments were supportive of the proposal.

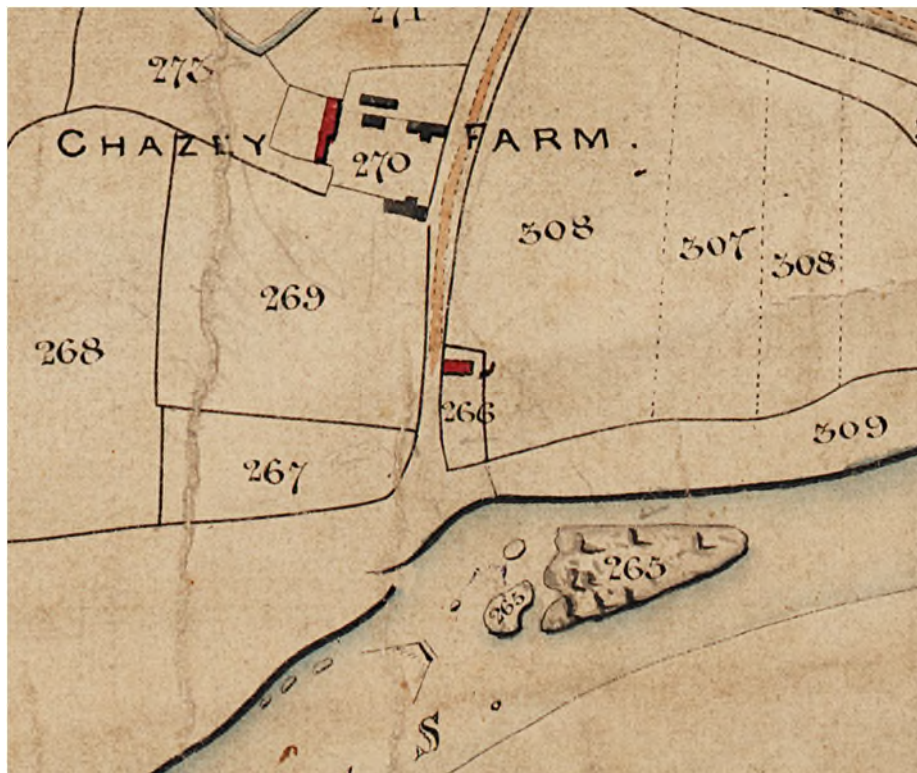
- 3.1.1 The Mapledurham tithe map (1841) shows The historic core of The Fishery with a rectangular footprint located within a roughly rectangular garden on the eastern side of a track leading to the river. Chazey Farm is shown to the north.

Figure 2: Extract from the Mapledurham tithe map (1841)

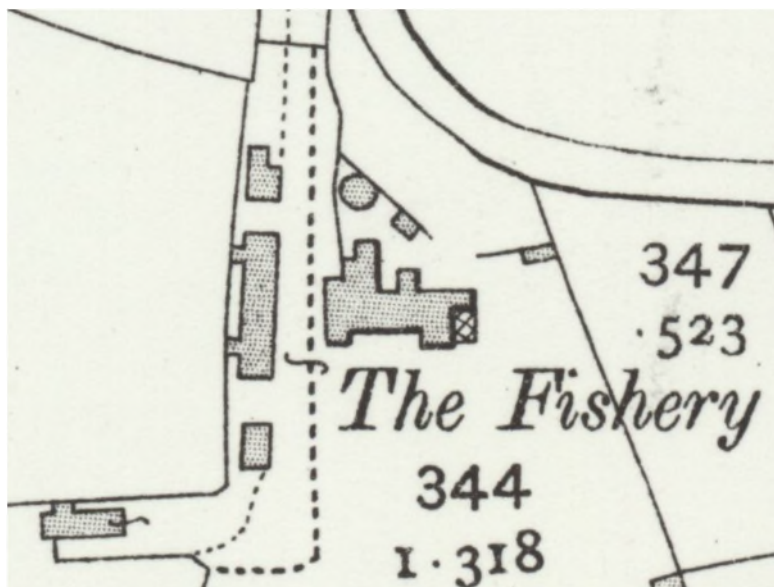
- 3.1.4 The 3<sup>rd</sup> edition of the Ordnance Survey map (1913) shows the western wing projecting southwards and suggests that the lean-to on the north side of this wing had been built. A projecting element on the north-east side of the building had been built by this time and the

Figure 5: Extract from the 3<sup>rd</sup> edition of the Ordnance Survey map (1913)

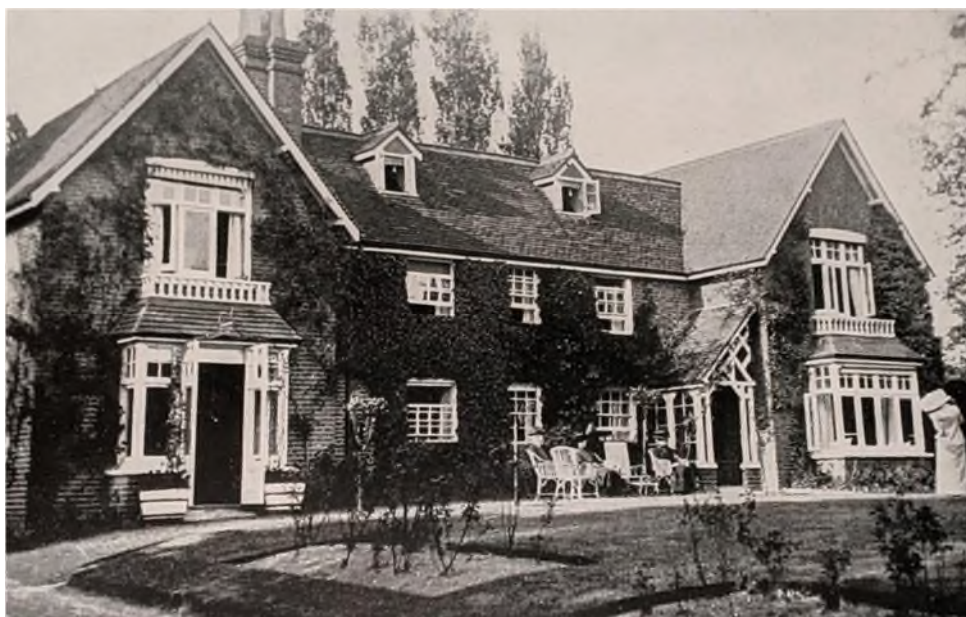
- 3.1.5 An early 20<sup>th</sup> century photograph of the south elevation of The Fishery shows the pattern of window openings on this side of the original 18<sup>th</sup> century cottage, two flanking wings with balconies over ground floor bays, an open-sided porch to the right and a flush sided bay window with no central door to the right.

Figure 6: Early 20<sup>th</sup> century photograph of the south elevation of The Fishery

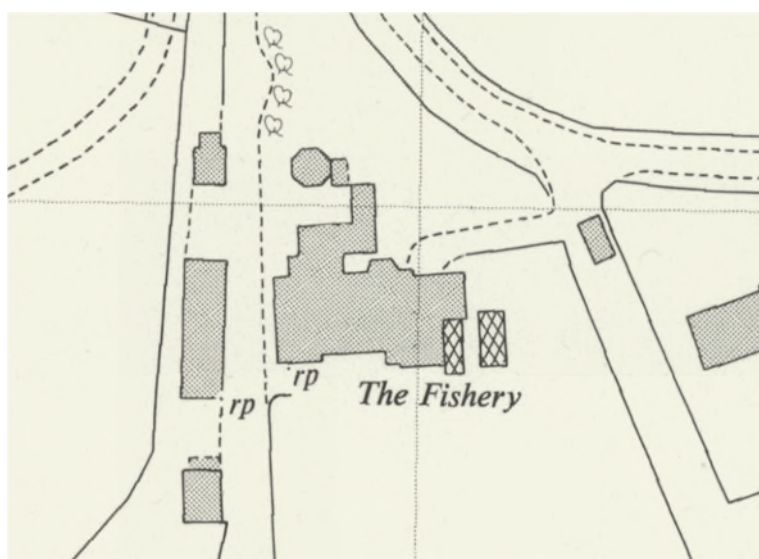
- 3.1.7 The 1959-60 edition of the 1:1,250 Ordnance Survey map shows a number of changes to the footprint of the house, including the enlargement of the projecting elements on the north-east corner, an extension to the rear, a canted bay window to the rear and an enlargement of the conservatory on the eastern side of the house.

Figure 8: Extract from the 1959-60 edition of the 1:1,250 edition of the Ordnance Survey map

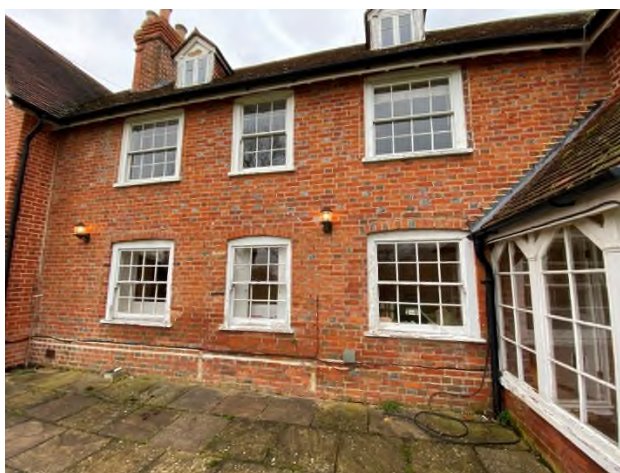
- 3.2.1 Phase 1 is a 2-storey, 2-unit house of brick construction in Flemish bond. All elevations apart from the front elevation are masked by later extensions (rear wall can be observed in the Phase 2 entrance hall/passage). The front elevation is symmetrical and includes a mix of horned and unhorned sash windows with multi-paned upper and lower sashes. The central window on the ground floor was originally a door as demonstrated by the pattern of closer bricks and brick infill/straight joints below sill level. The window openings to the left and right on the first floor have been reduced slightly in width, as demonstrated by infill brickwork. It also appears that the ground floor openings have been modified to accommodate slightly smaller sash windows.

Figure 9: South elevation of the Phase 1 cottage

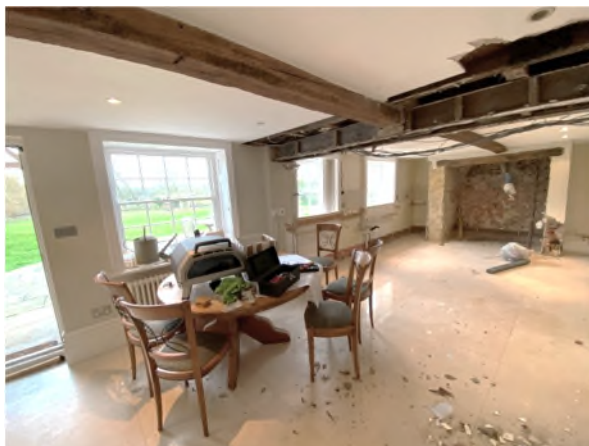
- 3.2.2 The ground floor is a single space but was originally two rooms of unequal size typical of 2-unit plans. A modern steel defines the position of the original partition. There are chamfered axial beams on each side of the modern steel beam. Exposed joists demonstrate that the original ceiling finish was lath and plaster. There is a fireplace with brick jambs and a timber lintel on the western side of the ground floor. The presence of a fireplace demonstrates that this larger room would have originally functioned as a kitchen/living room. The smaller apparently unheated room on the eastern side of the Phase 1 footprint would probably have been a parlour and also potentially used for storage. An original winder stair may have been on this side of the 2-unit cottage. There is a door along the rear wall and a blocked door adjacent to it.

Figure 10: Ground floor of Phase 1

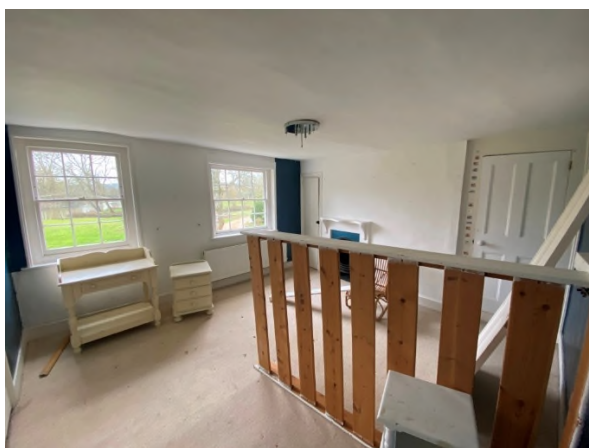
- 3.2.3 The first floor is divided into two rooms of unequal size. The larger room on the western side includes a fireplace with a beaded surround and later mantel shelf and grate. The plank and batten cupboard door to the left of the fireplace is 18<sup>th</sup> century. The 4-panel door to the right is late 19<sup>th</sup> to early 20<sup>th</sup> century. There is a late 19<sup>th</sup> to early 20<sup>th</sup> century door that leads to the smaller first floor room which is currently a bathroom. Stairs leading to the attic cuts into this room. The stairs are constructed using machine sawn timber and presumably relates to the late 19<sup>th</sup> century remodelling of the house (Phase 2).

Figure 11: Western room on the first floor

- 3.3.2 The fireplace with brick jambs and a timber lintel contributes to the historic character of the interior. The windows on the front elevation are all replacements but are probably of 19<sup>th</sup> century date. There are internal shutters on the ground floor that are of interest. The position of the original stair is currently unknown but was probably located in the smaller room on the east side of Phase 1. The first-floor layout is better defined. The larger bedroom on the western side was originally heated by a fireplace and there is an 18<sup>th</sup> century plank door to cupboard on the left-hand side of the chimney breast. The roof structure appears to be relatively intact.

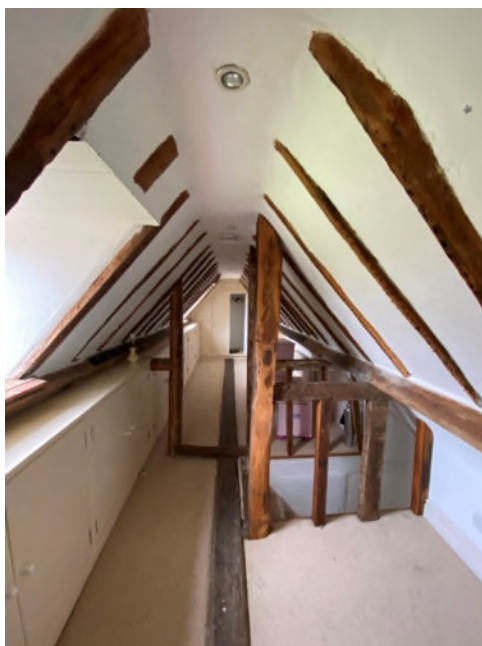
- 3.2.4 The roof structure of Phase 1 is characterised by clasped purlins and collars. The common rafters remain as expressed features and include evidence for a lath and plaster finish. The latter suggests that the attic has historically been used as part of the accommodation of the house. Axial beams are visible in the floor.

Figure 14: Attic of Phase 1

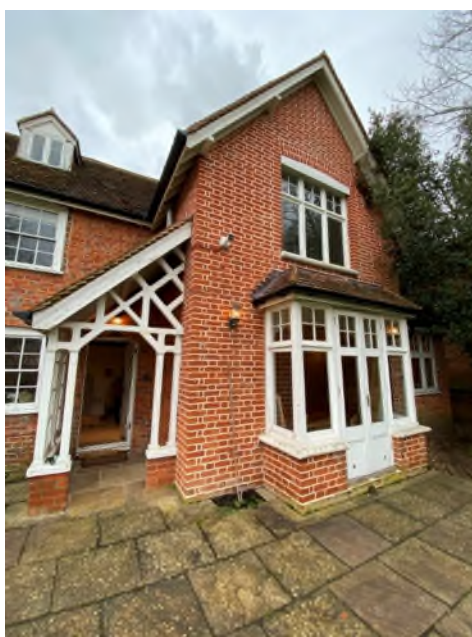
- 3.2.5 Phase 2 includes east and west gabled wings and extensions to the rear (north). The eastern gabled wing includes a single storey bay window that has been altered by the insertion of central doors. The low balustrade cresting the bay window shown on the early 20<sup>th</sup> century photo has been removed. Otherwise, the window pattern remains the same as in the early 20<sup>th</sup> century. There is an original porch in the angle between the original cottage and the wing.

Figure 15: South elevation of the eastern wing

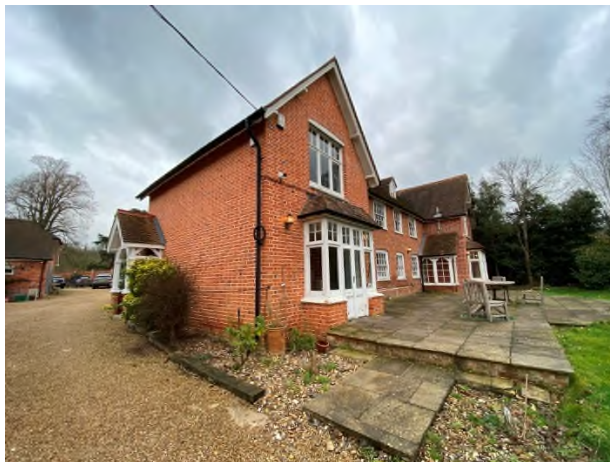
- 3.2.6 The western wing includes the same details in terms of a bay window and a first floor mullion and transom window with multi-paned top lights. There is an original part-glazed door on the left-hand side of the west elevation with an expressed timber lintel. The decorative glazing includes coloured glass and painted glass showing a fish and the name *The Fishery*. The porch is relatively recent.

Figure 16: Oblique view of the western wing

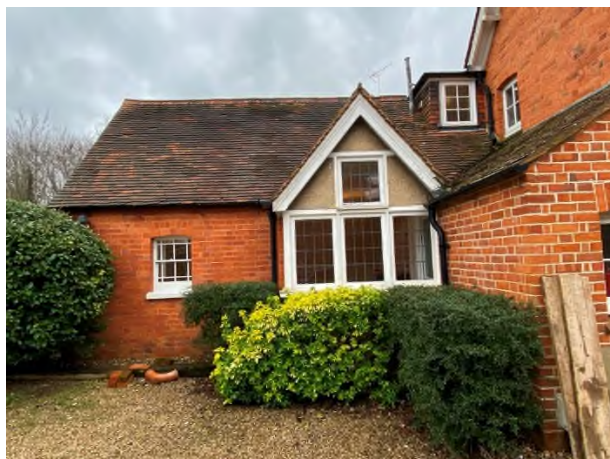
- 3.2.7 The single storey rear wing is of brick construction with a projecting bay on the west elevation and a small opening with a margin light sash window to the left. The large opening with a mullion and transom window on the north gable end elevation replaced a window and door as part of the 2005 approval. The shorter projection of the roughly central extension to the rear is largely masked by later extensions and is not particularly legible externally.

Figure 17: Single storey rear extension

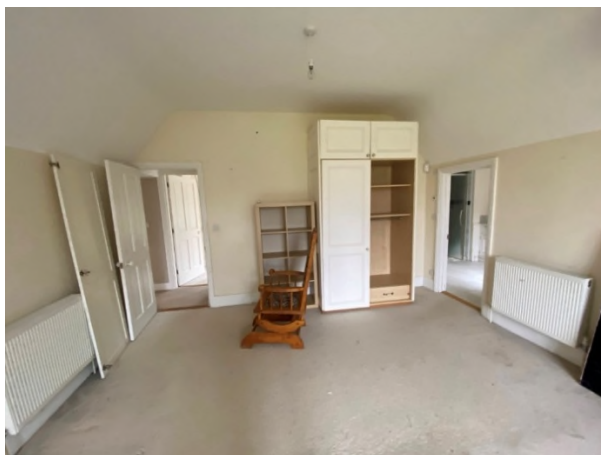
- 3.2.10 The first floor of the east wing has been much altered as a result of the removal of a partition in the same position as the double door partition on the ground floor below and of a staircase. The partition on the north side of the first floor room aligns with the rear wall of the Phase 2 wing

Figure 23: View towards a removed staircase and internal partition wall looking north on the first floor of the east wing

**4.1.16 Insertion of a partition on the first floor of the east wing** – The existing partition on the first floor of the east wing relates to the position of the removed back stair and probably relates to the late 19<sup>th</sup> century layout of the house (**figure 23**). The 2005 plan shows a partition for a landing providing access to bedroom 3 on the south side of the east wing. This was removed as part of the 2005 works. The proposed partition would reinstate the definition of the original landing and would better reflect the original layout of the late 19<sup>th</sup> century east wing.

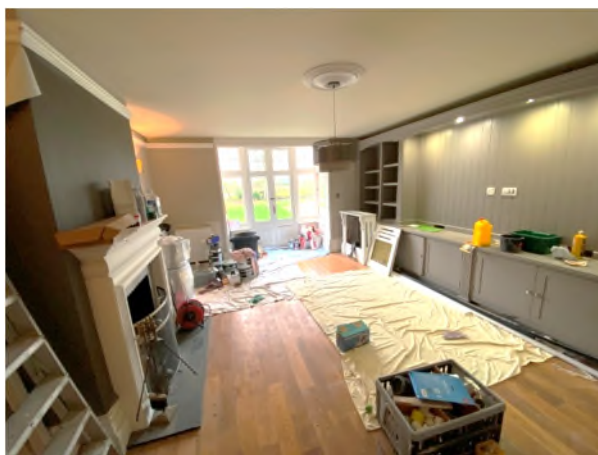
3.2.11 The ground floor layout of the west wing includes an entrance hall and a room with a fireplace and a bay on the south side. The glazed doors and top lights of the bay are modern replacements.

Figure 24: Ground floor room of the west wing

- 3.3.4 The ground floor room in the west wing remains relatively intact and is accessed from the entrance hall and this room includes a fireplace. There is a bay window with central French Doors (later replacements) which is of the same design as the bay on the south side of the east wing. The principal ground floor room in the east wing has been more fundamentally as a result of the removal of the east external wall and chimney breast. The stairs shown on the 2005 plans, which may have been a back stair, was also removed as part of the 2005/2006 approval. The partition with the double doors appears to be part of the Phase 2 layout.

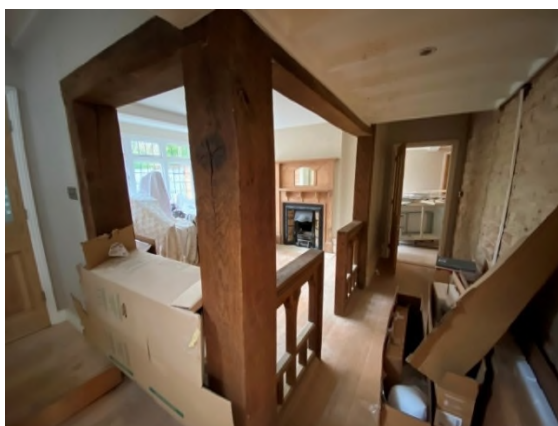
- 3.2.13 The ground floor of the small central rear extension has also been much altered with the insertion of beams and posts. There is a chimney breast with a turn of the century style grate along the east wall. The original external north wall has been removed. The first floor of this element is less altered and includes a late 19<sup>th</sup> to early 20<sup>th</sup> century fireplace. The north external wall has been removed.

Figure 27: Ground floor of the central rear extension viewed from the entrance hall

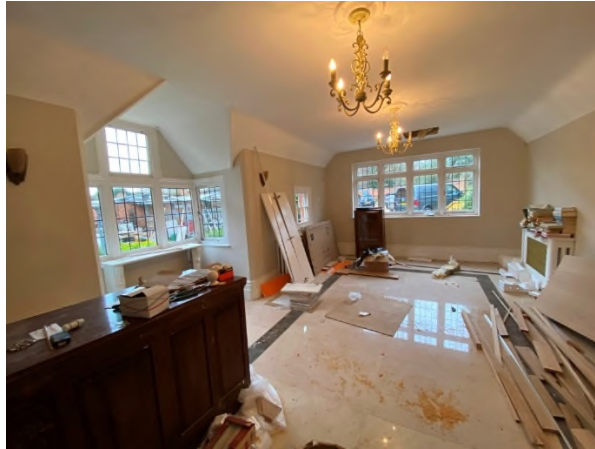
- 3.2.14 The existing plan submitted with the 2005 applications show that there was a partition with what appears to have been a chimney breast to the north of the projecting gable (west elevation). This would make sense as this extension was presumably a service wing and would have included a kitchen. As such, this space has been much-altered.

Figure 29: Ground floor of the single storey rear extension looking north

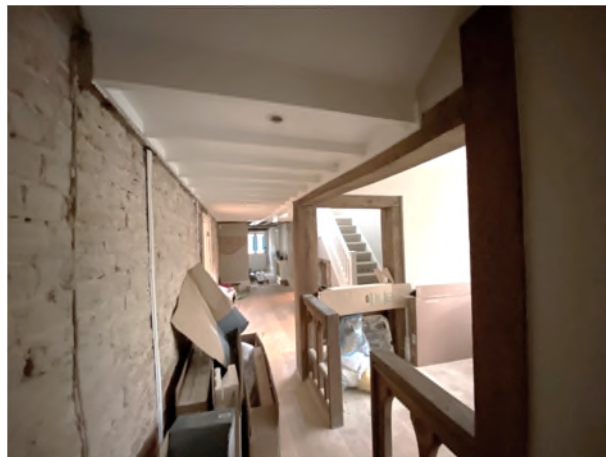
- 3.2.15 The entrance hall remains defined by beams and joists to the rear of the Phase 1 part of the house. The Phase 2 landing also remains relatively intact.

Figure 30: Phase 2 entrance hall

- 3.3.6 The entrance hall is more legible at the western end and includes an original door. The definition of the eastern part of the entrance hall is blurred as a result of the Phase 4 staircase insertion which perhaps replaced a late 19<sup>th</sup> century staircase in this part of the entrance hall. The 'library' accessed from the eastern end of the entrance hall has been much altered by later alterations but the proportions of the room remain legible and there is a fireplace along the east wall. The first floor over the 'library' is better defined and includes a metal fire surround.

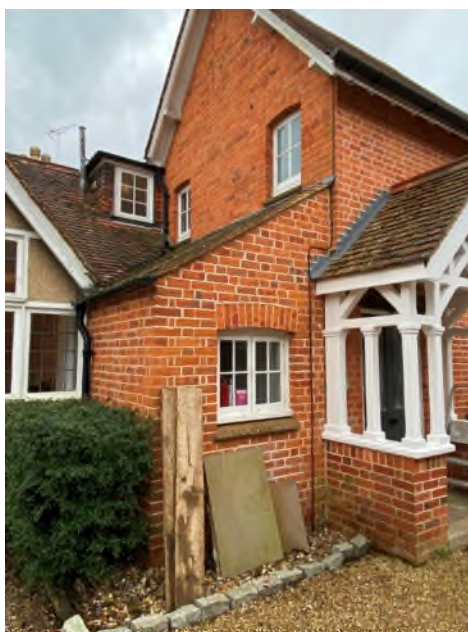
3.2.16 Phase 3 changes to the house include the addition of a single storey lean-to extension on the north side of the Phase 2 west wing and, according to historic map regression, an extension on the north-east side of the east wing. The lean-to is of brick construction with a casement window and segmental arched brick head on the west elevation. The interior is characterised by modern cupboards. The southern side of the 2-storey projecting element on the north-east side of the Phase 2 east wing correlates with the footprint of a structure in this location. It is possible that this was a single storey structure but not clear. The south wall has been removed. The interior is characterised by modern finishes.

Figure 32: Early 20<sup>th</sup> century lean-to on the north side of the west wing

- 4.1.9 **Block up door to the Phase 3 utility room** - The existing door and architrave are of 20<sup>th</sup> century date (**figure 34**). The door could be fixed shut and infill recessed to preserve the position of the door.

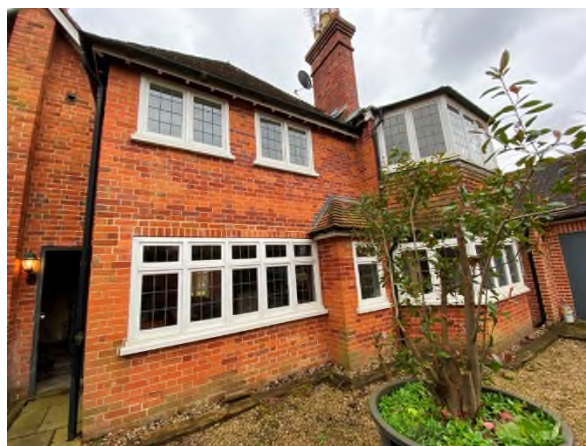
3.2.17 Phase 4 includes a 2-storey rear extension to the east wing, an extension to house the current staircase and the addition of a 2-storey canted bay window on the rear elevation.

Figure 35: 2-storey rear extension

- 4.1.3 **French doors and windows on the rear elevation** – The existing window in this location is modern and replaced part-glazed French doors and a window with leaded lights (**figure 35**). This element of the proposals would reinstate the original appearance of this part of the rear elevation. The pre-application comments recognised that this would have beneficial impacts.

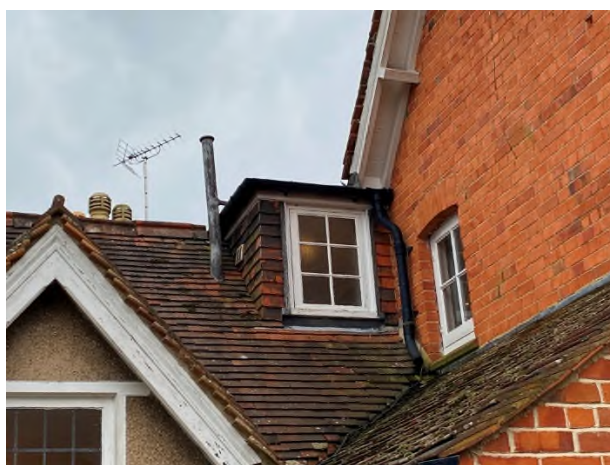
Figure 37: Dormer on the west side of the service wing roof

3.2.19 The staircase extension is characterised by a flat leaded roof and tile hanging. Of note, the flat roof appears to extend over the ridge of the service wing to form a flat roof dormer on the west elevation (**Figure 37**). The style of the staircase accessed from the Phase 2 entrance hall is consistent with 1920s style. The flat roof dormer on the west elevation may have been created to form a first-floor water closet. This space has been much altered by modern alterations.

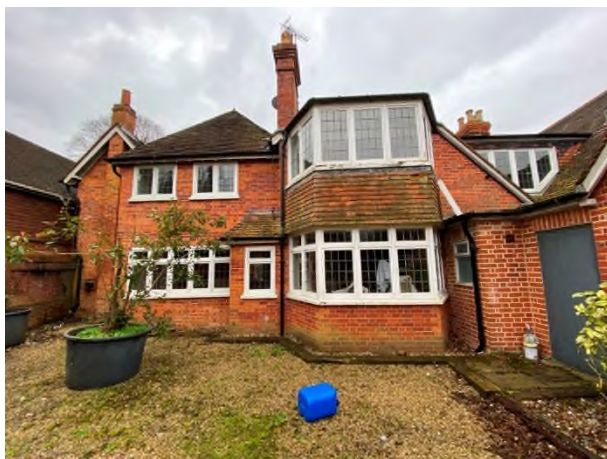
Figure 38: 2-storey canted bay extension

- 3.2.18 The 2-storey extension to the east wing created an additional room on each floor. The ground floor is a single space but included partitions for a downstairs loo and a store on the 2005 plan. The 2005 existing elevations show that the north elevation formerly had a pair of part-glazed doors flanked by leaded lights. The current strip of windows is therefore modern. The first floor is a bedroom with a corner fireplace and a metal fire surround typical of early 20<sup>th</sup> century style. The canted bay increased the size of the central Phase 2 extension to the rear.

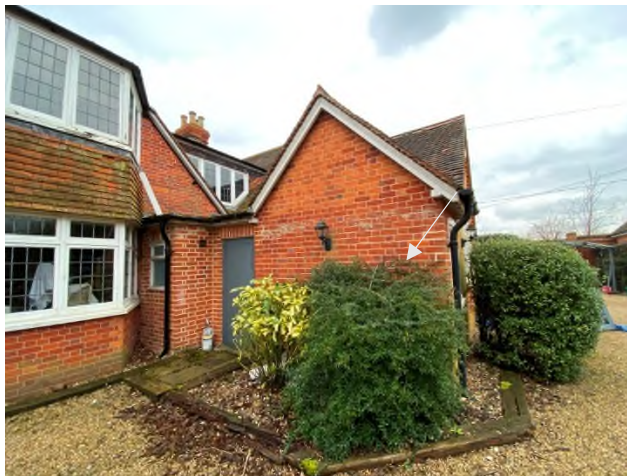
Figure 45: East elevation of the extension to the service wing

3.2.20 Phase 5 is interpreted as a single storey extension to the Phase 2 service wing and the 2-storey element on the eastern side of the extended east wing. The service wing extension formed part of a larger addition which has been demolished.

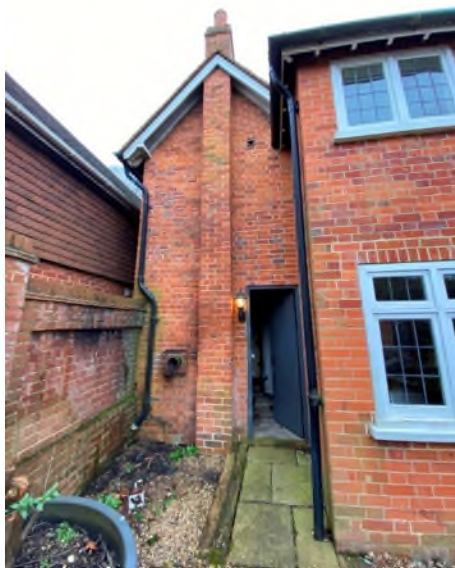
Figure 46: 2-storey side extension to the east wing

3.2.21 The 2-storey side extension may have incorporated part of the Phase 3 element in this position. Logically, the 2-storey extension post-dates the Phase 4 extension to the east wing. This addition is of brick construction with a double pitched roof. The ground floor is a boiler room. The first floor is a bathroom.

- 4.1.7 **Replacement doors** – It is proposed to replace modern solid doors on the north and east elevations of the Phase 5 extensions (**figures 46 and 49**). The proposed part-glazed doors would be in keeping with the style of doors that characterise the exterior of the listed building.

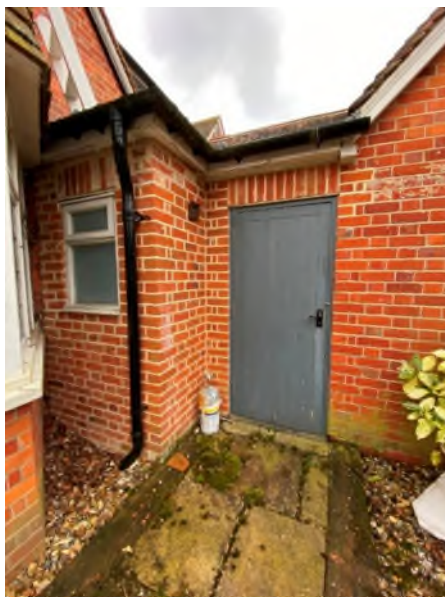
Figure 49: Modern infill of the area between the service wing extension and the staircase extension

3.2.22 Later 20<sup>th</sup> and early 21<sup>st</sup> century extensions to the house include the replacement of a conservatory with a single storey brick extension on the east side of the Phase 2 east wing and the infilling of the area between the Phase 5 service wing extension and the Phase 4 staircase extension.

- 4.1.4 **Removal of a flat roof infill extension** – This is modern and of no heritage value (**figure 49**). Removal of this element would better define the various phases of historic development to the rear of the house.

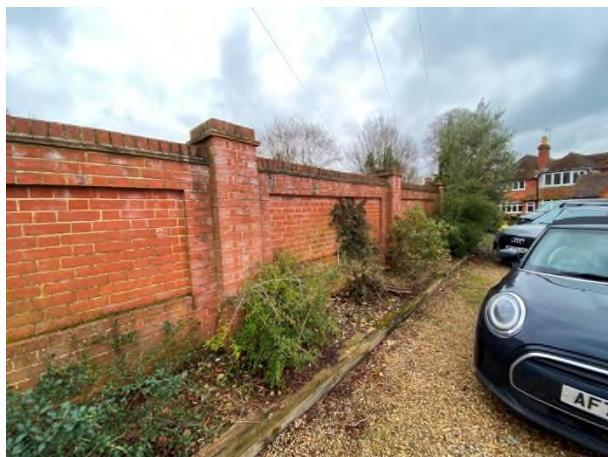
Figure 51: Modern brick boundary wall

3.2.23 The boundary wall to the north of the house was built as part of the 2005/2006 approved works. This wall is of no heritage value.

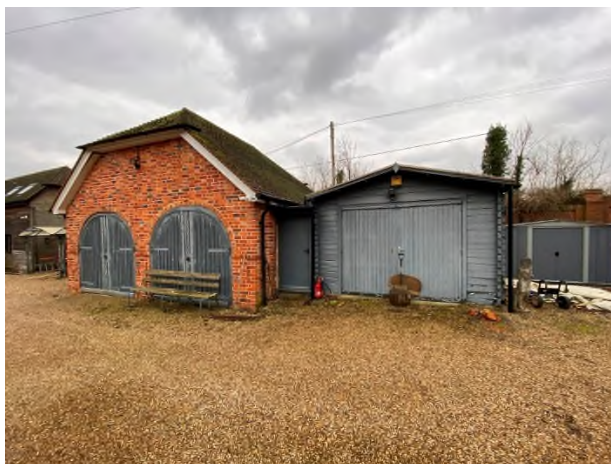
Figure 52: Modern garage to the north-west of the house

3.2.24 The garage to the north-west of the house was built replacing a ruinous structure in this position as part of the 2005/2006 approved works. The garage is of no heritage value.

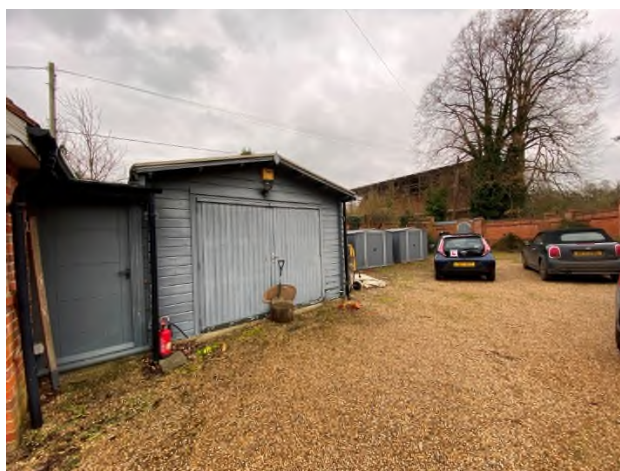
Figure 53: Sheds to the north of modern garage

3.2.25 There are modern sheds to the north of the garage which are of no heritage value.

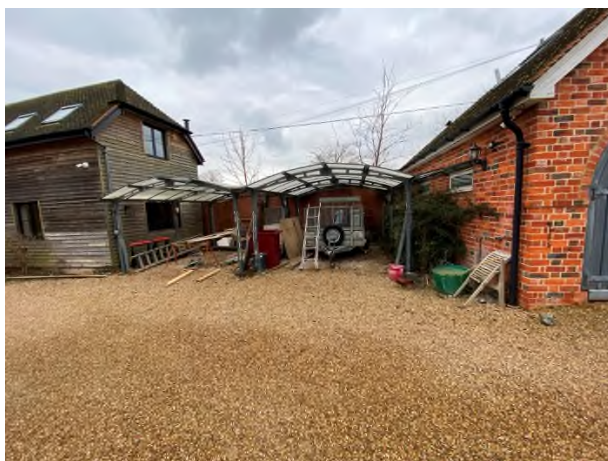
Figure 58: Existing carports

**4.1.17 Removal of carports and garden sheds** – The carports are modern and unsightly. The removal would represent an enhancement to the setting of the listed building. The sheds are also modern and of no heritage value.
