# Memo

**Re:** Consultation on an Application

**Planning Application Ref:** PL/25/1667

**Proposal:** Application for Approval of Details Reserved by Conditions 5 and 6 of application PL/25/0342

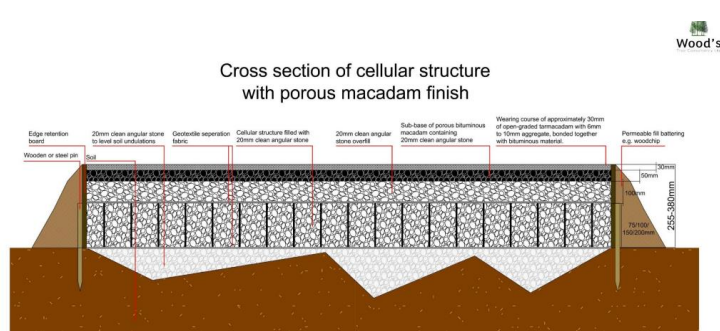
Appendix 3 of the AMS describes special surface constructions under tree's RPAs. The special surfacing is generally described as *'a wet pour soft permeable surface is to be installed over the whole area. This will require a surface scape of the present surface to expose the chalk substrate which has been approved by the play equipment installation company as being an acceptable subbase.'* Appendix 3 then goes on to describe the use of a cellular confinement system which is positive as it allows for tree root growth and movement. It provides a diagram of how this will be constructed using the wet soft pour surface. This is all acceptable.

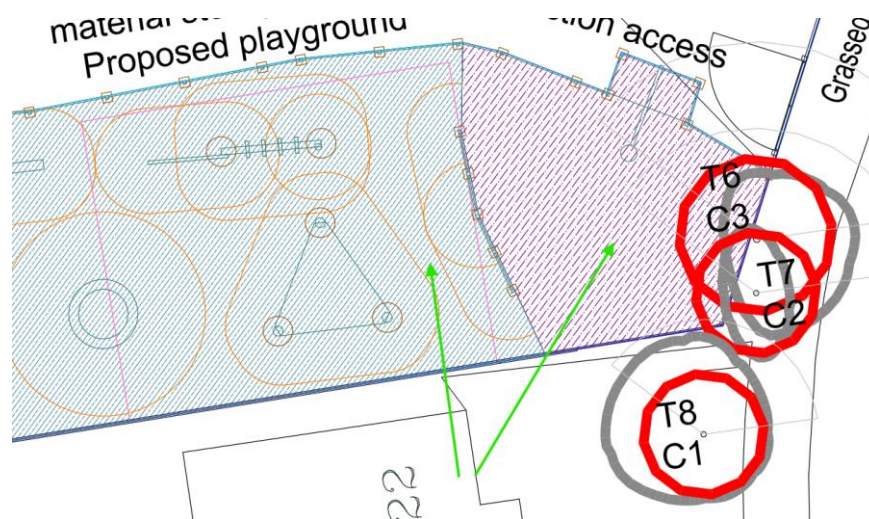
With reference to the Tree Protection Plan, 18<sup>th</sup> November 2025, Ref: WTC/TSPS/TPP/002, I am slightly unclear on the difference in surfacing shown below. Some clarity should be provided on this given the pink hatched area impacts T6 and T7 RPAs.

To conclude, some clarity is required regarding the crown lifting to facilitate the boundary fencing. The measurements for the foundations edges for the playground should also be clarified to demonstrate the extent they lay within RPAs. It would also be useful if the playground equipment could be labelled so that we are clear on what is proposed and where. It would also be useful if a plan showing the proposed vs existing fencing was shown to improve clarity. The difference in surfacing within the TPP should also be clarified.
