## Former Hemdean House School, Caversham

### Flood Risk Assessment

| <b>Project No.</b> | 1953 |

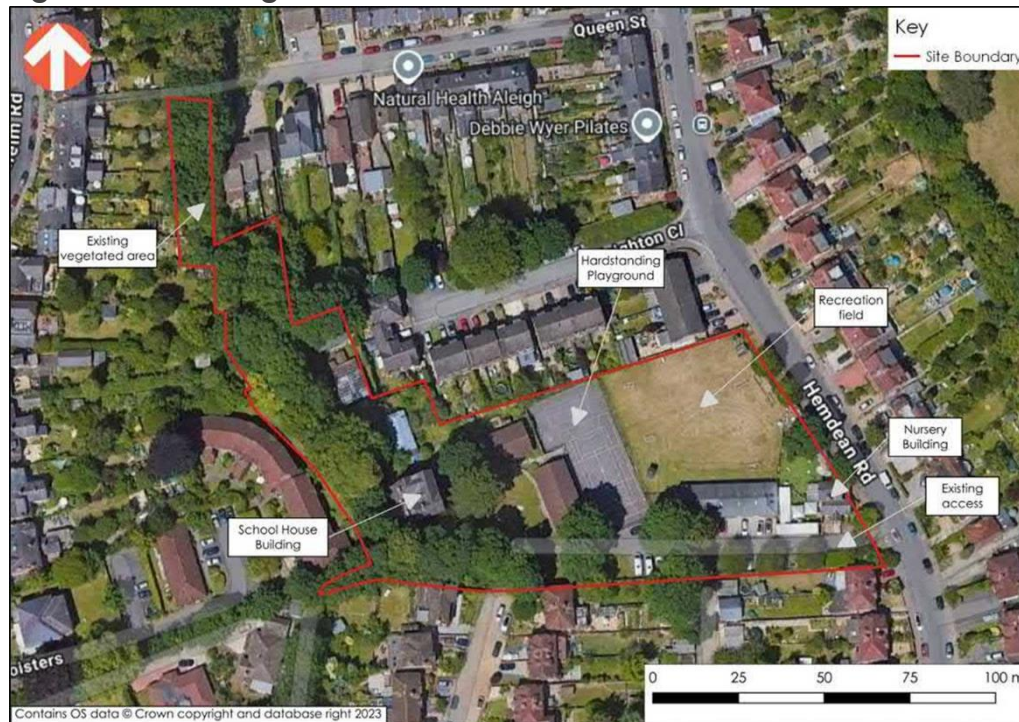
**Figure 1.2 – Existing site features**

- 2.4 The site access represents the lowest point of the site, with levels between 39.4 – 39.6mAOD. Site levels within the site access fall toward Hemdean Road to the east, with no external catchments falling toward the site.
- 2.5 A copy of the Cube Surveys Topographic Survey is included within Appendix B.
- 2.6 An annotated sketch of existing site features is shown within Figure 1.2.

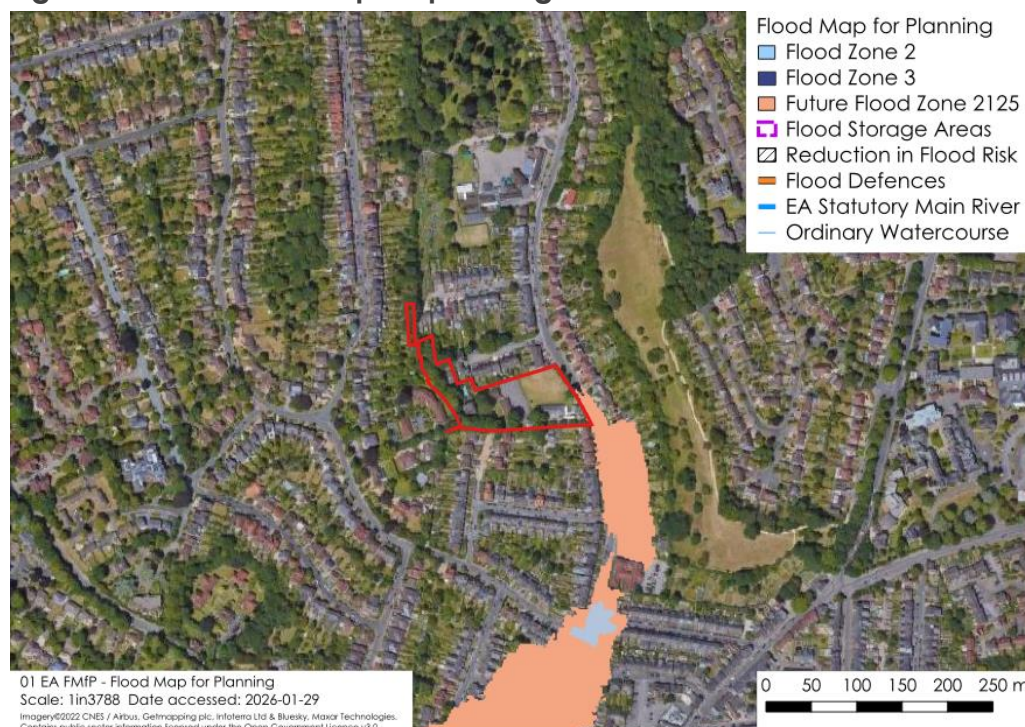
**Figure 2.1 – EA Flood map for planning**

- 2.12 The entirety of the site and immediate surrounding area is within 'Flood Zone 1' (low risk), with less than 1 in 1,000 annual exceedance probability (AEP) of river or sea flooding (<0.1% AEP) as shown in Figure 2.1.

- 2.13 When climate change is considered to 2125, flood zones may extend north from the River Thames and marginally impact the existing access with Hemdean Road, at the south-east corner of the site. No new buildings are impacted by future zones and the development is therefore considered safe from fluvial and coastal flooding during its lifetime.

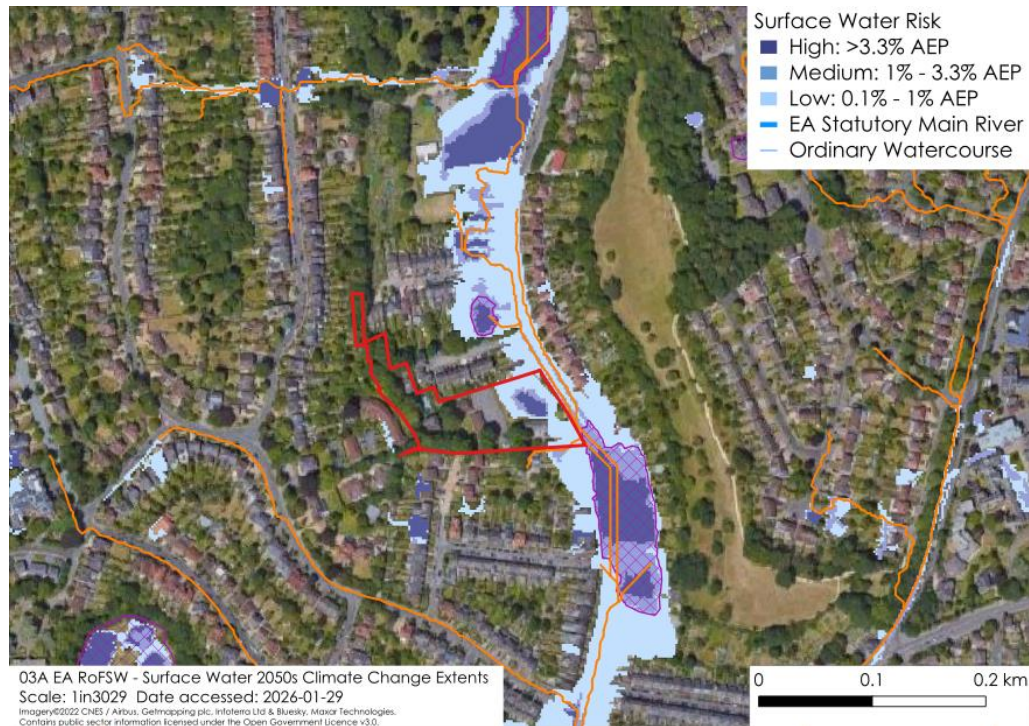
**Figure 2.2 – EA Extents of Flooding from Surface Water Climate Change 2050s (orange lines = flow routes, purple hatch = storage areas)**

- 2.15 The EA's 'Flooding from Surface Water – Climate Change 2050s' map has been reproduced as Figure 2.2 and shows the majority of the proposed development site as being at 'very low risk', with less than 1 in 1,000-year AEP from surface water flooding (<0.1% AEP) when climate change is considered.

- 2.16 The extent of surface water flooding expected in the 1 in 100-year +40% climate change design rainfall event is represented by the 1%-3.3% AEP 'medium' event in Figure 2.2 and shows a small area of flooding in the recreation field – in the localised low-point of the site. The 'low' risk light blue extents indicated in Figure 2.2 are beyond the surface water design flood extents. No other flooding is expected within the development site during the design event and there are no areas of flooding within the site indicated as flow routes or serving as flood storage areas.

- 2.17 Overlay of the 'medium' extent of flooding in Figure 2.2 on the topographic survey indicates a peak level of circa 39.9mAOD and peak depths of 100mm at the lowest level indicated on the topographic survey in that area. The estimated peak level is 300mm below the proposed finished floor level of 40.2mAOD. These existing estimated flood levels are anticipated to be worst-case for 'medium' risk events as the indicated on-site flood extents occur as a result of site generated run-off. The introduction of a Surface Water Management Plan to intercept and accommodate run-off from the development site, up to the 1 in 100-year event, including

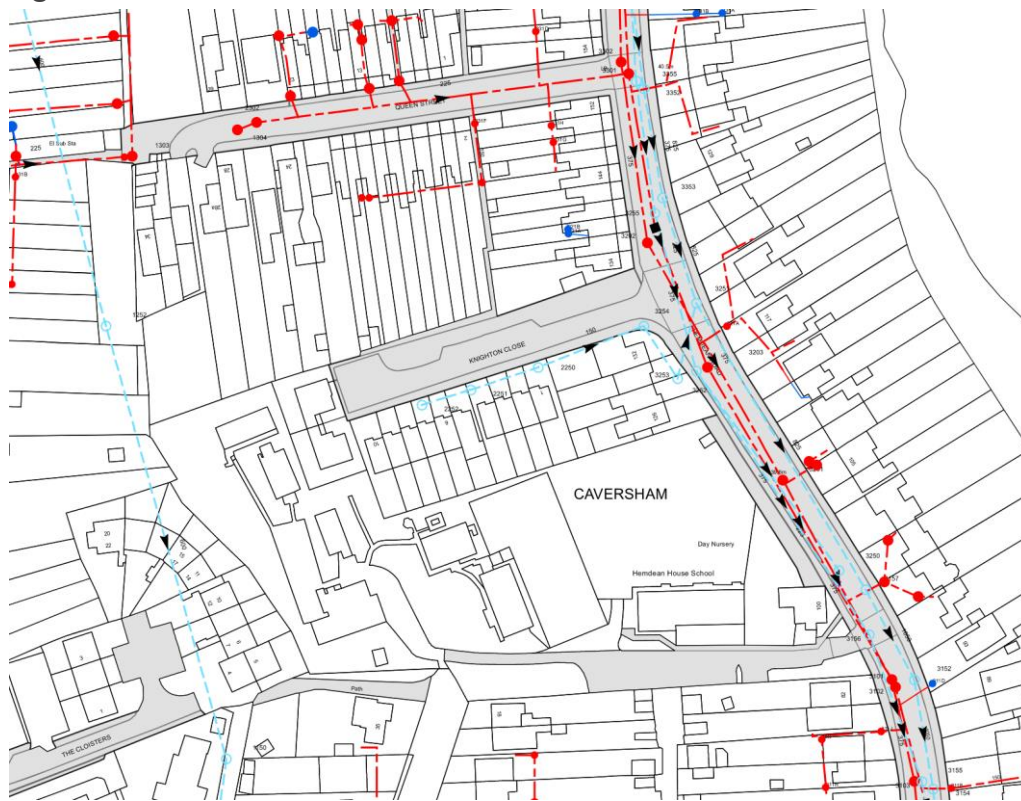
**Figure 2.3 – Thames Water Asset Records**

- 2.28 The TW sewer records are reproduced in Figure 2.3, with full copies included in Appendix E. Foul and surface water sewers are shown in red and blue, respectively.
- 2.29 The asset records identify no adopted sewers exist within the site, but that adopted surface water sewers are located to the east in Hemdean Road.
- 2.30 TW recording indicate surface water manholes (SWMH) 3252 and 3156 with invert levels of 38.80mAOD and 37.64mAOD respectively. The invert level of

the adopted 375mm surface water 40m downstream from SWMH3252 is 38.24mAOD.

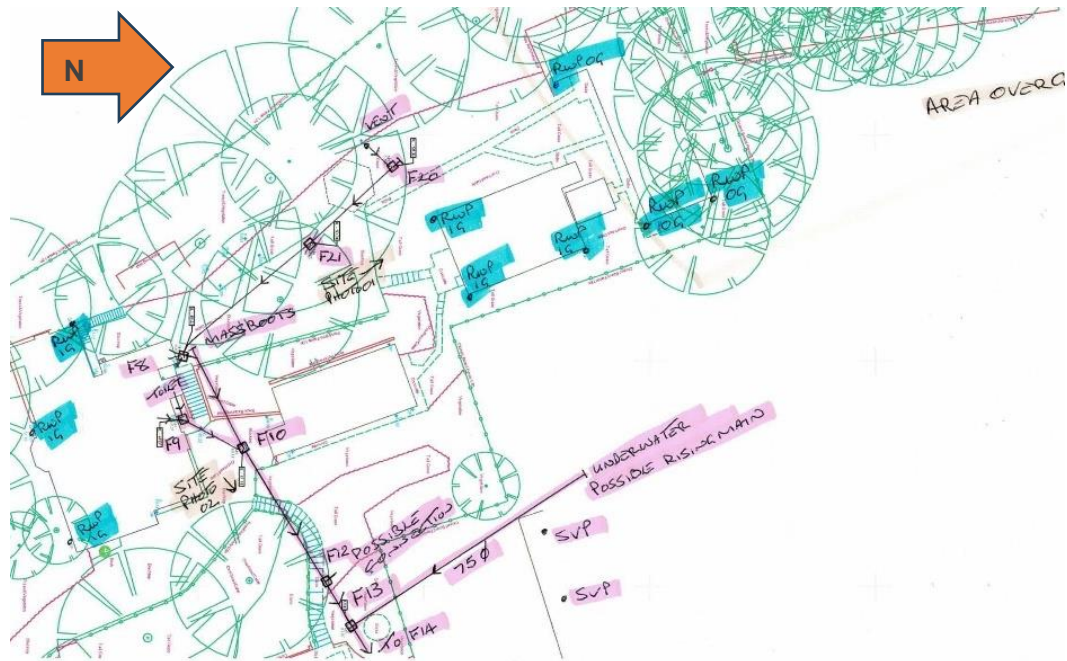
Figure 2.4 - CCTV Drainage Survey Extract 1

- 2.31 A CCTV drainage survey was completed by Utility Surveys LTD in May 2025. The survey indicates that buildings on the site have rainwater downpipes which discharge to ground and with no other storm drainage identified it is assumed these downpipes must lead to existing infiltration systems. Extracts from the CCTV Drainage Survey are shown in Figures 2.4 and 2.5, with a full copy of the CCTV drainage report included within Appendix F.

- 2.32 The data from the CCTV survey indicates a potential sewer/pumped drainage discharge crossing the northern boundary of the site and discharging in a gravity system along the northern boundary of the site. This sewer is likely a transferred asset under the Transfer of Private Sewer Regulations (2011) and is subject to a 3m easement in which new buildings cannot be placed.

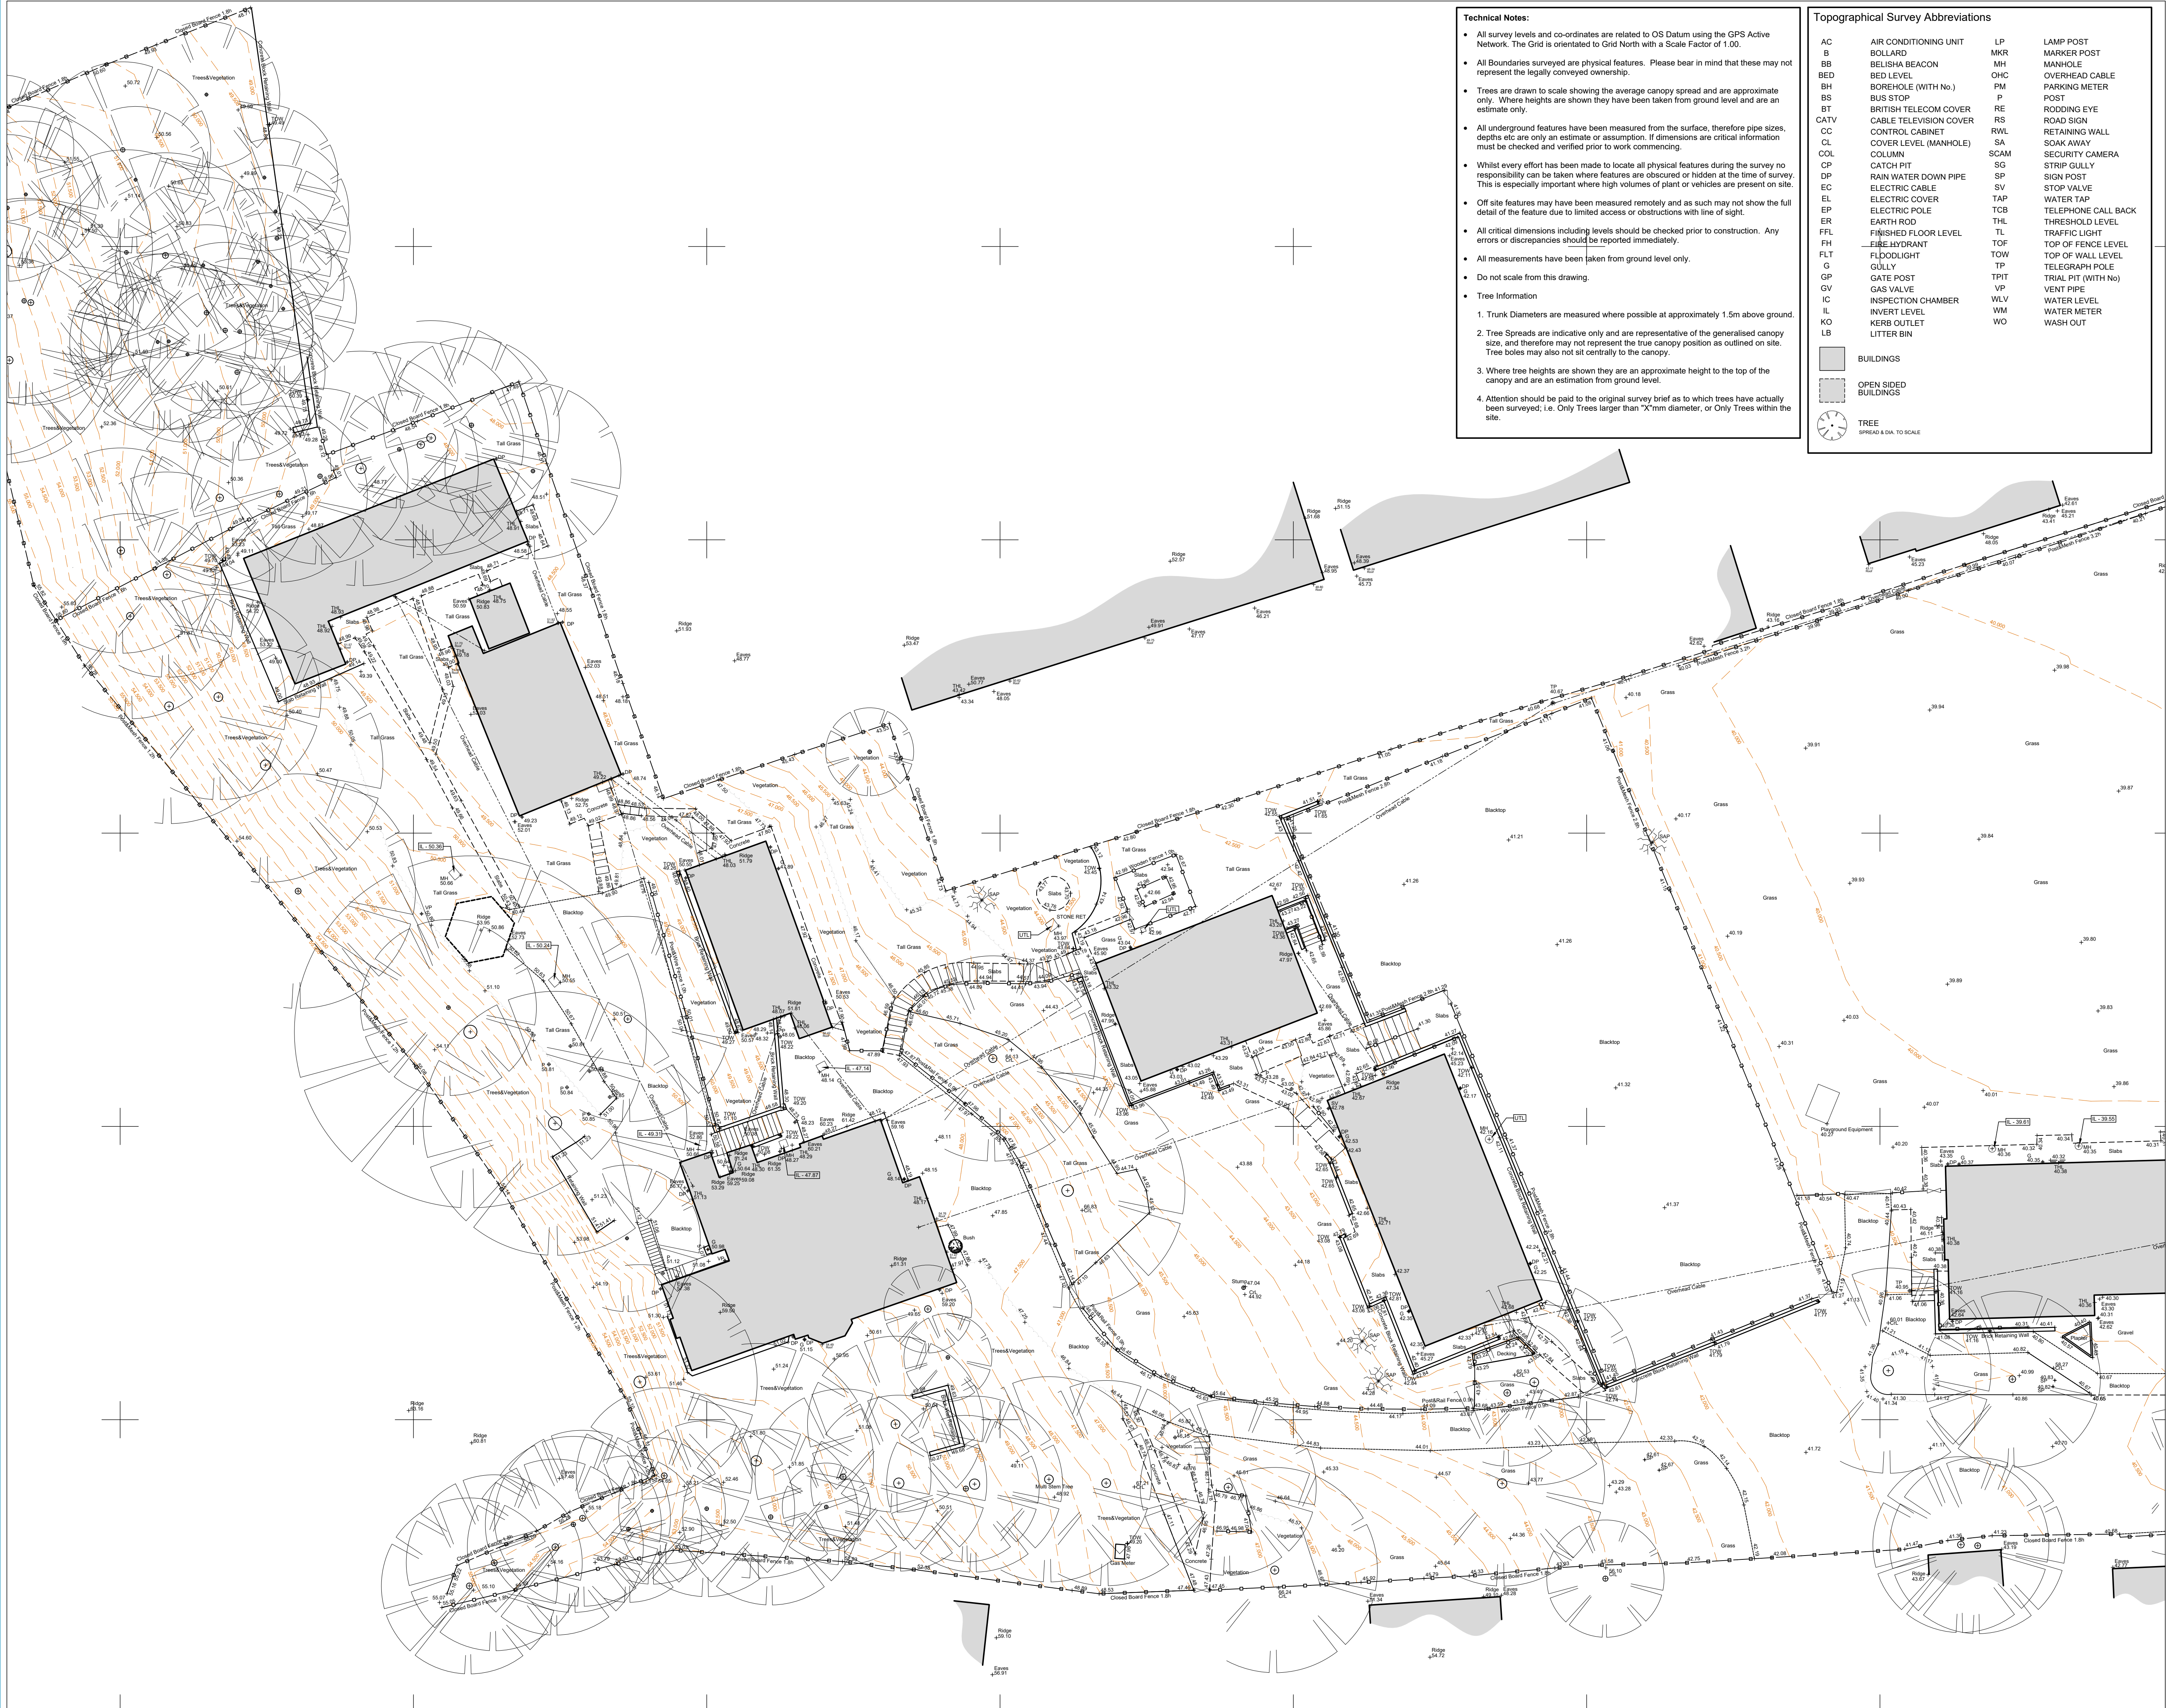
Client : Churchill Retirement Living  
Project Title : Former Hemdean House School  
Drawing Title : Topographical Survey  
Surveyed By and Date : VM 06/08-05-2025  
Drawn By and Date : VM 14-05-2025  
Approved By and Date : AJS 14-05-2025  
Drawing Number : CUB-RBS-CRL-024  
Sheet Number : 1 of 3  
Scale: A1: 1:200

- All survey levels and co-ordinates are related to OS Datum using the GPS Active Network. The Grid is orientated to Grid North with a Scale Factor of 1.00.

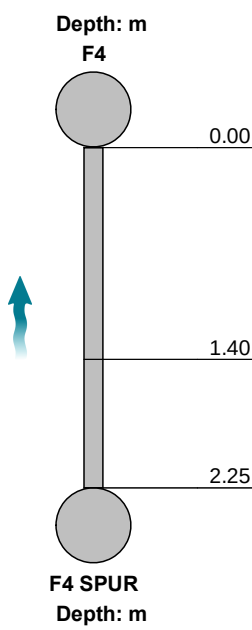
| Scale: | 1:50 | Position [m] | Code | Observation | Grade | | | | |
|---|---|---|---|---|---|---|---|---|---|
| <div><div><div>Depth: m</div><div>F4</div><div></div><div><div>0.00</div><div>WL</div><div>Water level, 0% of the vertical dimension</div></div><div><div>1.40</div><div>LL</div><div>Line deviates left</div></div><div><div>2.25</div><div>GYF</div><div>Finish node, gully, reference: F4 SPUR</div></div><div><div>F4 SPUR</div><div>Depth: m</div></div></div></div> | | | | | | | | | |

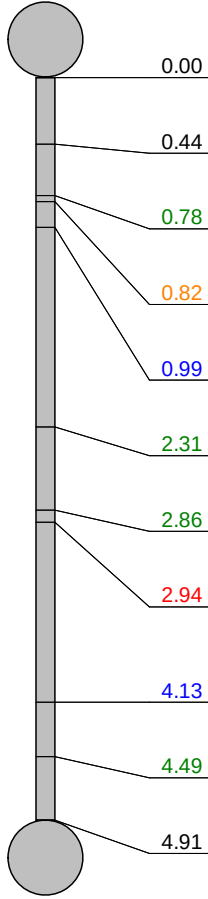
| Scale: 1:50 | Position [m] | Code | Observation | Grade | |
|---|---|---|---|---|---|
| <div> <p>Depth: m</p> <p>F9</p> <p>F10</p> <p>Depth: m</p> </div> | | | | | |
| | 0.00 | WL | Water level, 0% of the vertical dimension | | |
| | 0.44 | SC | Pipe size changes, new size(s), 150 mm high | | SC - 0.44 |

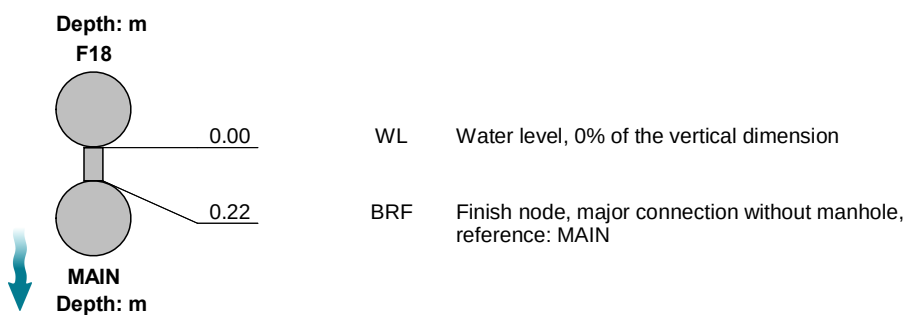
| Scale: | 1:50 | Position [m] | Code | Observation | Grade | | | | |
|---|---|---|---|---|---|---|---|---|---|
| <div><div><div>Depth: m</div><div>F18</div><div></div><div>0.00</div><div>0.22</div><div>MAIN</div><div>Depth: m</div></div><div><div>WL</div><div>Water level, 0% of the vertical dimension</div></div><div><div>BRF</div><div>Finish node, major connection without manhole,<br/>reference: MAIN</div></div></div> | | | | | | | | | |

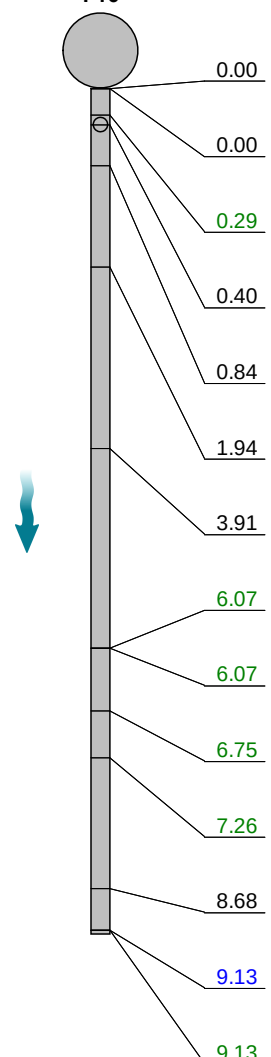
| Scale: 1:82 | Position [m] | Code | Observation | Grade | |
|---|---|---|---|---|---|
| <div> <div>Depth: m</div> <div>F16</div> </div> | | | | | |

| Scale: 1:82 | Position [m] | Code | Observation | Grade | |
|---|---|---|---|---|---|
| | 0.00 | WL | Water level, 0% of the vertical dimension | | |
| | 0.00 | RPL | Point repair, localised lining, from 12 o'clock to 12 o'clock | | RFJ - 0.29 |
| | 6.07 | CL | Crack, longitudinal, at 11 o'clock | 2 / 2 | |
| | 6.07 | CCJ | Crack, circumferential at joint, from 9 o'clock to 3 o'clock | 2 / 2 | RPL - 1.94 |
| | 9.13 | FLJ | Fracture, longitudinal at joint, at 8 o'clock | 3 / 2 | |
