# Heritage Impact Statement

19-21 Castle Street  
Reading  
RG1 7SB

## 19-21 Castle Street, Reading, RG1 7SB

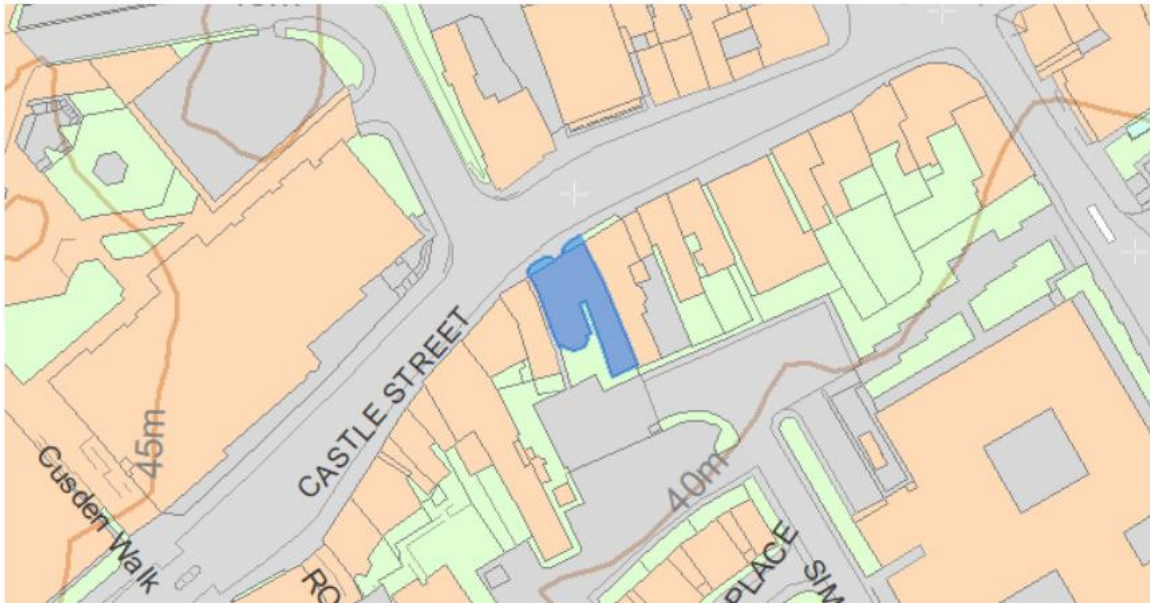
Figure 1: Historic England .org.uk

The principal (north) elevation onto Castle Street is symmetrical and of five bays with a parapet which has stone copings and a moulded brick cornice. The centrally placed entrance has a six-panel door with a plain transom replacing the original arched fanlight. The door surround has fluted Doric pilasters and Doric entablature and cornice capped by a segmental pediment. Fenestration is of timber sash windows, those on the ground floor having one-over-one plate glass panes, the first floor six-over-six glazing bars and the second floor three-over-six. The ground and first floor windows have deep segmental heads of gauged brick with fluted keystones and brick hoodmould. The second-floor windows have square-headed openings, also with fluted keystones. There are cast-iron rainwater goods with rounded hoppers on the interior of the two outer bays.

The rear (south) elevation is rendered with an ashlar effect and dominated by the full height, five-sided, bow of the rear extension. Fenestration, on the three principal faces, is of replacement timber sashes in plain, square-headed, openings, those on the first floor have six-over-six glazing bars while the ground floor ones are two-over-two apart from the larger central window which is eight-over-eight. The western return (to the alley between number 21) is blind with the western return having a window with paired four-over-four timber sashes on the ground floor and two, six-over-six, sash windows on the first floor. The roof slope above has a lead-covered, flat-roofed dormer with a pair of two-over-two timber casement windows. To the east of the extension is an oriel bay, with a six-over-six timber sash window, adjoining the sloping, slate-covered, roof of the start of the south-eastern range.” [Historic England]

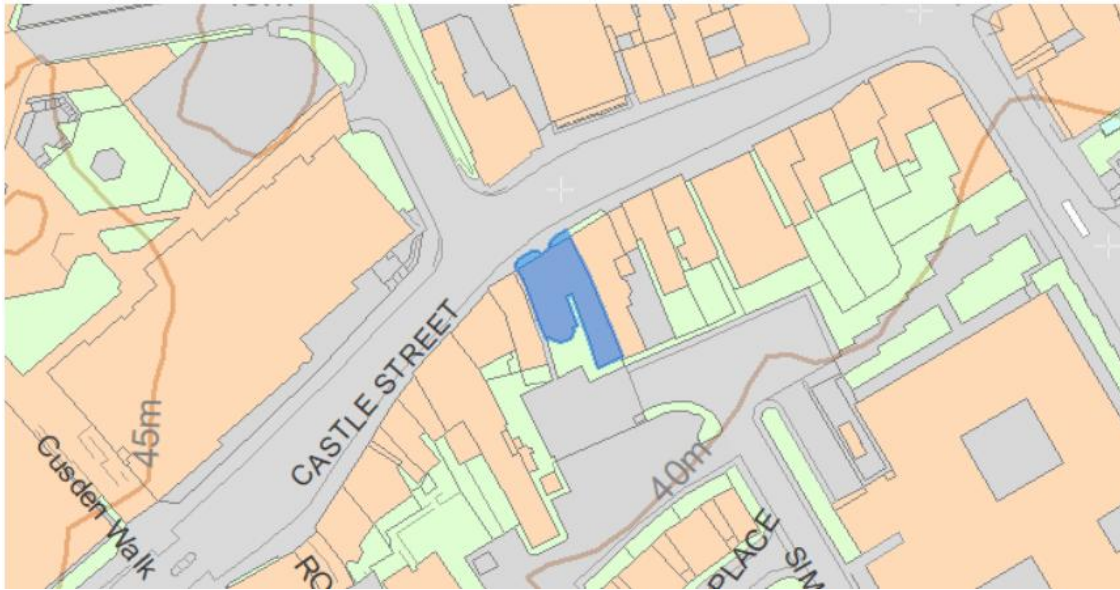
Figure 2: Historic England .org.uk

The west elevation of the rear range is blank, while the east elevation has a variety of timber sash and casement windows to all floors. There is a door at the basement level of the south elevation, a full-height casement window and smaller, two-pane, timber sash window on the ground floor, and a tripartite timber sash window on the first and second floors.

The front range has an M-shaped roof with partially infilled roof valleys and the rear, south range has a hipped roof with brick chimney stack.” [Historic England]

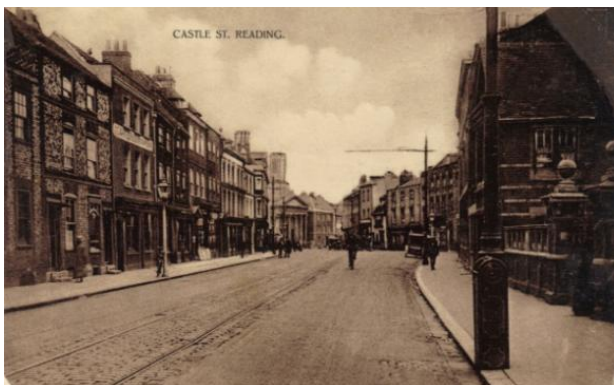
The below photos show how streetscape has largely changed with the buildings north side of Castle Street have been demolished and replaced with a modern construction but still in a red brick.

Figure 7: North and south sides of Castle Street c.1900s- Reading Museum.org.uk

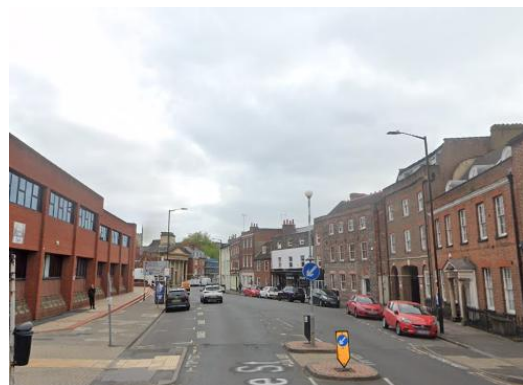
Figure 8: North and south sides of Castle Street 2026 – Googlestreetview.co.uk

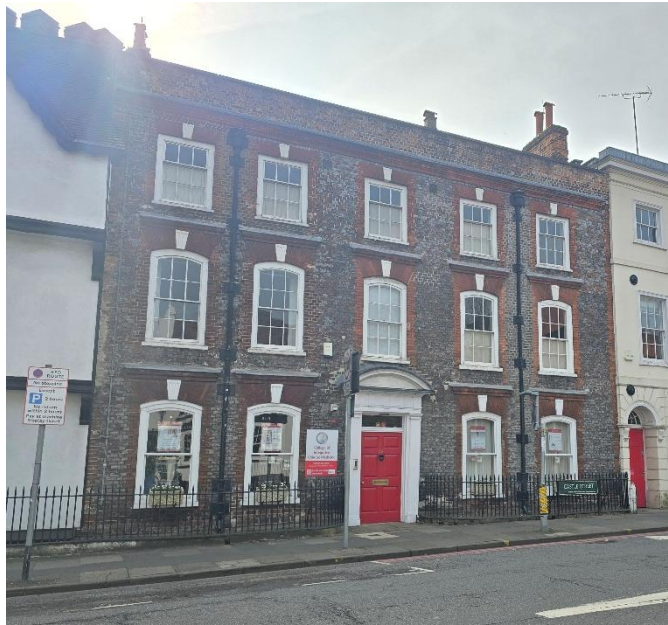
Fig 16 – Frontage of 19 Castle Street – Photograph taken by Applicant/Agent

19 Castle Street is a Grade II\* listed building built in the early 18<sup>th</sup> Century and is a former town house of considerable status with well-proportioned and architecturally refined facades with polychromatic brickwork, a noted feature of the architectural of Reading.
