# Memo

**From:** Transport Development Control  
**To:** Jonathan Markwell Jonathan.Markwell@reading.gov.uk  
**Date:** 8 July 2026  
**Re:** Transport Development Control response to the Updated Design Codes in connection with the development proposals at Forbury Retail Park (Ref. PL/25/1706).

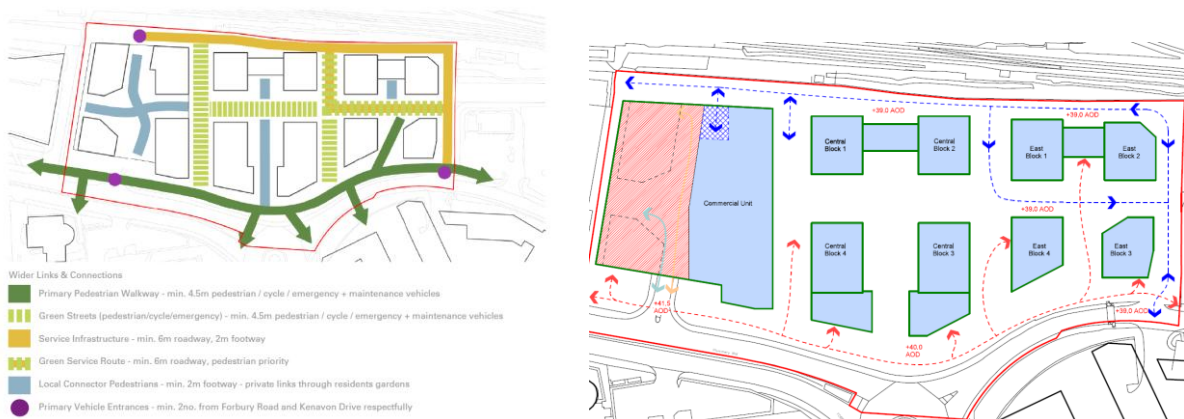
The Design Code sets out a clear hierarchy of vehicle, cycle, and pedestrian routes linking the site with Reading Town Centre and surrounding areas. It is indicated that the servicing route will be located to the north and a series of Green Streets will be provided within the site for pedestrian/cycle/emergency/maintenance movement only.

The Green Streets will provide access for pedestrian/cycle/emergency access. However, given that these routes are to be 4.5m in width, there is no indication of any access control to prevent general vehicle traffic from abusing the internal routes. The Design Codes have been updated in response to the comments from the Natural Environment Officer, Transport Development Control and Thames Valley Police, however, it does not appear that the applicant has commented on this point.

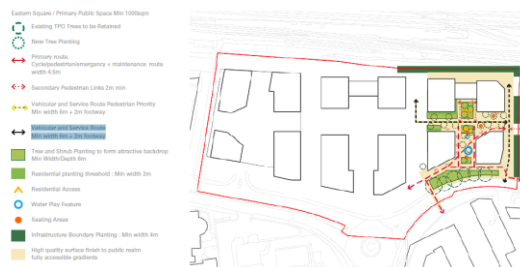
#### 5.2.4 Eastern Square

The diagram in 5.2.4 indicates that the eastern square will function as a primary pedestrian/cycle route, while also accommodating a service access route. However, it is not clear how both functions will operate within the same space without compromising pedestrian/cycling safety and servicing requirements. The Design Codes have been updated but it does not appear that the applicant has commented on this point.
