| Project | Refurbishment & Alterations<br>Carlisle House, 118 Oxford Road<br>Reading<br>RG1 7NG | | | | Drawing | Existing & Proposed Entrance Doors (1) D-B-01 | | | | | |
| | | | | | Job-Dwg<br>Number | 18009-PL-44 | | Rev. | A | | |

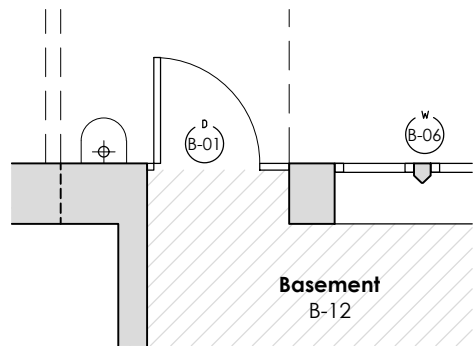
GENERAL ARRANGEMENT PLAN 1/50

EXISTING BASEMENT B-12  
EXISTING ARCHED ENTRANCE DOOR D-B-01
