| Project | Refurbishment & Alterations<br>Carlisle House, 118 Oxford Road<br>Reading<br>RG1 7NG | | | | | Drawing | Existing & Proposed Windows (3) W-B-02 & 03 | | | |
| | | | | | | Job-Dwg Number | 18009-PL-40 | | Rev. | A |

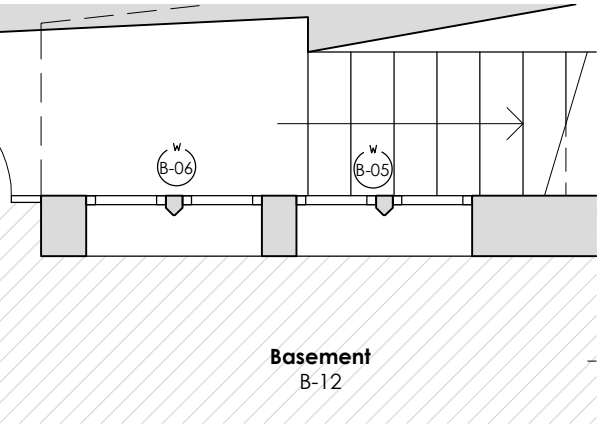
GENERAL ARRANGEMENT PLAN 1/50

EXISTING BASEMENT B-12  
EXISTING WINDOW W-B-05 & W-B-06

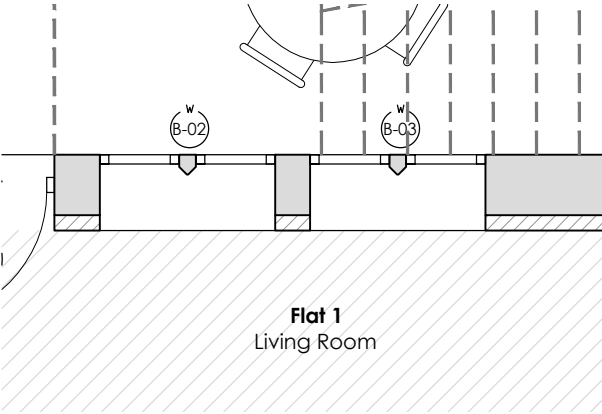
GENERAL ARRANGEMENT PLAN 1/50

PROPOSED FLAT 1 LIVING ROOM  
PROPOSED NEW WINDOWS W-B-02 & W-B-03
