| Project | Refurbishment & Alterations<br>Carlisle House<br>Reading<br>RG1 7NG | | | | | Drawing | Drawing & Photographic Recording:<br>Existing Second Floor Dormer Volume | | | |
| | | | | | | Job-Dwg<br>Number | 18009-PL-37 | Rev. | - | |

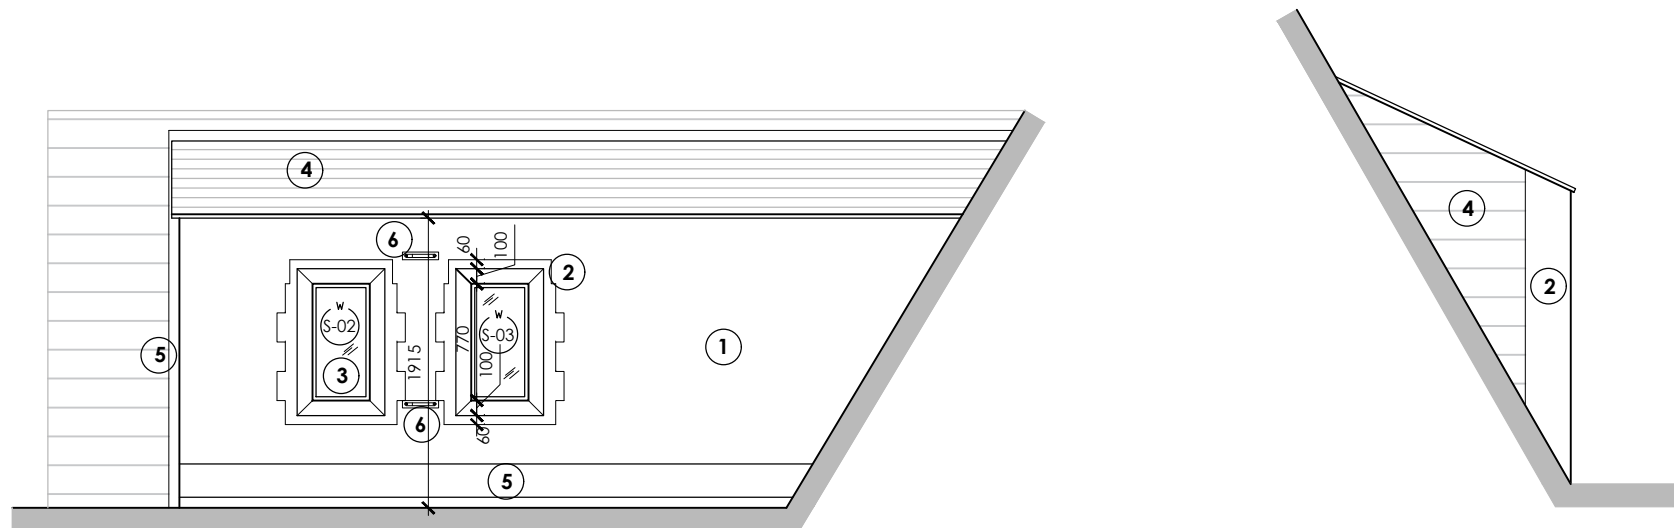
ELEVATION **A** 1/50

(To be removed & stone recycled into repairs elsewhere on the building)

- ① Coarse stonework wall finish
- ② Dressed stone played window surround & corner quoining
- ③ Slim metal framed single glazed windows
- ④ Roof and dormer cheeks with natural slate tile finish
- ⑤ Lead flashing to flat roof abutment
- ⑥ Cast iron rainwater pipe straps
