| Project | Refurbishment & Alterations<br>Carlisle House, 118 Oxford Road<br>Reading<br>RG1 7NG | | | | | Drawing | Existing & Proposed Windows (2) W-B-05 | | | |
| | | | | | | Job-Dwg Number | 18009-PL-39 | | Rev. | - |

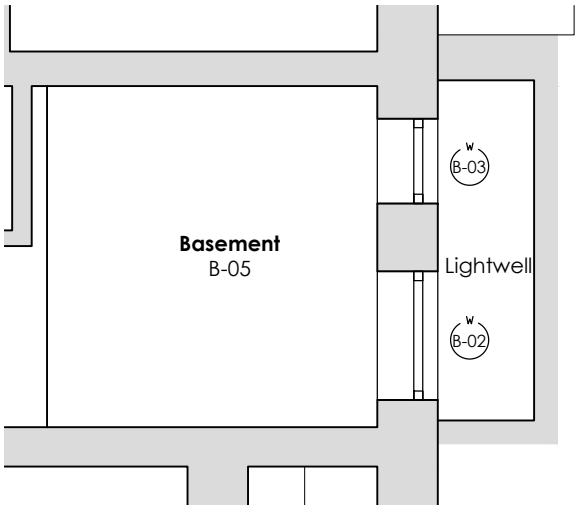
GENERAL ARRANGEMENT PLAN 1/50

EXISTING BASEMENT B-05  
EXISTING WINDOW W-B-02 & W-B-03

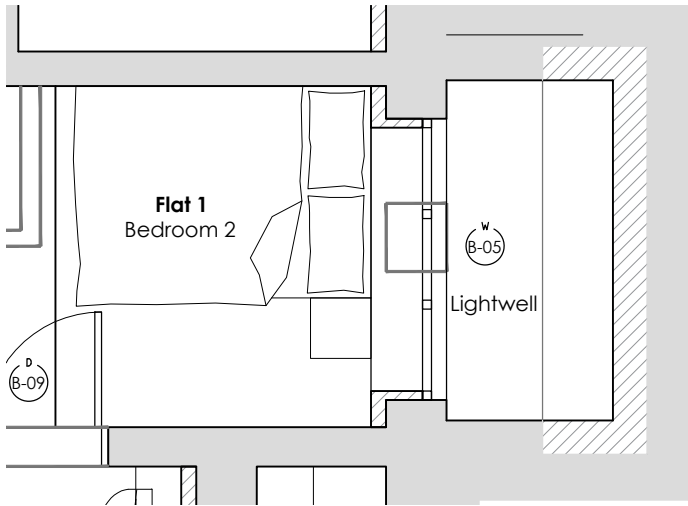
GENERAL ARRANGEMENT PLAN 1/50

PROPOSED FLAT 1 BEDROOM 2  
PROPOSED NEW WINDOW W-B-05

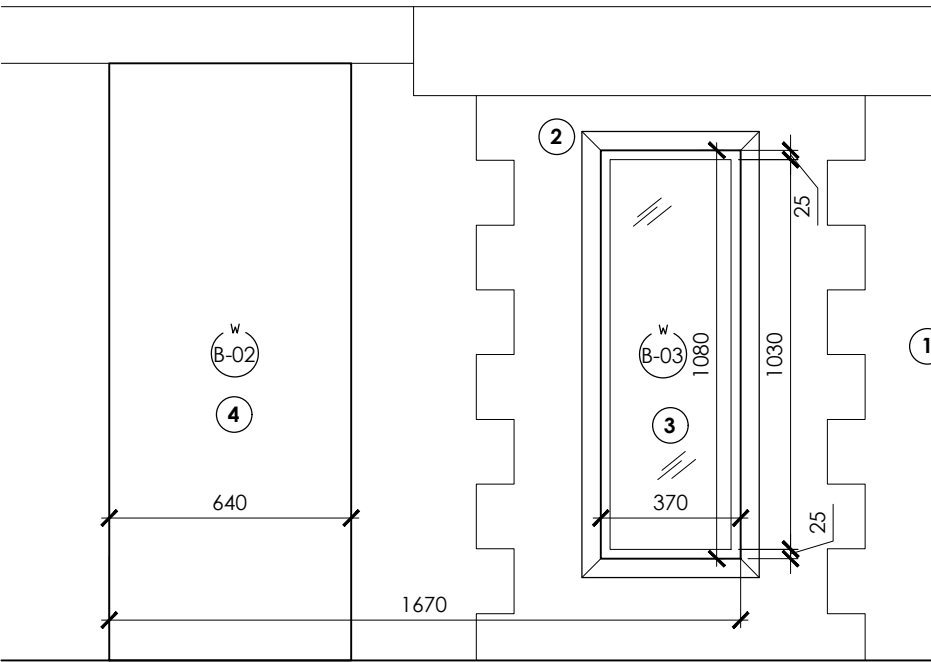
EXTERNAL ELEVATION 1/20

- 1 Coarse stonework wall finish
- 2 Dressed stone splayed window surround
- 3 Dilapidated slim metal framed window
- 4 Dilapidated window opening
- 5 Proposed new slim-framed PPC aluminium heritage frame profile window, colour: dark grey
- 6 Dressed stone window surround extended to match existing
- 7 Proposed new white glazed brickwork to lightwell
- 8 Proposed damp proofing & insulating dry-lining system
