Viewpoint 2: Kirton Farm Road

Viewpoint 3: PRow across Farnham Flint Lakes

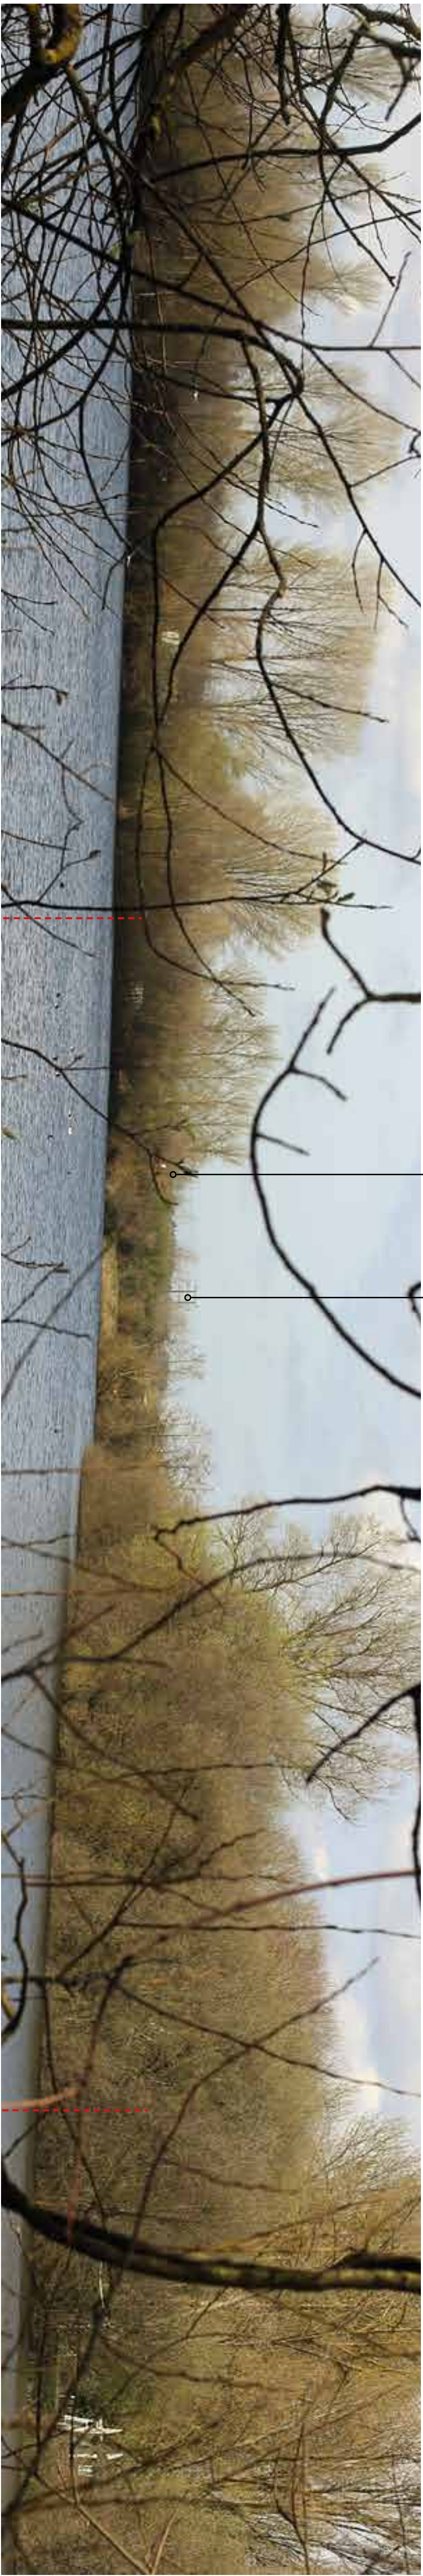
Existing View

Built structures glimpsed  
between trees

Overhead lines  
appear on the skyline

Approx. Extent of Site

Viewpoint ID: 2  
Map Co-Ordinates: SU 69096 69849  
Height at Ground Level (AOD): 41.3m  
Approx. Distance to Site: 465m  
Direction from Site: East  
Date of Photo: 20.03.2020  
Weather Conditions: Sunny  
Surveyor: SH  
Receptors:  
Residents and visitors to Reading  
Lake Hotel

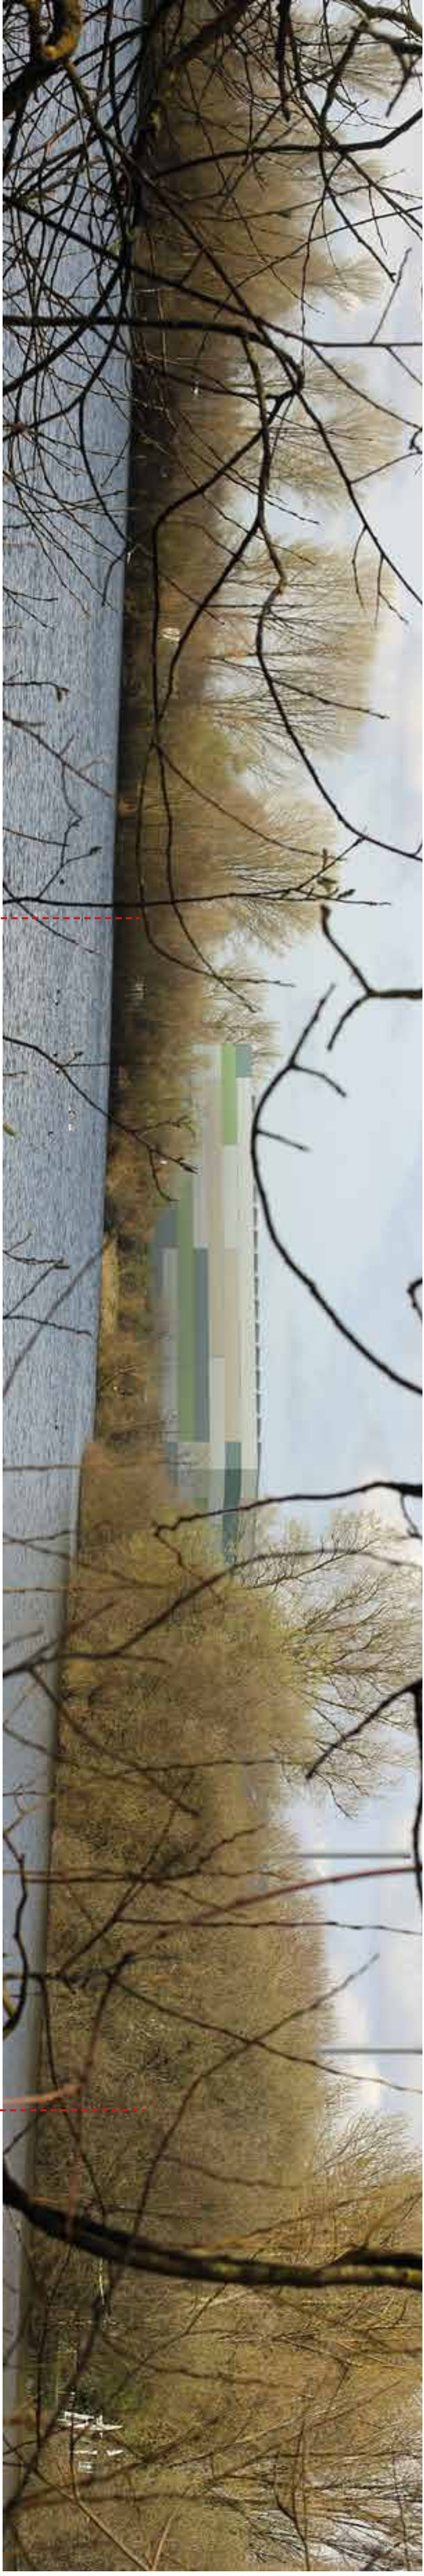
View including proposed development - year 1

Approx. Extent of Site

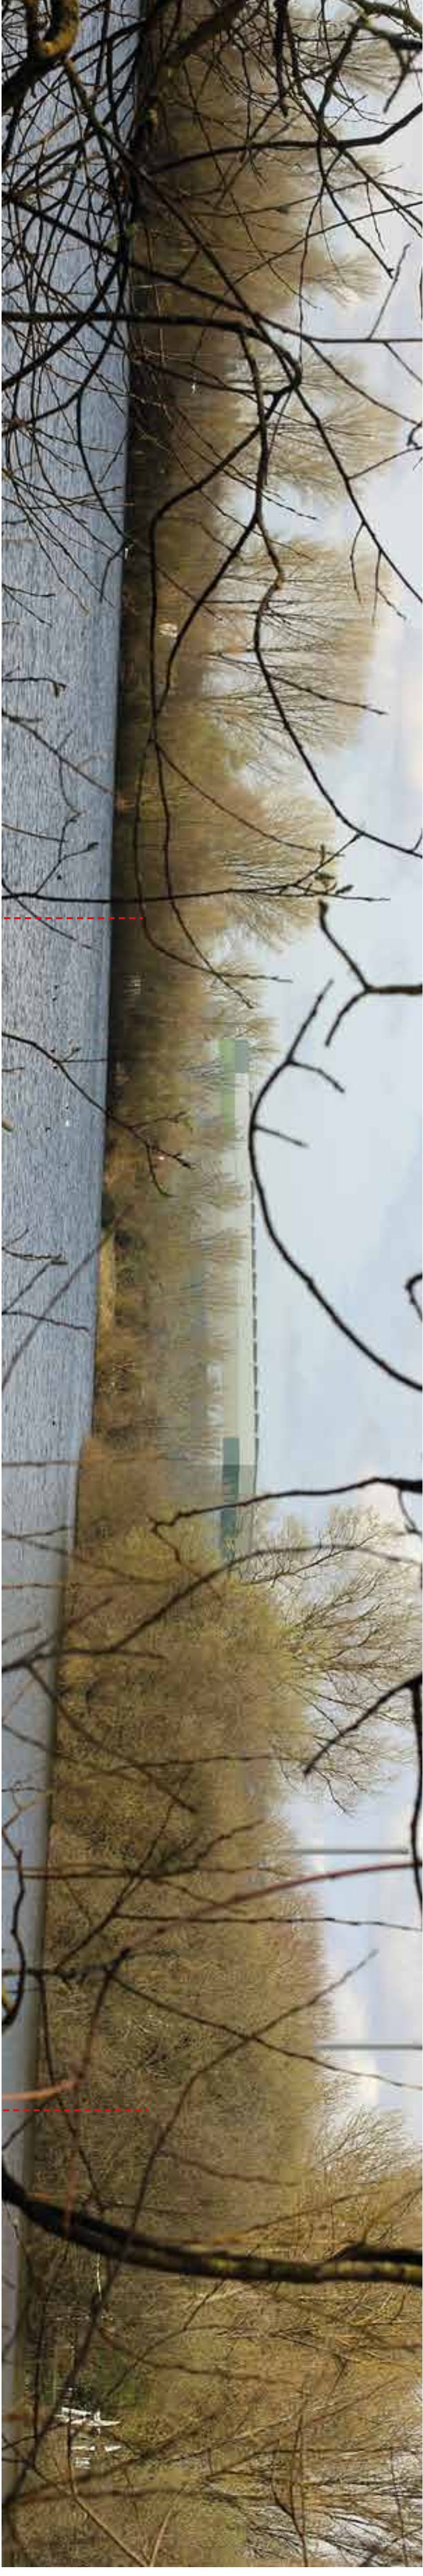
View including proposed development - year 15

Approx. Extent of Site

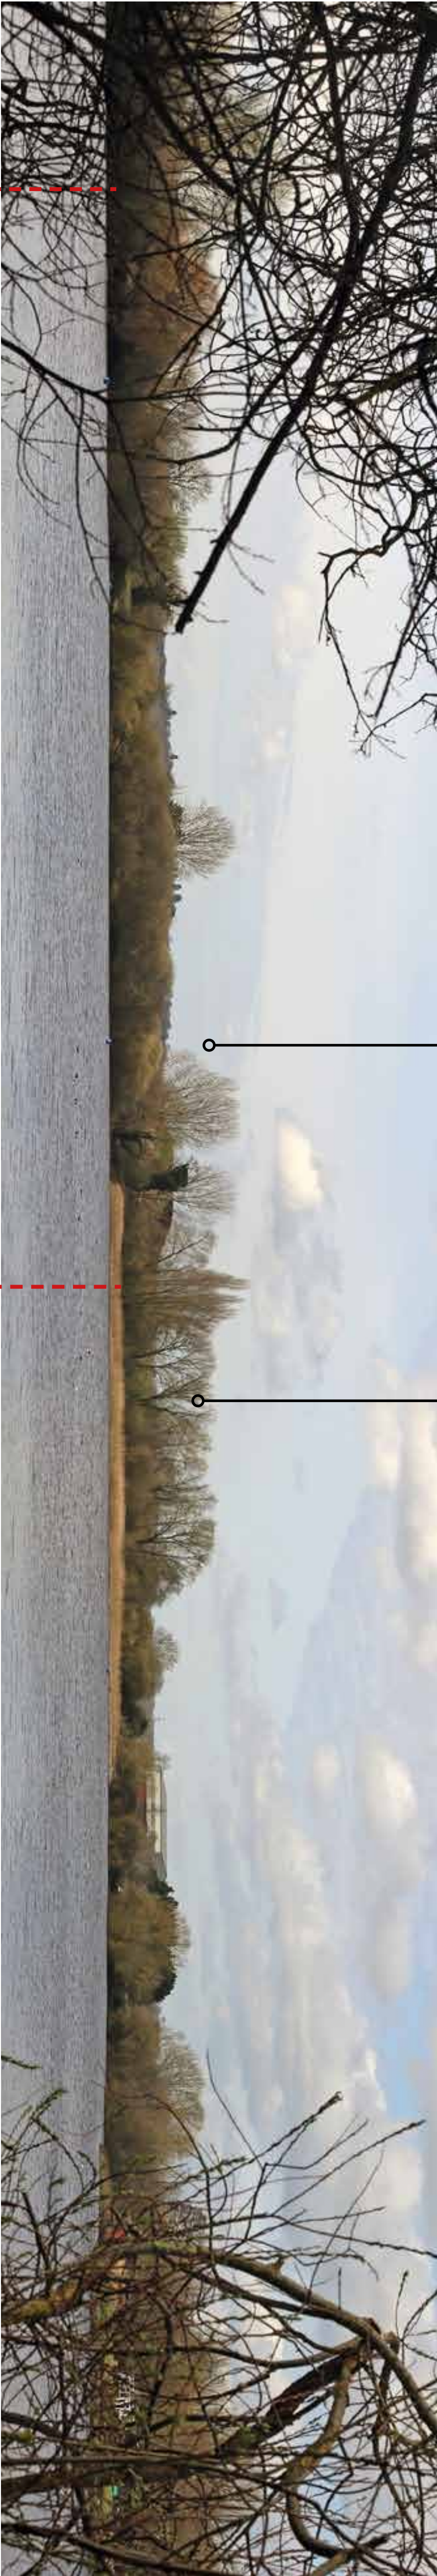
Existing View

Approx. Extent of Site

Viewpoint ID: 3  
Map Co-Ordinates: SU 68958 70098  
Height at Ground Level (AOD): 42.2m  
Approx. Distance to Site: 485m  
Direction from Site: North East

Date of Photo: 20.03.2020  
Weather Conditions: Sunny  
Surveyor: SH  
Angle of View: 90°  
Distance from Viewer: 500mm

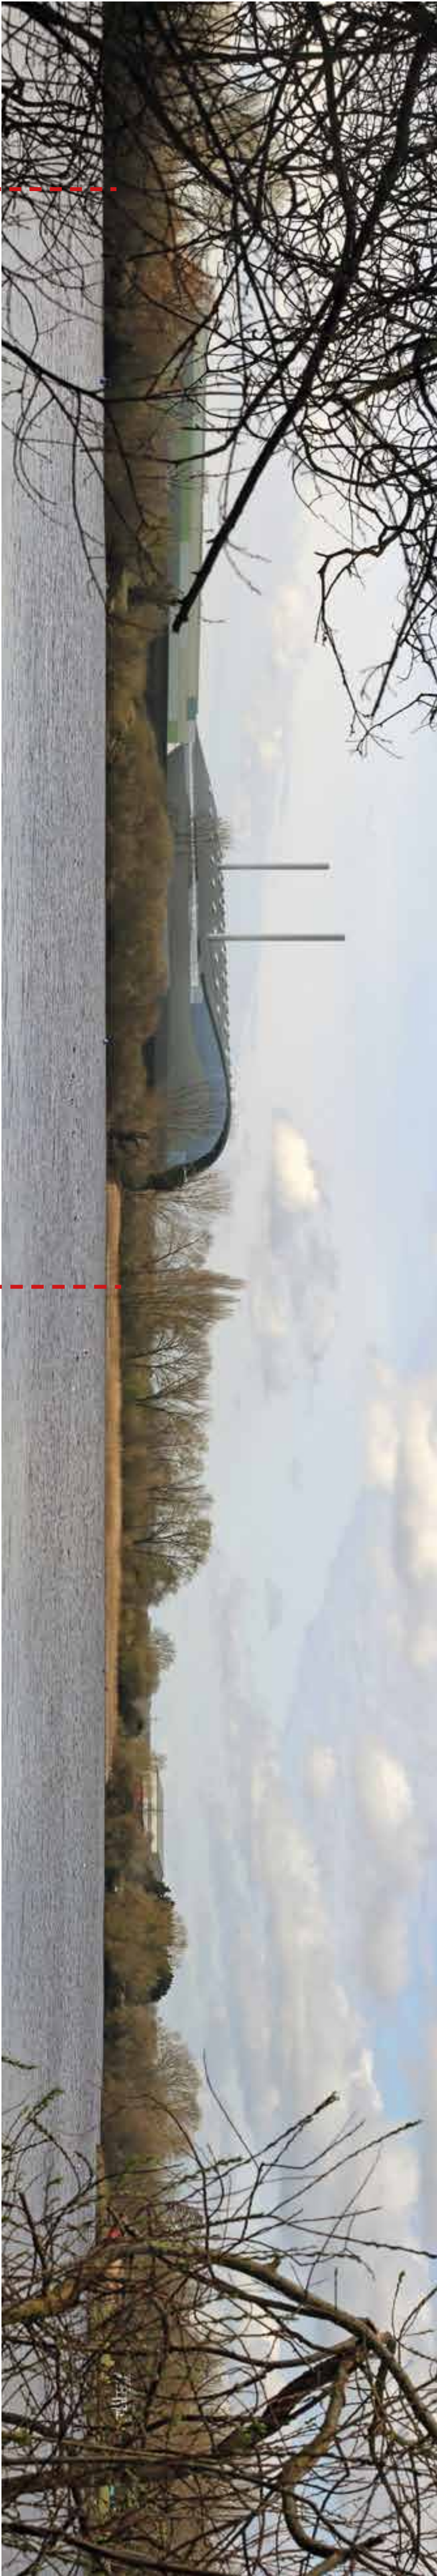
View including proposed development - year 1

Approx. Extent of Site

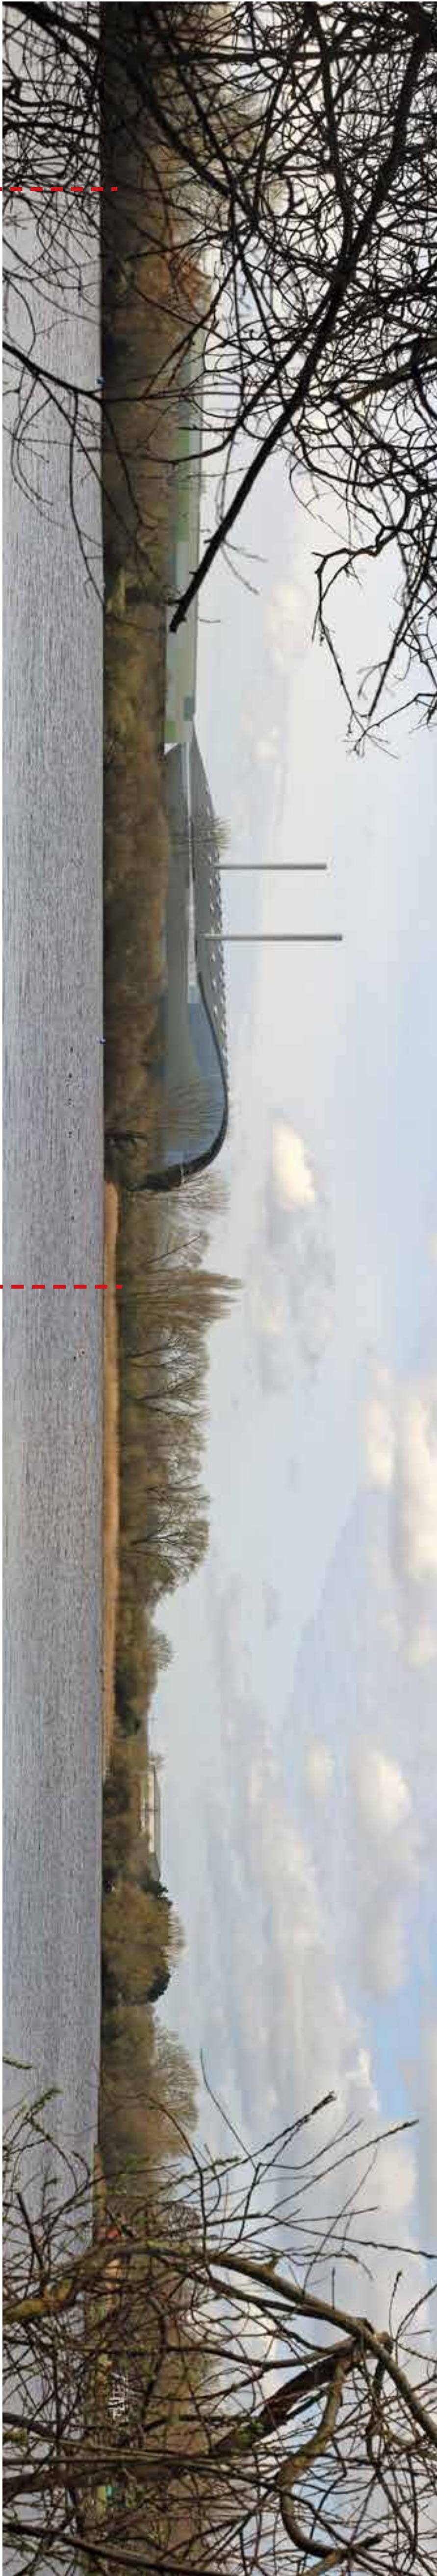
View including proposed development - year 15

Approx. Extent of Site
