# Site Investigation Report

113774.1.TSI

Auger were commissioned by Sedgwick to undertake a site investigation within the area of concern at the property.

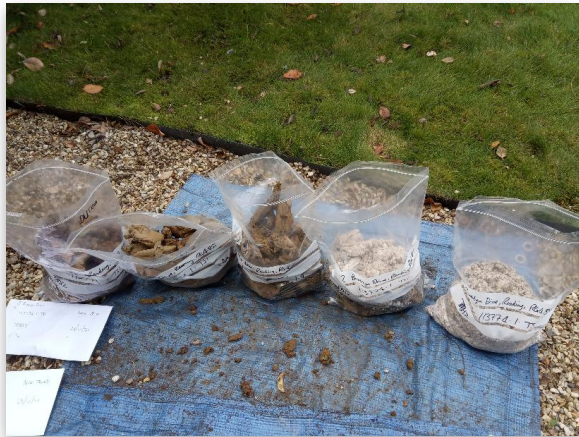
Fig 3.1: Soil samples collected

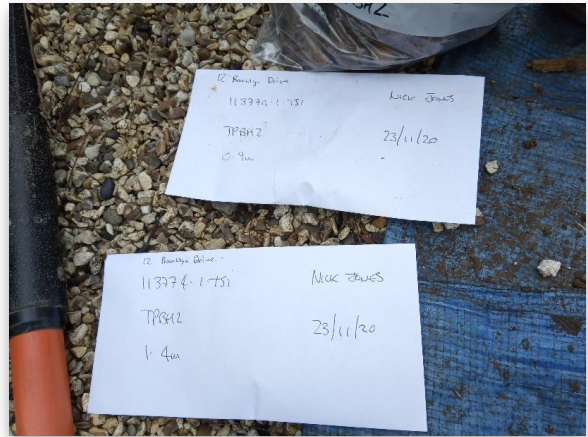
Fig 3.2: Root samples collected

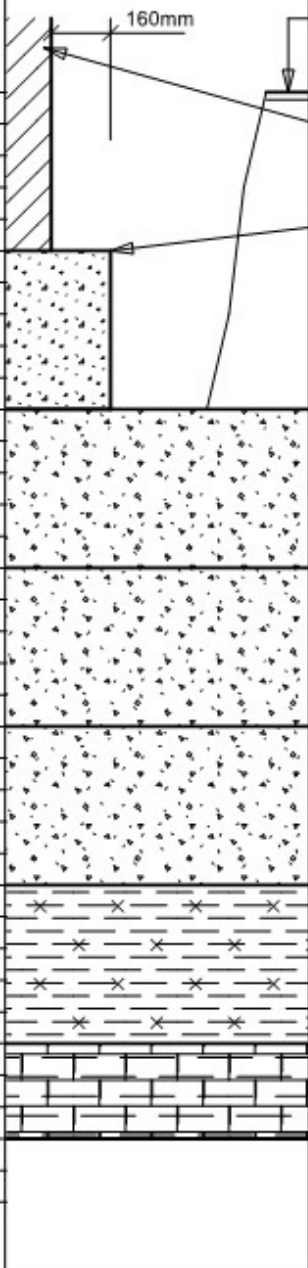
# Trial Hole Log No.1

Location: Front left x2 ext

| Depth<br>(m) | Symbolic Log | Strata Description | Insitu Tests | | Soil<br>Sample | Root<br>Sample |
|---|---|---|---|---|---|---|
| | | Soil (Border) | | | | |
| | | Blockwork | | | | |
| | | Concrete | | | | |
| 1.0 | | Dry medium dense Brown sandy GRAVEL | | 90blows | Soil @ 1m | Root @ 1m |
| 1.5 | | Brown fine gravelly sandy silty CLAY | | 66blows | Soil @ 1.5m | |
| 2.0 | | Brown sandy GRAVEL | | 150blows | Soil @ 2m | |
| 2.5 | | Dry very stiff Brown fine gravelly silty CLAY | 100kpa | | Soil @ 2.5m | |
| 3.0 | | Dry very stiff Brown off white fine to medium chalky silty CLAY | 120kpa | | Soil @ 3m | |
| 3.5 | | TRIAL HOLE TERMINATED | 120kpa | | | |

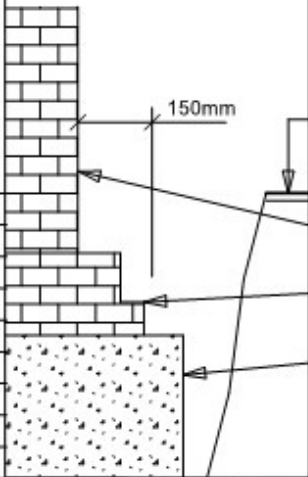
## Trial Hole Log No.2

Location: Front right x2 main house

| Depth<br>(m) | Symbolic Log | Strata Description | Insitu Tests | | Soil<br>Sample | Root<br>Sample |
|---|---|---|---|--|---|---|
| 0.0 | | Ground Level<br>Soil (Border)<br>Brickwork<br>Double Step<br>Concrete | | | | |
| 1.0 | | Dry very stiff Brown fine to medium gravelly silty CLAY | 120kpa | | Soil<br>@ 0.9m | Root<br>@ 0.9m |
| 1.5 | | Brown silty CLAY | 128kpa | | Soil<br>@ 1.4m | Root<br>@ 1.4m |
| 2.0 | | Dry very stiff Brown fine to medium gravelly silty CLAY | 126kpa | | Soil<br>@ 1.9m | |
| 2.5 | | Dry very stiff Off white brown CHALK | 120kpa | | Soil<br>@ 2.4m | |
| 3.0 | | Off white clayey CHALK | 120kpa | | Soil<br>@ 2.9m | |
| 3.5 | | TRIAL HOLE TERMINATED | 120kpa | | | |
