# Full Arboricultural Method Statement<sup>©</sup>

Site: 16 Russett Glade, Emmer Green, Reading RG4 8UJ Planning No: 201492

Client: Mr Greg Muden Date: May 2021 Surveyor: Hugo Loudon

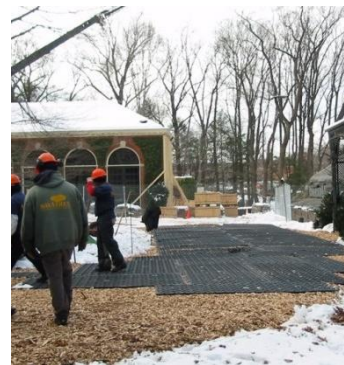
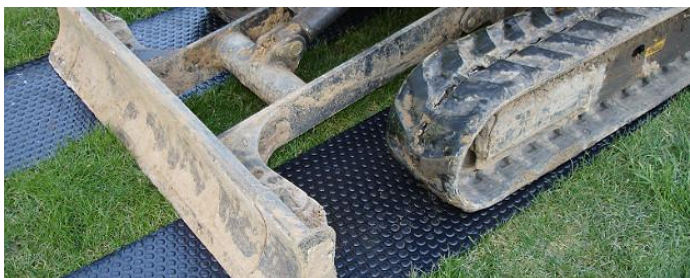
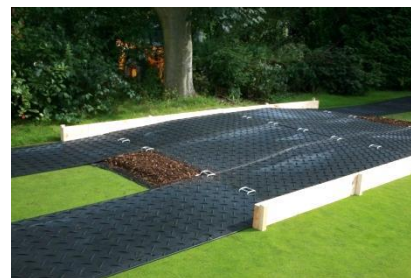
## Generic example of how to install ground weight distribution boards on uneven ground within a Root Protection Area (RPA) - Cross-sectional view

10.4 Should wheeled or tracked machinery be required within the RPA's, Temporary Track Road Systems or Ground Protection Boards, comprising of interlocking solid polythene sheets measuring 244cm x 122cm (made from 90% recycled materials) capable of dispersing weight, are available to hire from the Arborist. The sheets are lifted and taken away upon completion of the project. See further information here: MultiTrack Ground Protection Guards (<https://www.greentech.co.uk/ground-reinforcement/ground-guards/multitrack-ground-protection-guards>)

10.1 Any ground protection required, as shown on the Tree Protection Plan (TPP), must be capable of supporting loads evenly without causing ruts, divots or soil compaction which will inhibit the uptake of vital nutrients and moisture by the roots.

10.2 To protect the ground from pedestrian loads when working within the Root Protection Area (RPA), the advised following method allows oxygen and moisture to reach roots:

- Install a Geotextile membrane over the area.
- Top with a layer of bark chippings
- Place scaffold boards on top of chippings ensuring boards are firmly butted up close to one another
- Further scaffolding levels will give the construction team access to higher levels, if need be.

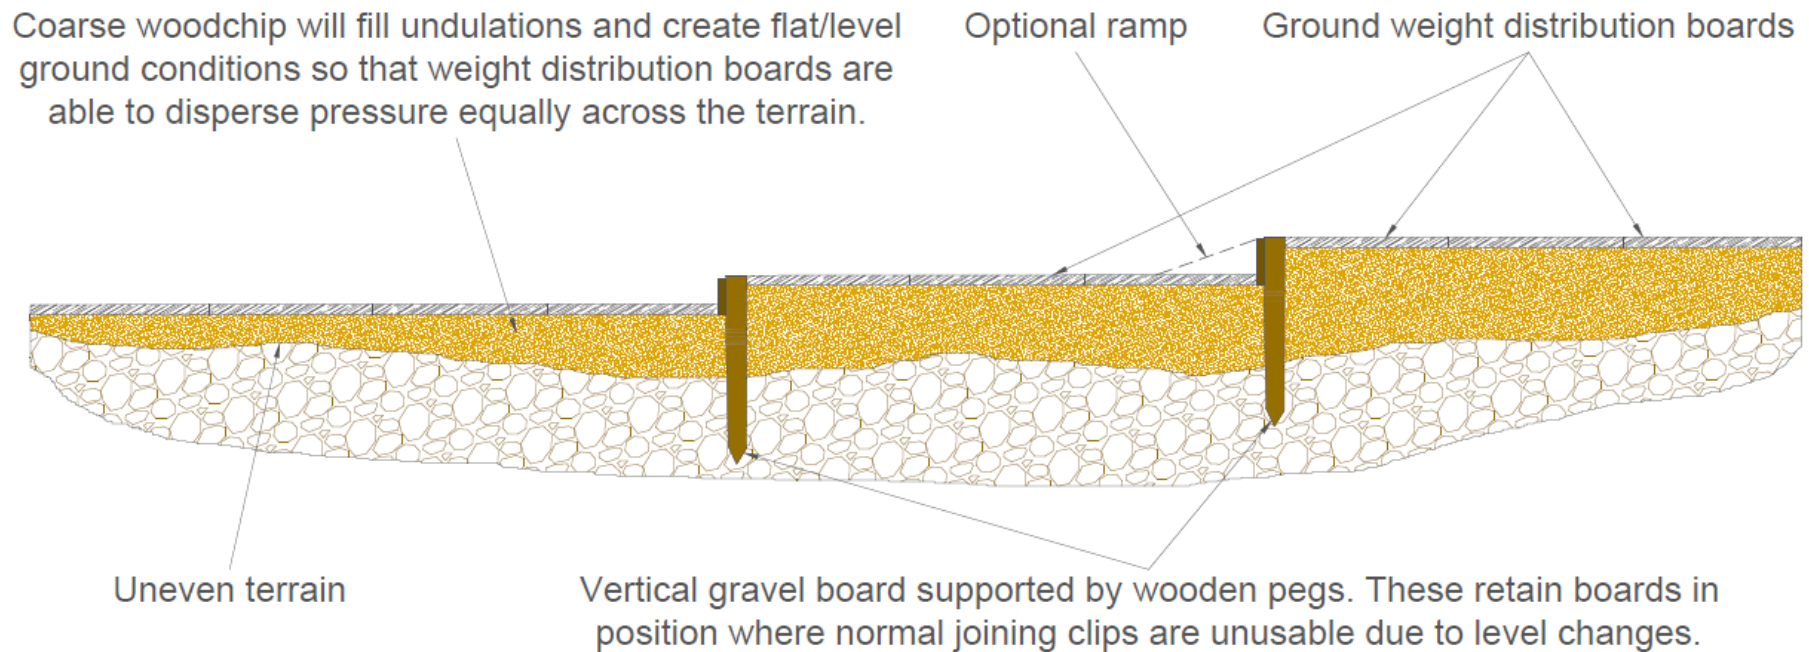
(Please refer to Section 10 of the Arboricultural Method Statement)

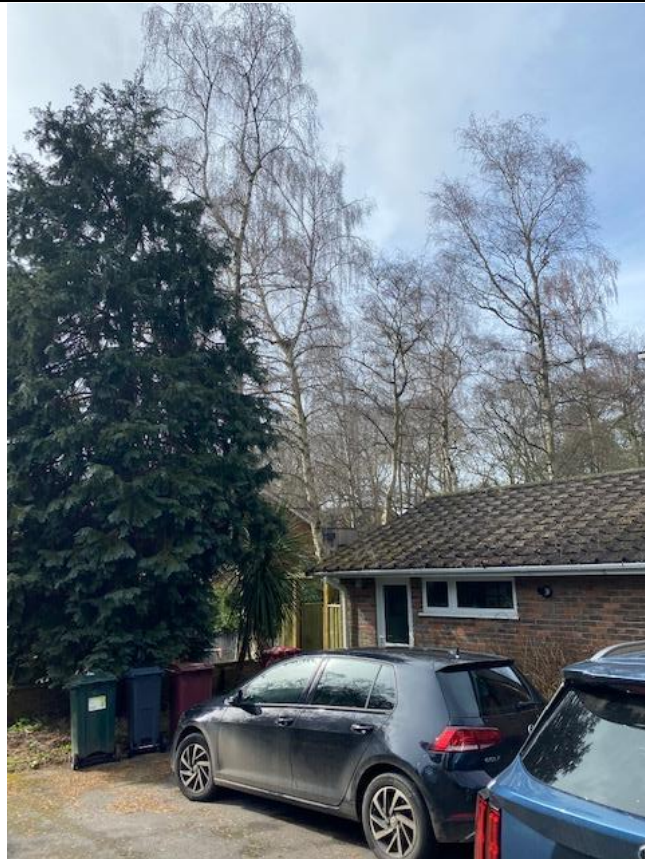
T1 Lawson Cypress to left

| TREE<br>or<br>Group<br>or<br>Hedge | Species<br>Common Name<br>If tree offsite,<br>record<br>estimated<br>measurements<br>using '#' | DBH at<br>1.5m<br>recorded<br>in mm | Canopy<br>Height in<br>metres + First<br>Branch in<br>metres from<br>ground level<br>with cardinal<br>direction | Branch<br>Spread<br><br>N E S W<br>metres | Age<br><br>Y<br>SM<br>EM<br>M<br>LM<br>OM<br>Vet | SULE<br><br><10<br>10+<br>20+<br>40+ | General Observations | Structural<br>form<br><br>Poor<br>Fair<br>Good<br>Dead | Physiological<br>form<br><br>Poor<br>Fair<br>Good<br>Dead | BS<br>5837<br>RC<br><br>A<br>B<br>C<br>U | BS 5837<br>RPA<br>Radius<br>recorded<br>in metres<br>m and m <sup>2</sup> | Recommended Works |
|---|---|---|---|---|---|---|---|---|---|---|---|---|
| T1 | Lawson<br>Cypress | 420 | H: 10m<br><br>FB: 1m/W | N 2<br>E 2<br>S 3<br>W 4 | M | 40+ | Historic sib-stem removal to<br>north.<br><br>Likely to become dominant and<br>shade property in time. | Good | Good | C2 | 5.1m<br>81m <sup>2</sup> | --- |

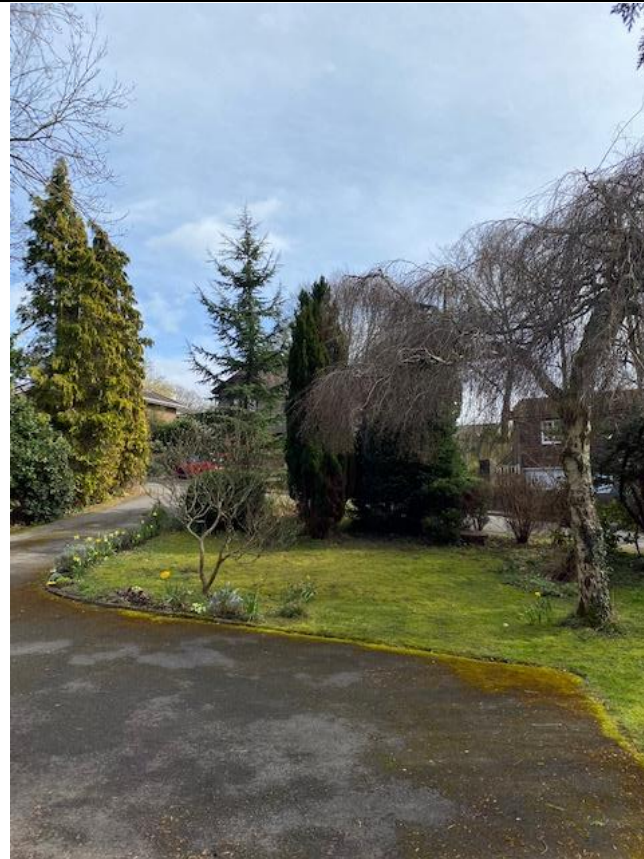
Road frontage to south. Right to left: T2, T3, T4, T5

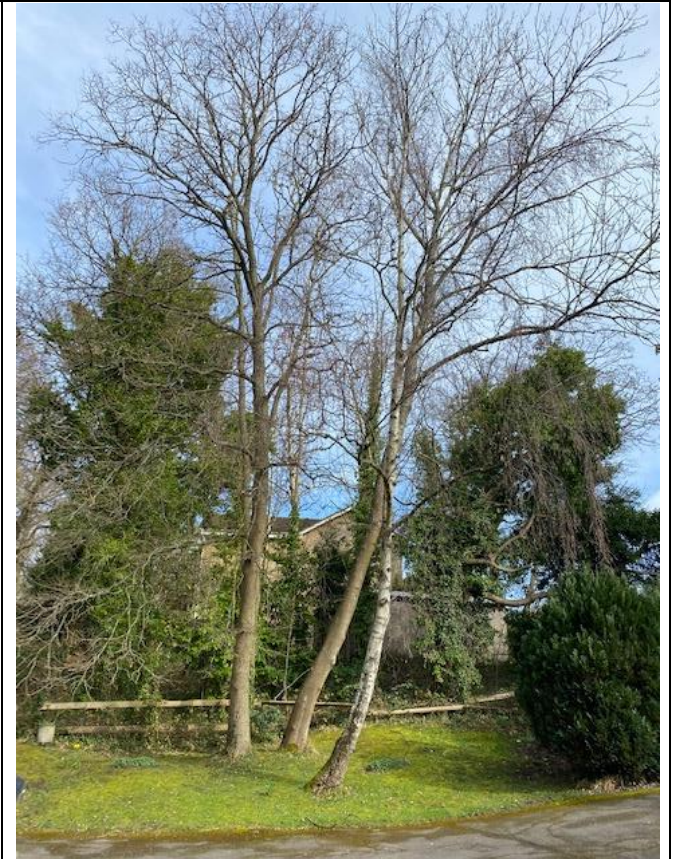
T6 in foreground with T7 and T8 behind. Note T8 being of high amenity value

| T6 | Birch | 250 | H: 12m<br><br>FB: 3m/S | N 0<br>E 1<br>S 6<br>W 4 | EM | 10+ | Canopy bias to south.<br>Some evidence of retrenchment. | Poor | Fair | C3 | 3.0m<br>28m <sup>2</sup> | --- |
| T7 | Ash | 330 | H: 14m<br><br>FB: 8m/S | N 3<br>E 3<br>S 7<br>W 3 | M | 10+ | Canopy bias to south. | Good | Good | B2 | 3.9m<br>48m <sup>2</sup> | Monitor for signs of Ash<br>Dieback. |
| T8 | Oak | 380 | H: 14m<br><br>FB: 4m/N | N 6<br>E 3<br>S 3<br>W 5 | EM | 40+ | Drawn form with competitive<br>proximity to T7 and T9. | Good | Good | A1 | 4.5m<br>64m <sup>2</sup> | --- |

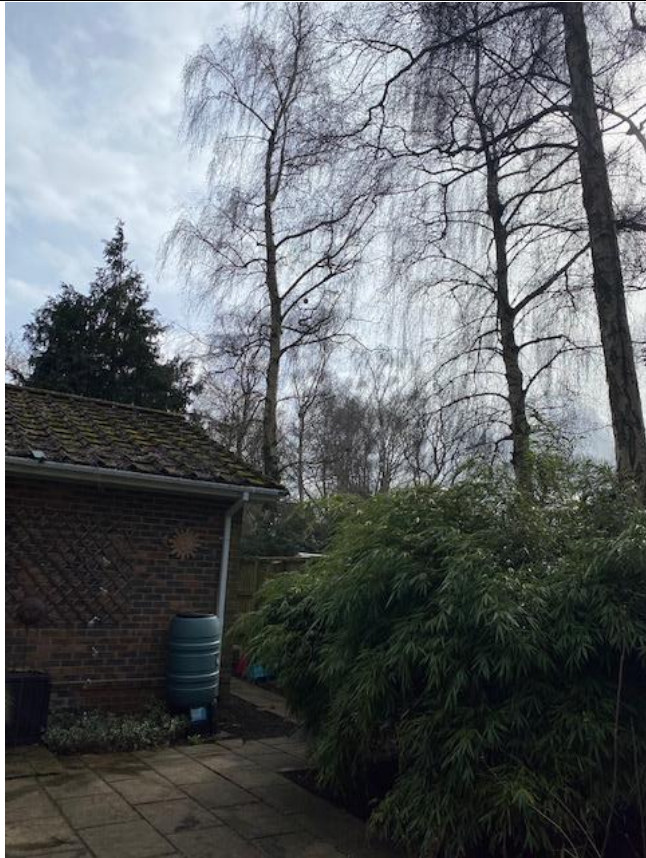
T10 left and T11 far right

| T10 | Birch<br># | 380 | H: 15m<br><br>FB: 5m/S | N 3<br>E 3<br>S 5<br>W 5 | M | 20-<br>40 | Some basal swelling.<br>Canopy bias to south. | Fair | Good | B2 | 4.5m<br>64m <sup>2</sup> | --- |
| T11 | Birch<br># | 250 | H: 13m<br><br>FB: 5m/S | N 4<br>E 4<br>S 4<br>W 4 | EM | 20-<br>40 | No access to next-door. | Good | Good | B2 | 3.0m<br>28m <sup>2</sup> | --- |

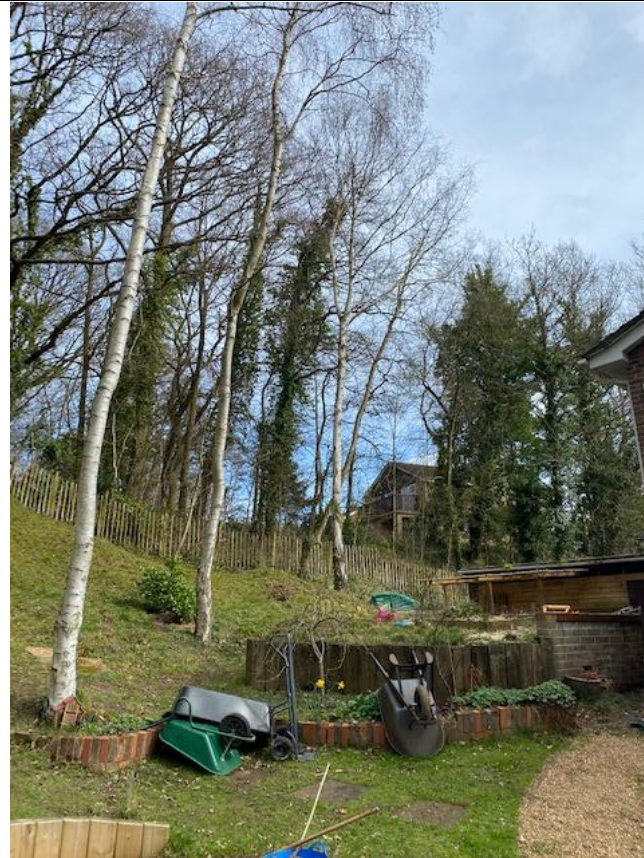
T12A+B, T13 and T14

| T12<br>A+B | 2x Birch | 200 | H: 16m<br><br>FB: 8m/S | N 1-3<br>E 1-3<br>S 1-3<br>W 1-3 | EM | 40+ | Nothing of note. | Fair | Fair | B2 | 2.4m<br>18m <sup>2</sup> | --- |
| T13 | Birch | 245 | H: 15m<br><br>FB: 8m/S | N 3<br>E 2<br>S 5<br>W 5 | M | 20-<br>40 | Bifurcation at 8.0. Basal cambium<br>lost with exposed scar to east.<br>Some embrittlement and wound<br>wood formation. | Poor | Fair | C2 | 3.0m<br>28m <sup>2</sup> | --- |
| T14 | Ash | 150 | H: 15m<br><br>FB: 7m/S | N 0<br>E 2<br>S 5<br>W 2 | SM | <10 | Acute decay in stem. Historical<br>leader loss apparent to south.<br>Tip dieback issues associated with<br>Ash Dieback Disease. | Poor | Poor | C3 | 1.8m<br>10m <sup>2</sup> | --- |

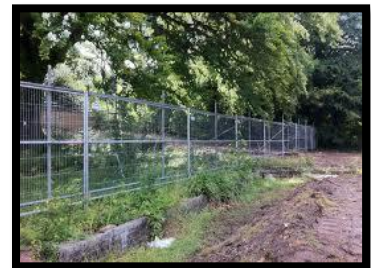
TREE PROTECTION BY HERAS PANELS  
OR MARINE BOARD BOXING

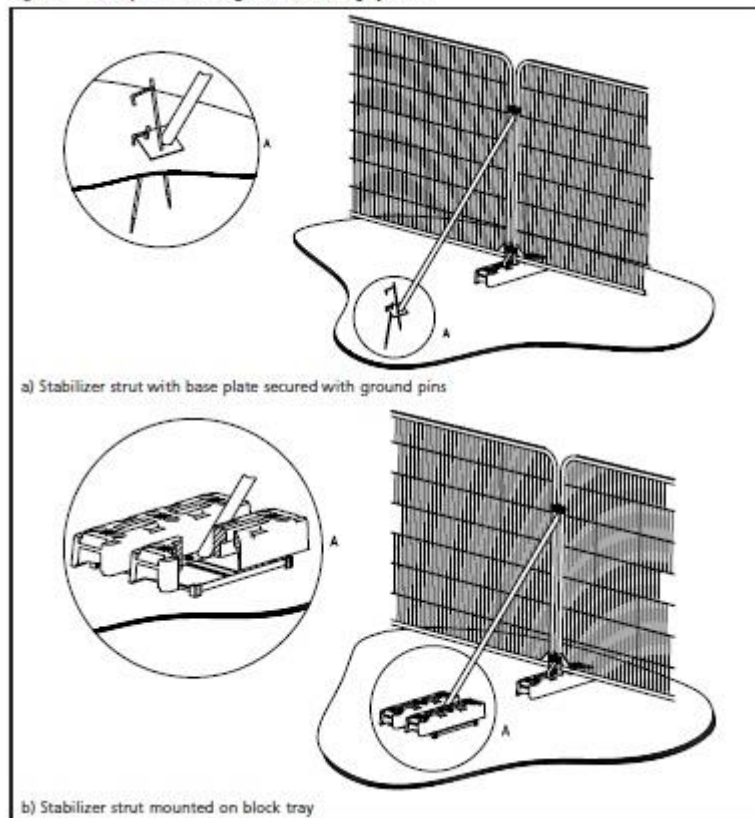
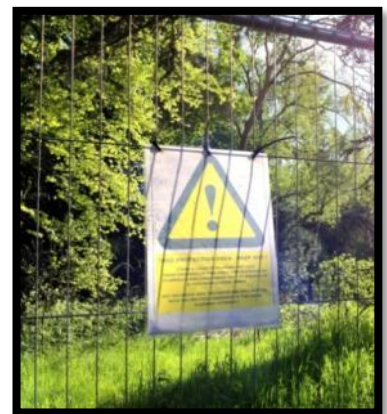
Figure 3 Examples of above-ground stabilizing systems

ALL WEATHER SIGNAGE  
(SHOWN IN APPENDIX D)  
DISPLAYED ON HERAS PANELS

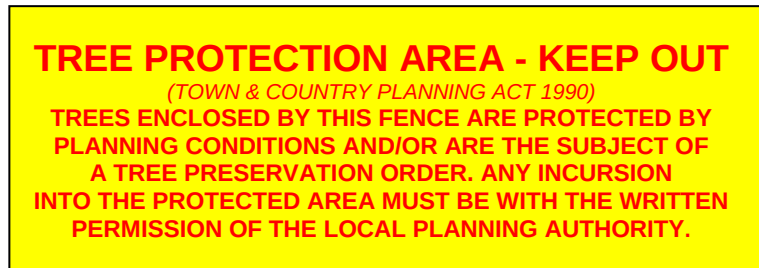
All weather signs, such as this example, must be fixed to the outer perimeter of the site, ideally to the fence panels, but not directly onto the trees.

- 9.4 The all-weather signage (Appendix D) must be attached to the fencing for public display and not attached directly to the tree stems. Once the Construction Exclusion Zone (CEZ) is clearly defined by the Tree Protection Fencing and relevant signage, construction can commence.
