7695: READING INTERNATIONAL  
LOGISTIC PARK, READING,  
BERKSHIRE

HABITAT LOSS, CREATION AND  
ENHANCEMENT

Rev: A  
Dec 2020

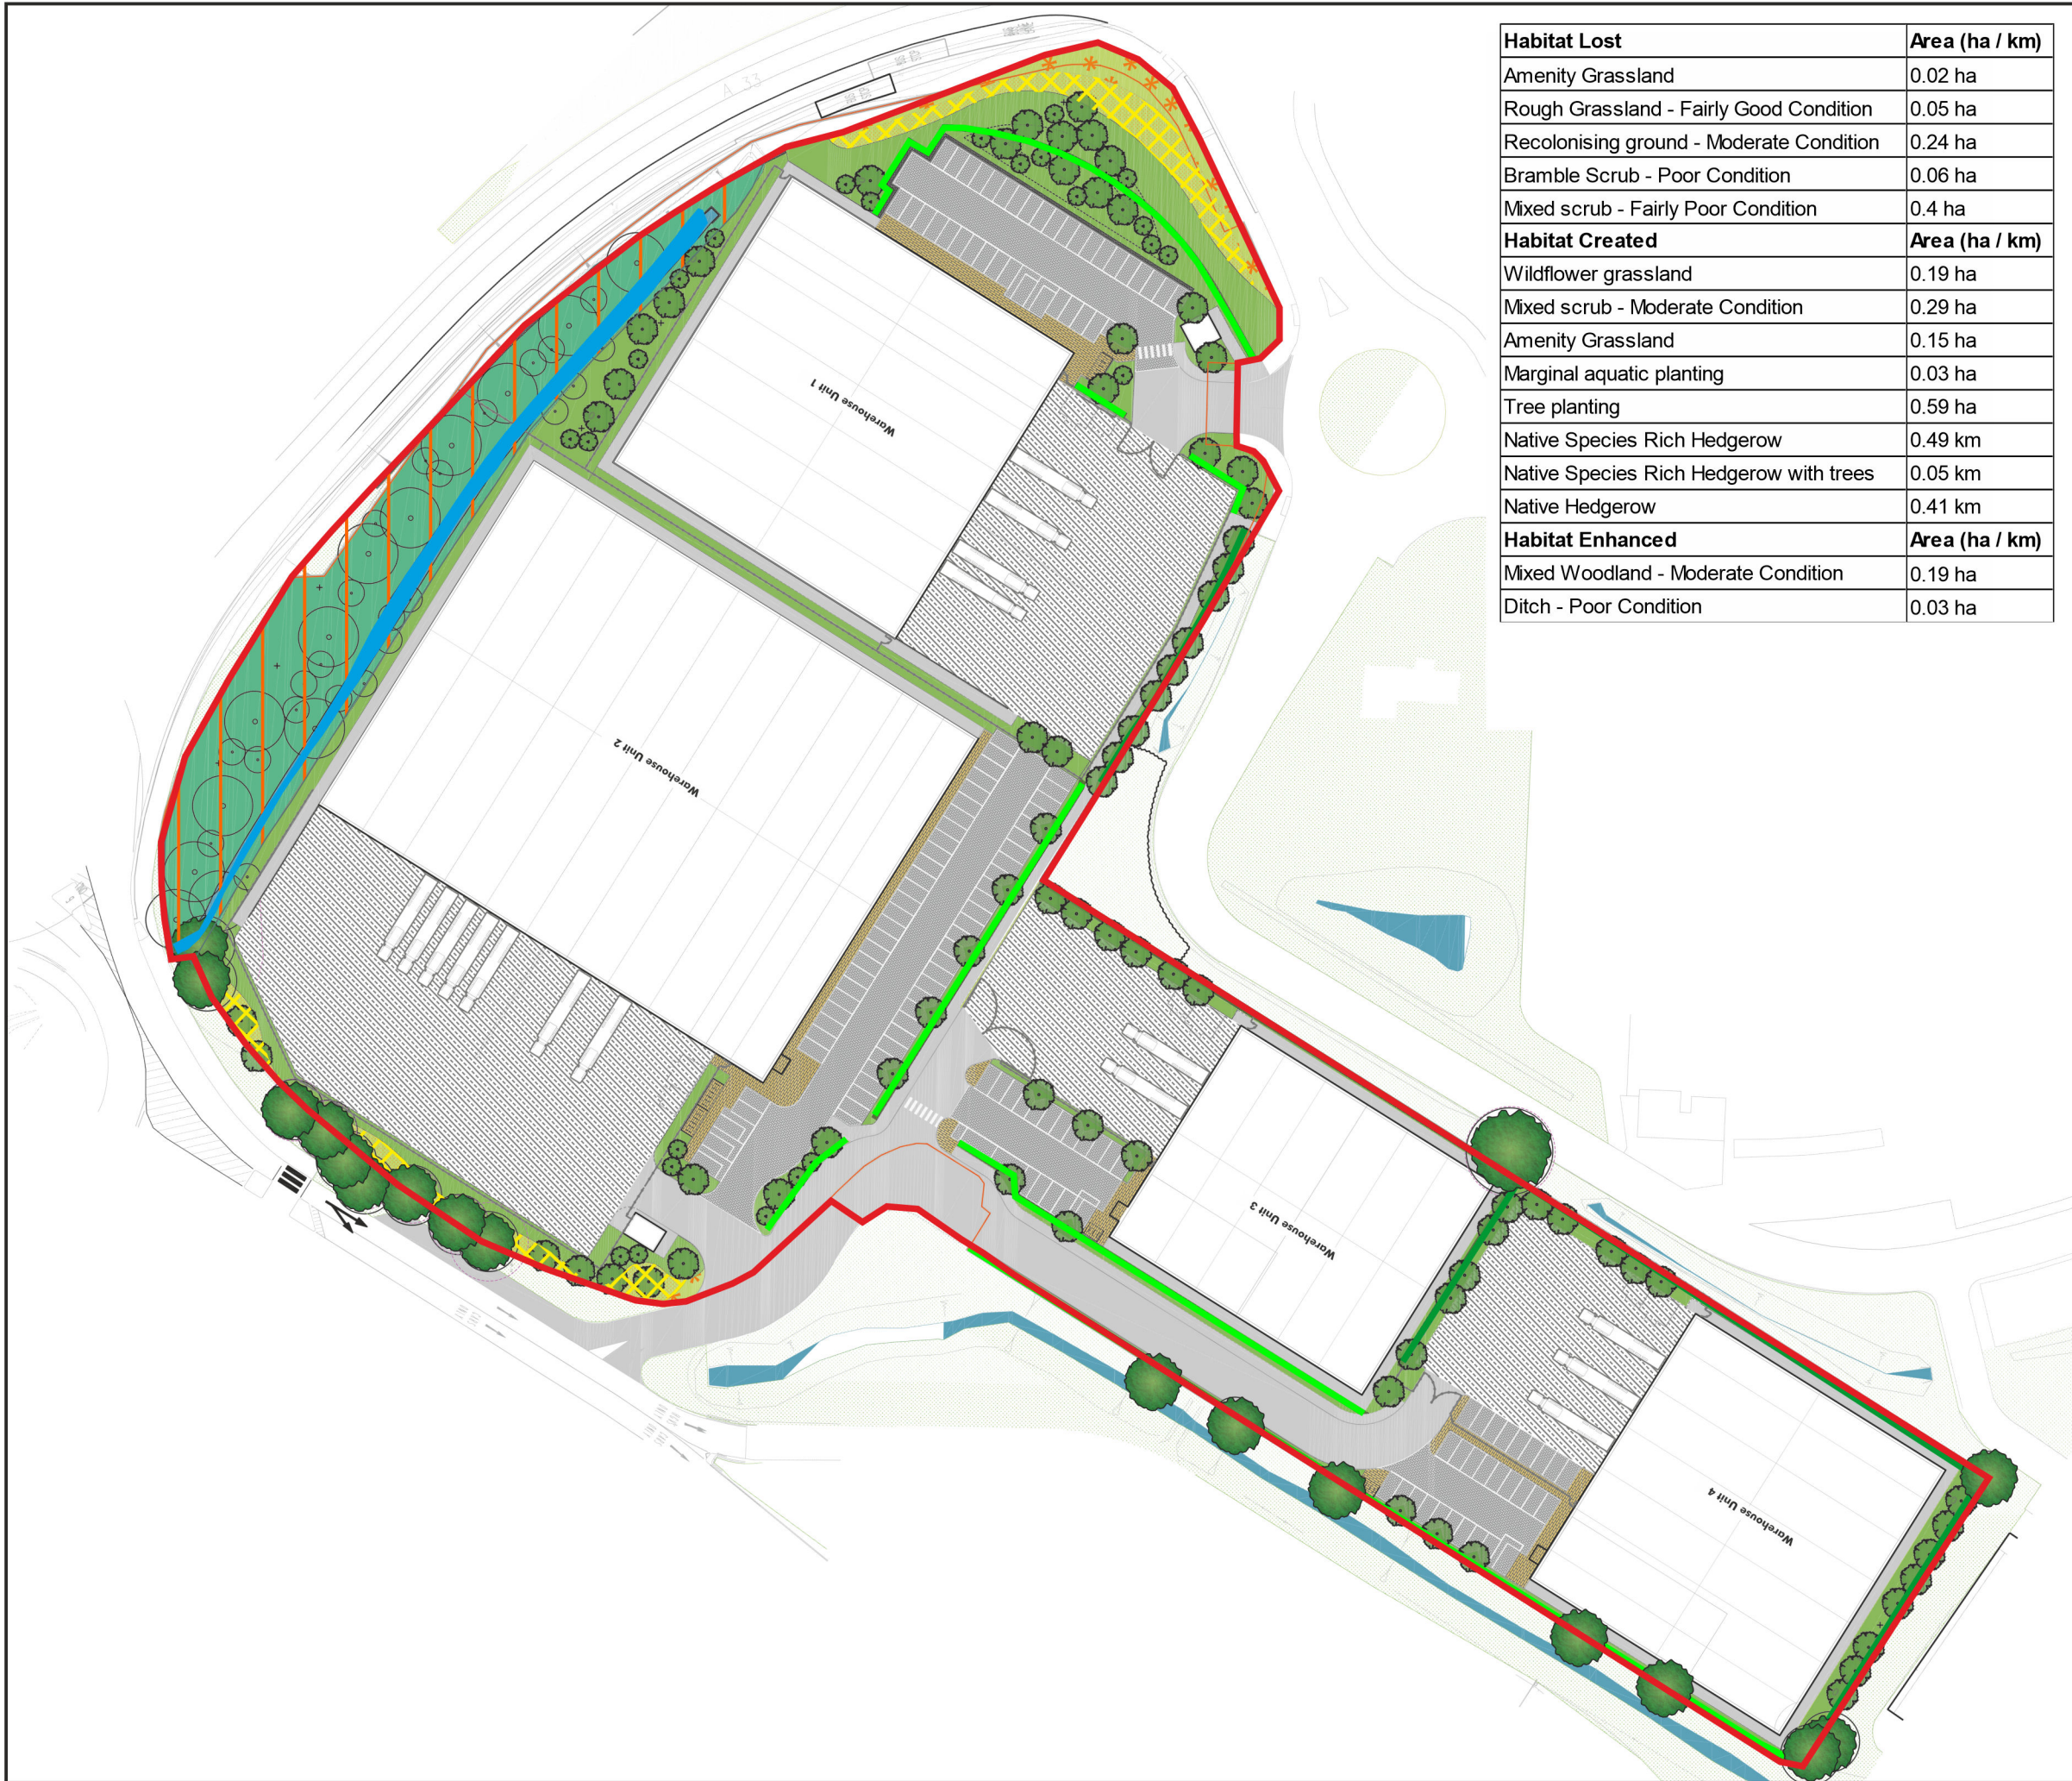
| Habitat Lost | Area (ha / km) |
| Amenity Grassland | 0.02 ha |
| Rough Grassland - Fairly Good Condition | 0.05 ha |
| Recolonising ground - Moderate Condition | 0.24 ha |
| Bramble Scrub - Poor Condition | 0.06 ha |
| Mixed scrub - Fairly Poor Condition | 0.4 ha |
| Habitat Created | Area (ha / km) |
| Wildflower grassland | 0.19 ha |
| Mixed scrub - Moderate Condition | 0.29 ha |
| Amenity Grassland | 0.15 ha |
| Marginal aquatic planting | 0.03 ha |
| Tree planting | 0.59 ha |
| Native Species Rich Hedgerow | 0.49 km |
| Native Species Rich Hedgerow with trees | 0.05 km |
| Native Hedgerow | 0.41 km |
| Habitat Enhanced | Area (ha / km) |
| Mixed Woodland - Moderate Condition | 0.19 ha |
| Ditch - Poor Condition | 0.03 ha |
