Upper & Lower Ground Floors to 245  
Oxford Road, Reading RG1 7PX

Proposed conversion of upper ground  
floor to 1 two bedroom flat and lower  
ground floor to 2 one bedroom flat.

### **Heritage Statement -REV A 04.04.20**

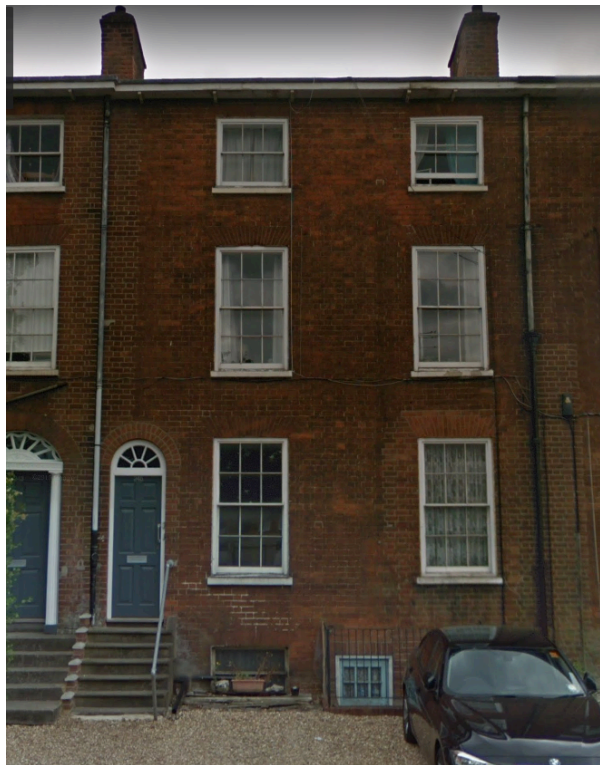
*Figure 1: 245 Oxford Rd-front-Existing photograph*

245 Oxford Road is a mid-terraced four  
storey building, forming Prospect  
Terrace which extends from 2 Lorne  
Street to No. 247 Oxford Road.

Prospect Terrace is grade 2 listed, built  
early-mid 19<sup>th</sup> century, with red clay  
facing brickwork and a slate tiled pitched  
roof, including timber sash windows to  
the upper elevations and replacement  
timber casements to the lower ground  
level. An arched fanlight feature is  
incorporated over the principle entrance  
door

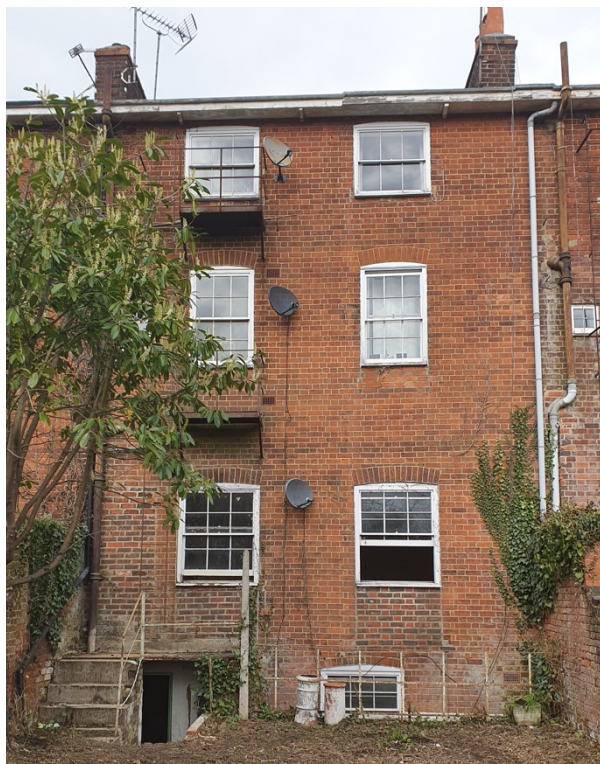
*Figure 2:: 245 Oxford Rd-rear-Existing photograph*

The external works are limited to installing 3 extract grills to the rear elevation and replacing the lower ground external door and window to the front elevation (please see proposed elevations).

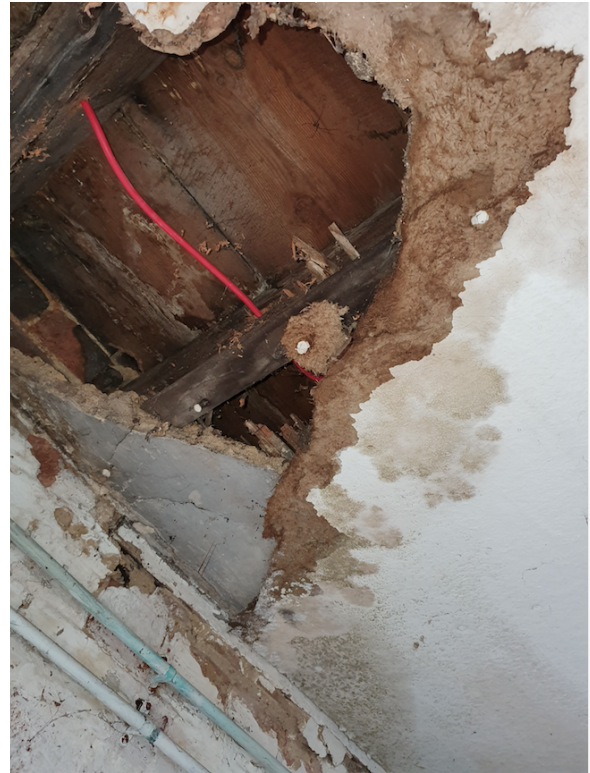
The lower ground floor ceiling is in an extremely poor state of repair, in order to protect the joists GYPROC FIRELINE will be installed throughout (please see image below).

*Figure 3: Ceiling of lower ground floor*
